Release Notification

CLOSURE REPORT

Lateral 2C-24 / Jicarilla L #2B Valve Release
NE ¼, S10 T24N R5W
Rio Arriba County, New Mexico

February 21, 2020
Ensolum Project No. 05A1226076

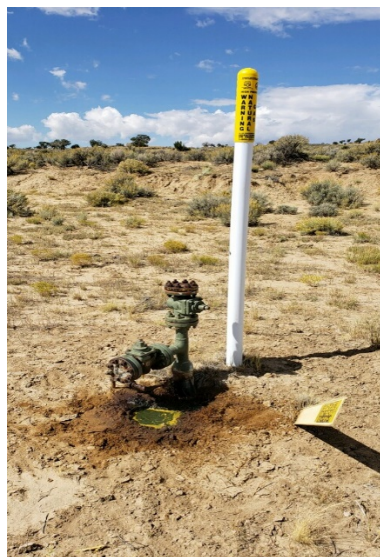
**Photograph 1**

Photograph Description: View of the release area.

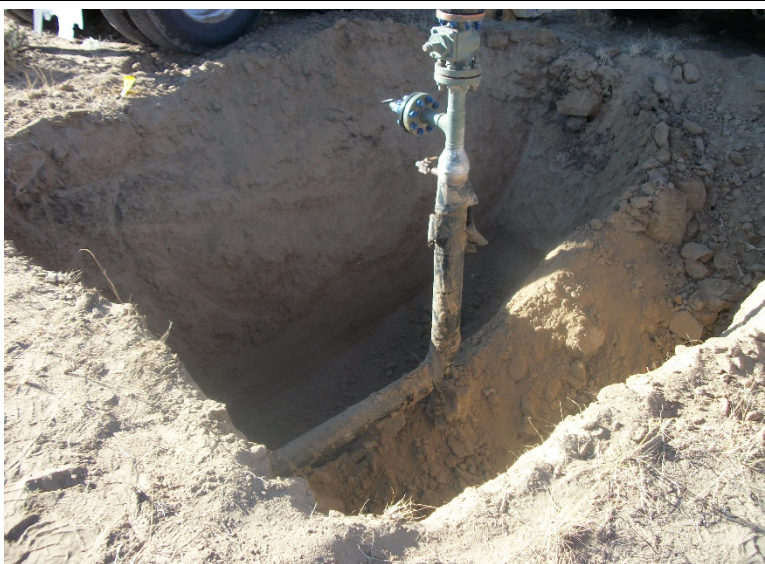
**Photograph 2**

Photograph Description: View of in-process excavation activities.

The final excavation measured approximately eight (8) feet long and eight (8) feet wide at the maximum extents. The average depth of the excavation measured approximately 8.5 feet below grade surface (bgs).

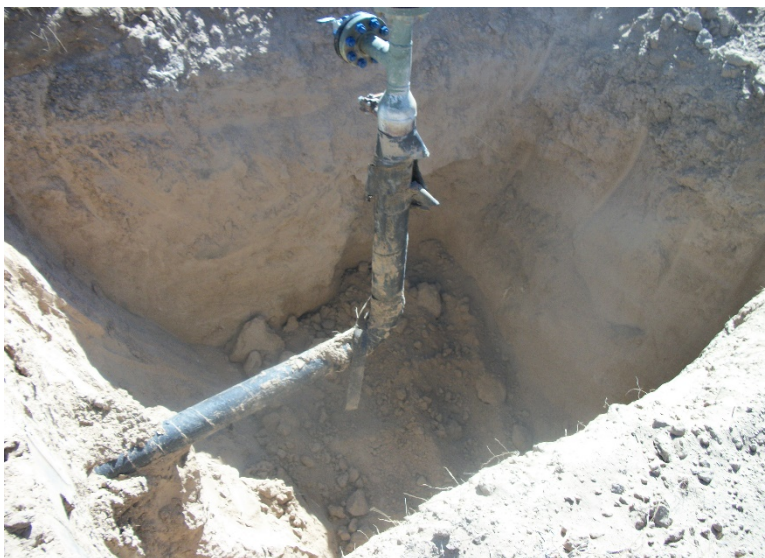
**Photograph 3**

Photograph Description: View of the final excavation.

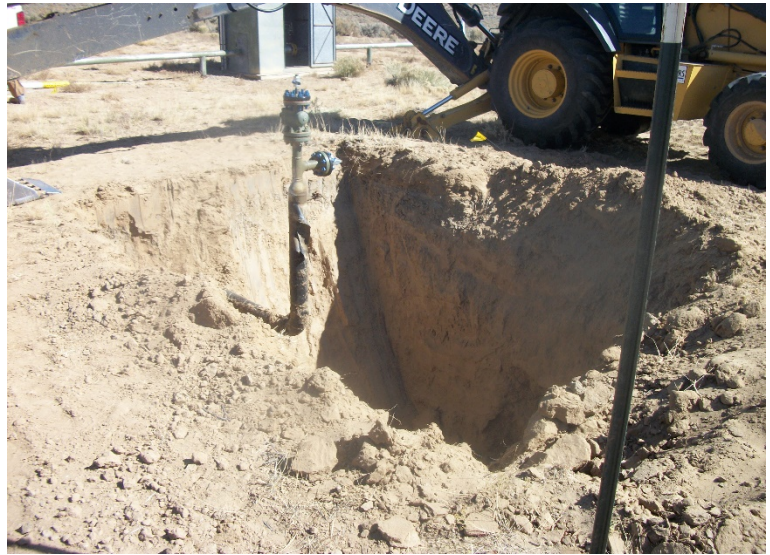
Photograph 4

Photograph Description: View of the final excavation.

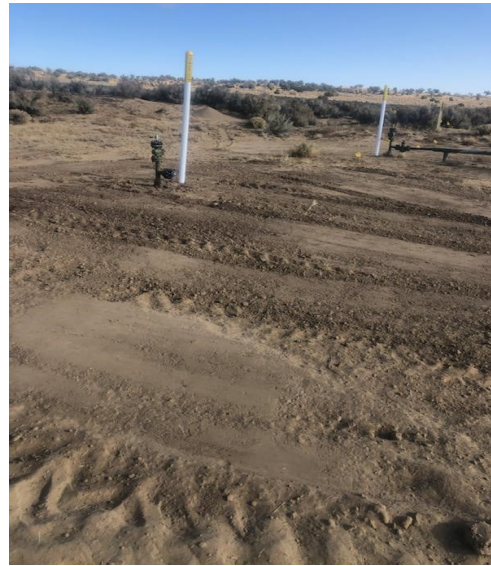
Photograph 5

Photograph Description: View of the final excavation after initial restoration.

The excavation was backfilled with imported unaffected fill and then contoured to match the surrounding grade. Jicarilla Apache Nation Environmental Protection Office correspondence indicating the approval to backfill the excavation is included in **Appendix F**.
