**RE: LINER INSPECTION REPORT
BELL LAKE 19 CTB 3 (NRM2028130276)**

Souder, Miller & Associates (SMA) is pleased to submit this letter report on behalf of Devon Energy Production (Devon) summarizing the liner inspection that occurred due to the Bell Lake 19 CTB 3 release. The site is located in Unit Letter J, Section 19, T24S, R33E (N32.199655 /W-103.608708) Lea County, New Mexico, on State land.

Bell Lake 19 CTB 3 (NRM2028130276) Photo Log

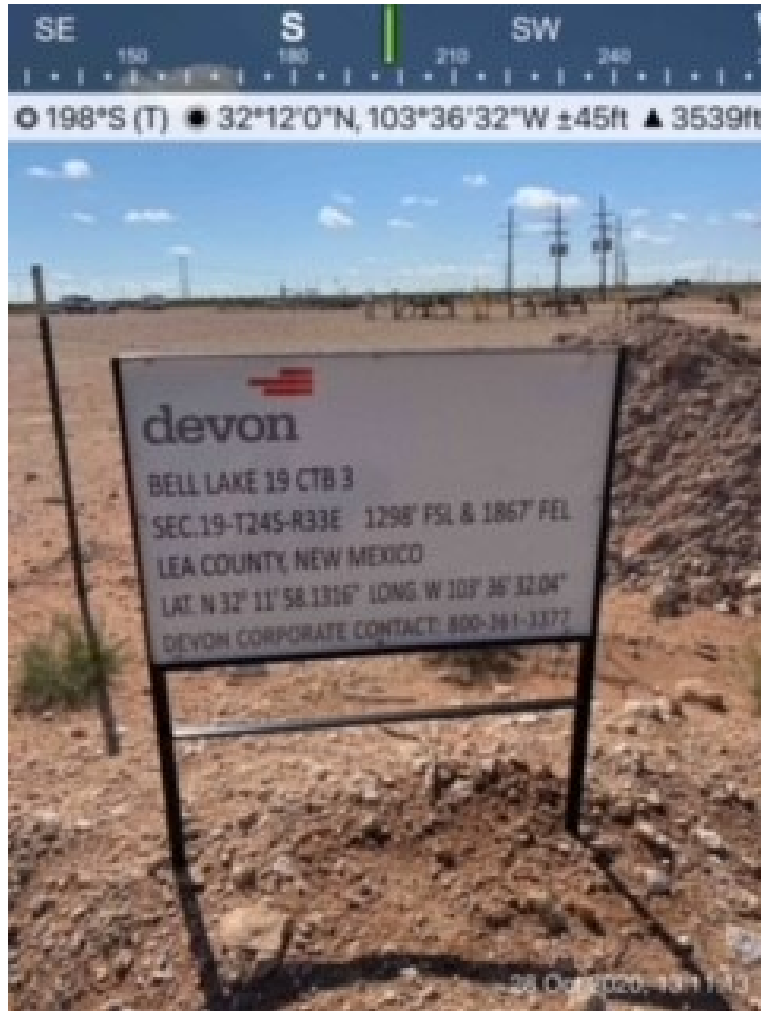
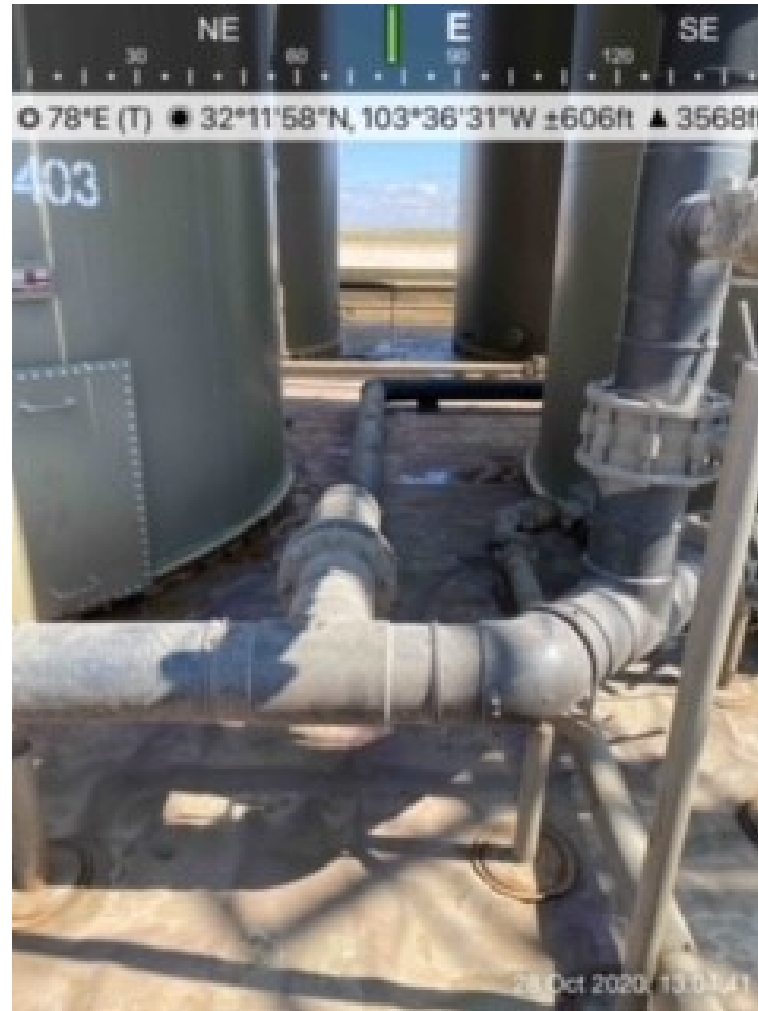
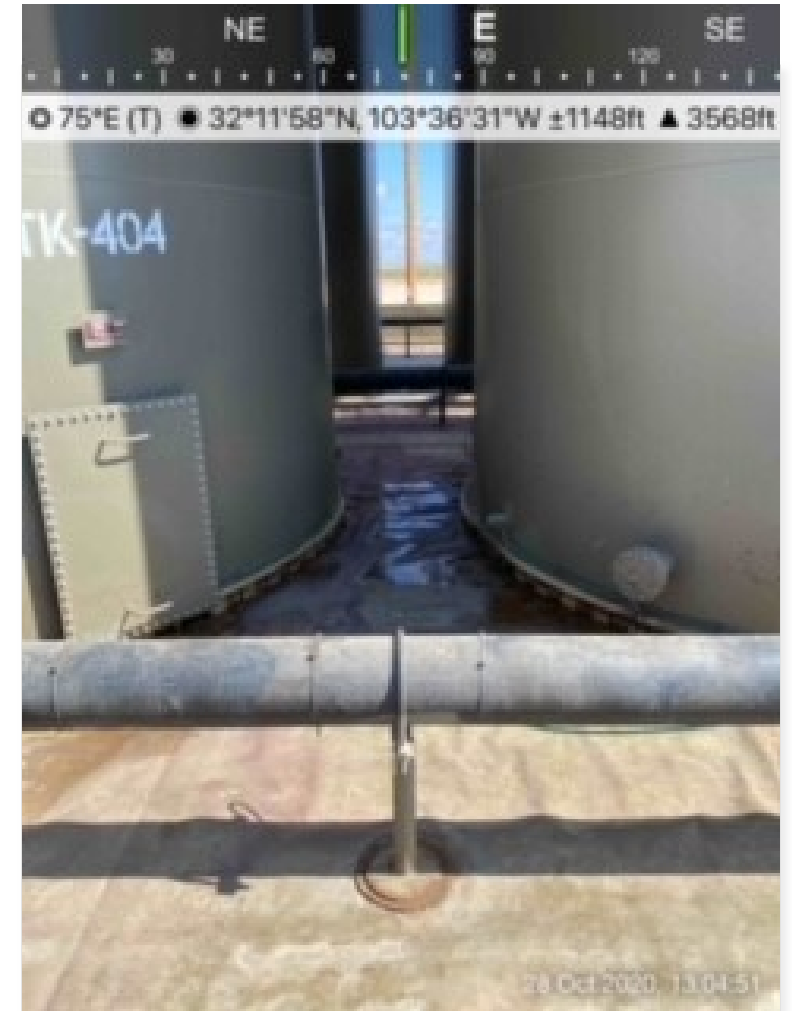
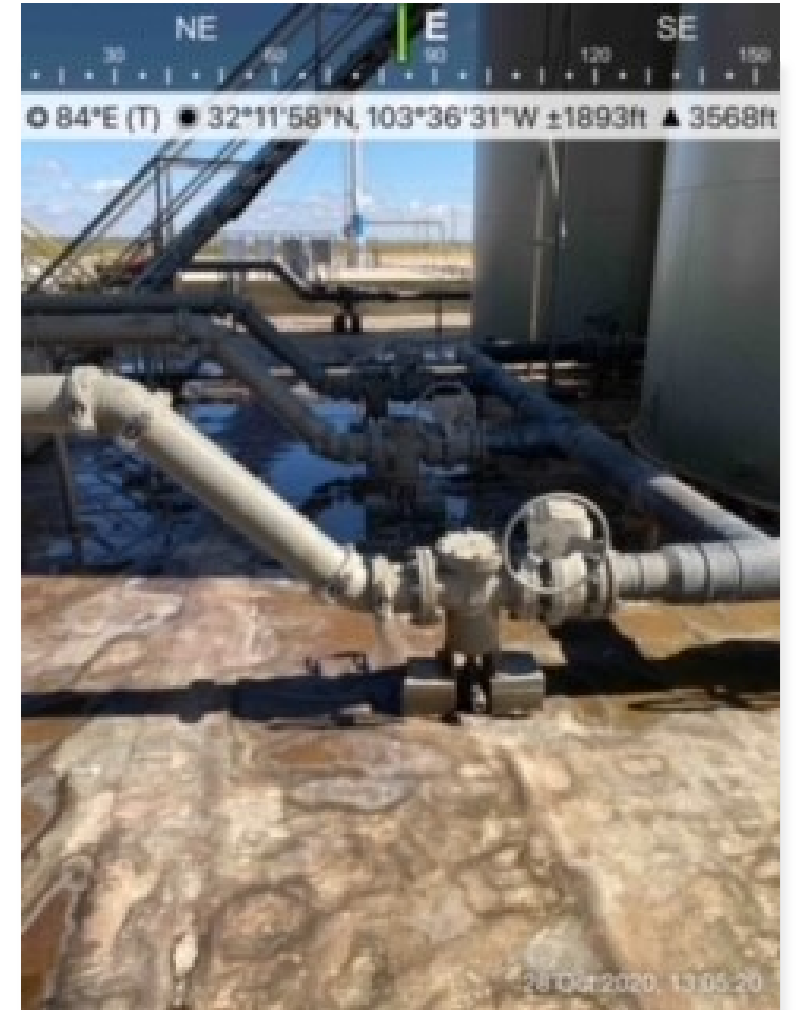
At the request of Devon, SMA conducted a liner integrity inspection per requirements of 19.15.29.11.A(5)(a) NMAC. NMOCD was notified on October 26, 2020 that the liner inspection was to occur, and the inspection was conducted on October 28, 2020. After a thorough visual inspection of the liner within the tank battery containment, the liner appeared to be intact and had the ability to contain the release in question. The location from which the release occurred was identified, and SMA verified

that the release did not occur outside of the lined containment. A photo log and field notes of the inspection is included in Appendix A.

All Damaged Areas Observed Marked in **White Paint** on Liner
Photos and Field Notes Detailing Failures Attached to This Form

SMA recommends no further action for this release and requests the closure of NRM2028130276.
