Incident ID	NRM2012856003
District RP	
Facility ID	
Application ID

Site Assessment/Characterization

On March 5, 2020, a release occurred at Chisholm's Grama Ridge site when a bull plug failed on one of 3 Bear's Lease Automatic Custody Transfer (LACT) units. This incident resulted in the release of approximately 34 barrels (bbls) of oil onto the Grama Ridge production wellpad and into the adjacent pasture. Upon discovery of the release, the LACT unit was repaired and a hydrovac truck was dispatched to the site to recover free-standing liquids. Approximately 32 bbls of oil were recovered from the impacted area and removed for disposal off-site. No oil was released into sensitive areas or waterways.

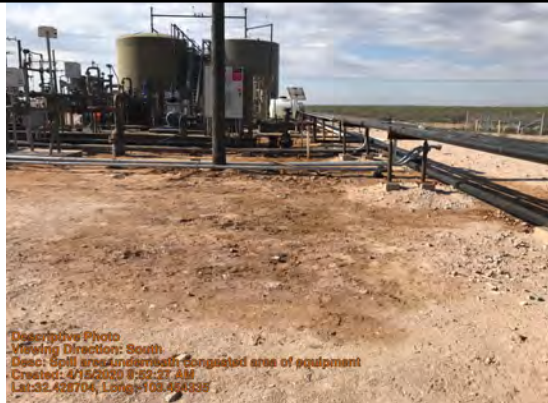
Spill area underneath congested area of equipment

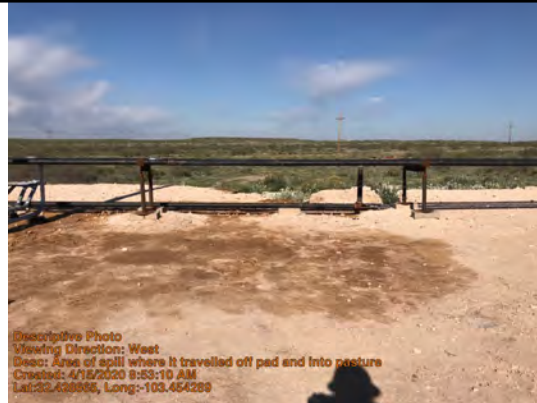
Area of spill where it travelled off pad and into pasture

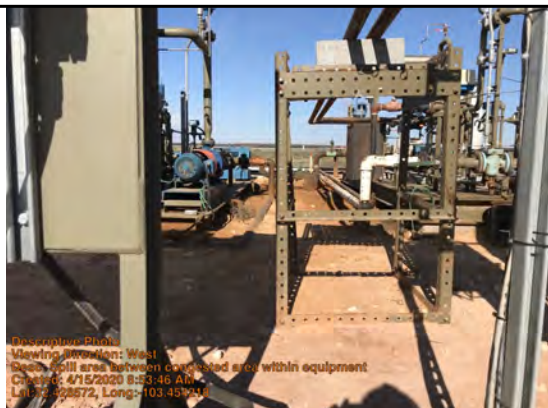
Spill area between congested area within equipment

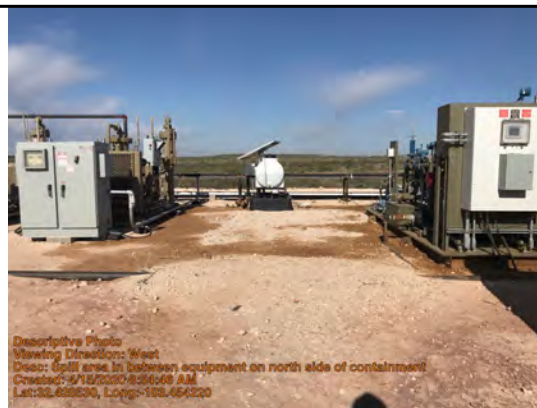
Spill area in between equipment on north side of containment

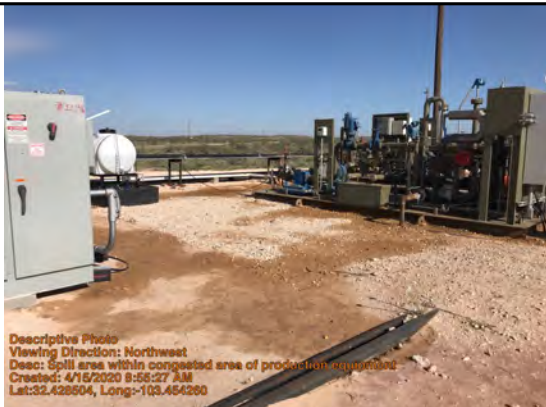
Spill area within congested area of production equipment

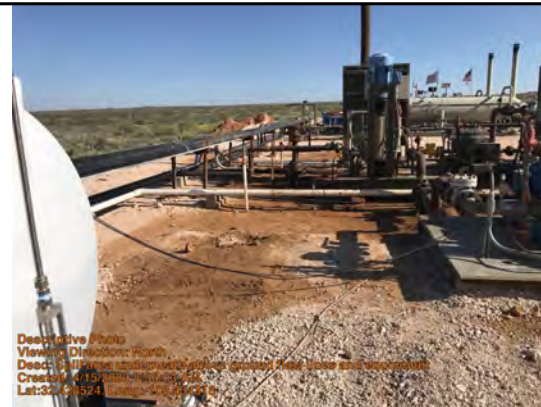
Spill area underneath above ground flow lines and equipment

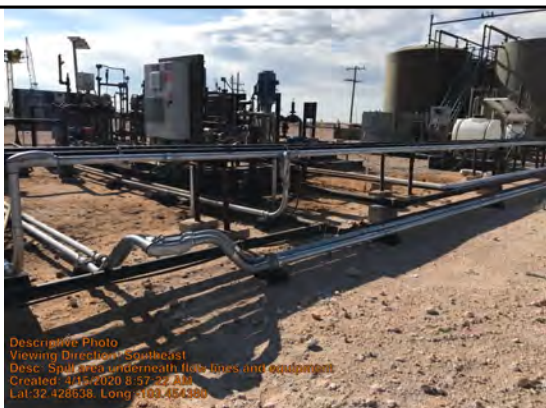
Spill area underneath flow lines and equipment

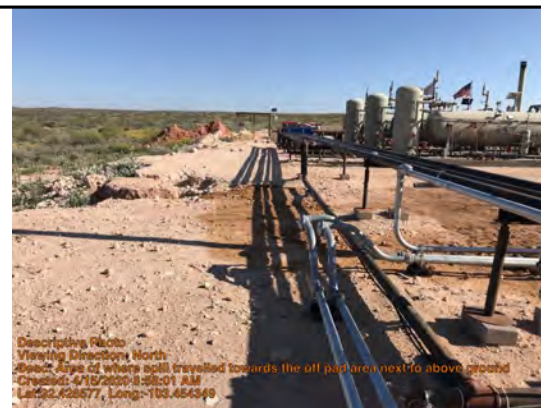
Area of where spill travelled towards the off pad area next to above ground flow lines

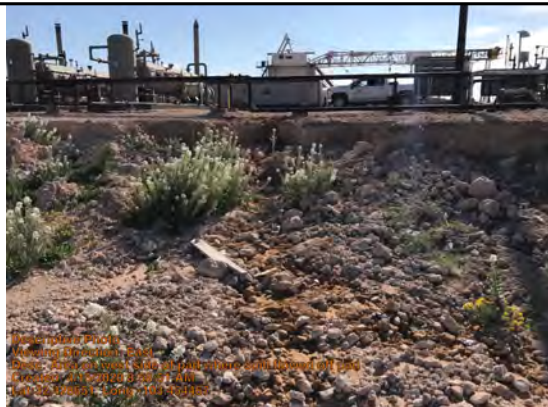
Area on west side of pad where spill flowed off pad

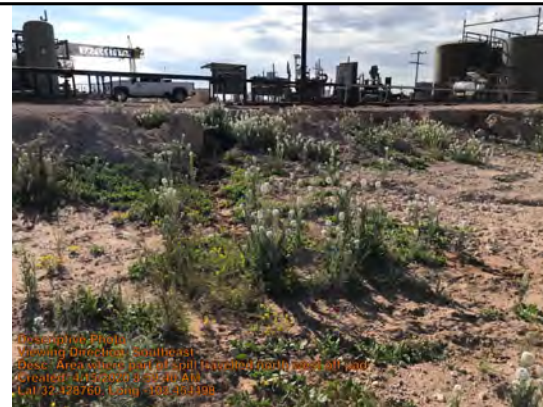
Area where part of spill travelled north west off pad

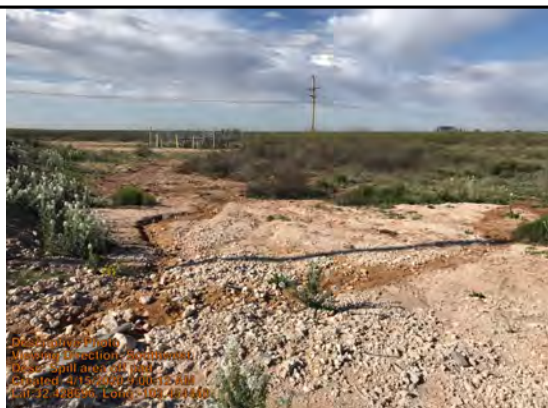
Spill area off pad

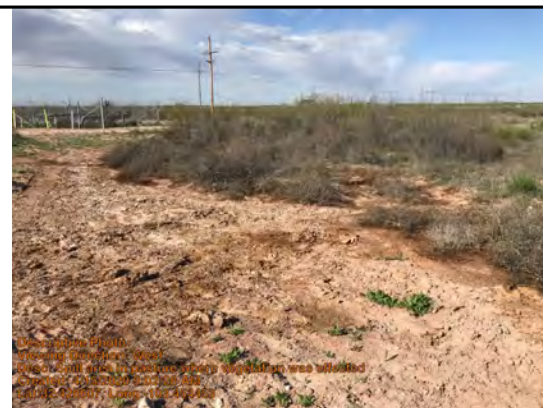
Spill area in pasture where vegetation was effected

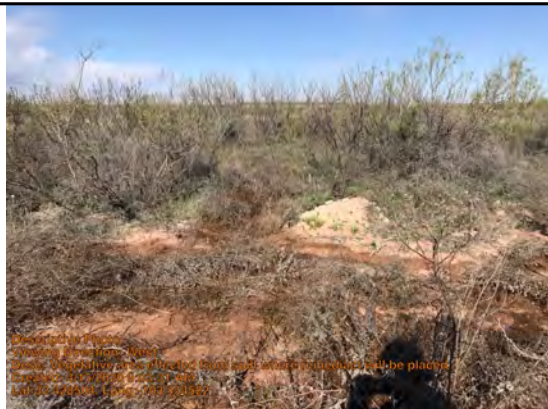
Vegetative area effected from spill where remediact will be placed

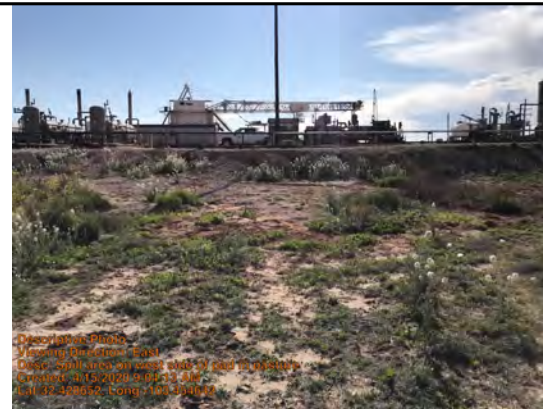
Spill area on west side of pad in pasture

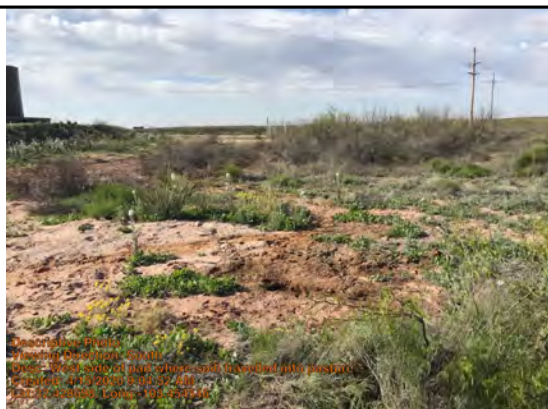
West side of pad where spill travelled into pasture

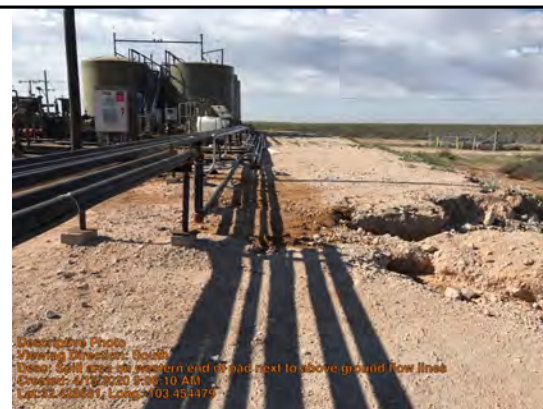
Spill area on western end of pad next to above ground flow lines

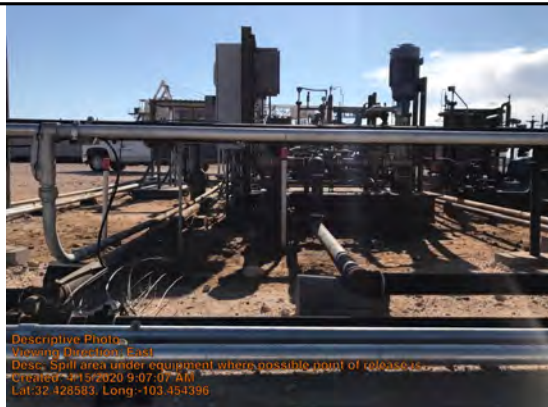
Spill area under equipment where possible point of release is

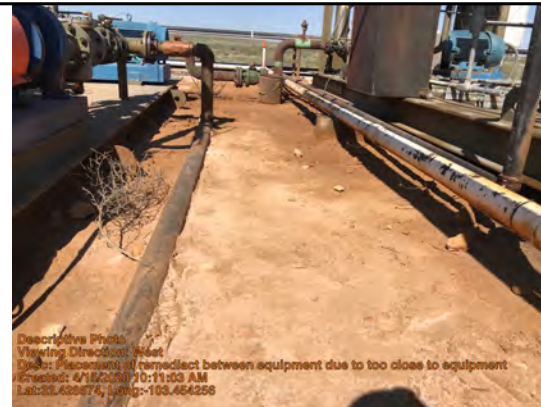
Placement of remedial material between equipment due to too close to equipment

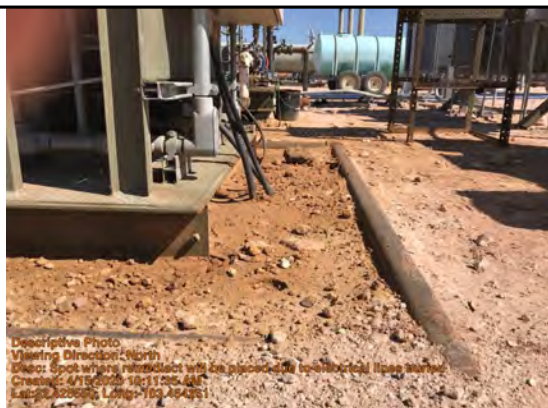
Spot where remedial material will be placed due to buried electrical lines

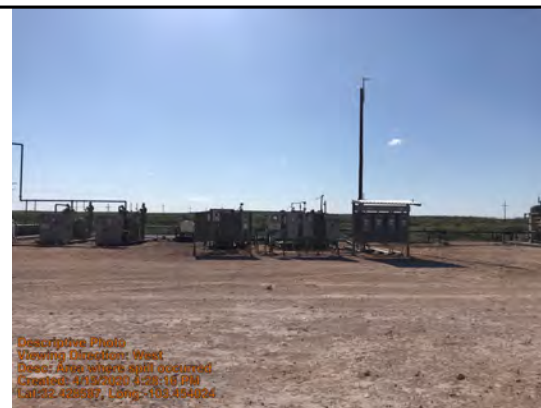
Area where spill occurred

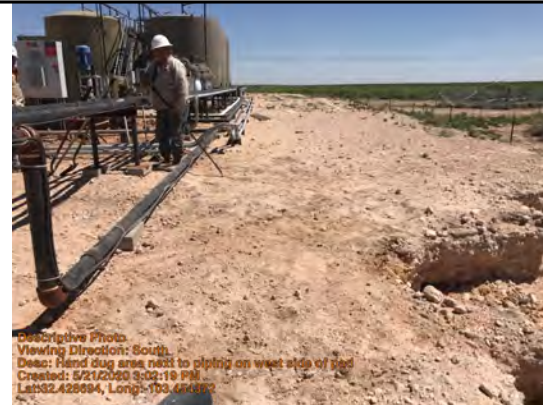
Hand dug area next to piping on west side of pad

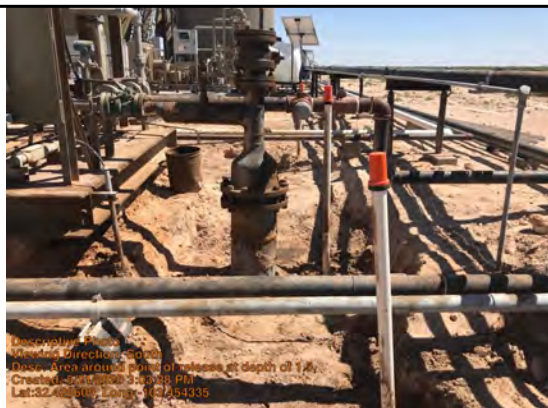
Area around point of release at depth of 1.5'

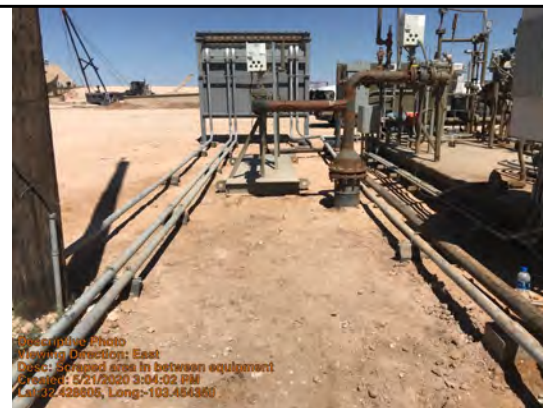
Scraped area in between equipment

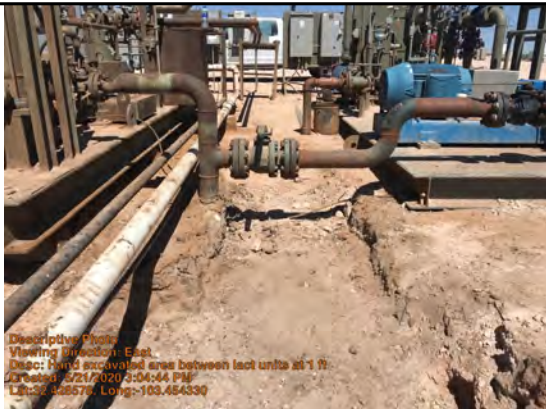
Hand excavated area between lact units at 1 ft

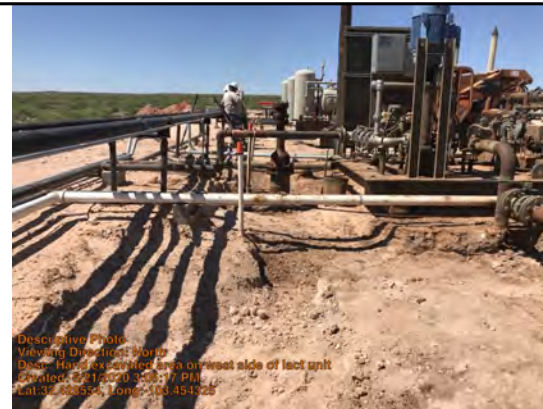
Hand excavated area on west side of lact unit

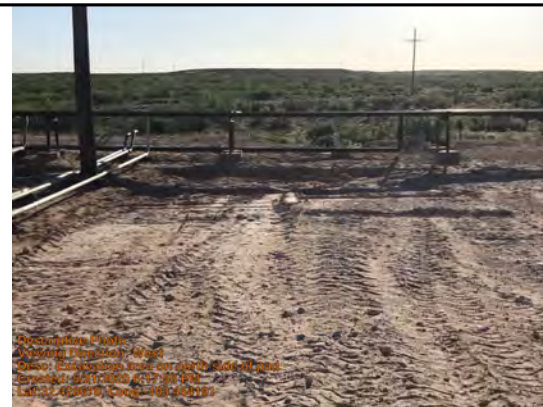
Excavation area on north side of pad

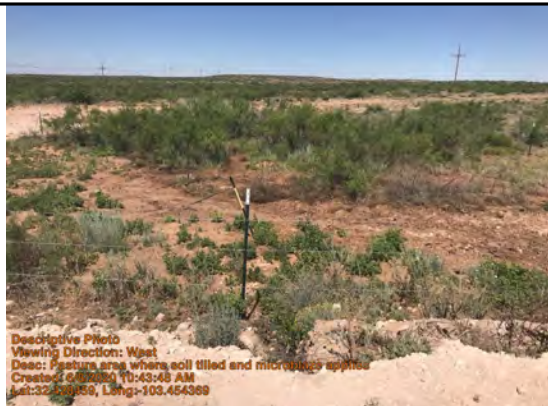
Pasture area where soil tilled and microblaze applied

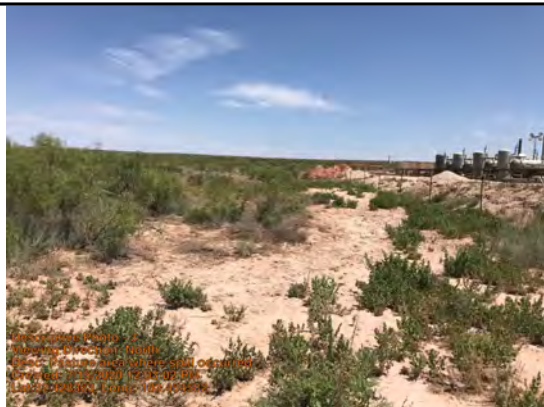
Pasture area where spill occurred
