Final Closure Report

**Grizzly Operating, LLC
CS Caylor #3 Flowline
Lea County, New Mexico
Unit Letter "H", Section 1, Township 17 South, Range 36 East
Latitude 32.86709 North, Longitude 103.301054 West
NMOCD Incident # NRM2022558133**

November 2020

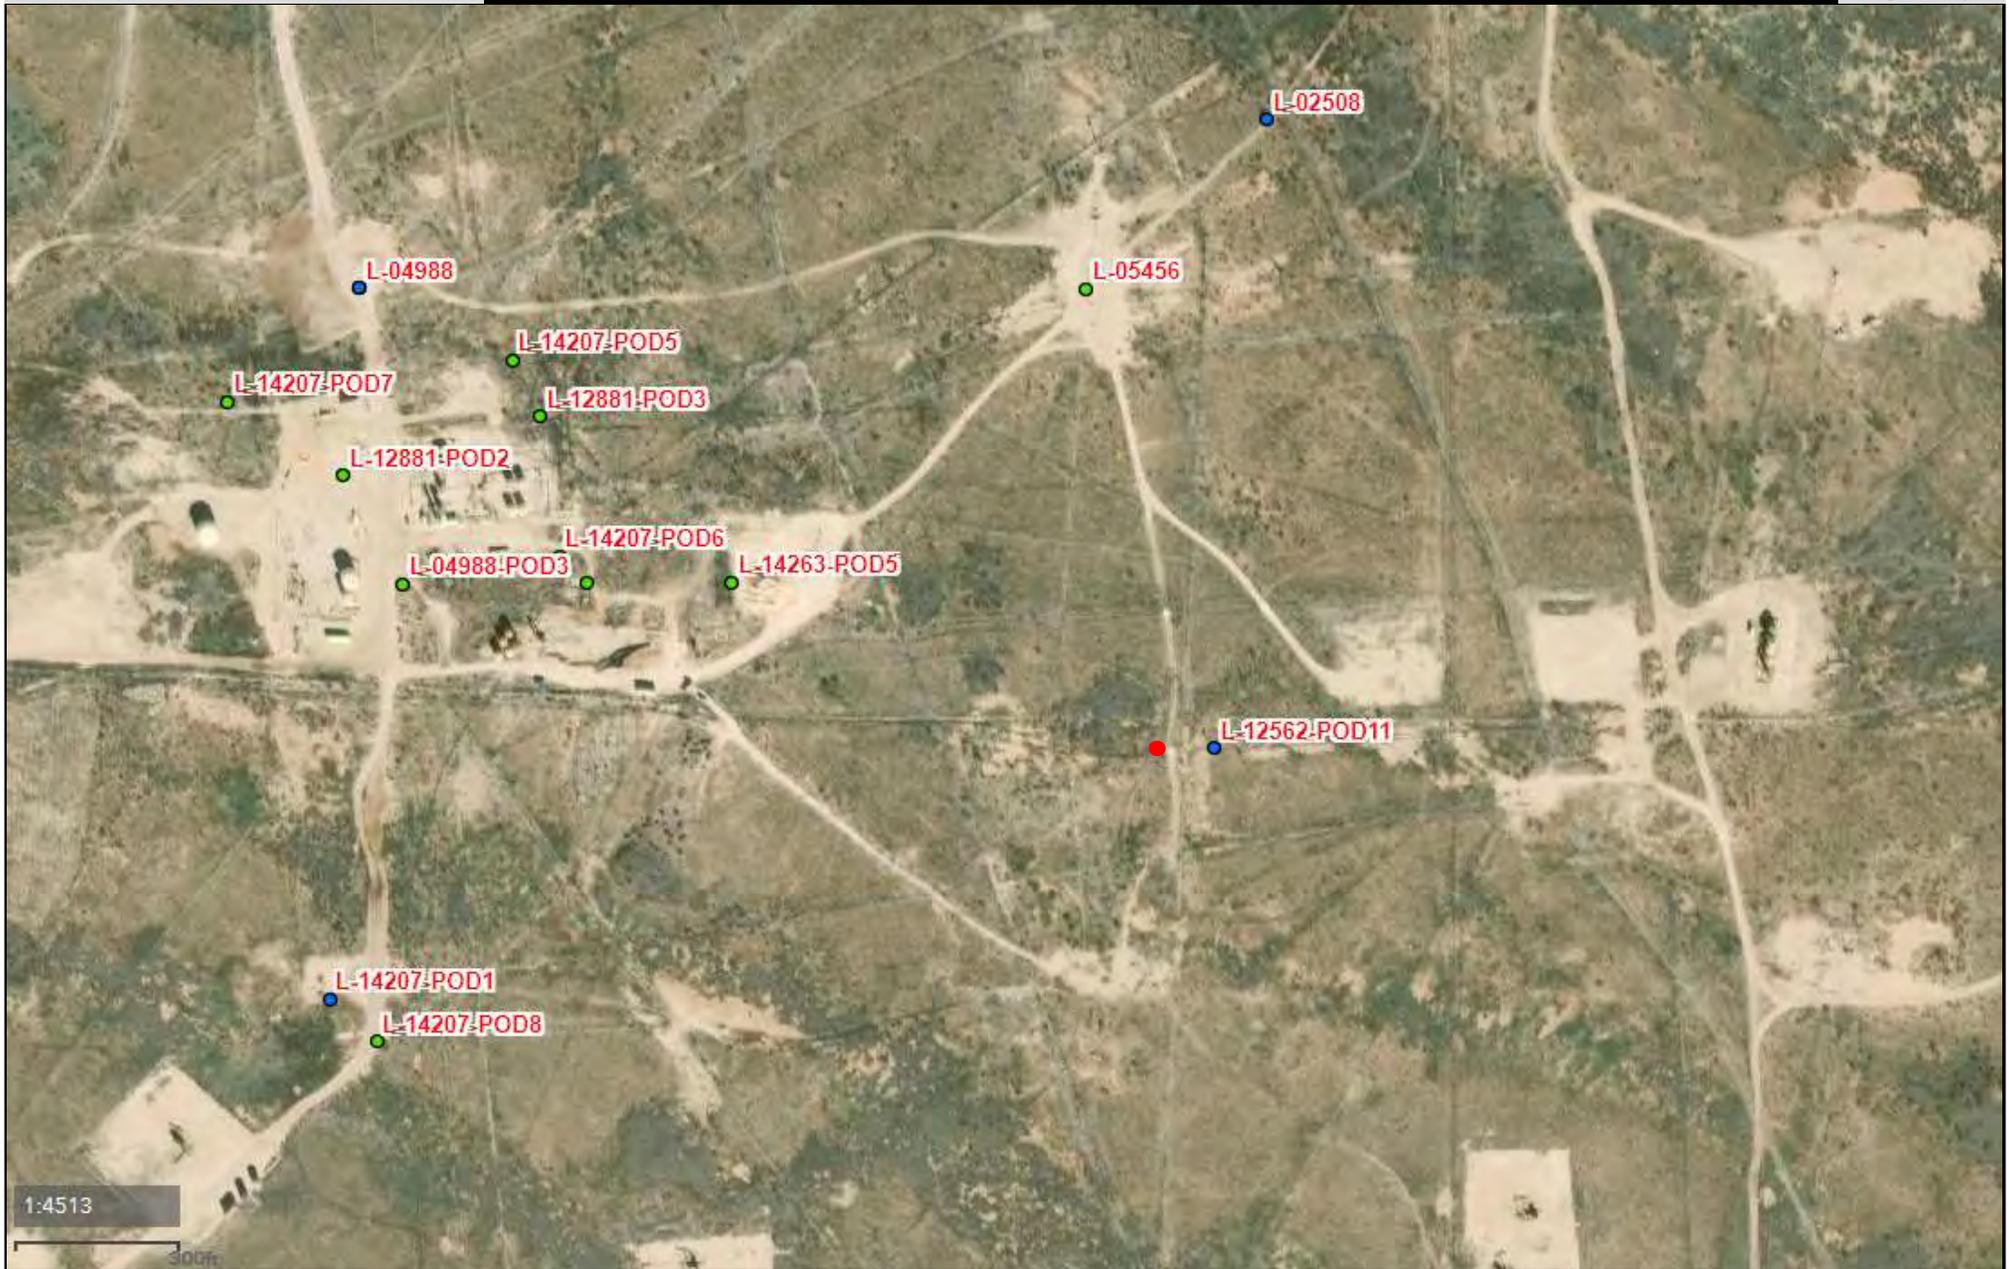
Figure 2

OSE POD Locations Map
 Grizzly Energy
 CS Caylor #3 Flowline
 GPS: 32.86709, -103.301054
 Lea County

The site is located in Unit Letter H (SE/NE), Section 1, Township 17 South, Range 36 East, approximately 5.8 miles southeast of Lovington, in Lea County, New Mexico. The property is owned by the city of Lovington. Topographic Map, OSE POD Locations Map, and USGS Well Locations Map are included as Figure 1, Figure 2, and Figure 3, respectively.

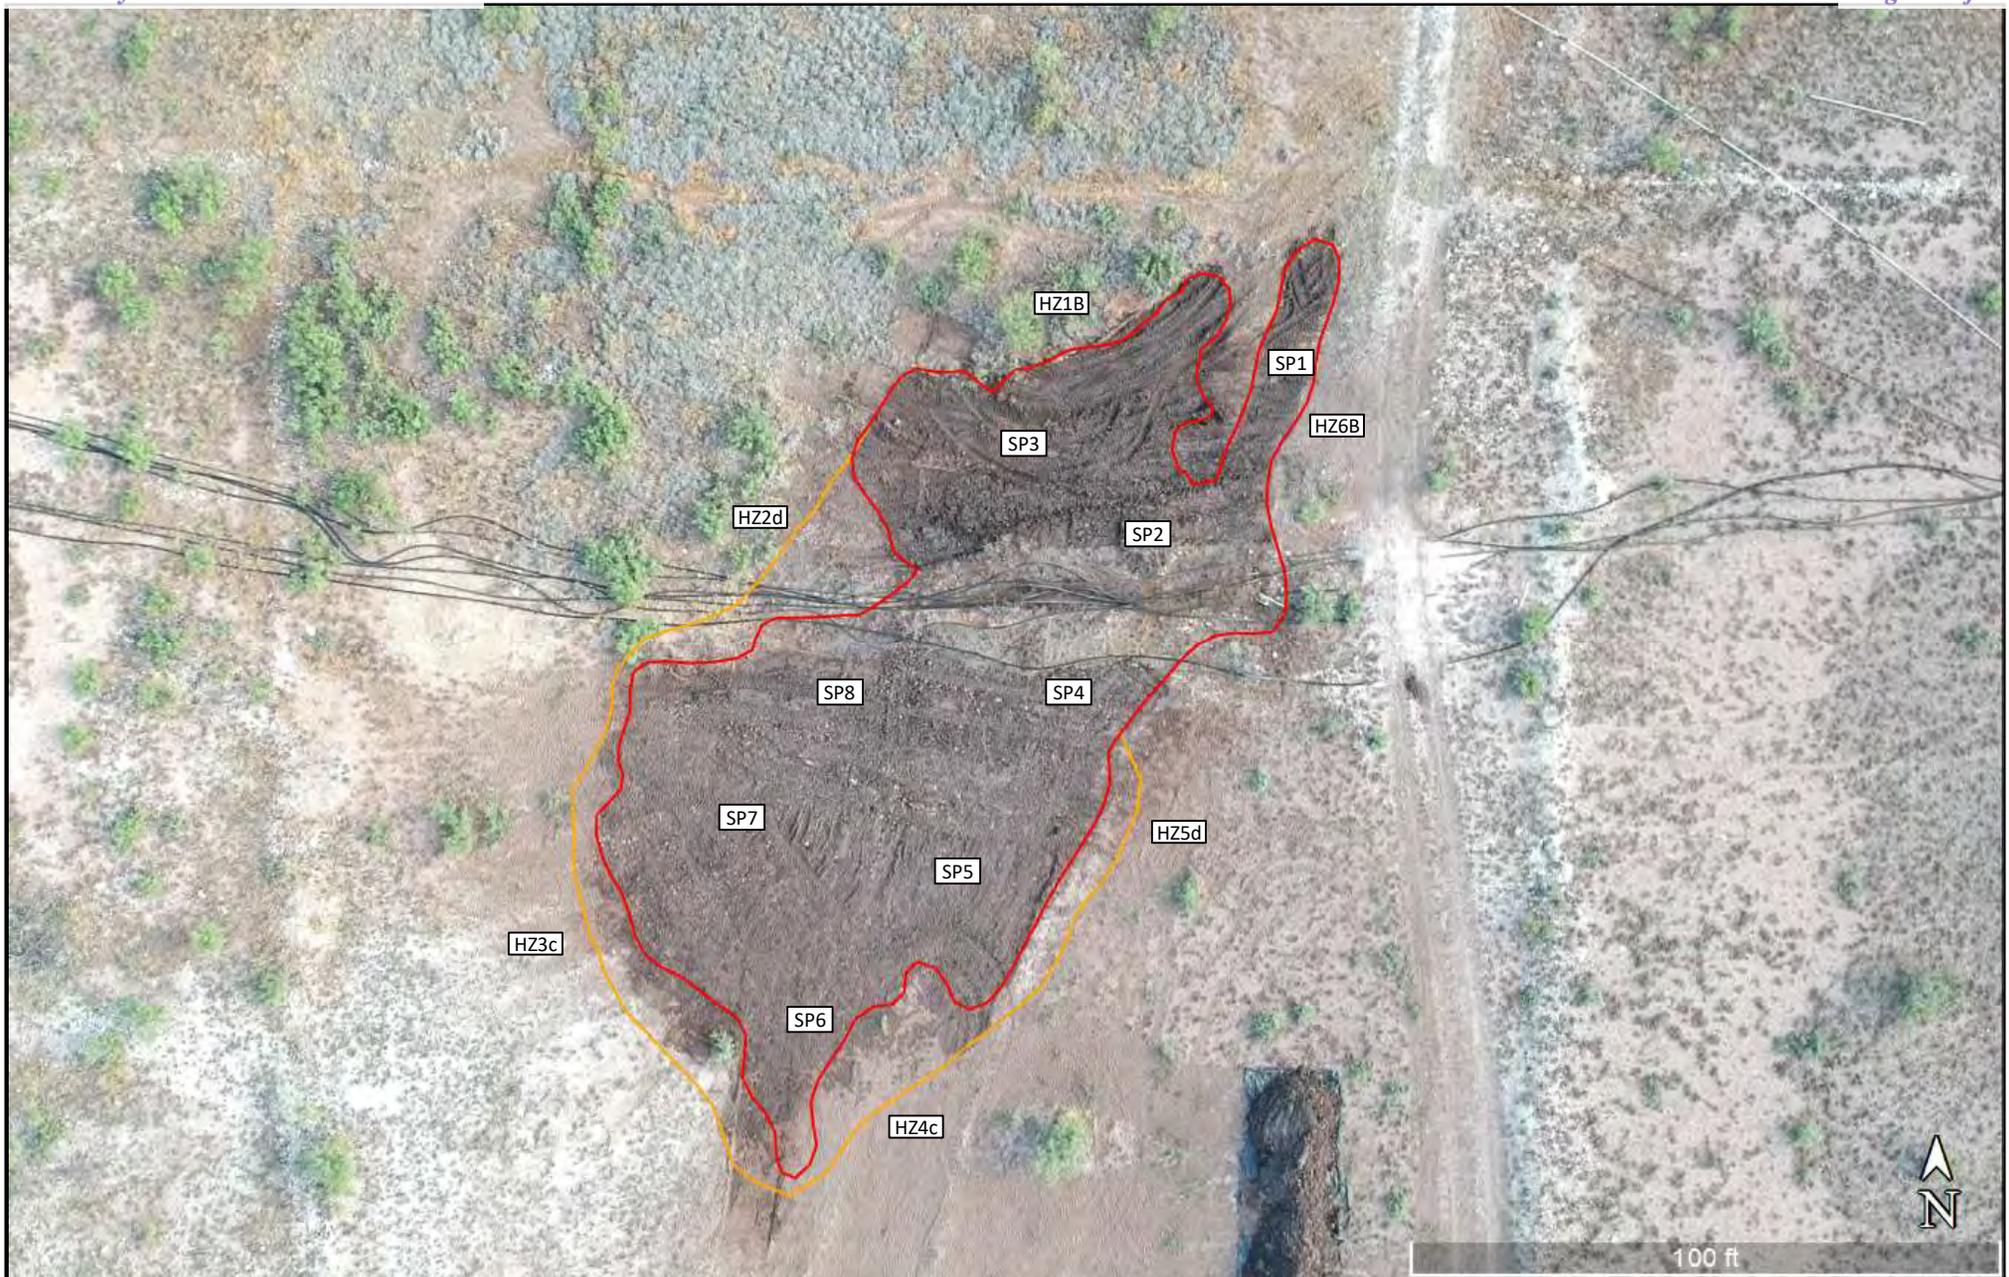
On August 13, 2020, sixteen (16) delineation soil samples, SP1 through SP8, were submitted to the laboratory for analysis of BTEX, TPH, and Chloride. Two (2) soil samples from each test trench (highest observed contaminated and deepest depth investigated) were submitted for laboratory analysis. Laboratory analytical results indicated BTEX concentrations were below the NMOCD Closure Criteria in each of the submitted soil samples. TPH concentrations were below the NMOCD Closure Criteria in each of the submitted samples with the exception of SP1 @ Surf, SP2 @ Surf, SP3 @ Surf, and SP4 @ Surf, which exhibited TPH concentrations of 488.1 mg/kg, 397 mg/kg, 764 mg/kg and 126 mg/kg, respectively. Chloride concentrations were below the NMOCD Closure Criteria in each of the submitted samples with the exception of the surface samples at sample locations SP1 through SP8.

On August 17, 2020, twelve (12) horizontal delineation samples, HZ1B through HZ6B, were submitted to the laboratory for analysis of BTEX, TPH, and chloride. Two (2) soil samples from each test trench (highest observed contaminated and deepest depth investigated) were submitted for laboratory analysis. Laboratory analytical results indicated BTEX, TPH, and chloride concentrations were below the NMOCD Closure Criteria in each of the submitted soil samples with the exception of HZ2B, HZ3B, HZ4B, and HZ5B, all at five (5) feet bgs. HZ2B, HZ3B, and HZ4B exhibited chloride concentrations of 2,940 mg/kg, 2,810 mg/kg, and 2,660 mg/kg, respectively. HZ5B exhibited a TPH concentration of 113 mg/kg.

On August 31, 2020, delineation sampling continued on site. Sample locations SP2, SP3, SP4, SP5, HZ2, HZ3, HZ4, and HZ5 were resampled in an effort to fully delineate the site. Four (4) delineation samples, SP2 through SP5, and eight (8) horizontal delineation samples, HZ2C through HZ5C, were sent to the laboratory for analysis of BTEX, TPH, and chloride. Laboratory analytical results indicated BTEX, TPH, and chloride concentrations were below the NMOCD Closure Criteria in each of the submitted soil samples with the exception of HZ2C at five (5) feet bgs and HZ5C at five (5) feet bgs which exhibited TPH concentrations of 659 mg/kg and 444 mg/kg, respectively.

Delineation Sample Map
 Grizzly Energy
 CS Caylor #3 Flowline
 GPS: 32.86709, -103.301054
 Lea County

A Delineation Sample Location Map and an Excavation Sample Location Map are provided as Figure 4 and Figure 5, and Field data is provided as Attachment III. A Summary of Soil Sample Laboratory Analytical Results is provided as Table 1 and Laboratory Analytical Reports are provided as Attachment IV.

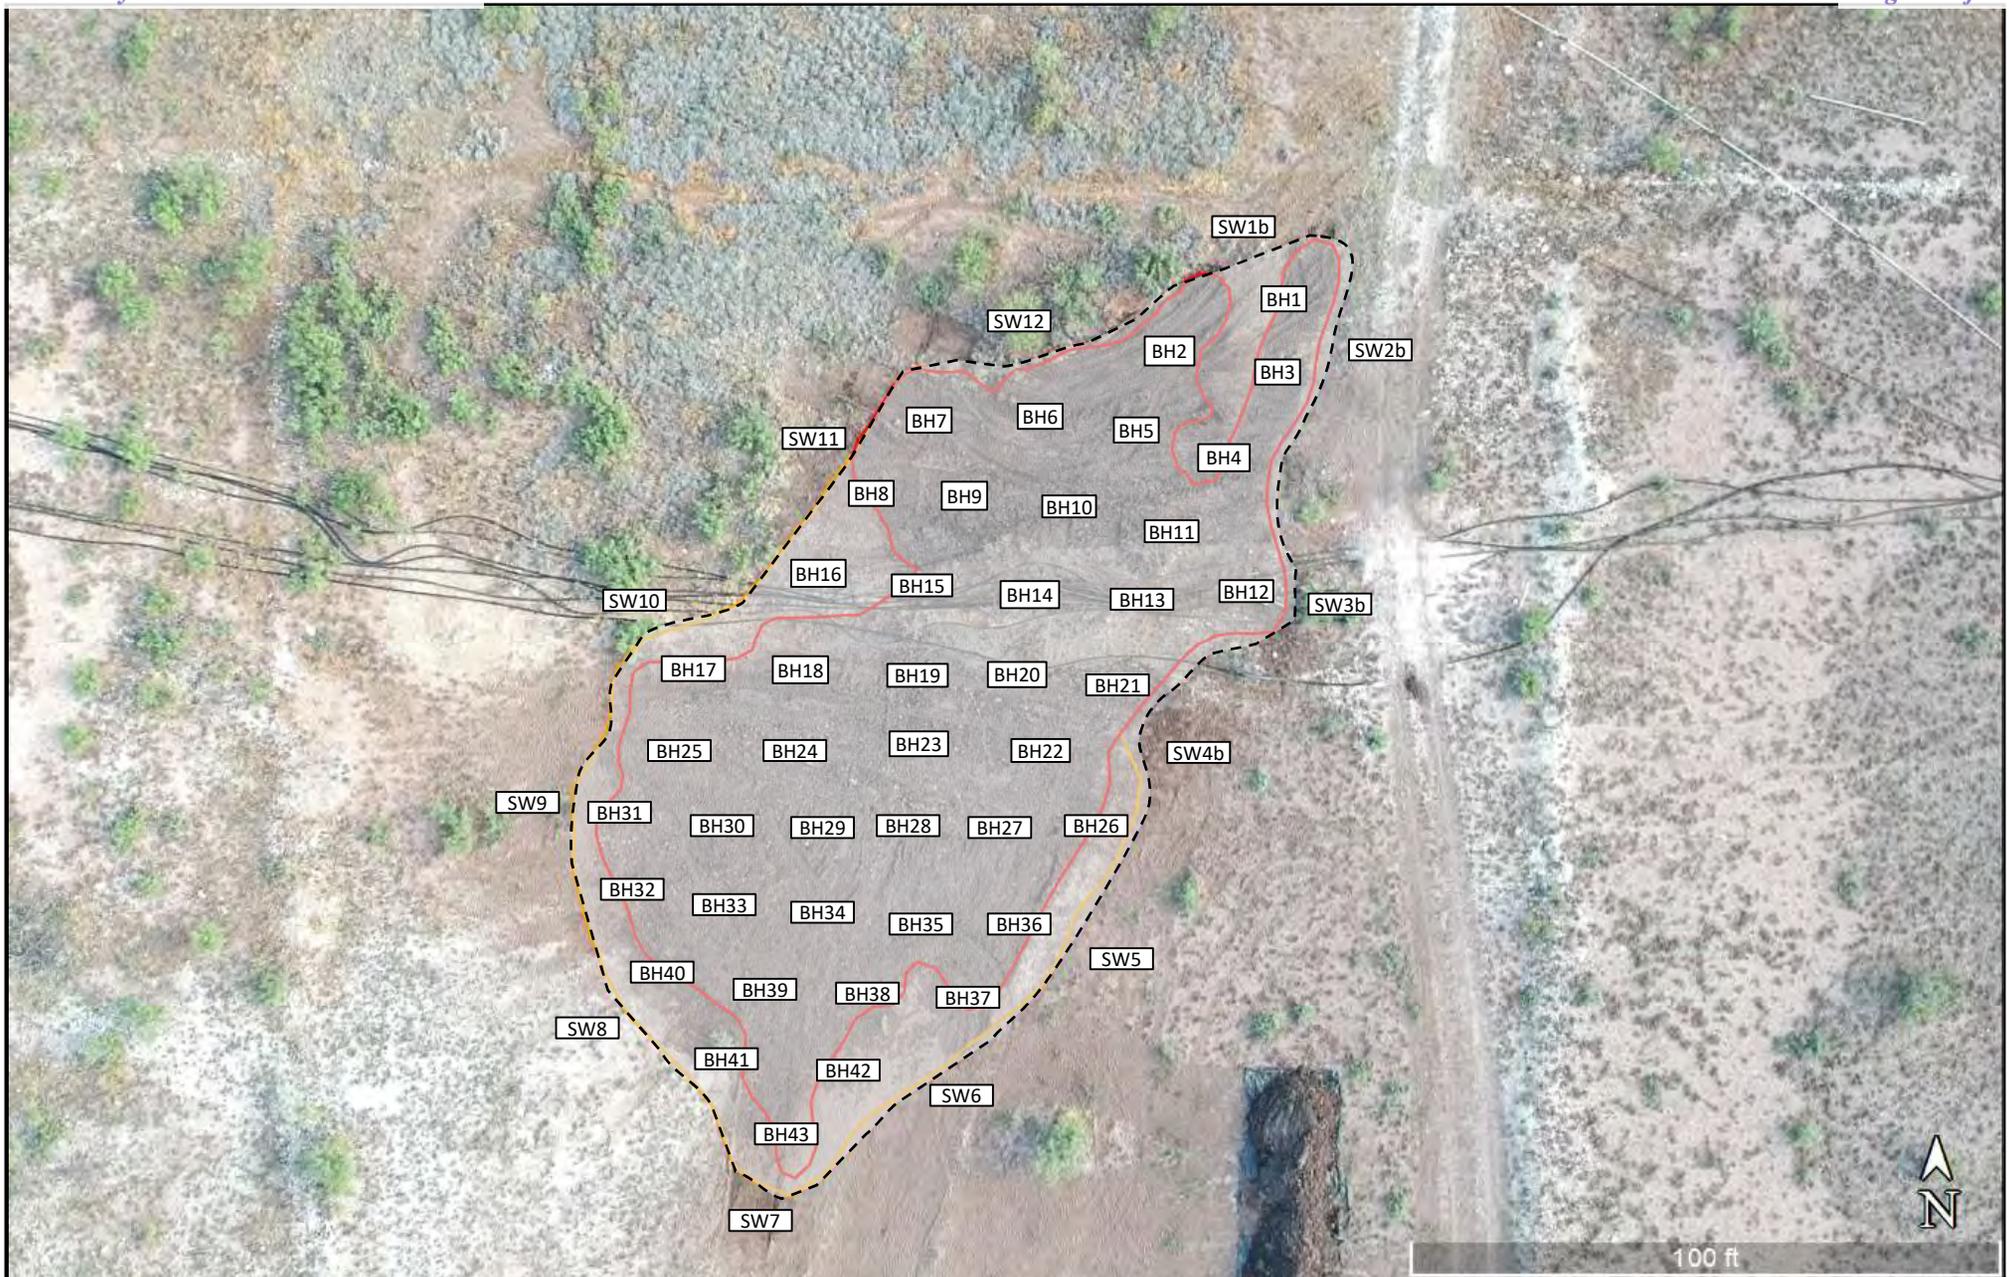
Figure 5

On October 28, 2020, after removal of impacted soil, composite confirmation soil samples, representing every 200 sq. ft., were collected from the excavation floor. Composite samples were also collected from the sidewalls of the excavation, each representing fifty (50) linear feet. Composite closure samples BH1 through BH43, and SW1 through SW12, were submitted to the laboratory for analysis of BTEX, TPH, and chloride. Fifty-five (55) composite samples were collected and submitted to the laboratory for analysis of BTEX, TPH, and chloride. Laboratory analytical results indicated BTEX, TPH, and chloride concentrations were below the NMOCD Closure Criteria in each of the submitted samples with the exception of SW1 through SW4 which exhibited chloride concentrations of 666 mg/kg, 718 mg/kg, 696 mg/kg, and 678 mg/kg, respectively.

On November 9, 2020, closure sampling continued on site. Four (4) composite closure samples, SW1b through SW4b, were collected from the excavation sidewalls and submitted to the laboratory for analysis of BTEX, TPH, and chloride. Laboratory analytical results indicated BTEX, TPH, and chloride concentrations were below the NMOCD Closure Criteria in each of the submitted samples.

Excavation Sample Map
 Grizzly Energy
 CS Caylor #3 Flowline
 GPS: 32.86709, -103.301054
 Lea County

The excavated area measured approximately 100 ft. in length, 86 ft. in width, and four and a half (4.5) feet in depth. During remediation activities approximately 2,300 cubic yards of impacted soil were hauled to an NMOCD approved disposal facility.

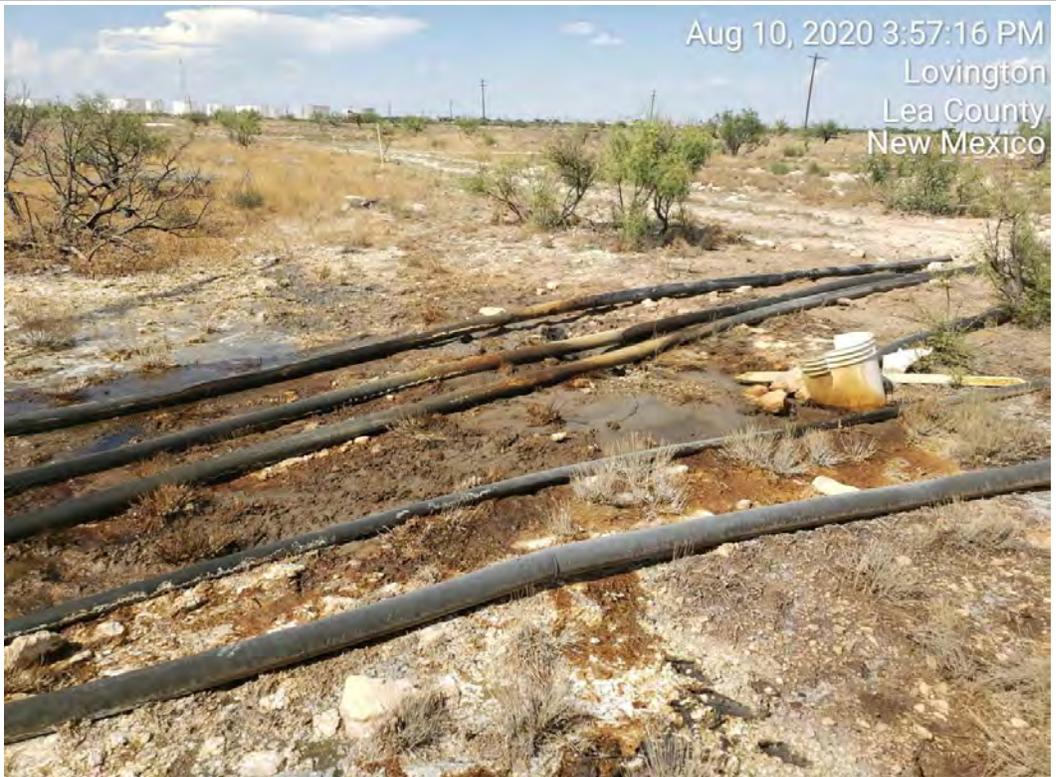
| Photo: 1 | <p>Aug 10, 2020 3:57:16 PM Lovington Lea County New Mexico</p> |

| Direction: Northeast | |
| Description: Release area | |

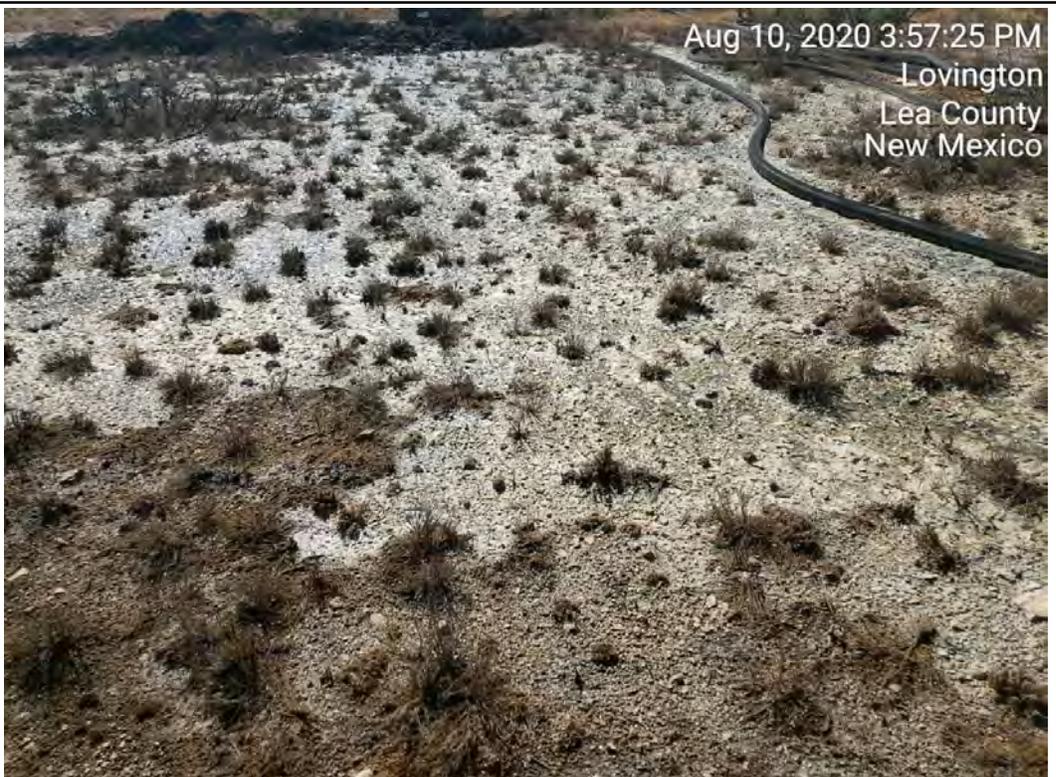
| Photo: 2 | <p>Aug 10, 2020 3:57:25 PM Lovington Lea County New Mexico</p> |

| Direction: East | |
| Description: Release area | |

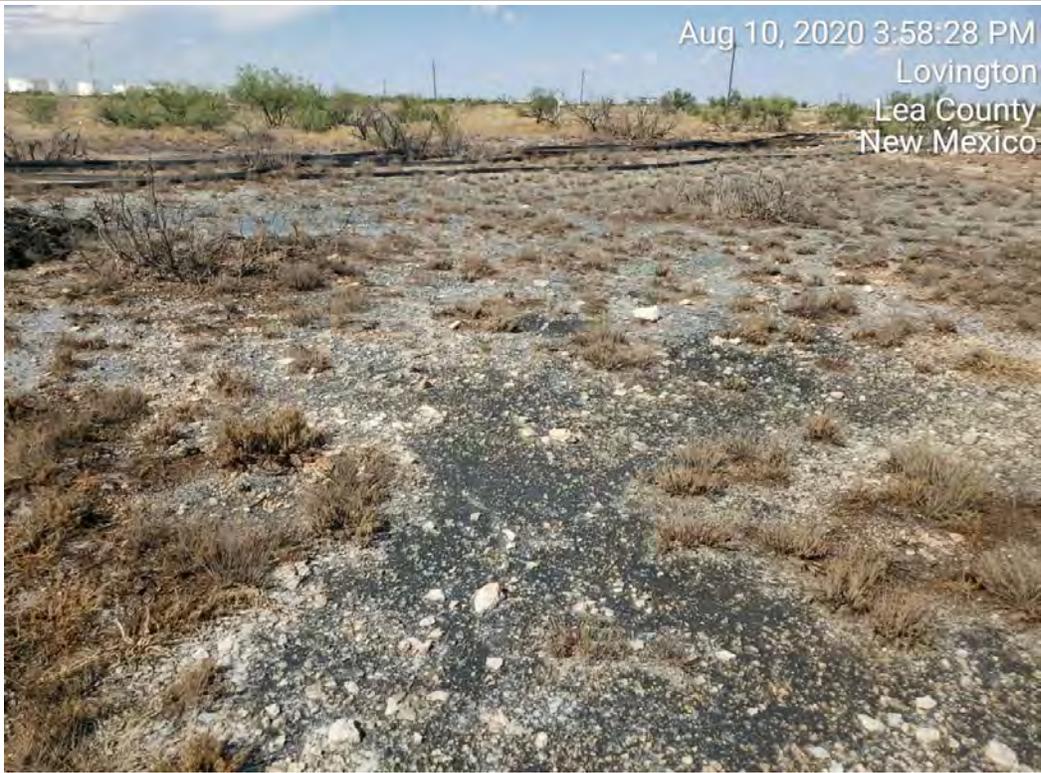
| Photo: 3 | |

| Direction: Northeast | |
| Description: Release area | |

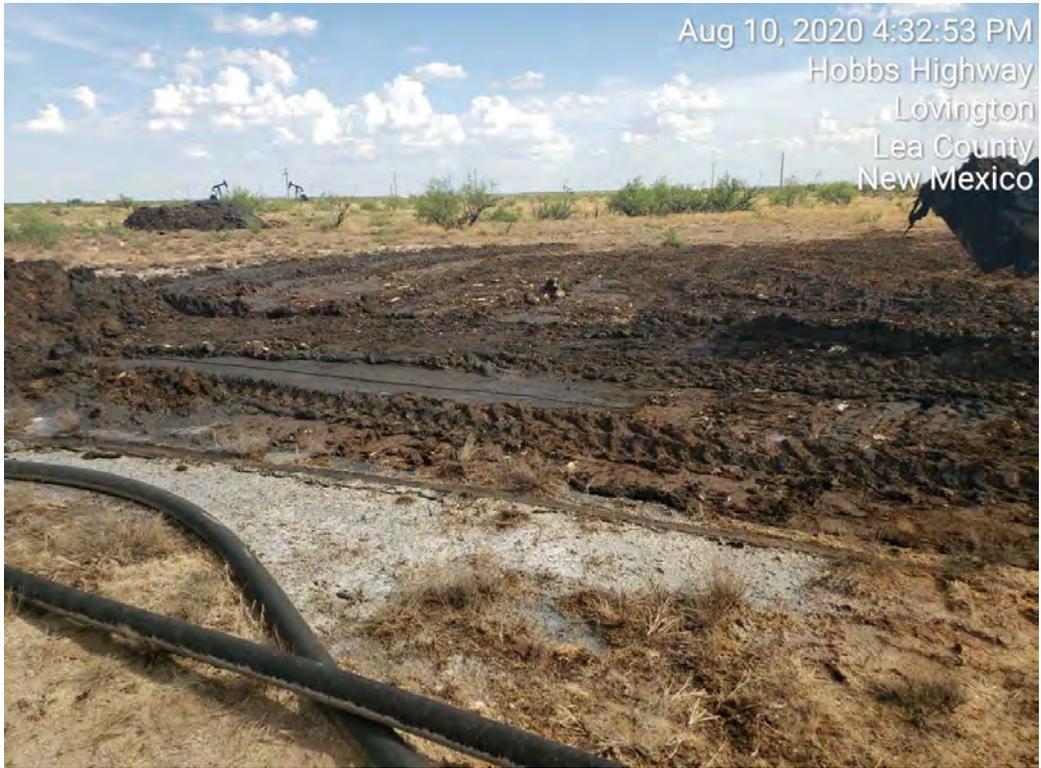
| Photo: 4 | |

| Direction: Southeast | |
| Description: Release area | |

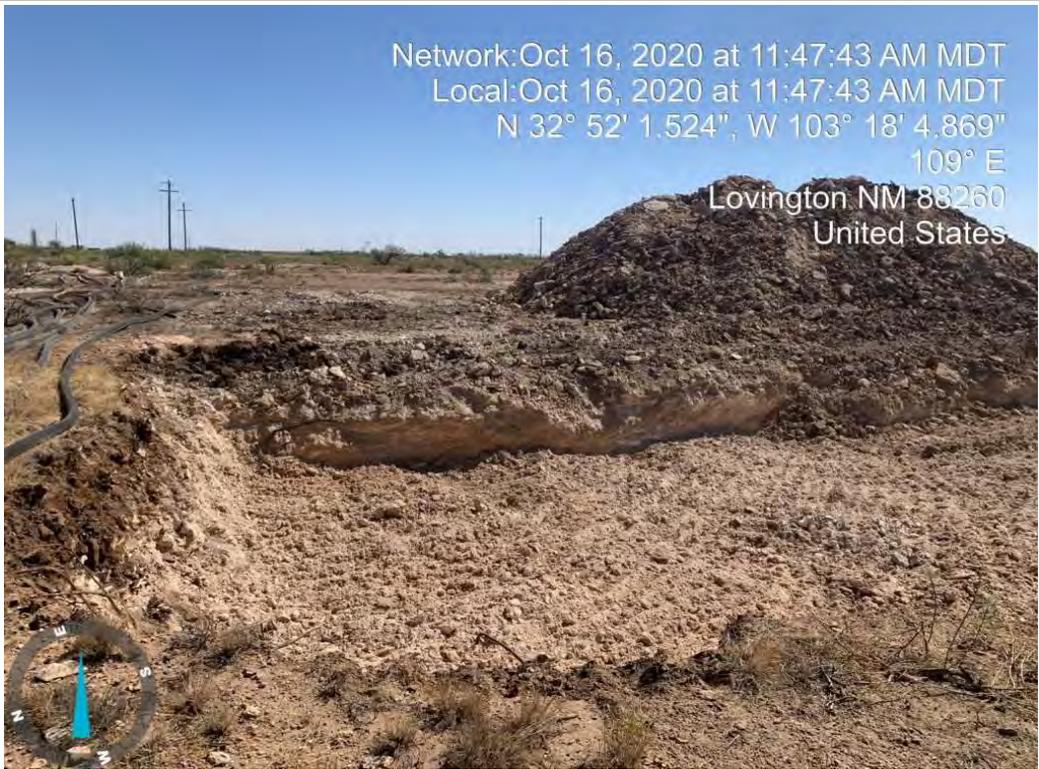
| Photo: 5 | <p>Network: Oct 16, 2020 at 11:47:43 AM MDT Local: Oct 16, 2020 at 11:47:43 AM MDT N 32° 52' 1.524", W 103° 18' 4.869" 109° E Lovington NM 88260 United States</p> |

| Direction: East | |
| Description: Excavation activities | |

On October 16, 2020, remediation activities commenced on location. In accordance with NMOCD guidelines, impacted soil was excavated to a depth of four and a half (4.5) feet bgs or until field observations and laboratory analytical data suggested BTEX, TPH, and chloride concentrations were below the NMOCD Closure Criteria. Excavated soil was transported to an NMOCD approved disposal facility.

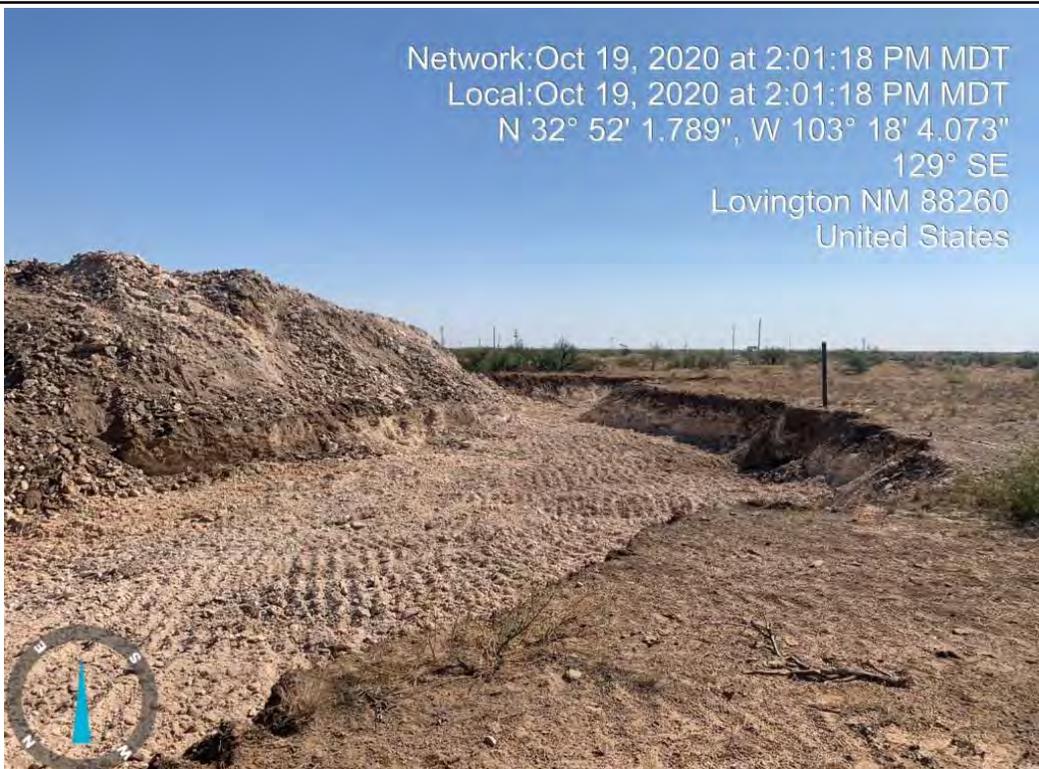
| Photo: 6 | <p>Network: Oct 19, 2020 at 2:01:18 PM MDT Local: Oct 19, 2020 at 2:01:18 PM MDT N 32° 52' 1.789", W 103° 18' 4.073" 129° SE Lovington NM 88260 United States</p> |

| Direction: Southeast | |
| Description: Excavation activities | |

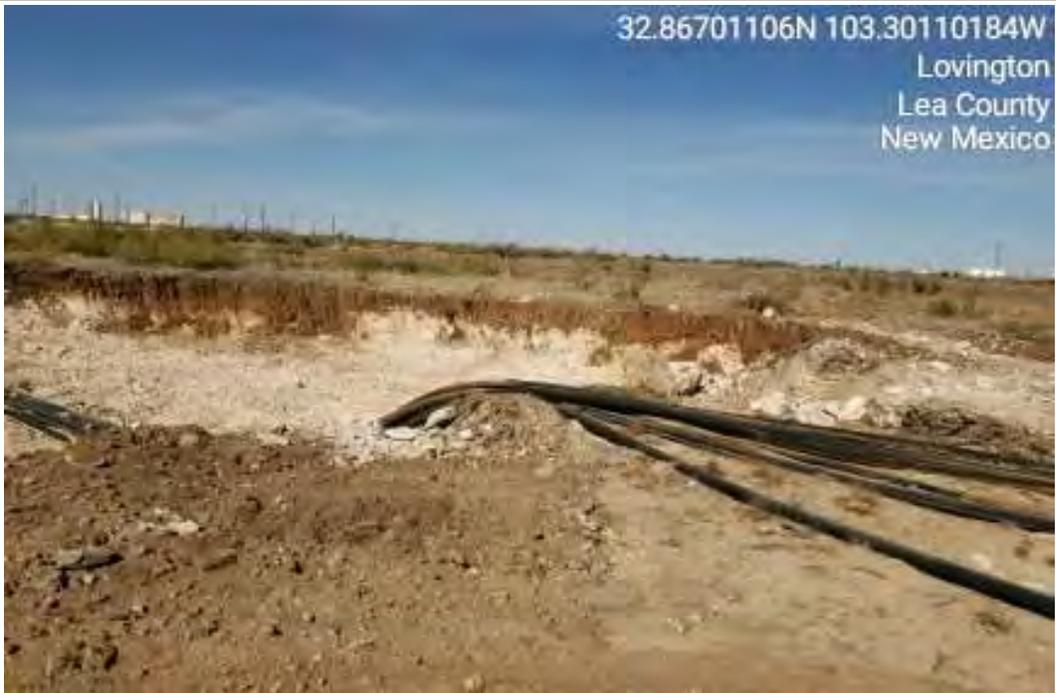
| Photo: 7 | <p>32.86701106N 103.30110184W Lovington Lea County New Mexico</p> |

| Direction: Northwest | |
| Description: Excavation activities | |

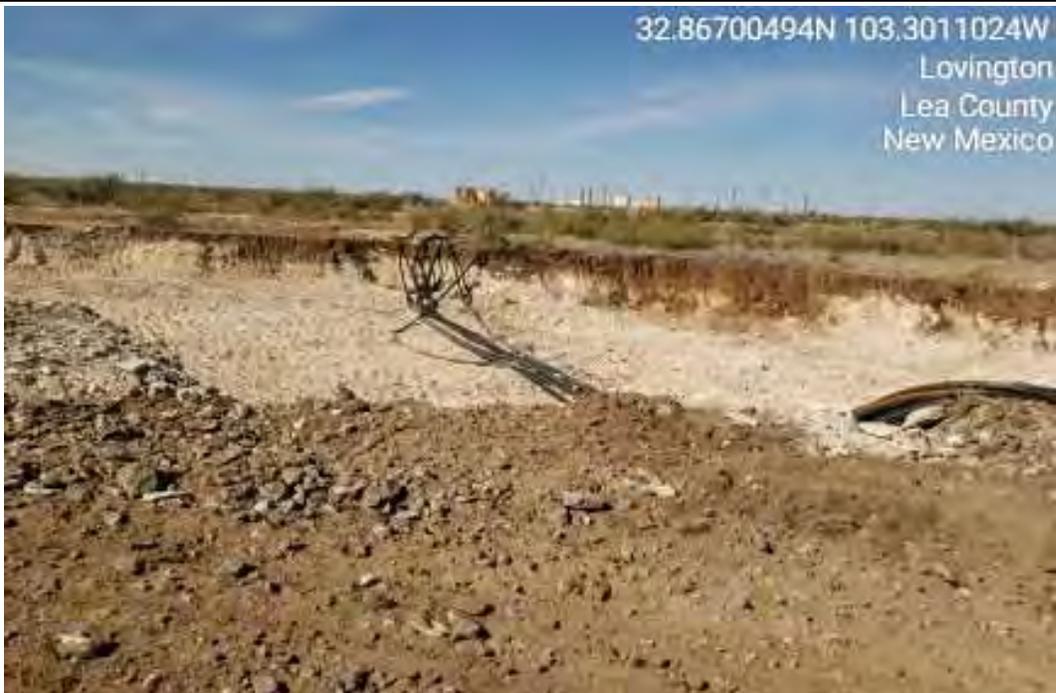
| Photo: 8 | <p>32.86700494N 103.3011024W Lovington Lea County New Mexico</p> |

| Direction: West | |
| Description: Excavation activities | |

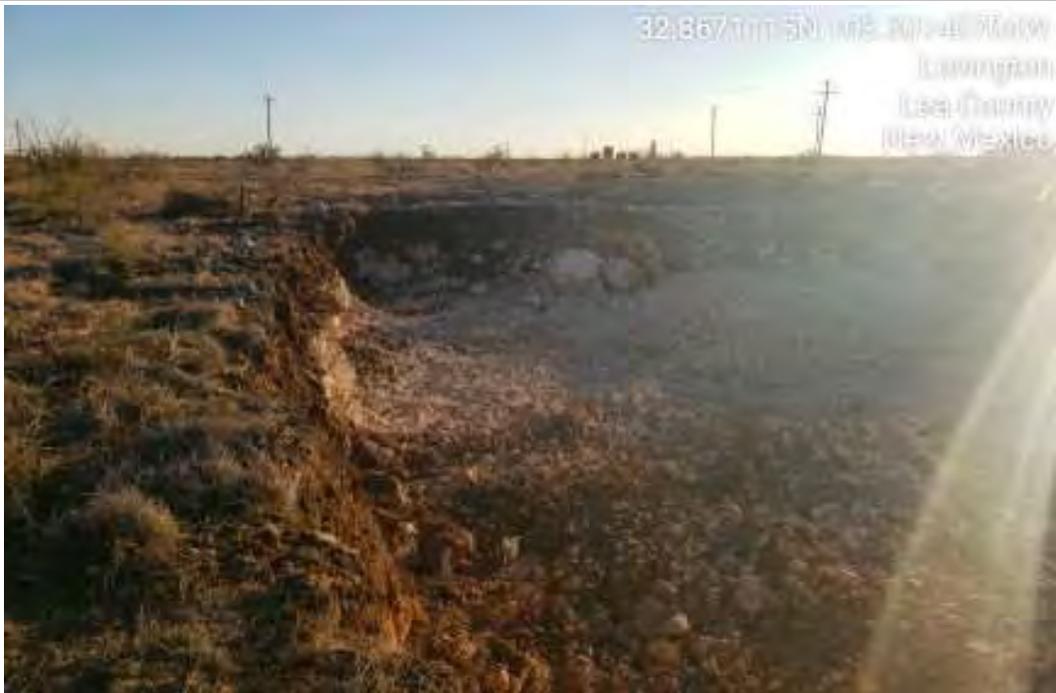
| Photo: 9 | |

| Direction: West | |
| Description: Excavation activities | |

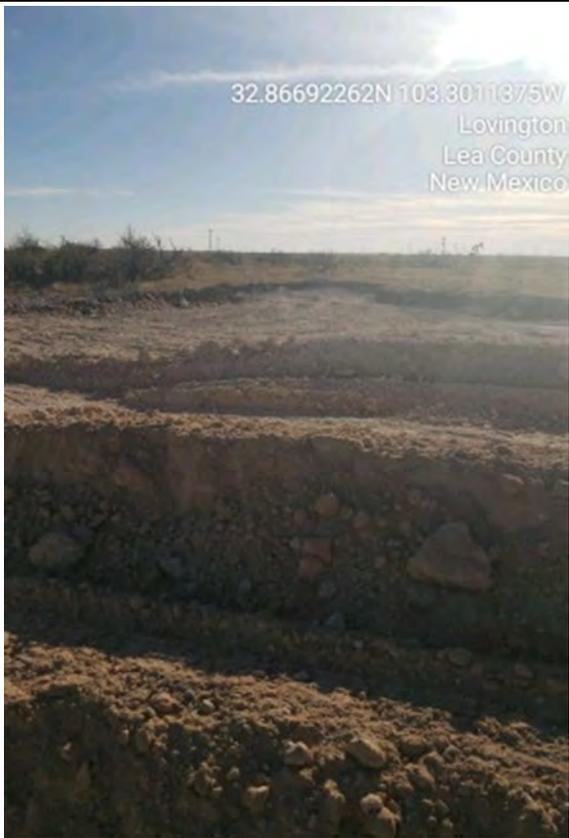
| Photo: 10 | |

| Direction: Southwest | |
| Description: Backfilling excavation | |

The area was then backfilled with clean, non-impacted, like material and brought back to at, or near, original relative positions. The affected area was contoured to achieve erosion control

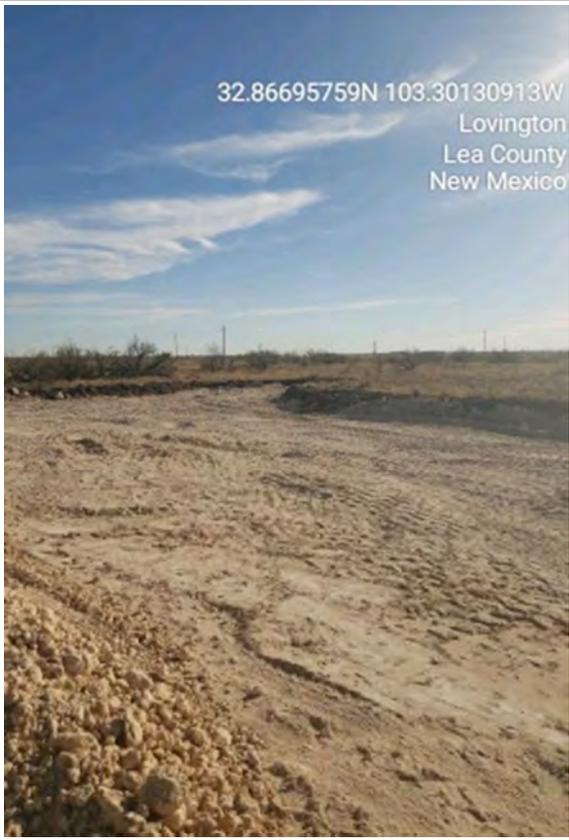
| Photo: 11 | |

| Direction: Southwest | |
| Description: Backfilling excavation | |

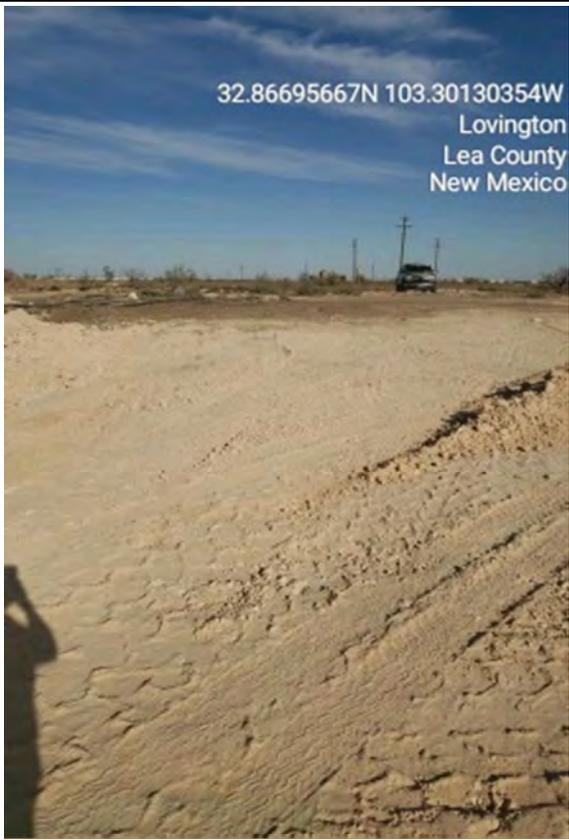
| Photo: 12 | |

| Direction: Northeast | |
| Description: Backfilling excavation | |

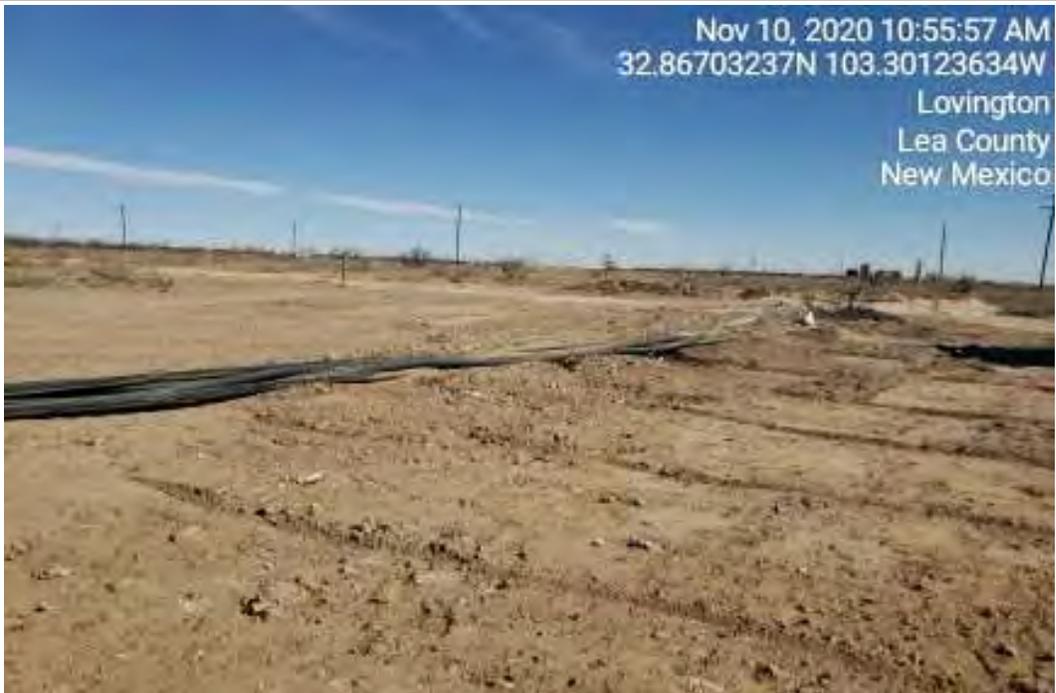
| Photo: 13 | <p>Nov 10, 2020 10:55:57 AM 32.86703237N 103.30123634W Lovington Lea County New Mexico</p> |

| Direction: East | |
| Description: Backfill complete | |

and preserve surface water flow. Affected areas not on production areas will be reseeded with an approved seed mixture during the first favorable growing season following closure of the site.

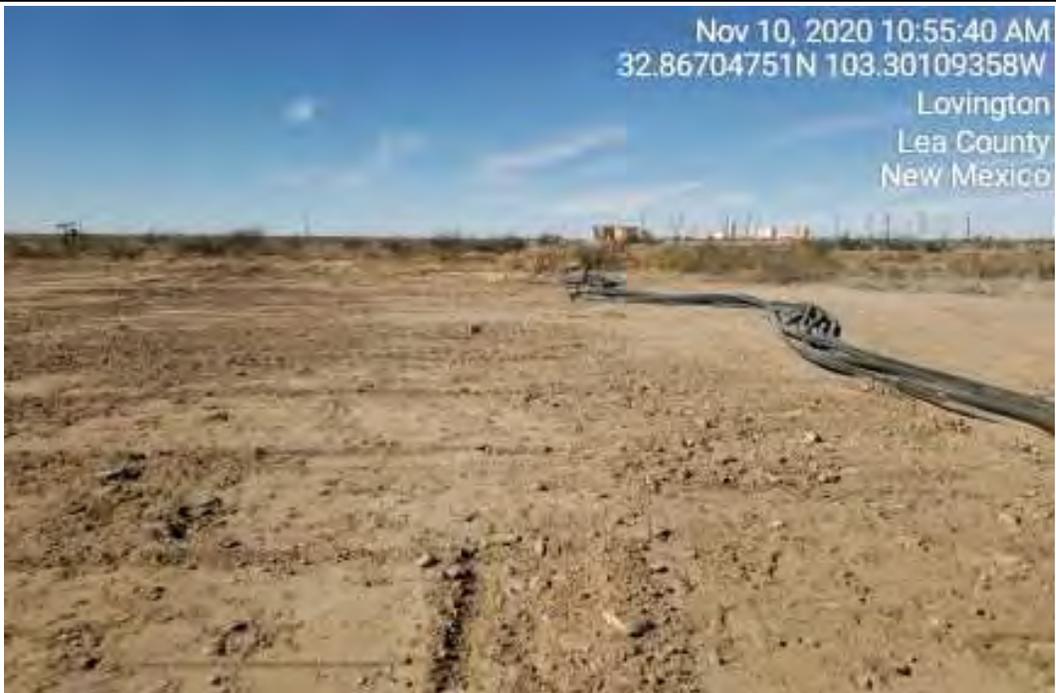
| Photo: 14 | <p>Nov 10, 2020 10:55:40 AM 32.86704751N 103.30109358W Lovington Lea County New Mexico</p> |

| Direction: West | |
| Description: Backfill complete | |

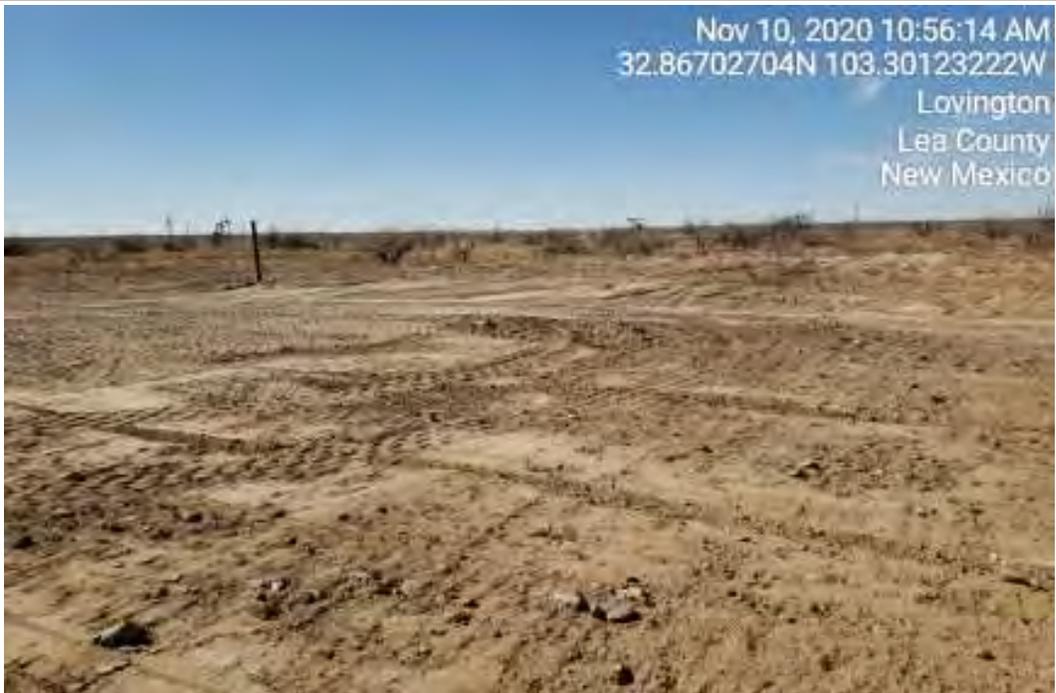
| Photo: 15 | <p>Nov 10, 2020 10:56:14 AM 32.86702704N 103.30123222W Lovington Lea County New Mexico</p> |

| Direction: Southwest | |
| Description: Backfill complete | |

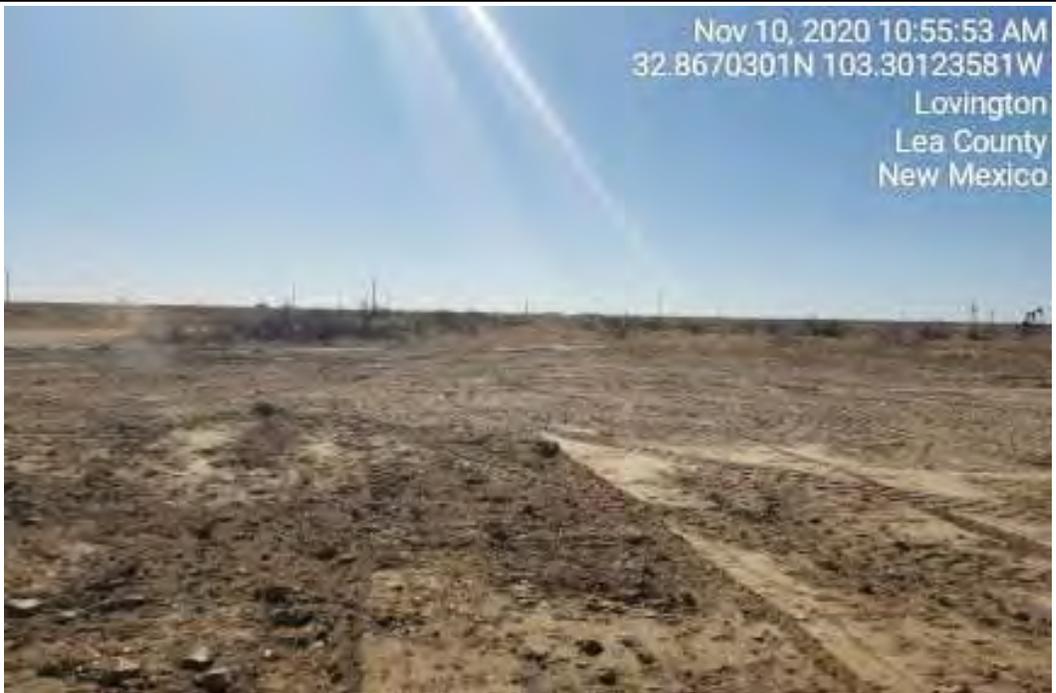
| Photo: 16 | <p>Nov 10, 2020 10:55:53 AM 32.8670301N 103.30123581W Lovington Lea County New Mexico</p> |

| Direction: South | |
| Description: Backfill complete | |
