## Release Notification

This report summarizes the secondary containment inspection activities at the Tucker Draw 9 4 Federal Com Tank Battery Pad (Site). The topographic map of the Site is provided as Figure 01. From May 17, 2020 to September 25, 2020, WPX had two separators fail at the bottoms and a produced water line directly connected to a separator develop a hole all due to corrosion. From the three releases, a total of 350 barrels (bbls) of produced water were released inside the lined secondary containment. 345 bbls of produced water were recovered using vacuum trucks. Remaining fluids evaporated, and evaporites were washed via power washing crew.

Tucker Draw 9 4 Federal (1H, 2H, 3H)  
32.0487592, -103.8800287

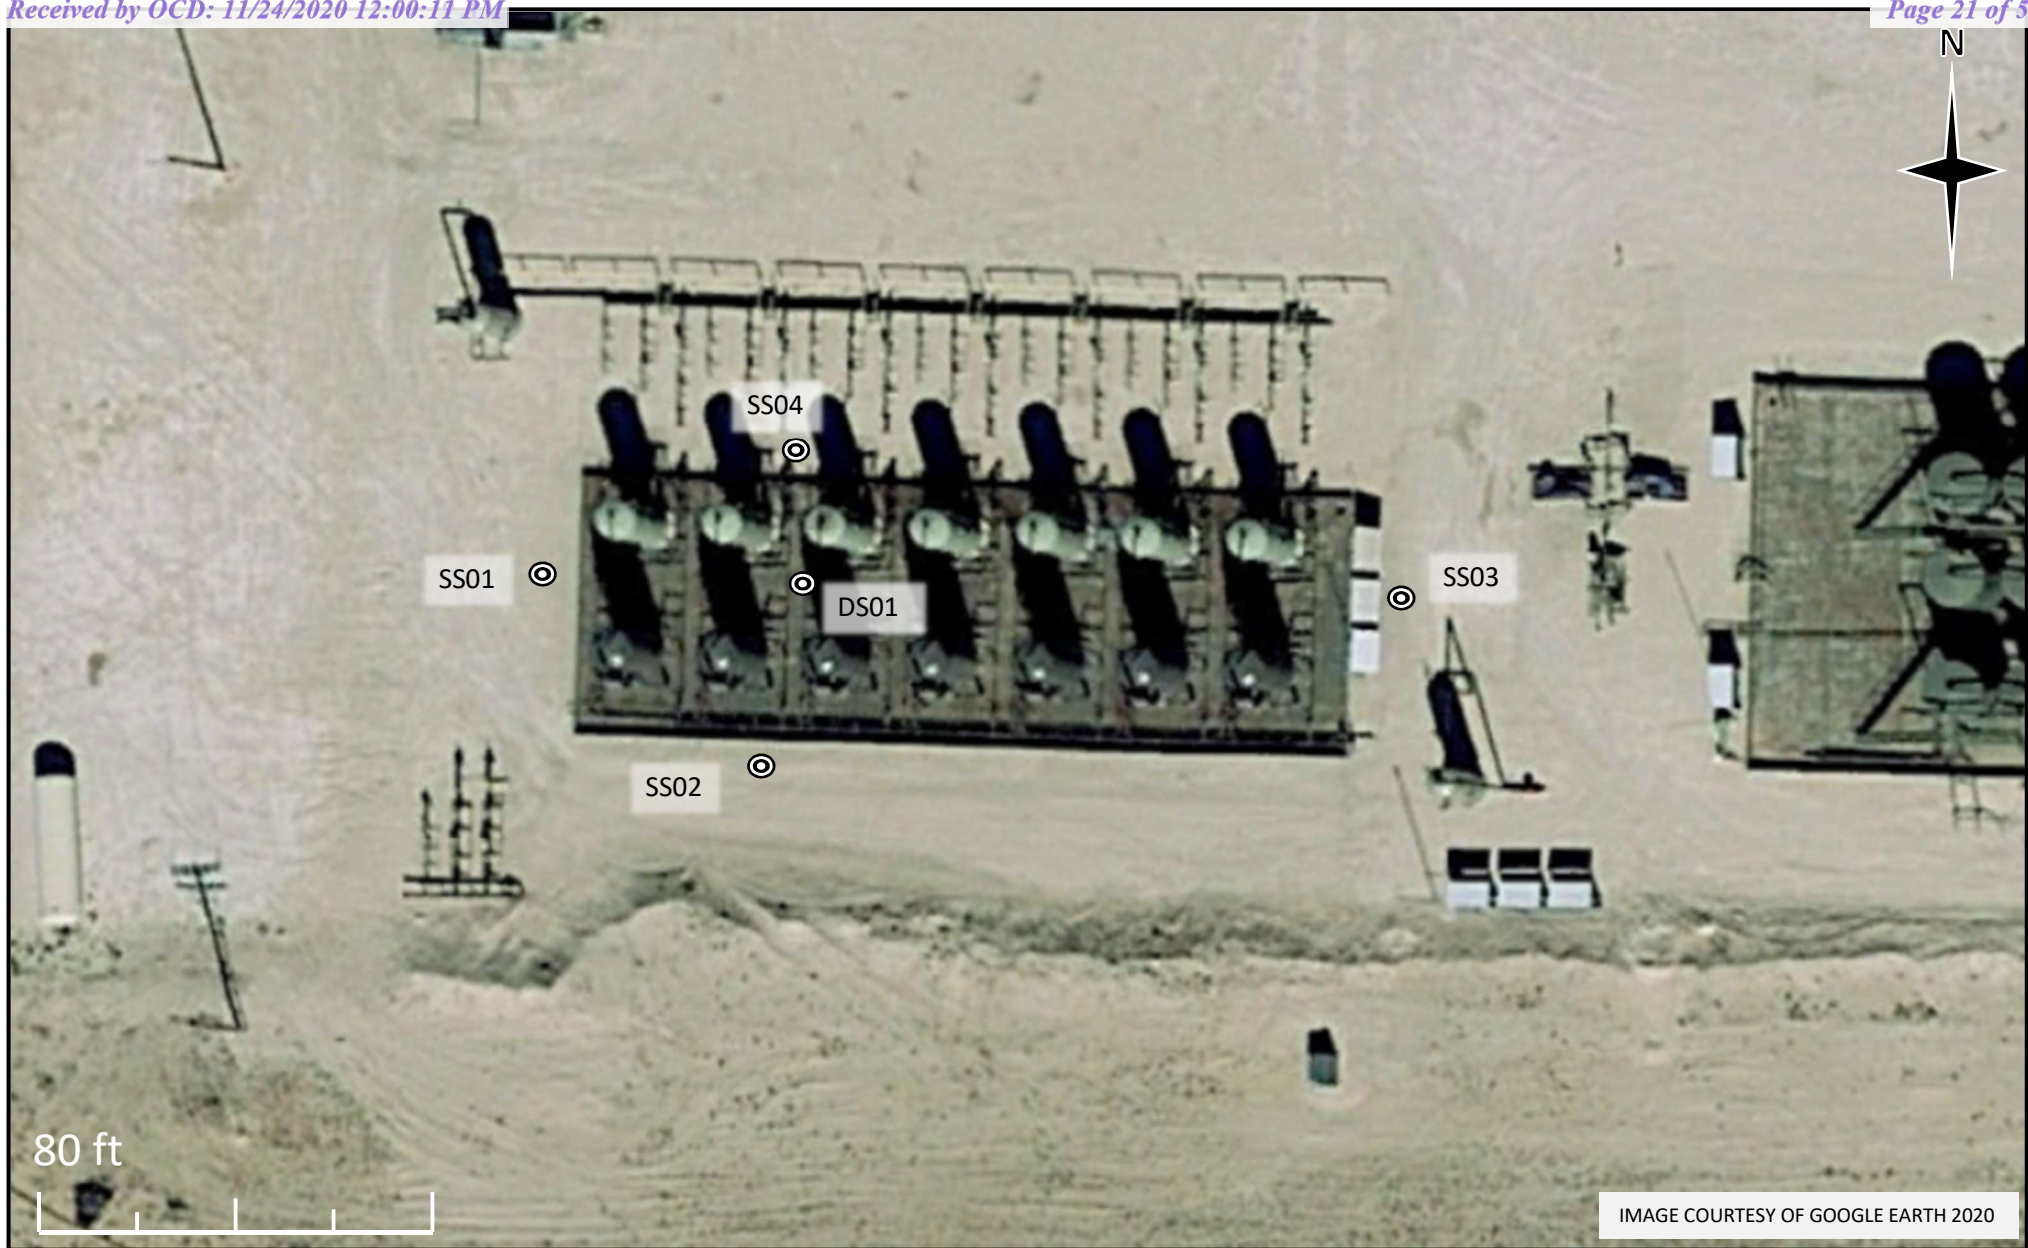
⊙ Sample Locations
