## Remediation and Closure Report

Paint 32 Fee #001H  
Eddy County, New Mexico  
30-015-39623  
**Incident ID #NRM2009054594**

Subject: **Remediation and Closure Report**  
Paint 32 Fee #001H  
Eddy County, NM  
**Incident ID #NRM2009054594**

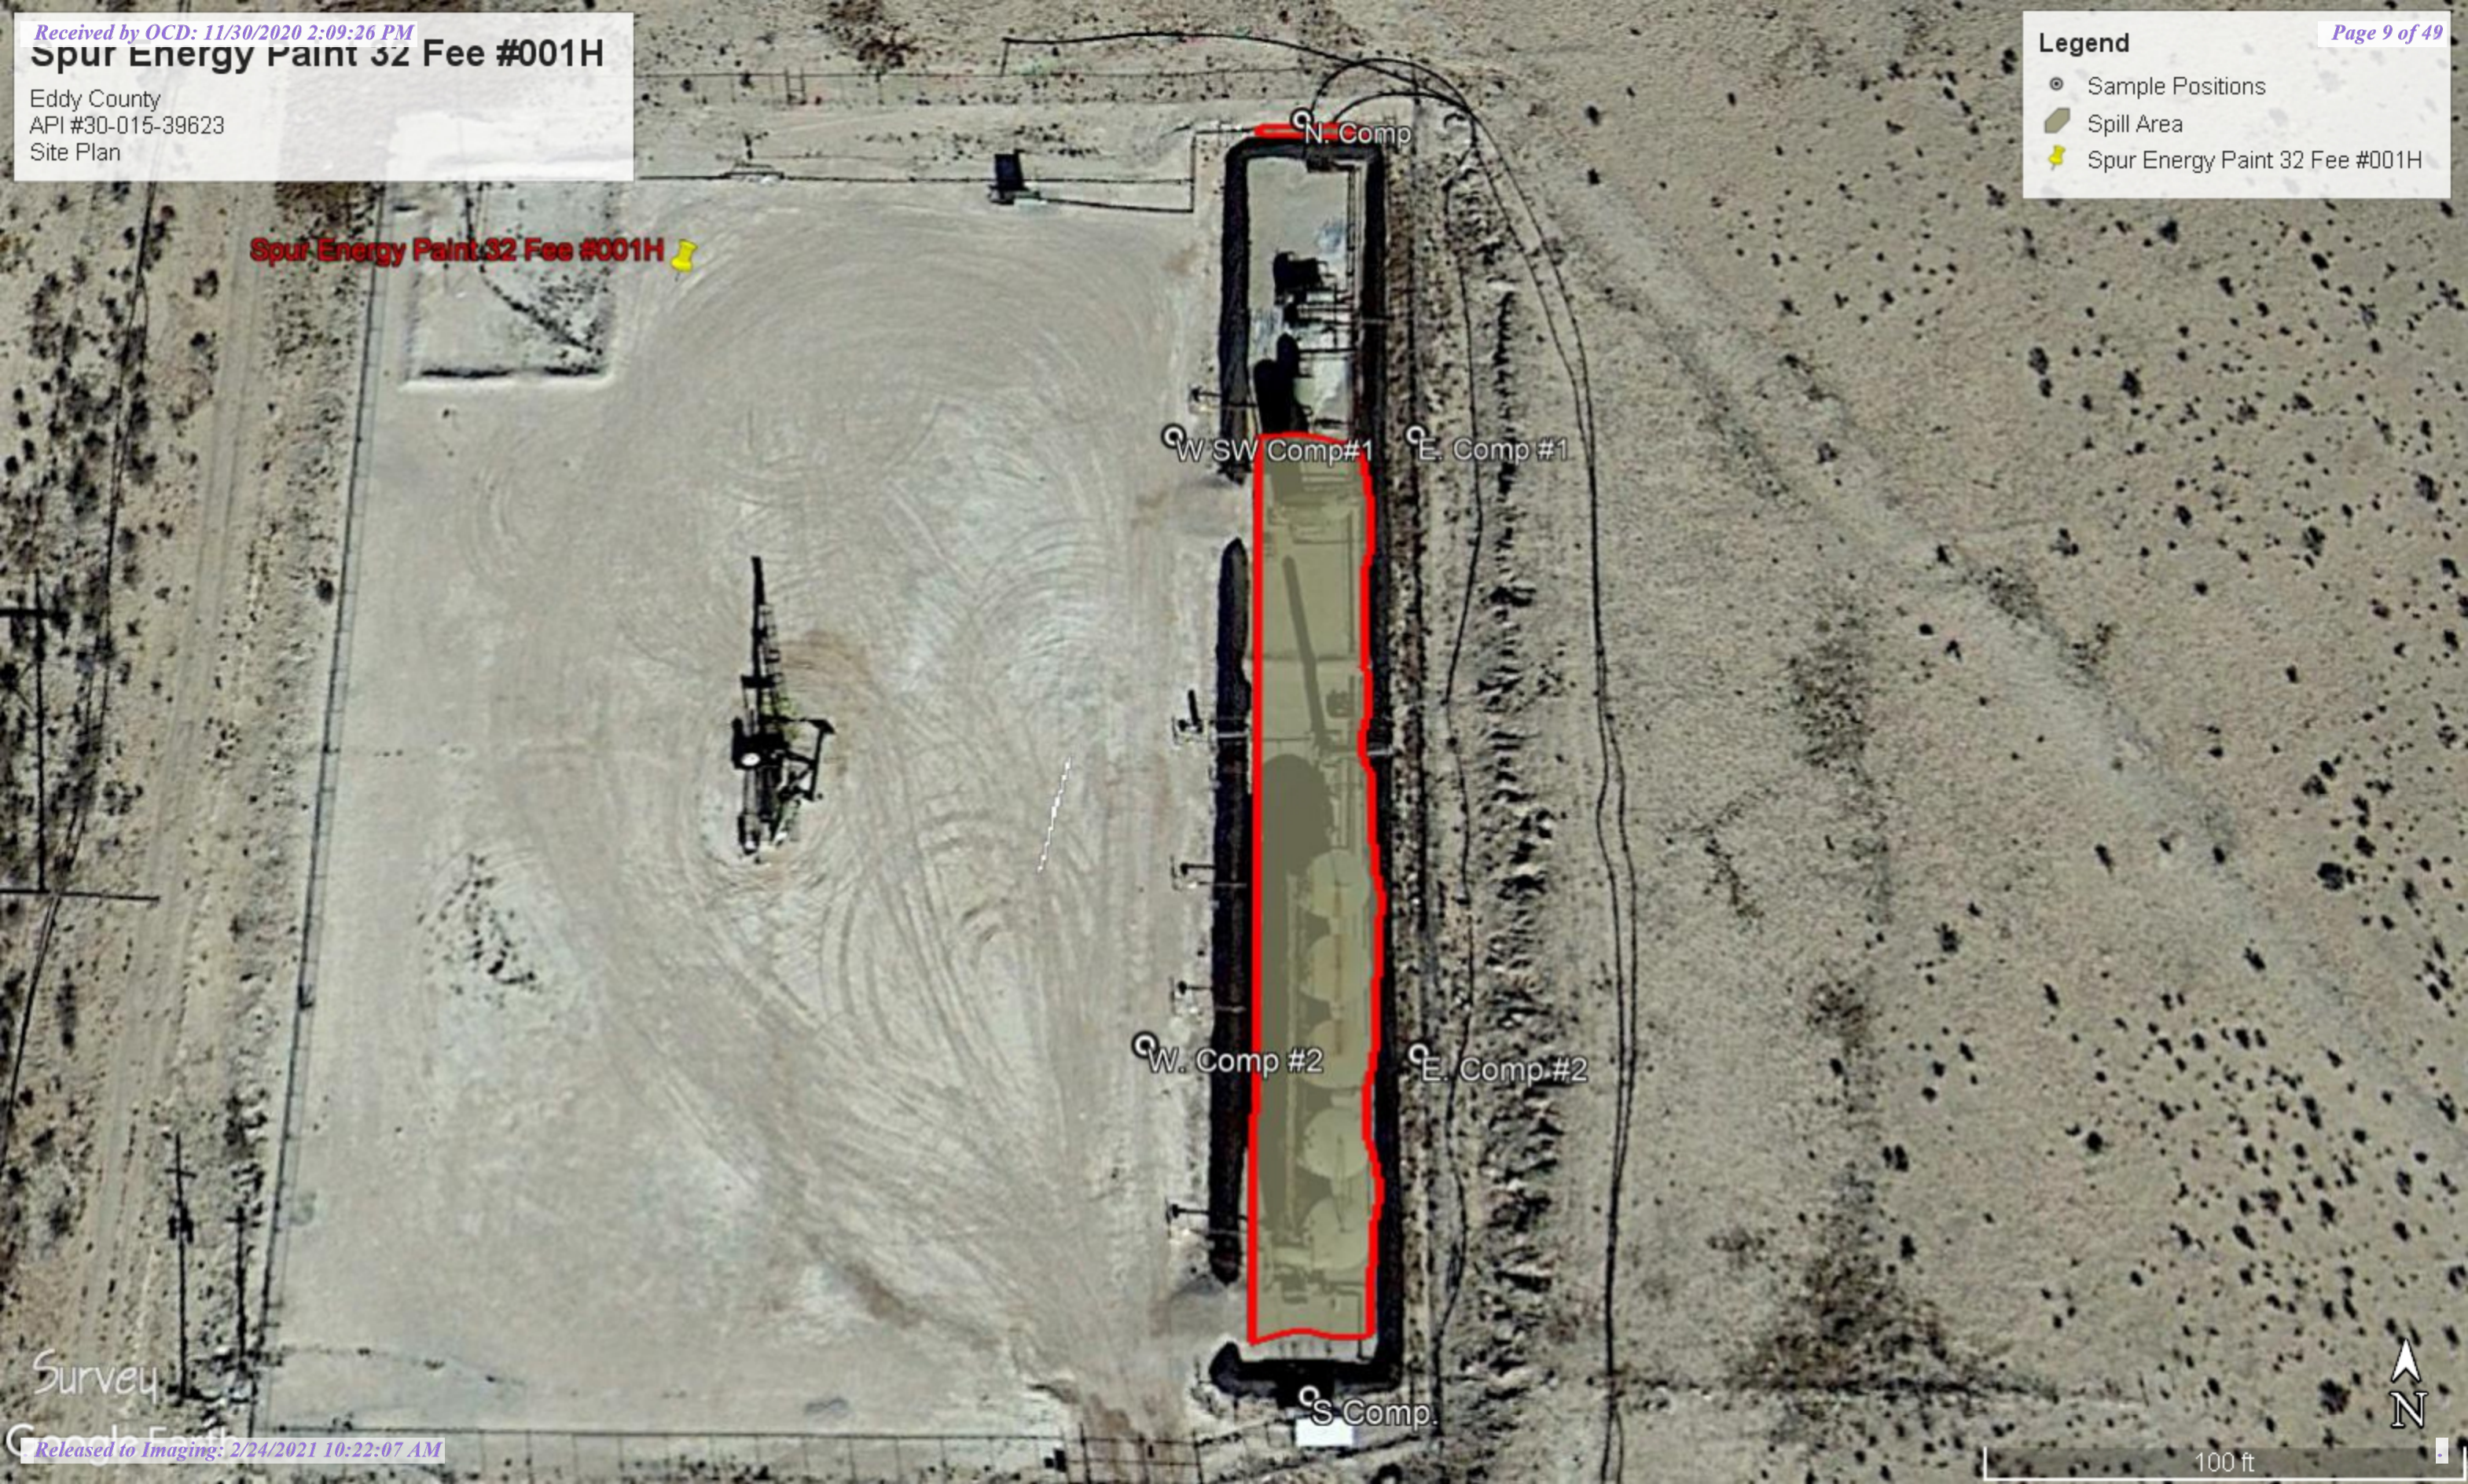
Eddy County  
API #30-015-39623  
Site Plan

- Sample Positions
- Spill Area
- Spur Energy Paint 32 Fee #001H

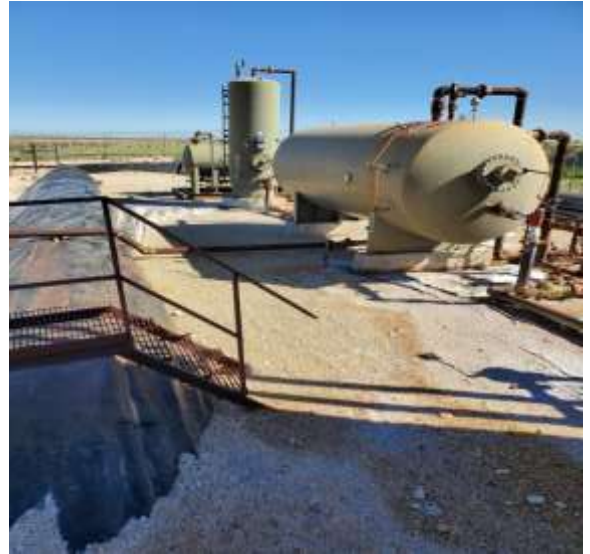
Looking North

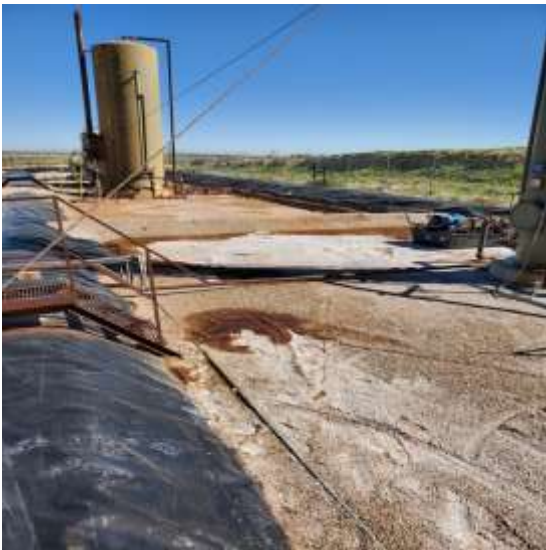
Looking East

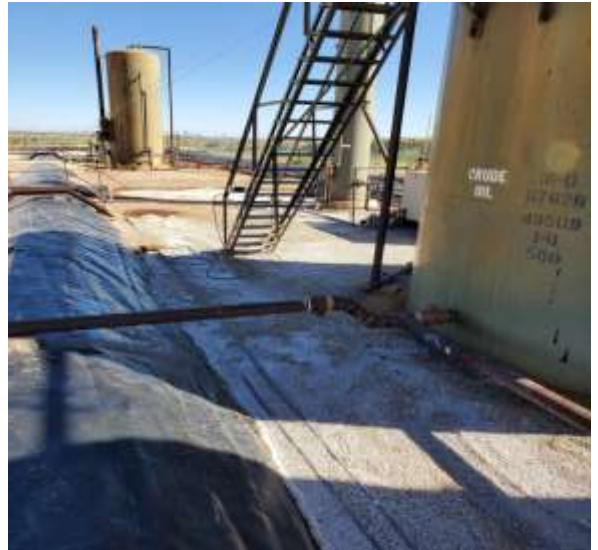
West side of interior berm

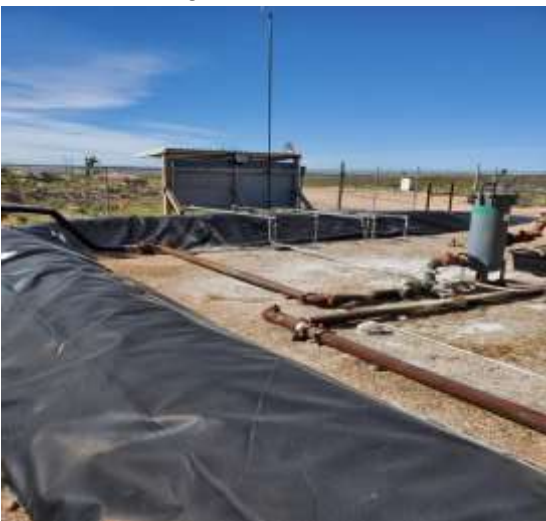
South Side

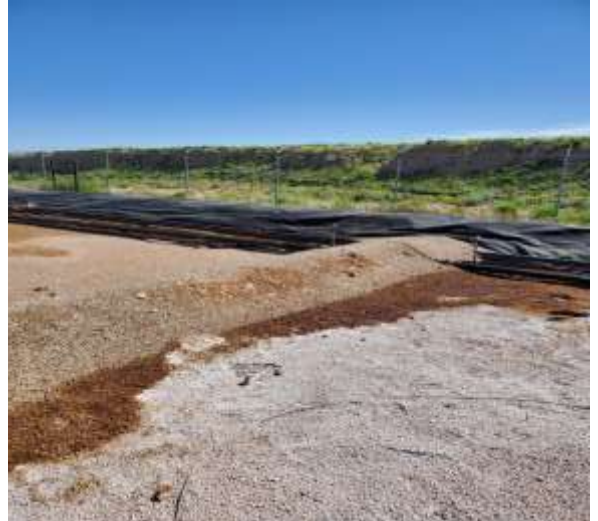
Center Berm Leaching

On November 02, 2020 Talon personnel returned to the Paint 32 Fee #001 Battery site, in order to hand excavate the North exterior side of the containment to a depth of 1' bgs. A hydro-vac was utilized to remove all stained pea gravel from the interior of the containment. The interior was power washed and all fluid removed so that the liner could be inspected for any possible breaches. No breaches were detected in the bottom of the liner. However, there were two small holes in the liner located on the crest of the west berms. Akome was dispatched to repair the liner as can be seen in the photo documentation ([Appendix IV](#)).

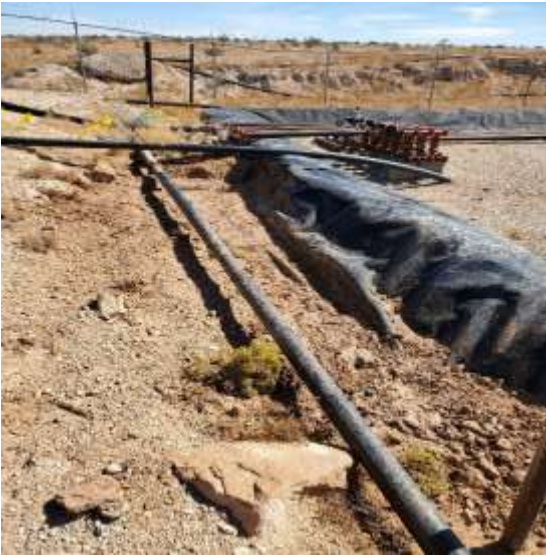
Excavation N Exterior of berm

- All impacted soil on the northern exterior side of containment and all surface staining was excavated and disposed of at an NMOCD approved facility.
- All stained pea gravel was removed from the interior of the containment and the liner power washed.
- The liner was repaired and final inspection conducted. Photo documentation is appended.
- Confirmation soil samples were retrieved and verified analyte levels within NMOCD guidelines.
- Fresh caliche, similar in grade was used to backfill the location.

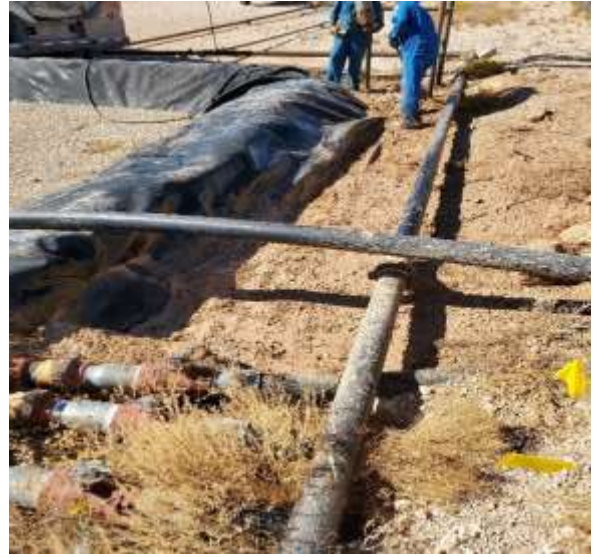
Looking West

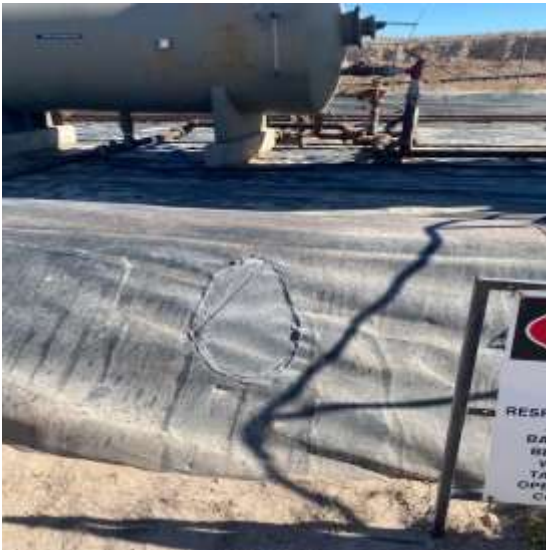
Liner Repair

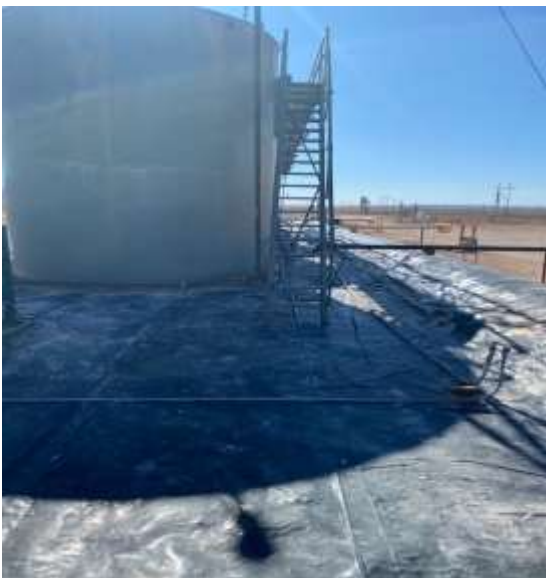
South Side
