Remediation Summary and Soil Closure Request

Sunoco Partners Marketing & Terminals, LP Whitehorn Road

Eddy County, New Mexico
Unit Letter D, Section 15, Township 26 South, Range 29 East
Latitude 32.04886 North, Longitude 103.98002 West
NMOCD Reference No. nRM2033538690

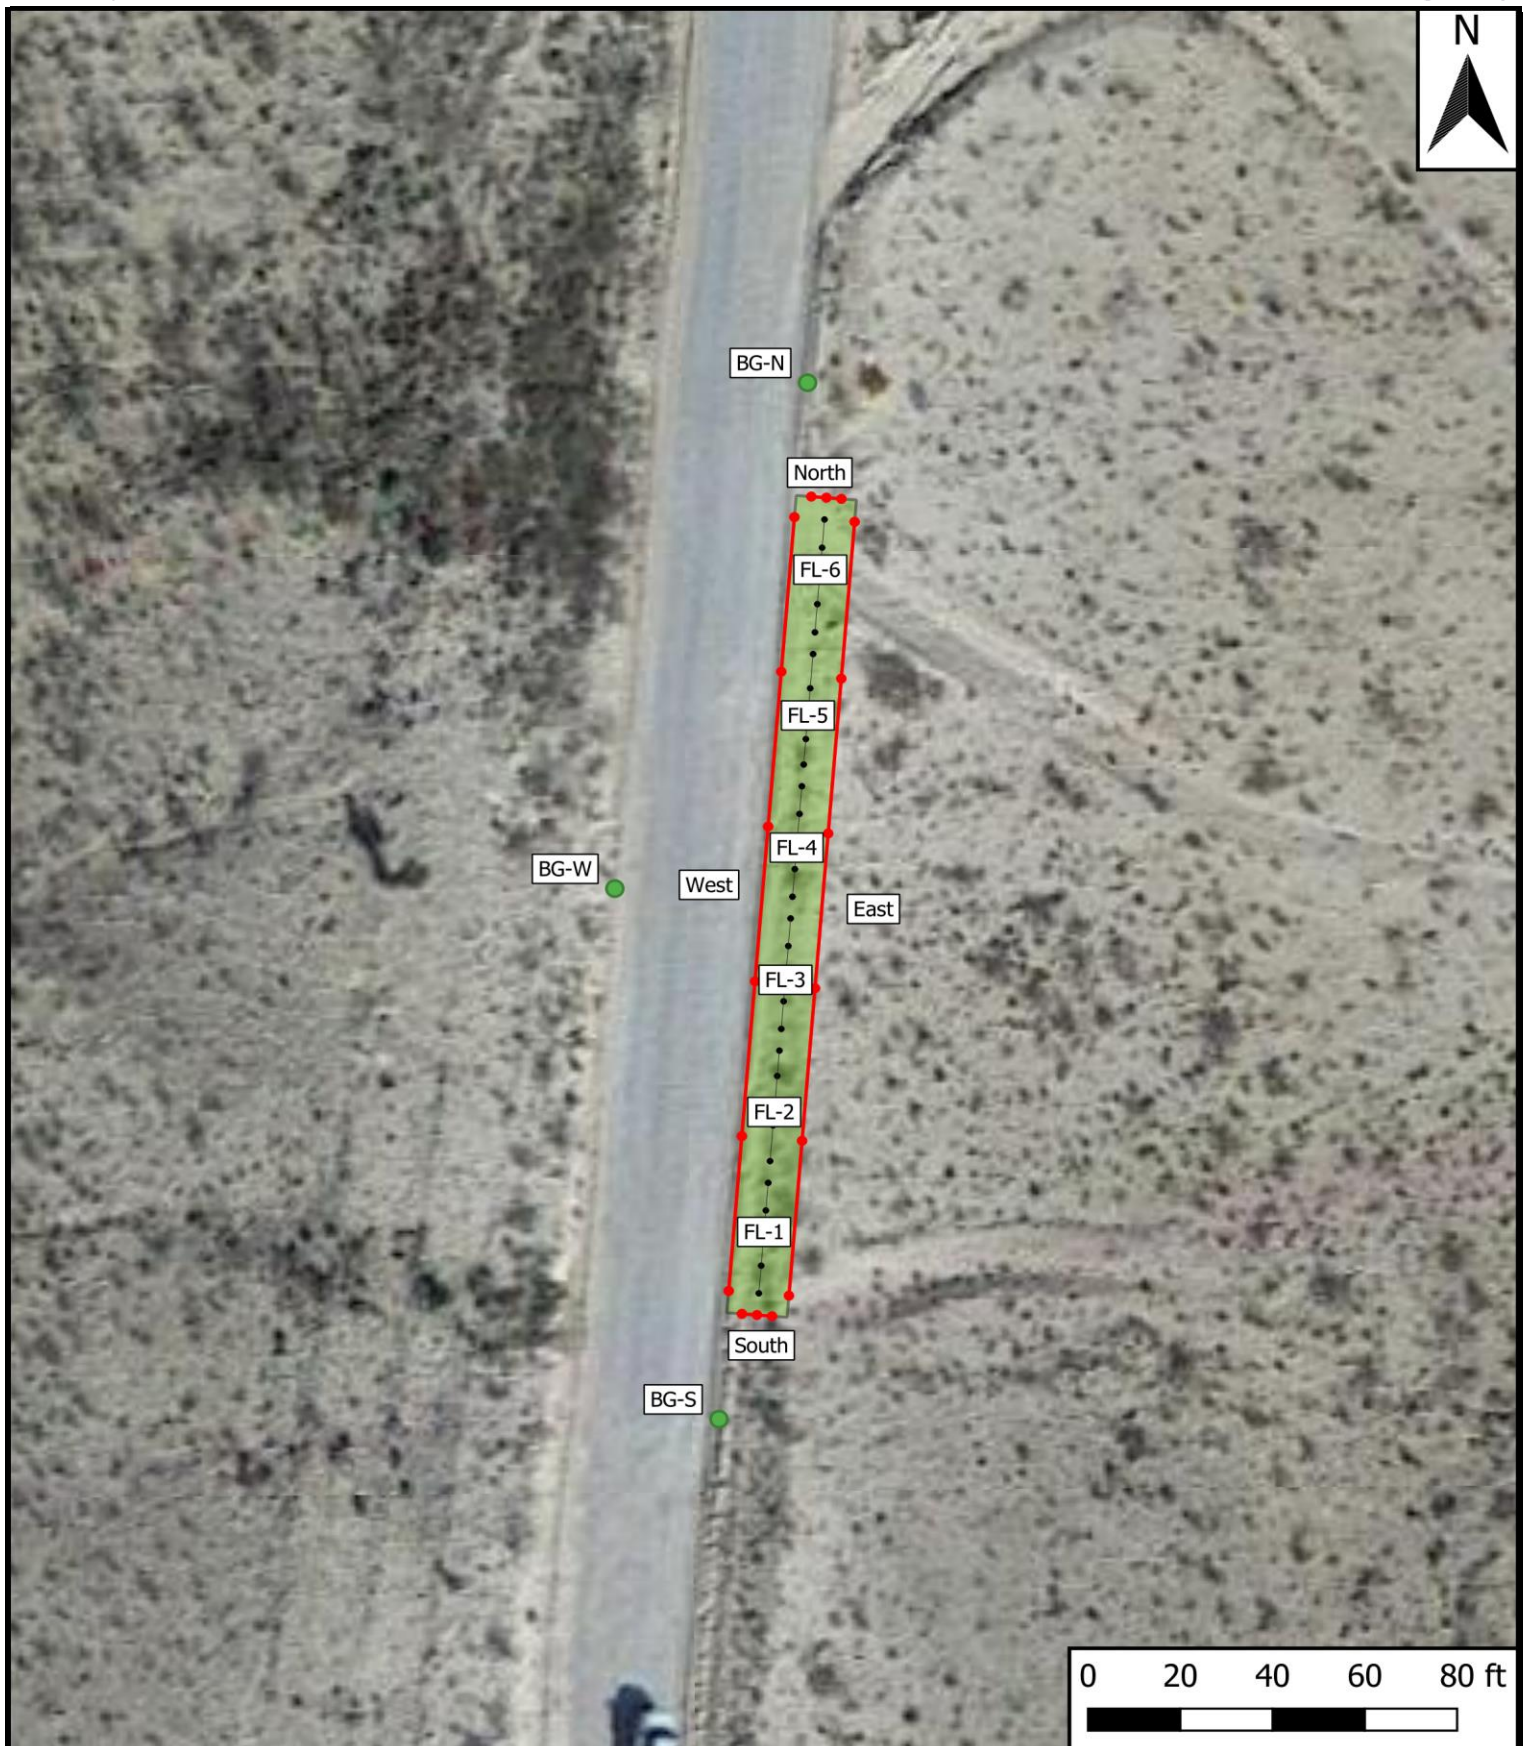
Figure 3

Site and Sample Location Map

- Excavation
- Background Sample
- Composite Floor Sample
- Composite Wall Sample

Etech collected ten (10) excavation confirmation soil samples (FL-1 through FL-6, North, East, South, and West). The soil samples were submitted to a certified commercial laboratory for analysis of BTEX, TPH, and chloride. Laboratory analytical results indicated BTEX and TPH concentrations were below the applicable NMOCD Closure Criteria and the NMOCD Reclamation Standard in each of the submitted soil samples. Laboratory analytical results also suggested the crude oil-only release commingled with an unrelated historical produced water release (or releases) of unknown date(s) and volume(s), based on elevated chloride concentrations in soil samples FL-4, FL-5, FL-6, East, South, and West.

A "Site & Sample Location Map" is provided as Figure 3. A soil chemistry table is provided as Table 1. Field data and soil profile logs are provided in Appendix B. Laboratory analytical reports are provided in Appendix C. General photographs of the release site are provided in Appendix D.

The final dimensions of the excavated area were 185 feet in length, 3 to 4 feet in width, and 2 to 3 feet in depth. During the course of remediation activities, approximately 80 cubic yards of impacted soil were transported to an NMOCD-approved surface waste facility for disposal.

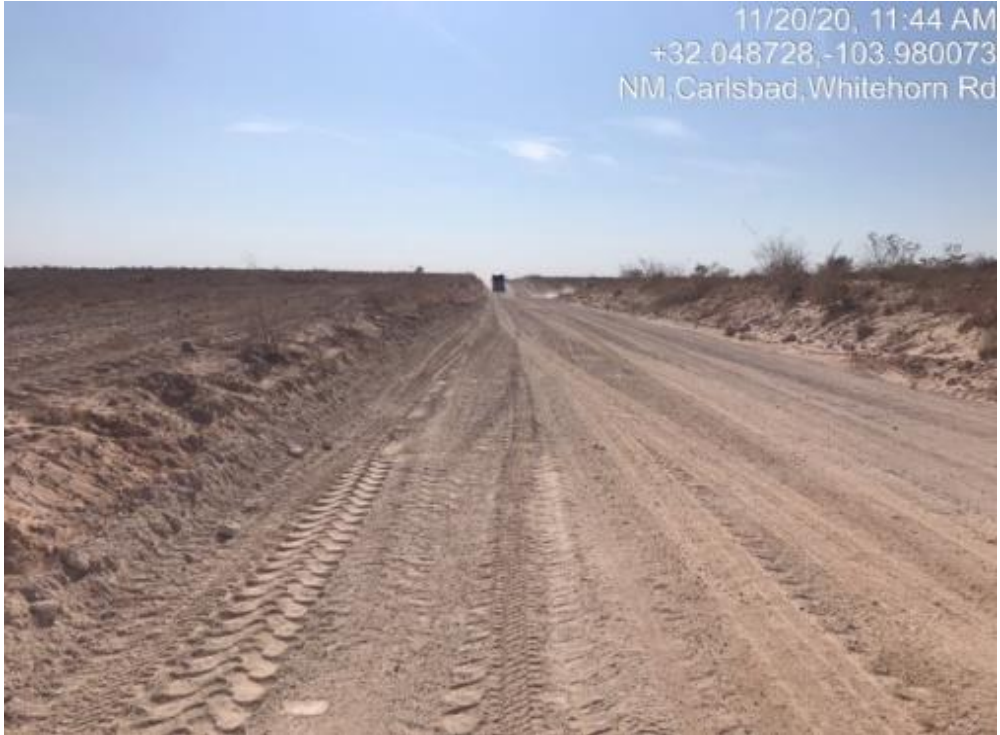
Photo Number: 4

Photo Direction: South	
Photo Description: Backfilled Excavation

Upon receiving laboratory analytical results from confirmation soil samples, the excavated area was backfilled with locally sourced, non-impacted "like" material placed at or near original relative positions. The affected area was contoured and compacted to achieve erosion control, stability and preservation of surface water flow to the extent practicable. Affected areas not on lease roads will be reseeded with an agency-approved seed mixture free of noxious weeds during the first favorable growing season following closure of the site.
