Based on laboratory analytical results and field activities conducted to date, Etech recommends ETC Texas Pipeline, Ltd. provide copies of this Remediation Summary and Soil Closure Request to the appropriate agencies and request closure be granted to the West Eunice Discharge Line Remediation Site.

Figure 2
Aerial Map
ETC Texas Pipeline, Ltd.
West Eunice Discharge Line Remediation
GPS: 32.30835, -103.20269
Lea County

Photographic Log

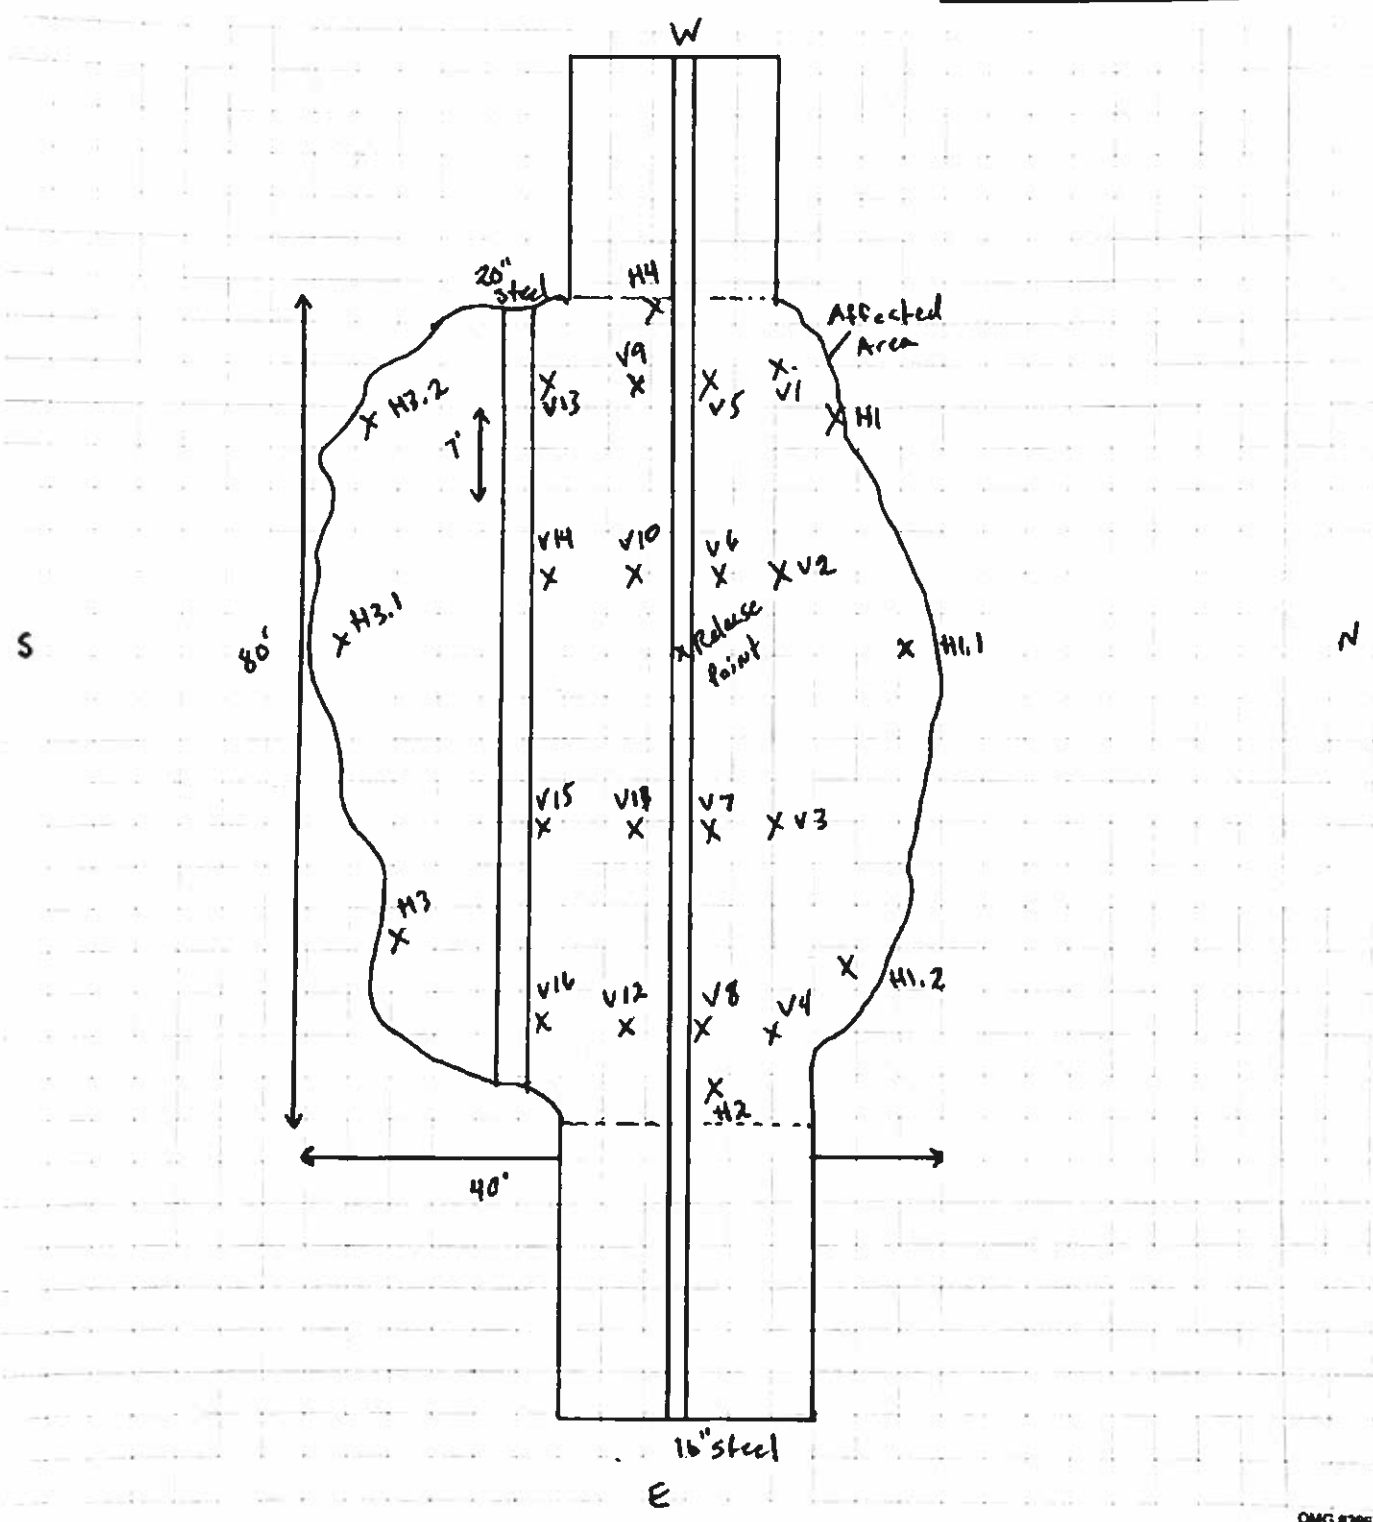
Date:	7/23/2020
Client:	ETC
Location:	West Eunice Discharge
GPS:	32.308381 -103.202841
Prepared By:	Tyler R.

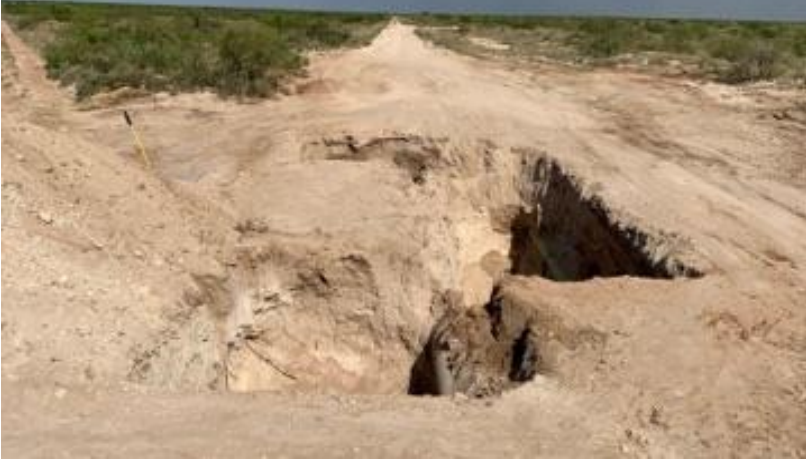
Photo Number: 1	<div>West Eunice Discharge 32.308381 -103.202841</div> <div>8/4/2020</div>

Photo Direction: West	
Photo Description: Excavated area.

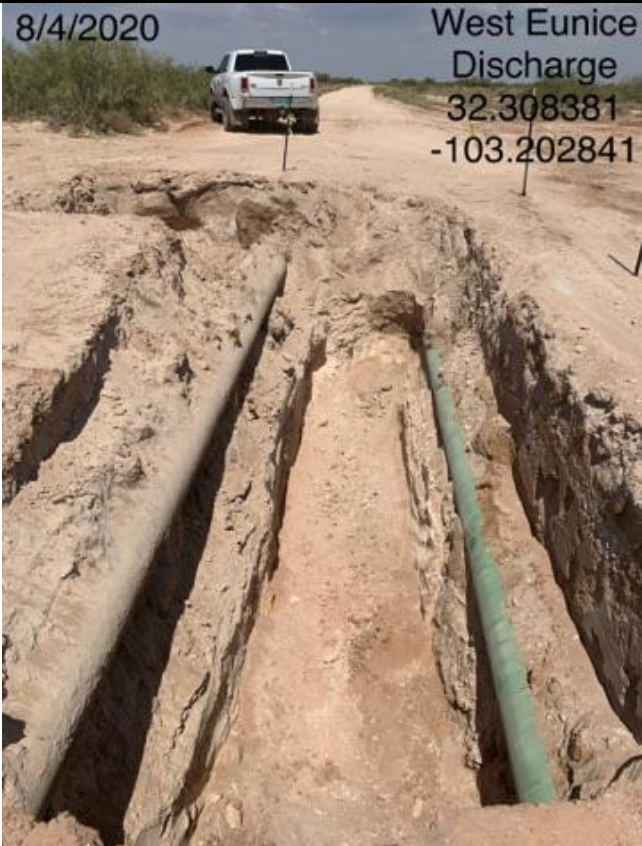
Photo Number: 2	<div>8/4/2020</div> <div>West Eunice Discharge 32.308381 -103.202841</div>

Photo Direction: West	
Photo Description: Excavated pipeline.

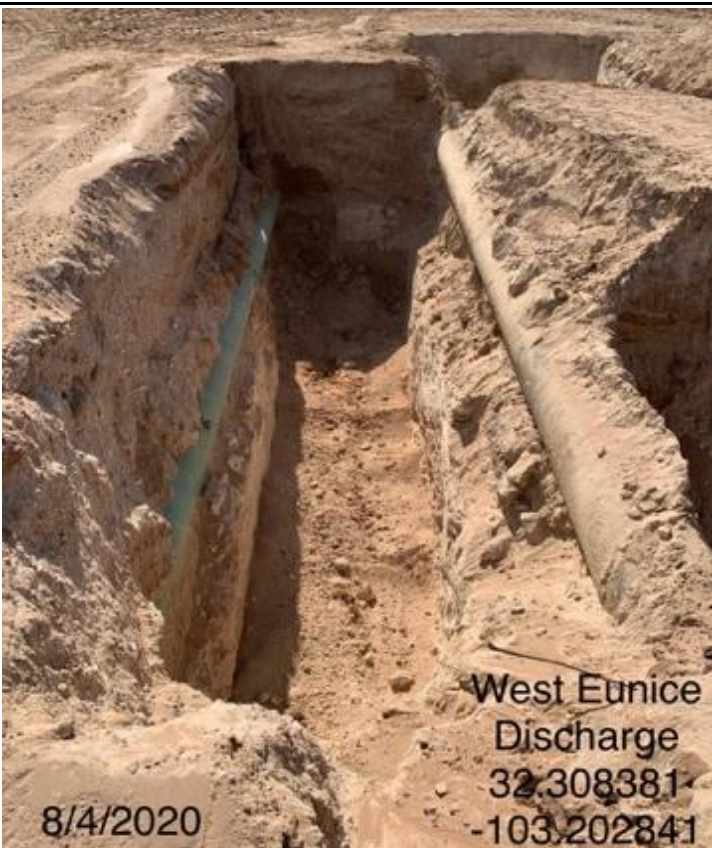
Photo Number: 3

Photo Direction: East	
Photo Description: Excavated pipeline.

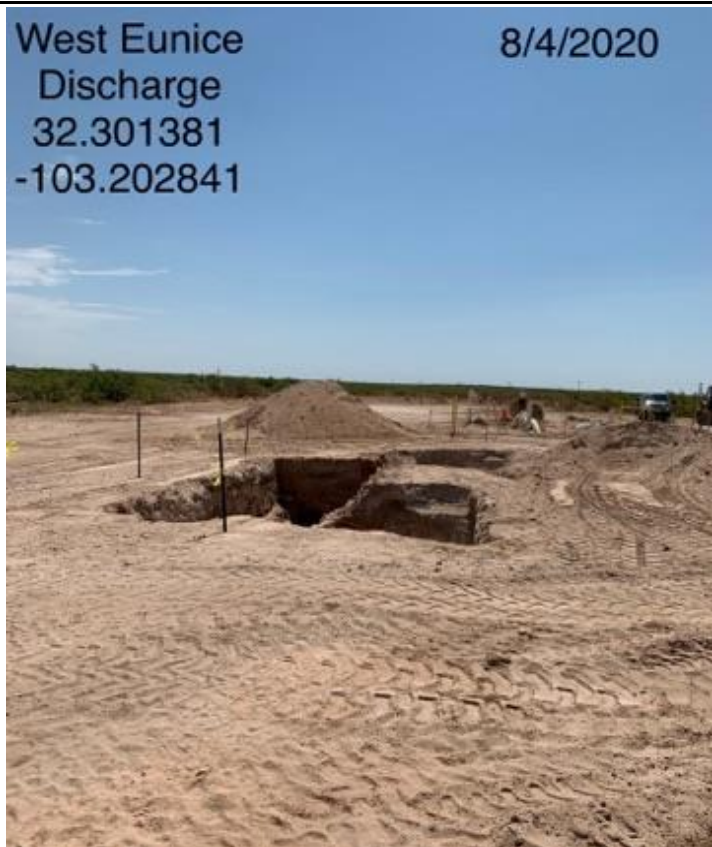
Photo Number: 4

Photo Direction: East	
Photo Description: Excavated area.

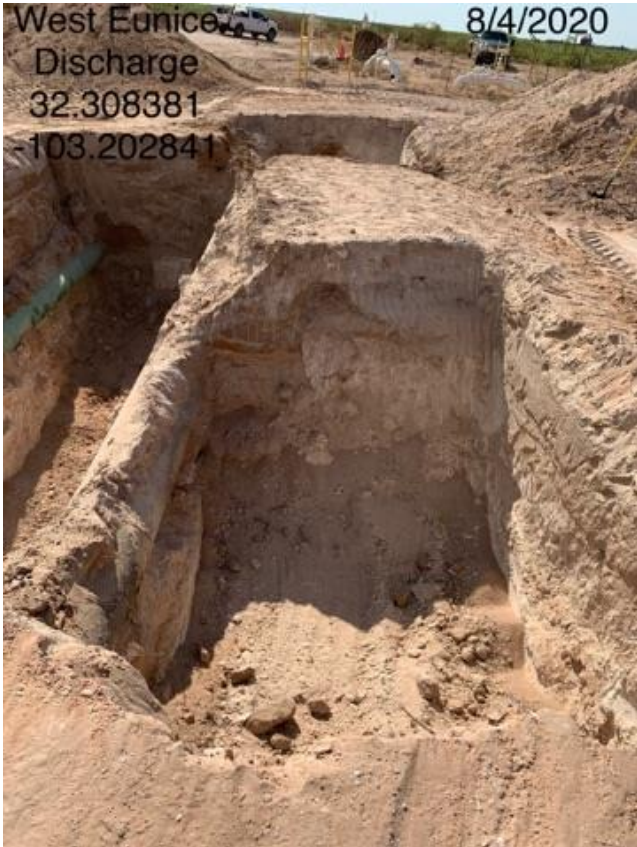
Photo Number: 5

Photo Direction: East	
Photo Description: Excavated pipeline.

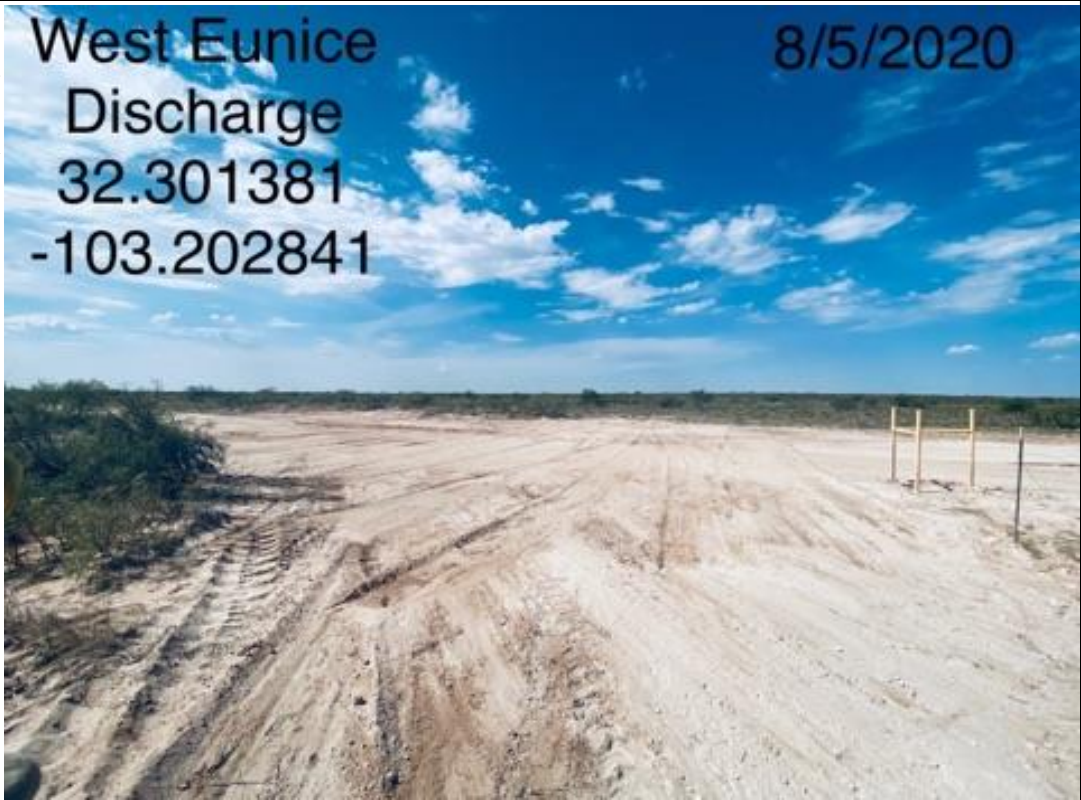
Photo Number: 6

Photo Direction: South	
Photo Description: Excavation area after backfill and grading.
