Incident ID	#NCD1926052330
District RP	
Facility ID	
Application ID

**SUBJECT: Closure Request for the Serendipity 3R Release (NCS1926052330),  
Farmington, New Mexico**

**Serendipity 3R (NCS1926052330)**  
**Soil Sampling**  
**San Juan County, New Mexico**

SUBJECT: Deferral Request for the Serendipity 3R Release (NCS1926052330), Farmington, New Mexico

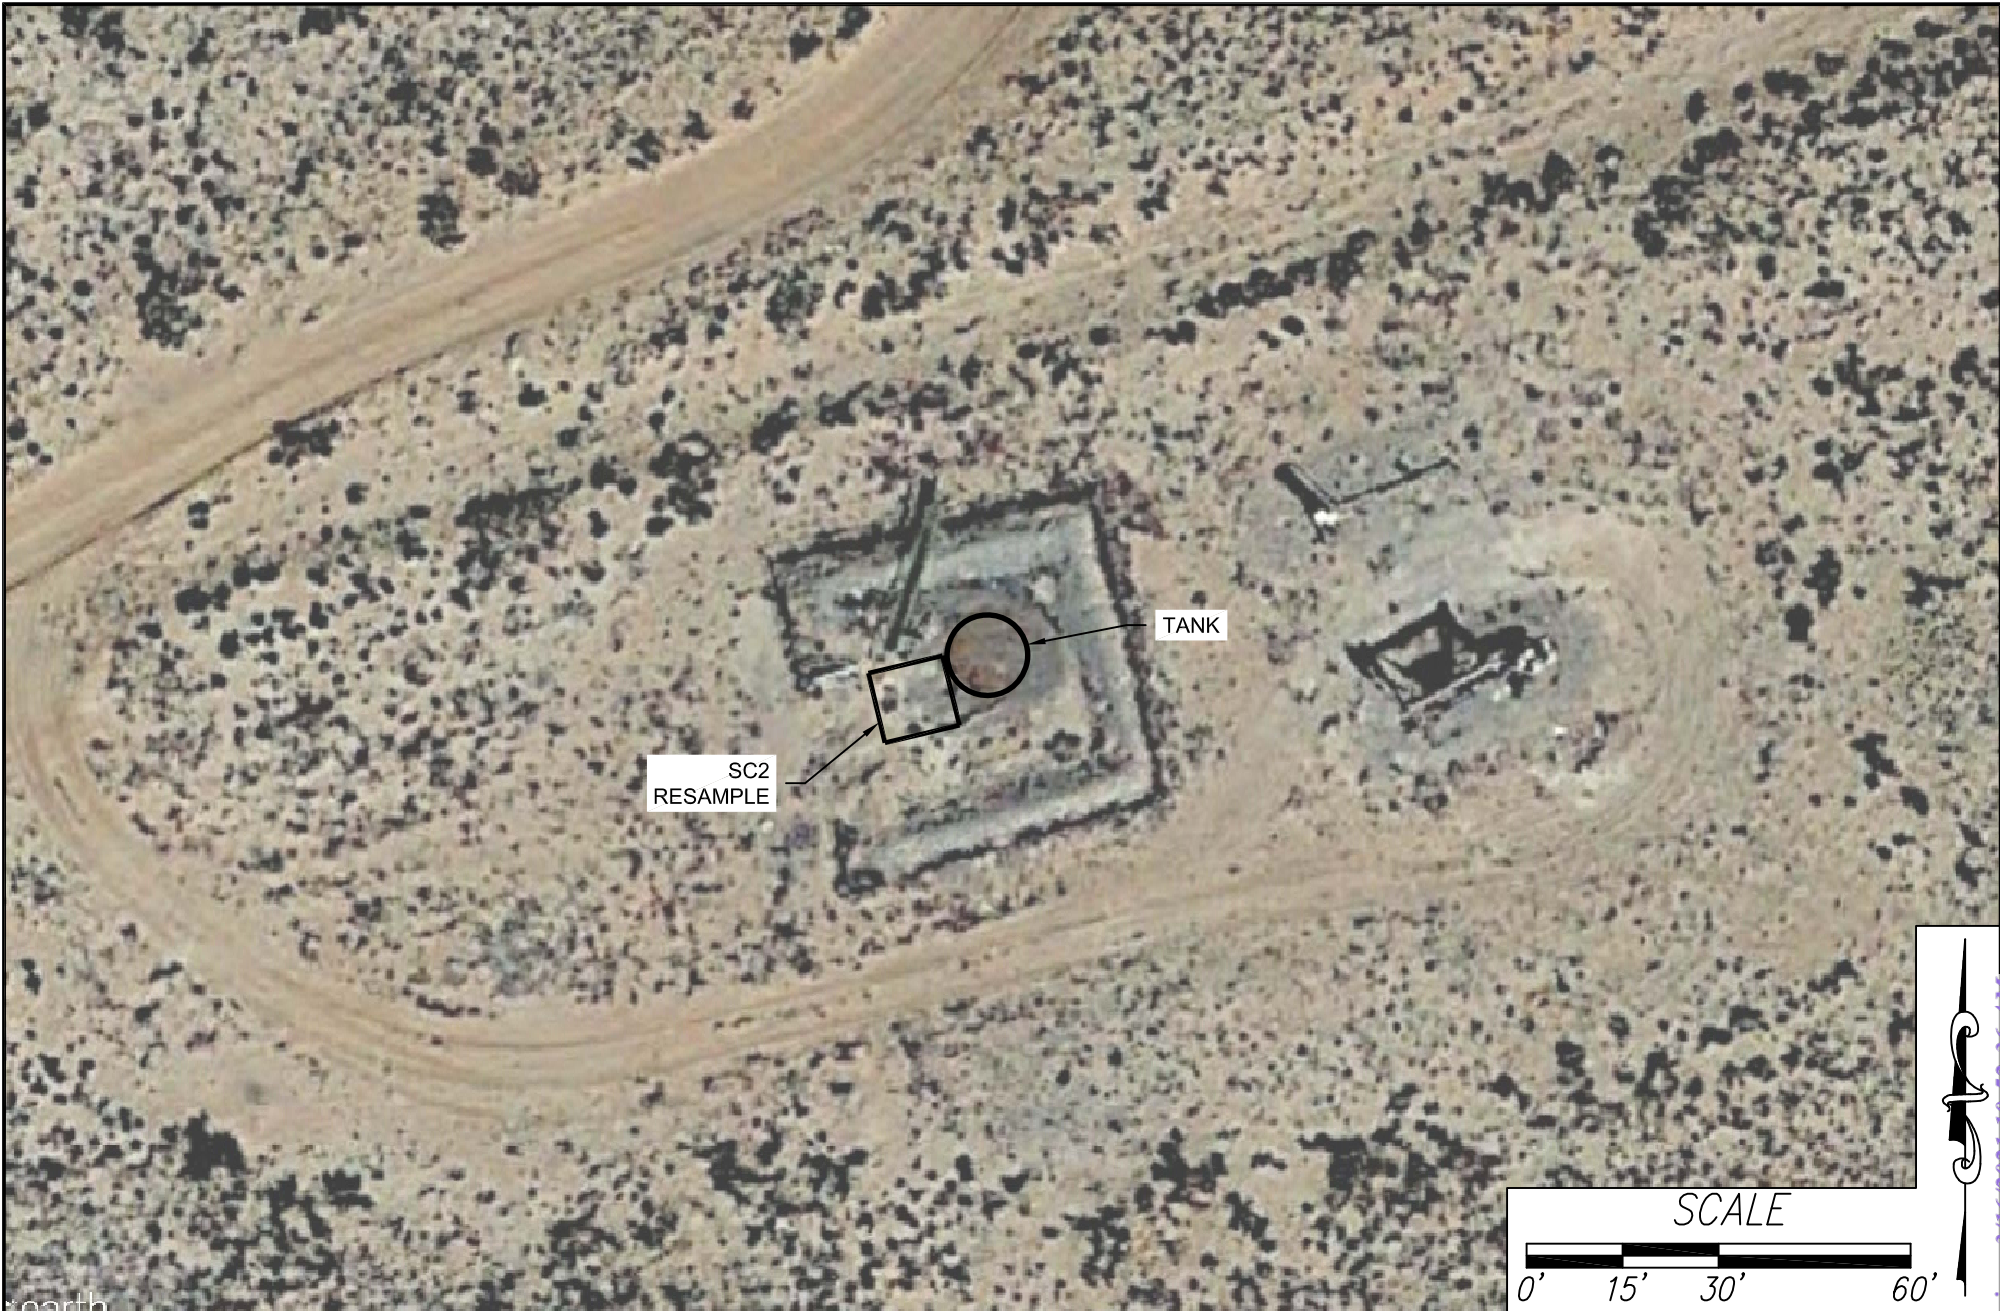
MUSTANG RESOURCES	FARMINGTON, NEW MEXICO
SAMPLE LOCATION MAP SERENDIPITY 3R M-26-26N-13W

Per the NMOCD-approved Deferral Request dated October 25, 2019, Mustang Resources, LLC applied gypsum to the impacted area and allowed for insitu treatment to occur for approximately one year. On September 1, 2020, SMA returned to site and collected one composite soil sample (SC2-Resample) from the deferred SC2 area at six (6) inches below grade surface (bgs). Figure 2 illustrates the location of SC2-Resample.

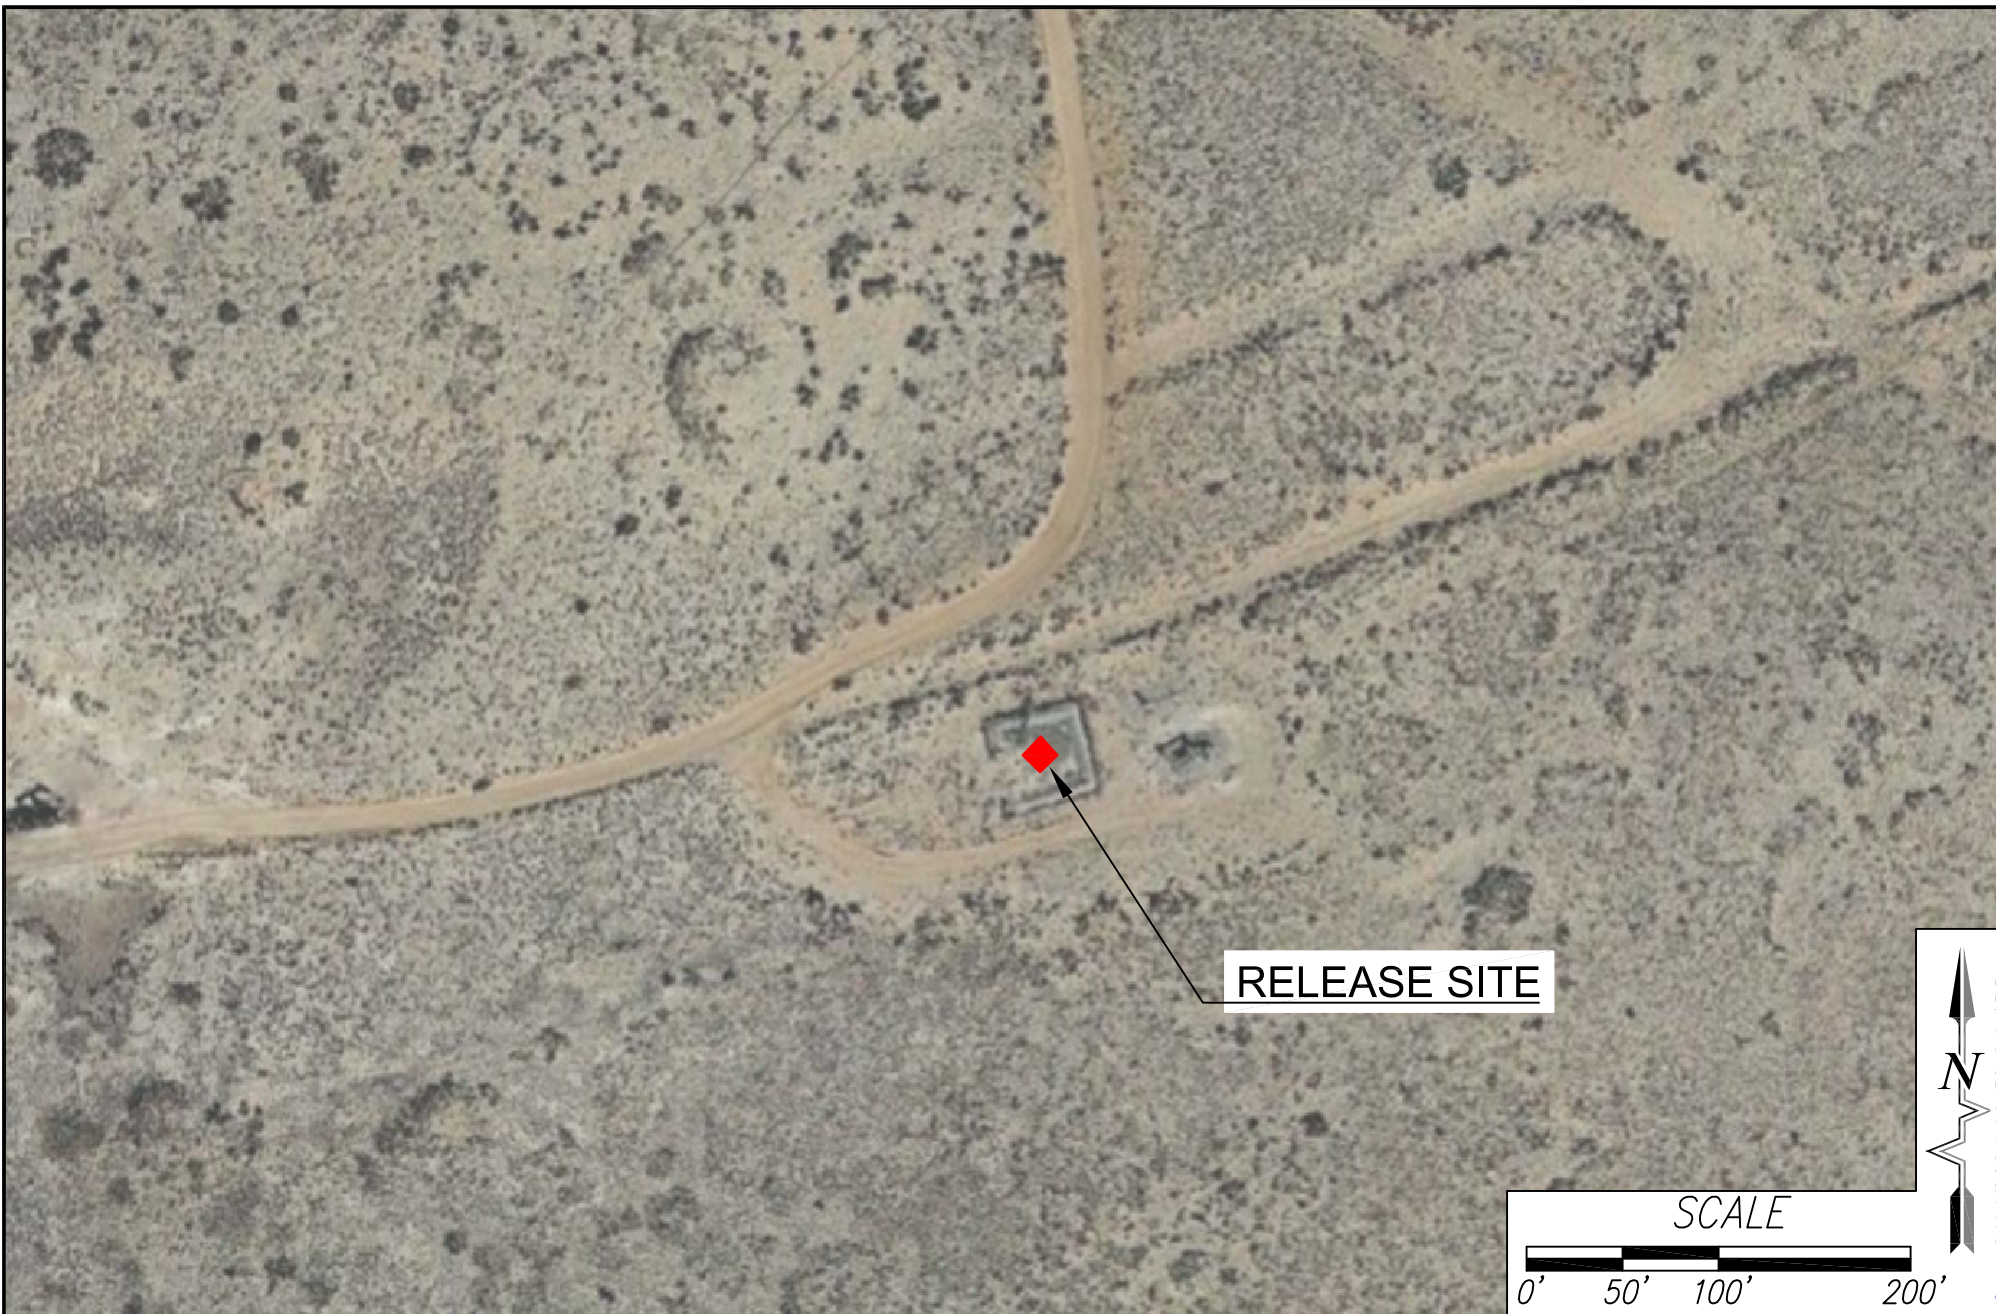
Figure 2

MUSTANG RESOURCES	FARMINGTON, NEW MEXICO
<b>SITE MAP</b> <b>SERENDIPITY 3R</b> <b>M-26-26N-13W</b>

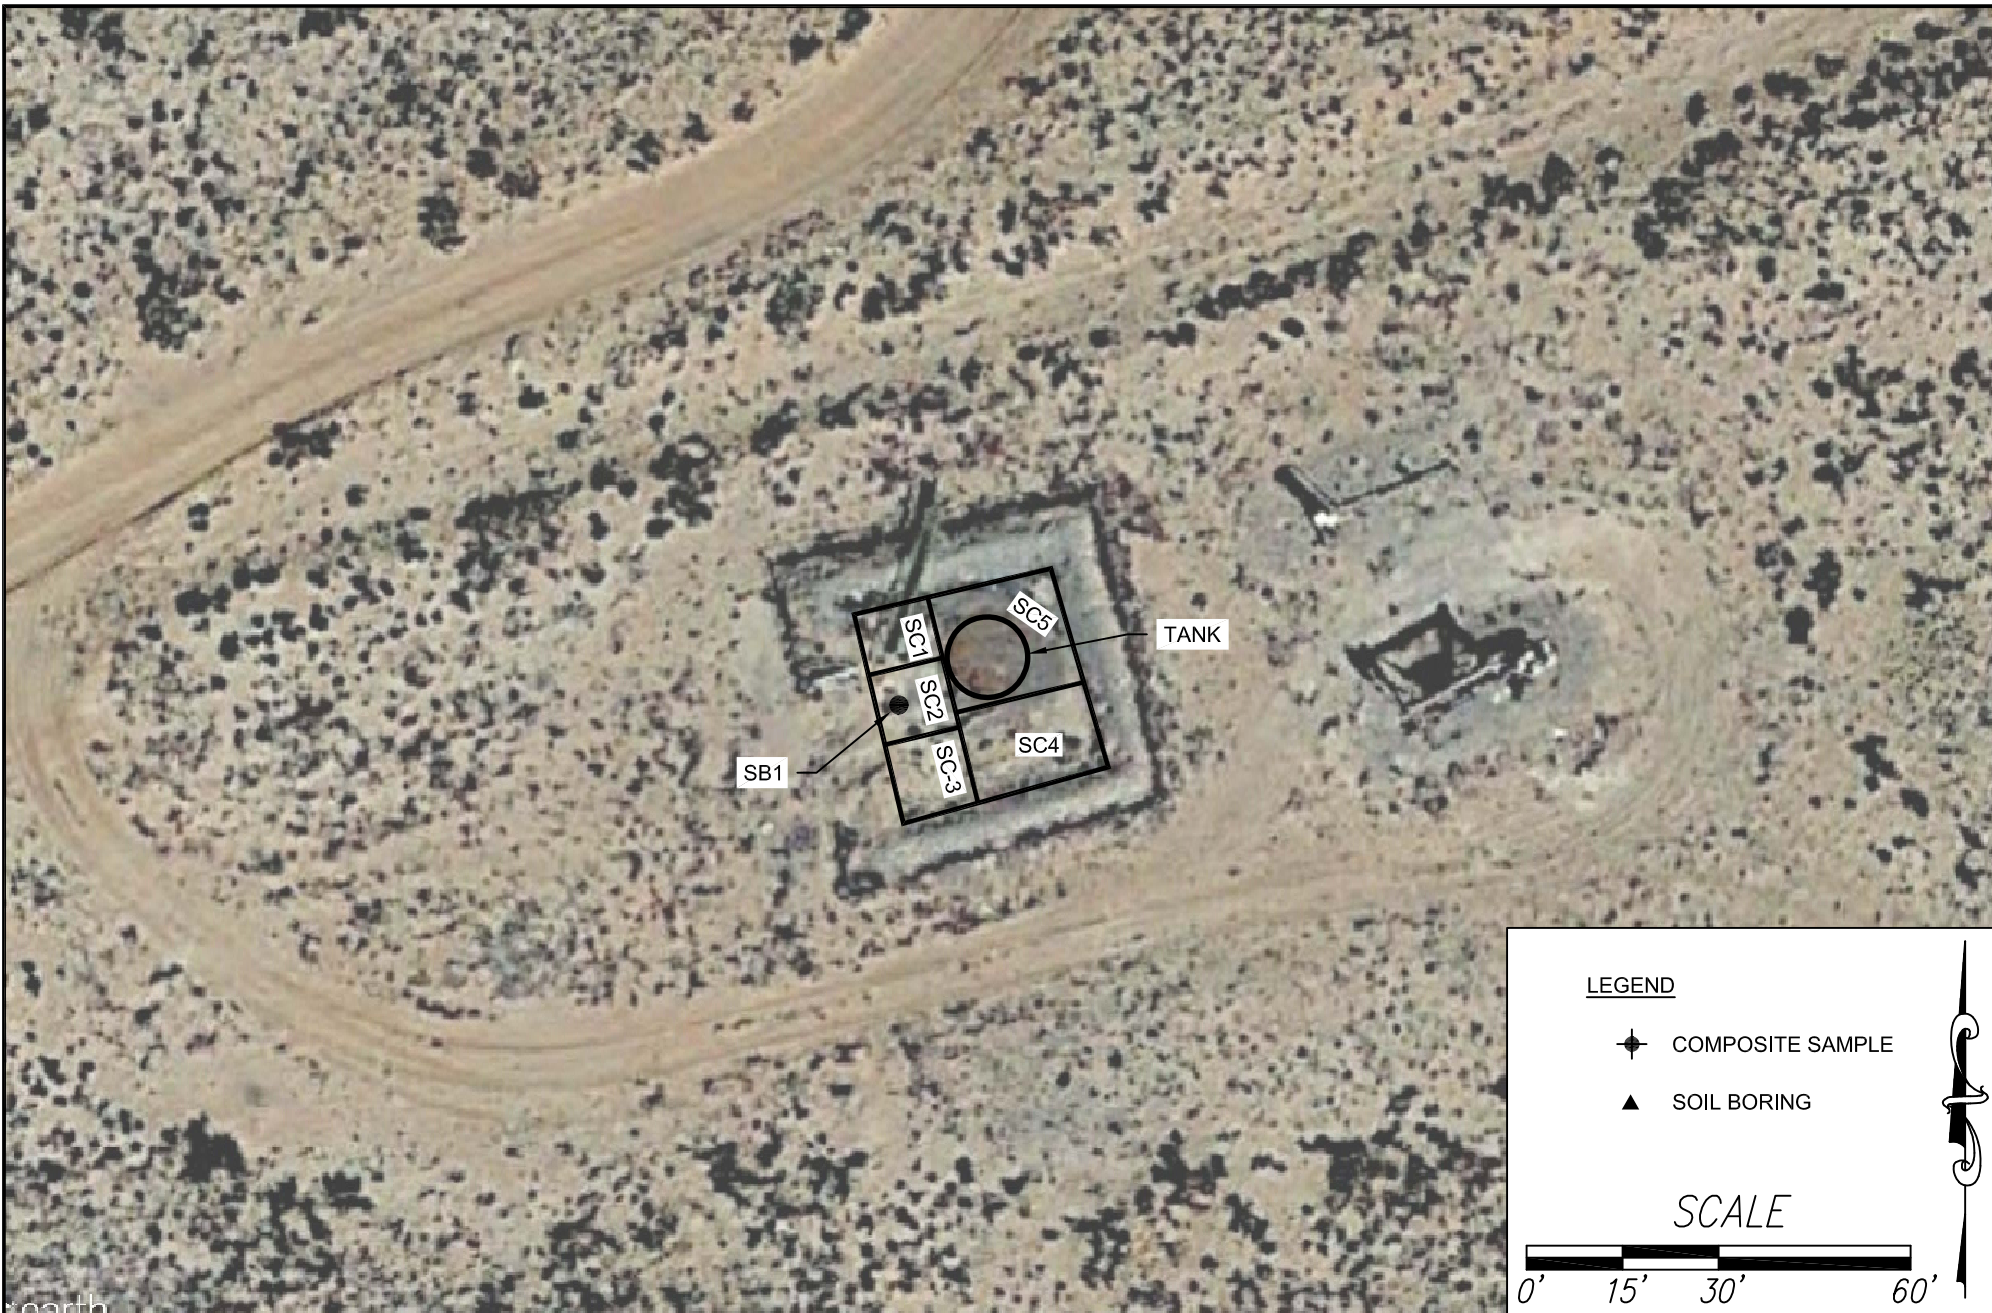
Figure 3

As summarized in Table 3, results indicate that an area approximately 14 feet by 11 feet by 6 inches deep has been impacted (sample location SC2) by chlorides above the reclamation requirement but remain below the Closure Criteria. Locations for all samples are depicted on Figure 3.

As summarized in Table 3, results from soil boring activities indicate that the impacted area of SC2 is limited to the surface. Locations for all samples are depicted on Figure 3.

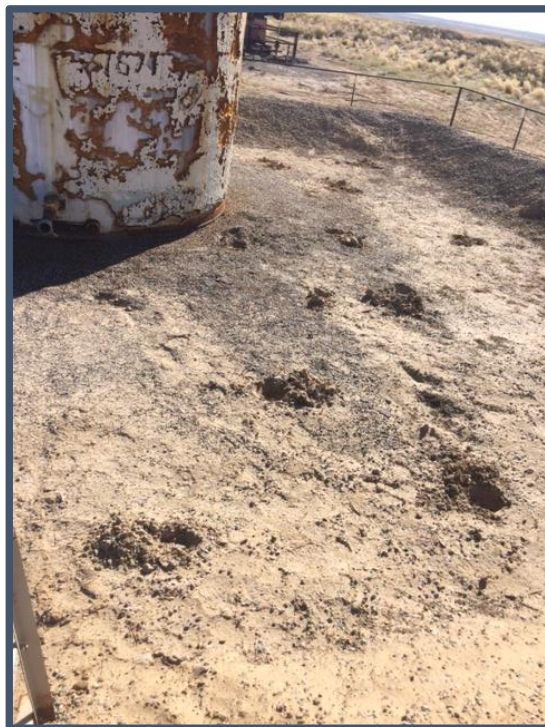
Photo 1: Sample area SC2.

On October 31, 2019, three bags of gypsum were applied to the impacted area at the SC2 sampling location as in situ remediation. SMA will collect one composite closure sample from the top 6 inches of the area identified as SC2 for 300.0 chlorides. The closure composite sample will be submitted to Hall Environmental Analysis Laboratory. It will take approximately 5 business days for results. This work will be completed in September 2020. 72 hour notification will be given to OCD.

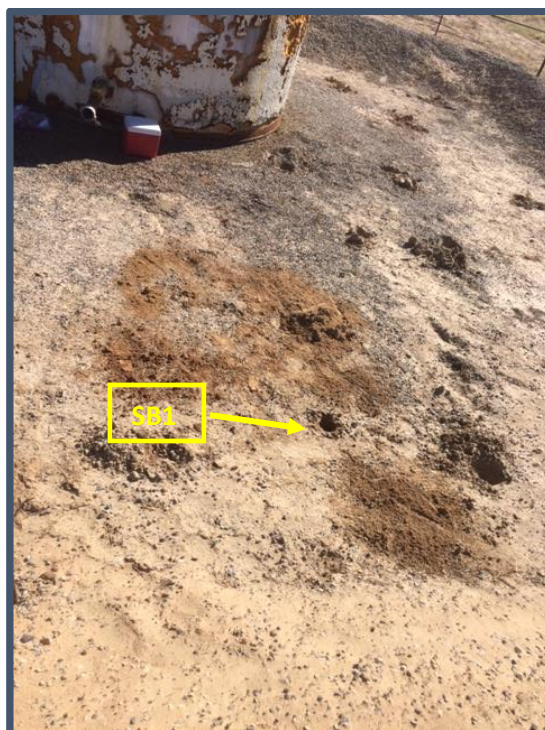
Photo 2: Location of SB1 in sample area SC2.
