**Devon Energy Production Company  
Cotton Draw Unit #254**

**Closure Report  
U/L N, Section 01, T25S, R31E  
Eddy County, New Mexico  
NAB1912056434  
2RP-5382**

**October 13, 2020**

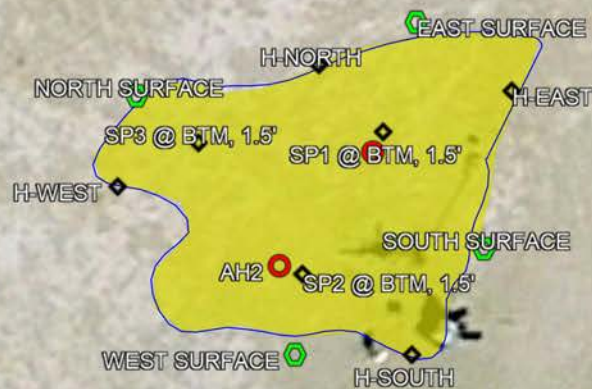
# Devon, CDU #254

1.5 ft excavation
-

Confirmation samples
-

Horizontal extent samples
-

Spill Area (blue)
-

Vertical extent samples

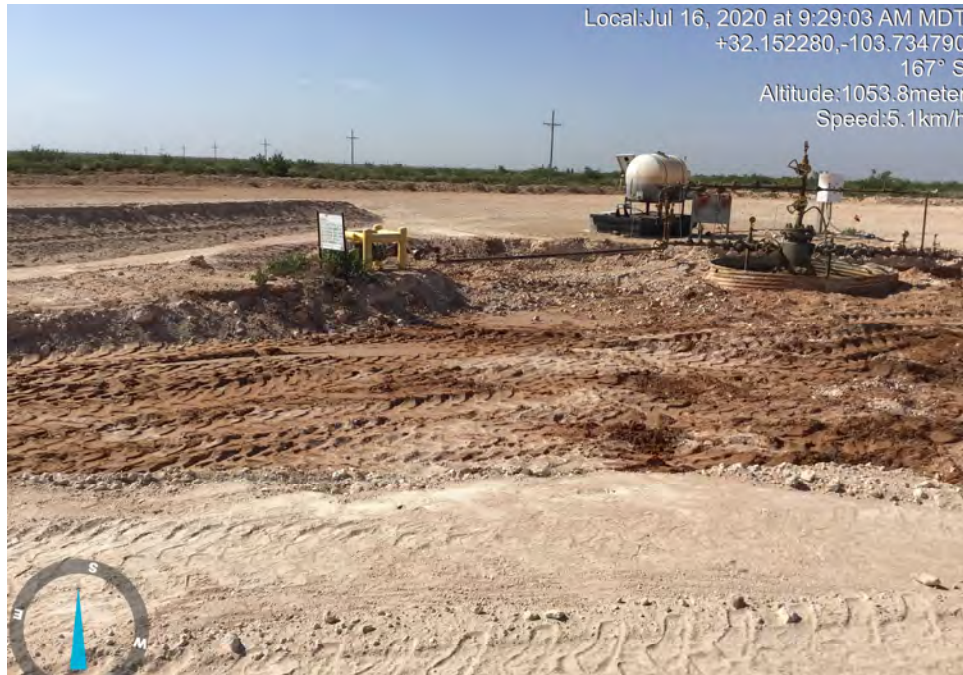
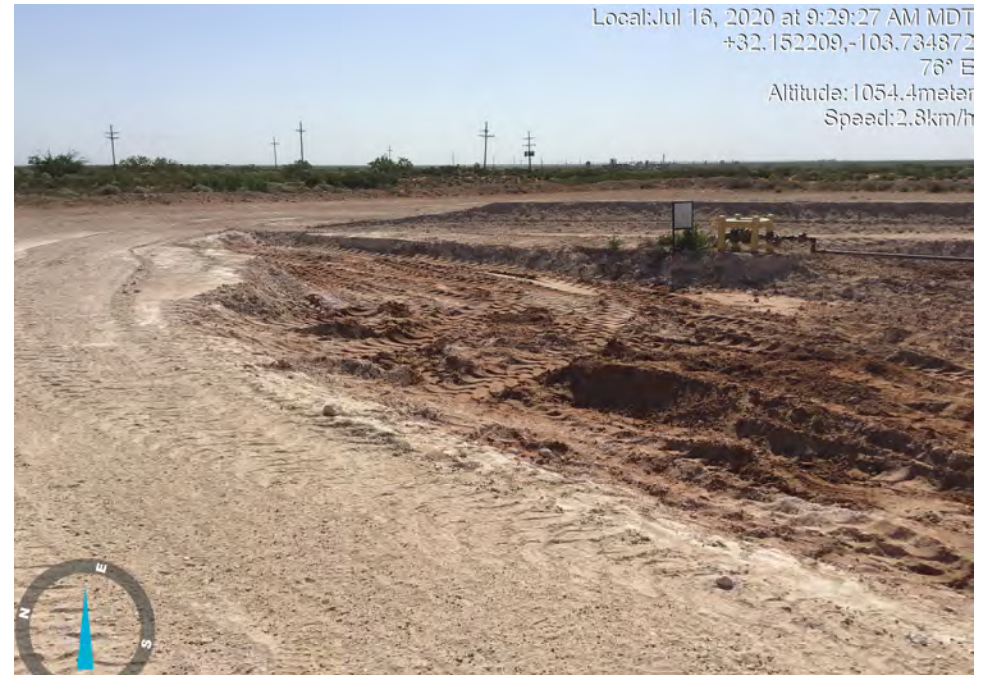
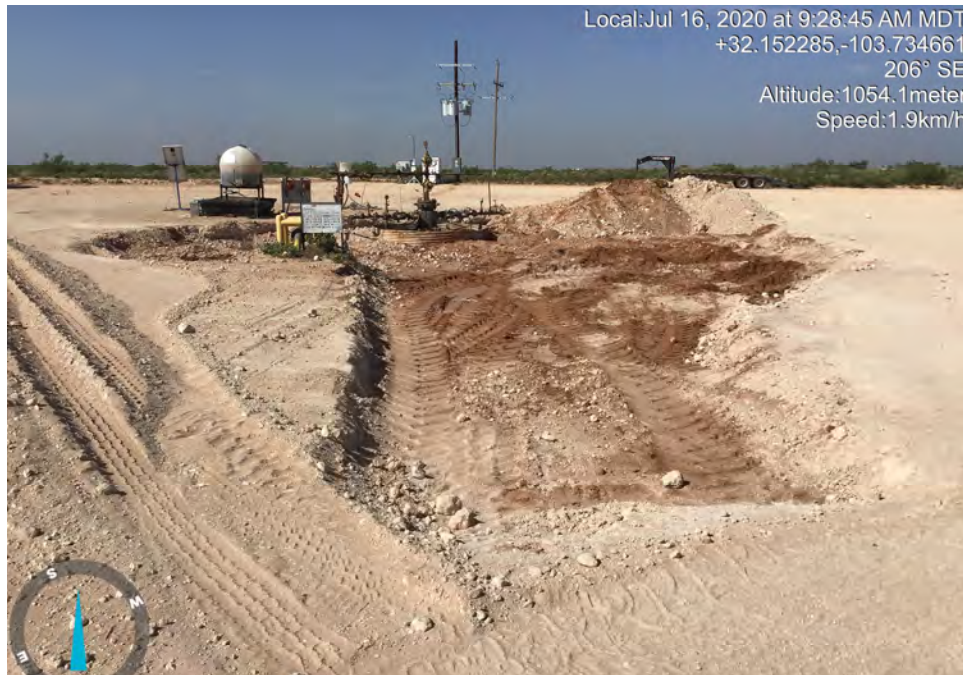
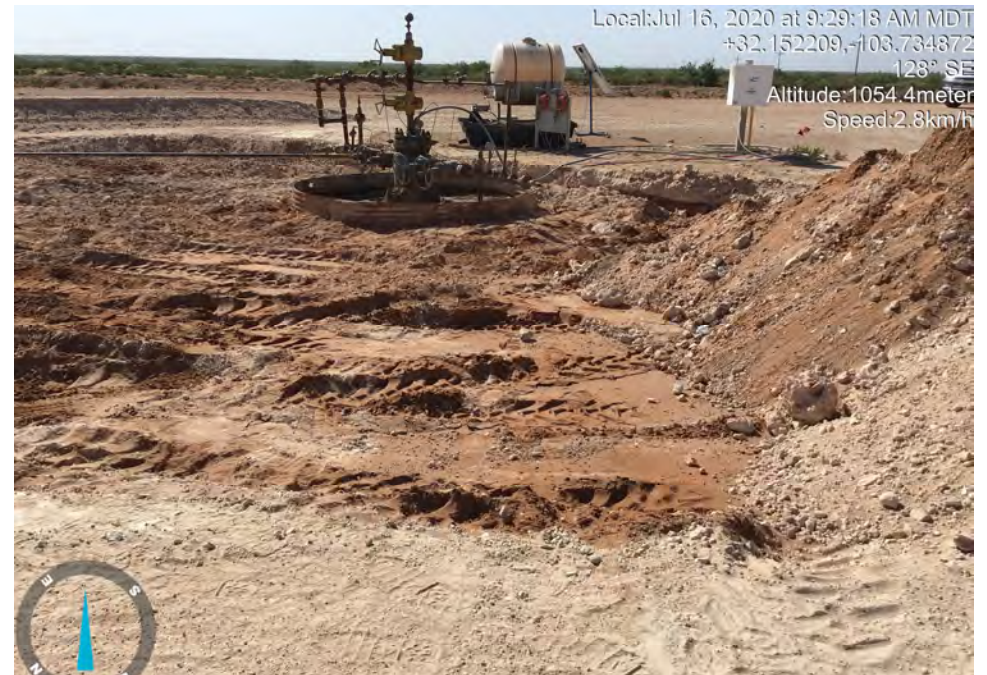
Once sample results verified successful remediation had been achieved, the site was backfilled with clean soil. Pictures of the remediation are included in this report.

Based on the findings of the sampling events, SESI, determined the best course of action was to excavate the contaminated soil to a depth of one foot. In July of 2020, approximately 125 yards of contaminated material were removed via shovel and backhoe. The contaminated soil was disposed of in a NMOCD-approved landfill.

During excavation, SESI performed field testing to ensure remediation efforts had been successful; however, the results revealed that the excavation had not quite removed the material to the most stringent standards, so SESI excavated another ½ foot. Therefore, an additional 60 yards of material were excavated and disposed of in a NMOCD approved landfill.

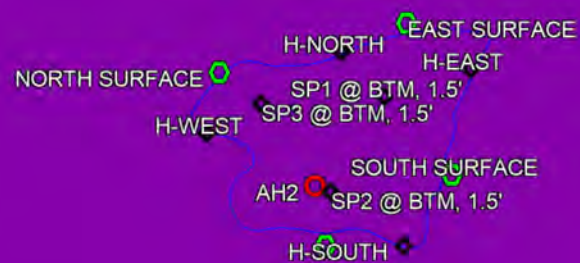
## Devon, CDU #254

1.5 ft excavation
-

Confirmation samples
-

Horizontal extent samples
-

Low potential
-

Spill Area (blue)
-

Vertical extent samples
