C- 141 Site Characterization Package Culwin Queen Lateral Release

NRM2020635561

RE: Culwin Queen Lateral Release, NRM2020635561
UL "K", Sec. 3; T19S. R30E. 32.686984, -103.96099 (NAD83)

Site Assessment/Characterization
Curry Comb Release - NRM2005744201

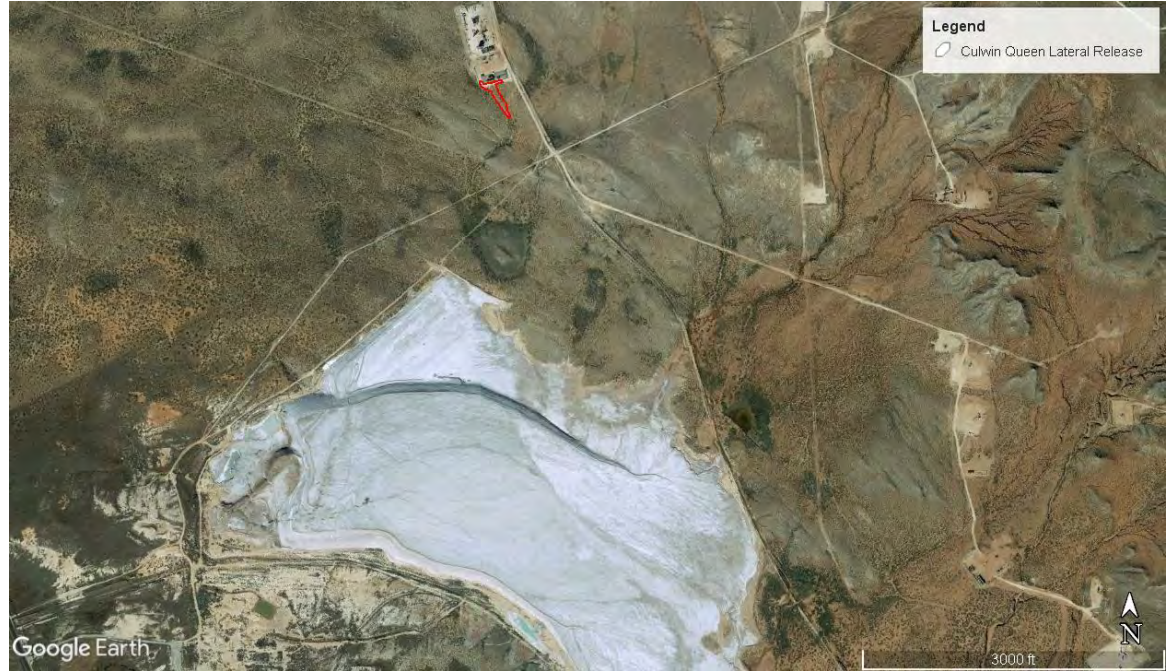
Google Earth image illustrating the proximity of the Culwin Queen release (red outline in northern portion of map) and a potash tailings pile (southern portion of the map).

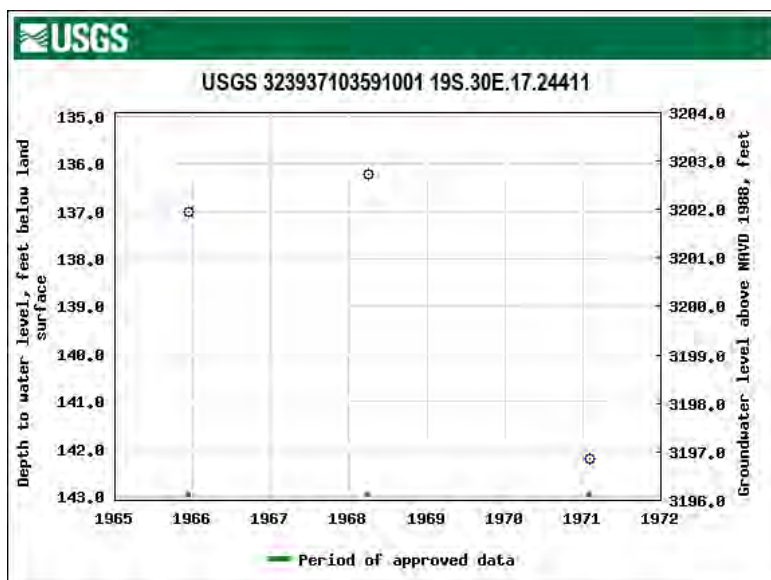
USGS-10034³ is 2.36 miles southwest of the release location and the historical record of water level measurements is presented in the graphic below. The data shows 6 feet decrease in ground water elevation over the 4-year record.

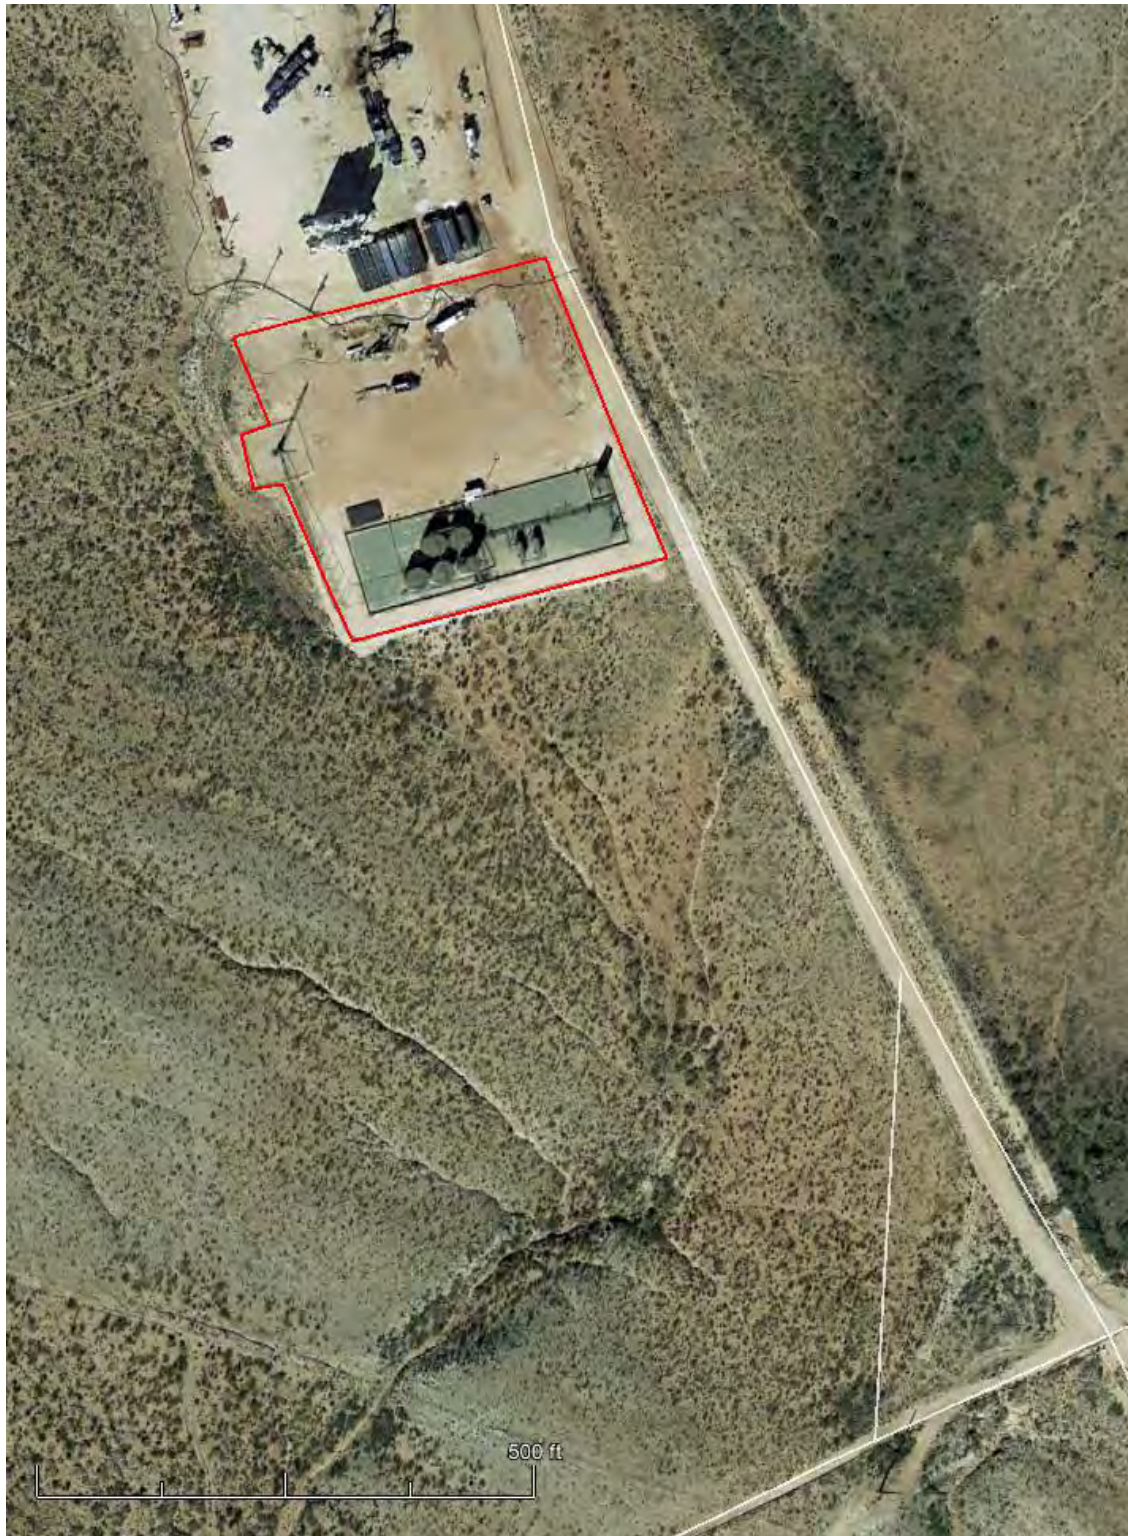
Google Earth Image 11/2/2017 that are consistent with current conditions. Note the two drainage channels that appear to emanate from the pad. A third channel on the west side of the road is an extension of the vegetated swale east of the road.

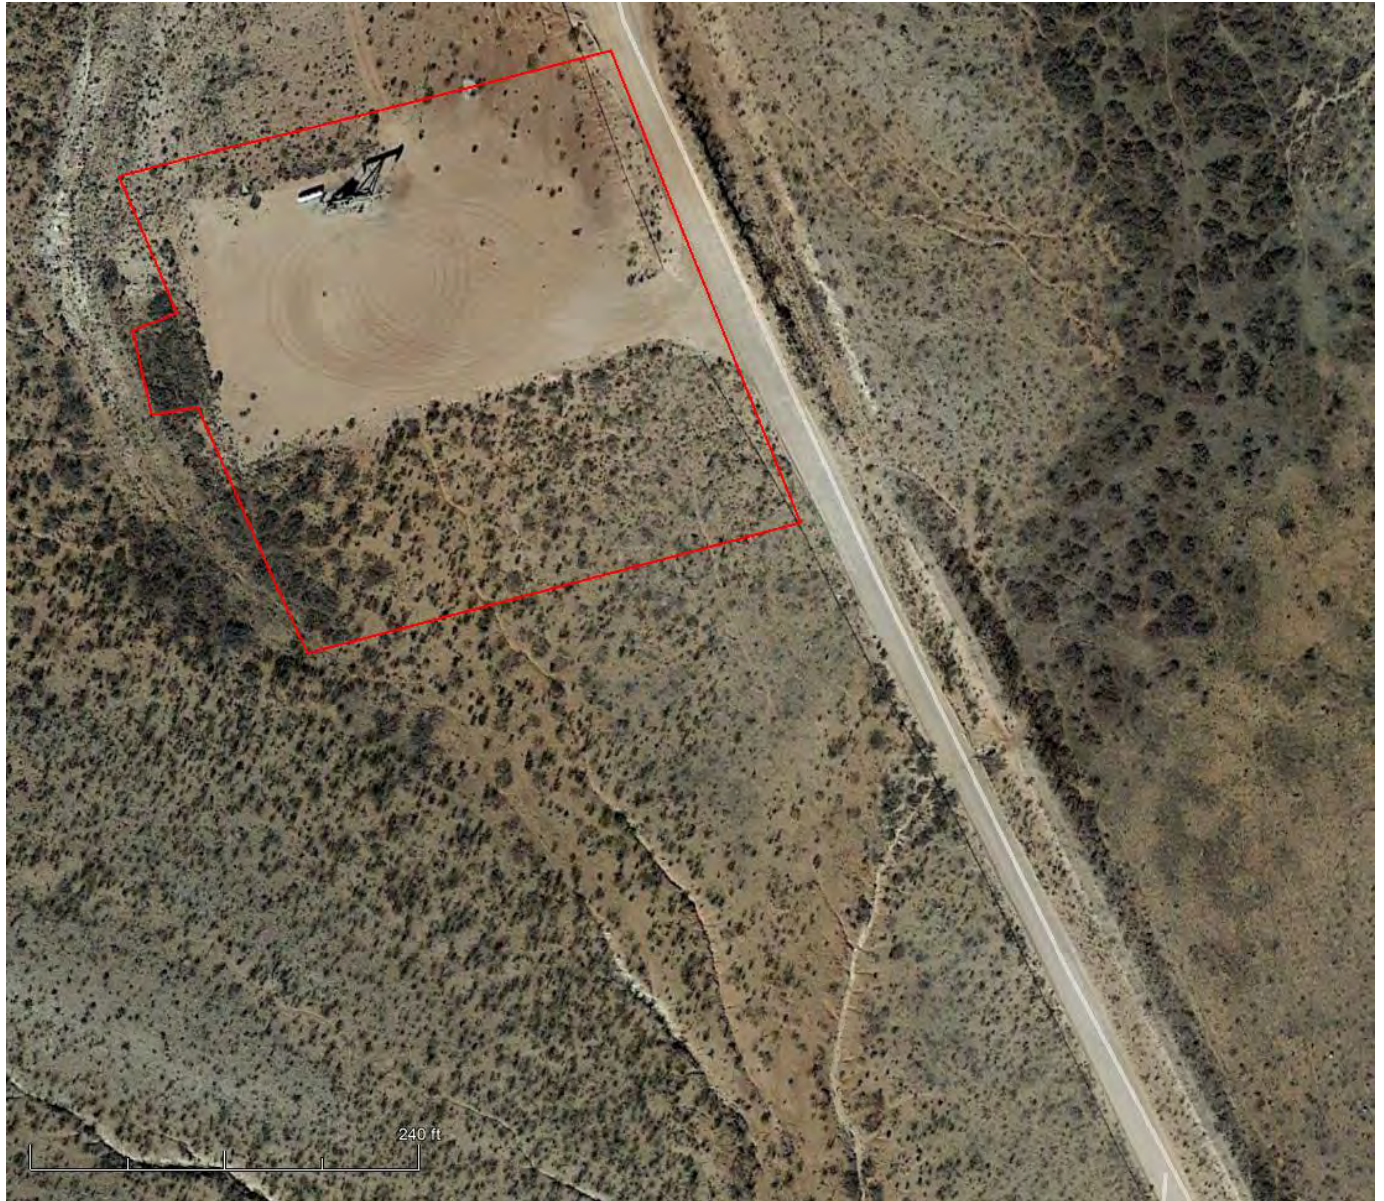
This 2/1/2017 image shows only one channel originating from the well pad, obviously prior to the construction of the tank battery. The drainage on the west side of the pad, which was not obvious in the Figure GE-1, continues southeast. Both the drainage and the channel are obvious in Google Earth images to 2012.

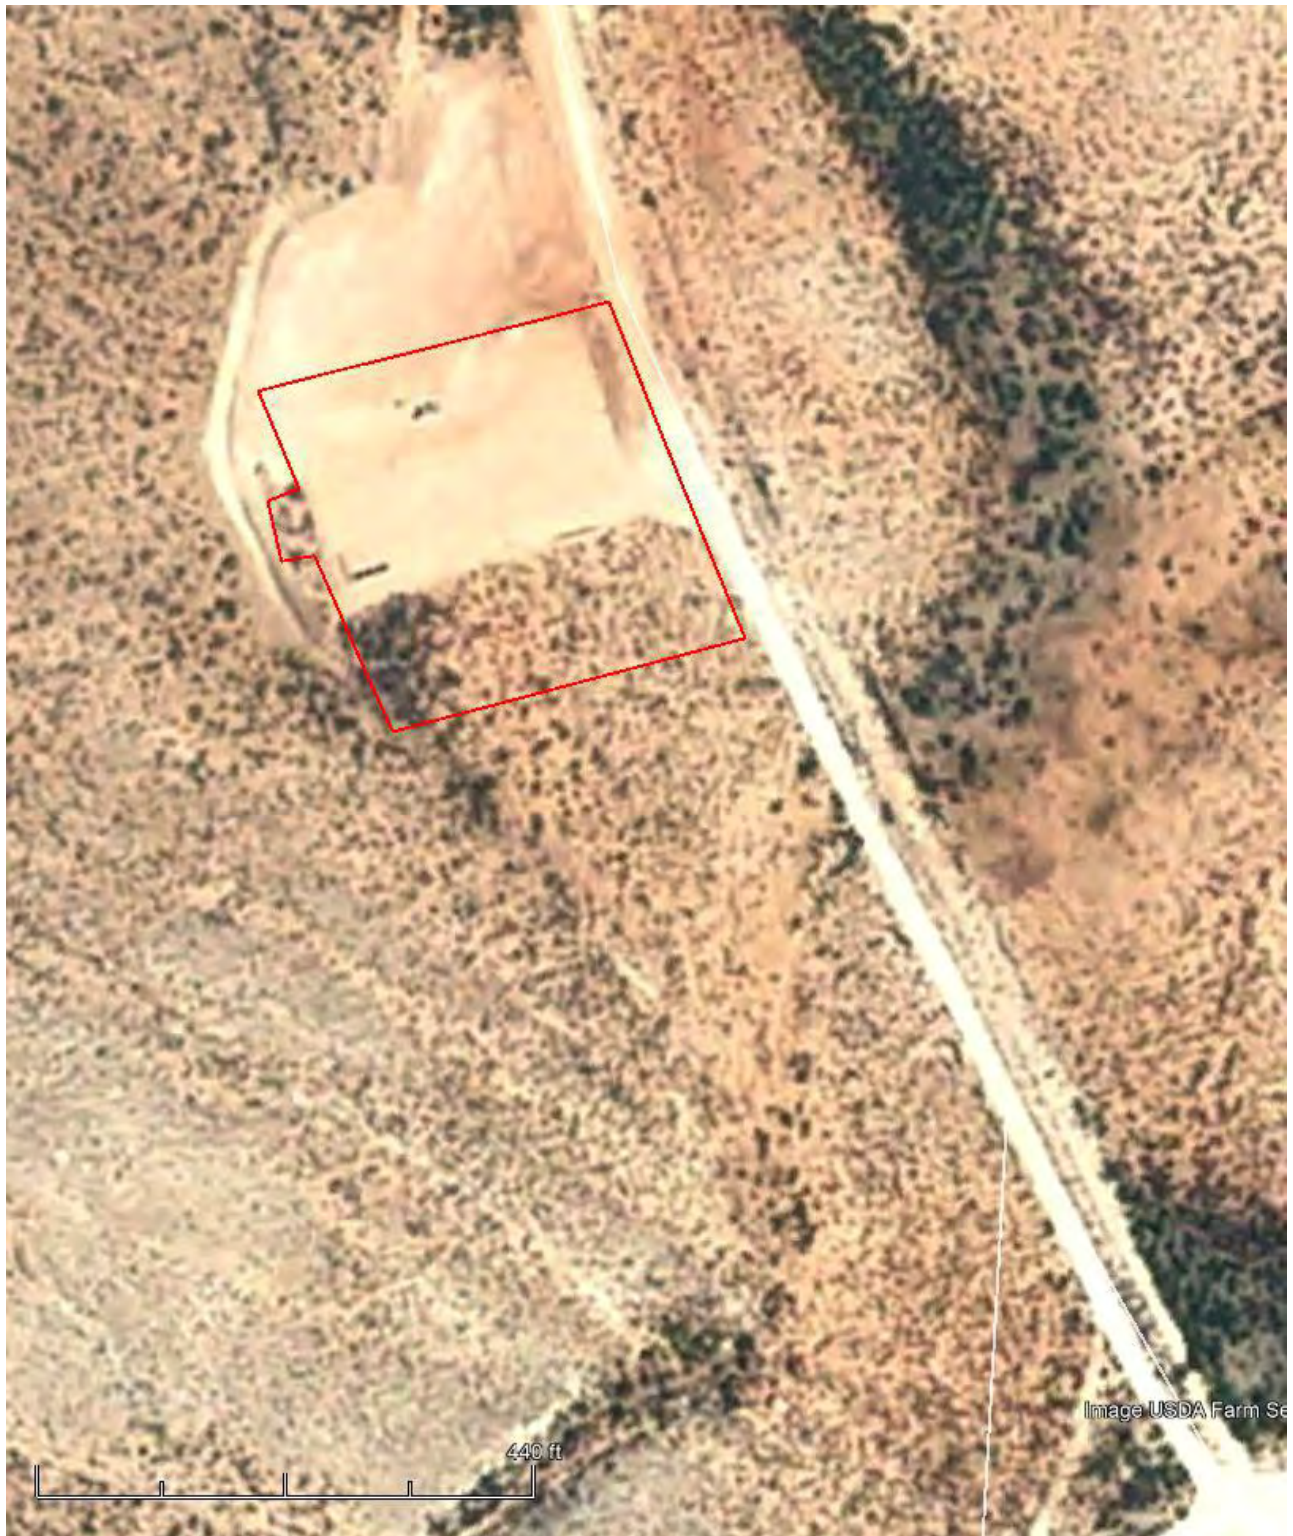
This 5/9/2009 image and the 2011 image do not provide any evidence of the previously described channel originating from the production pad or tank battery pad. Expanding the area of view shows that the road cut through the natural channel to the north, creating a need to construct a flow path to the west of the production pad.

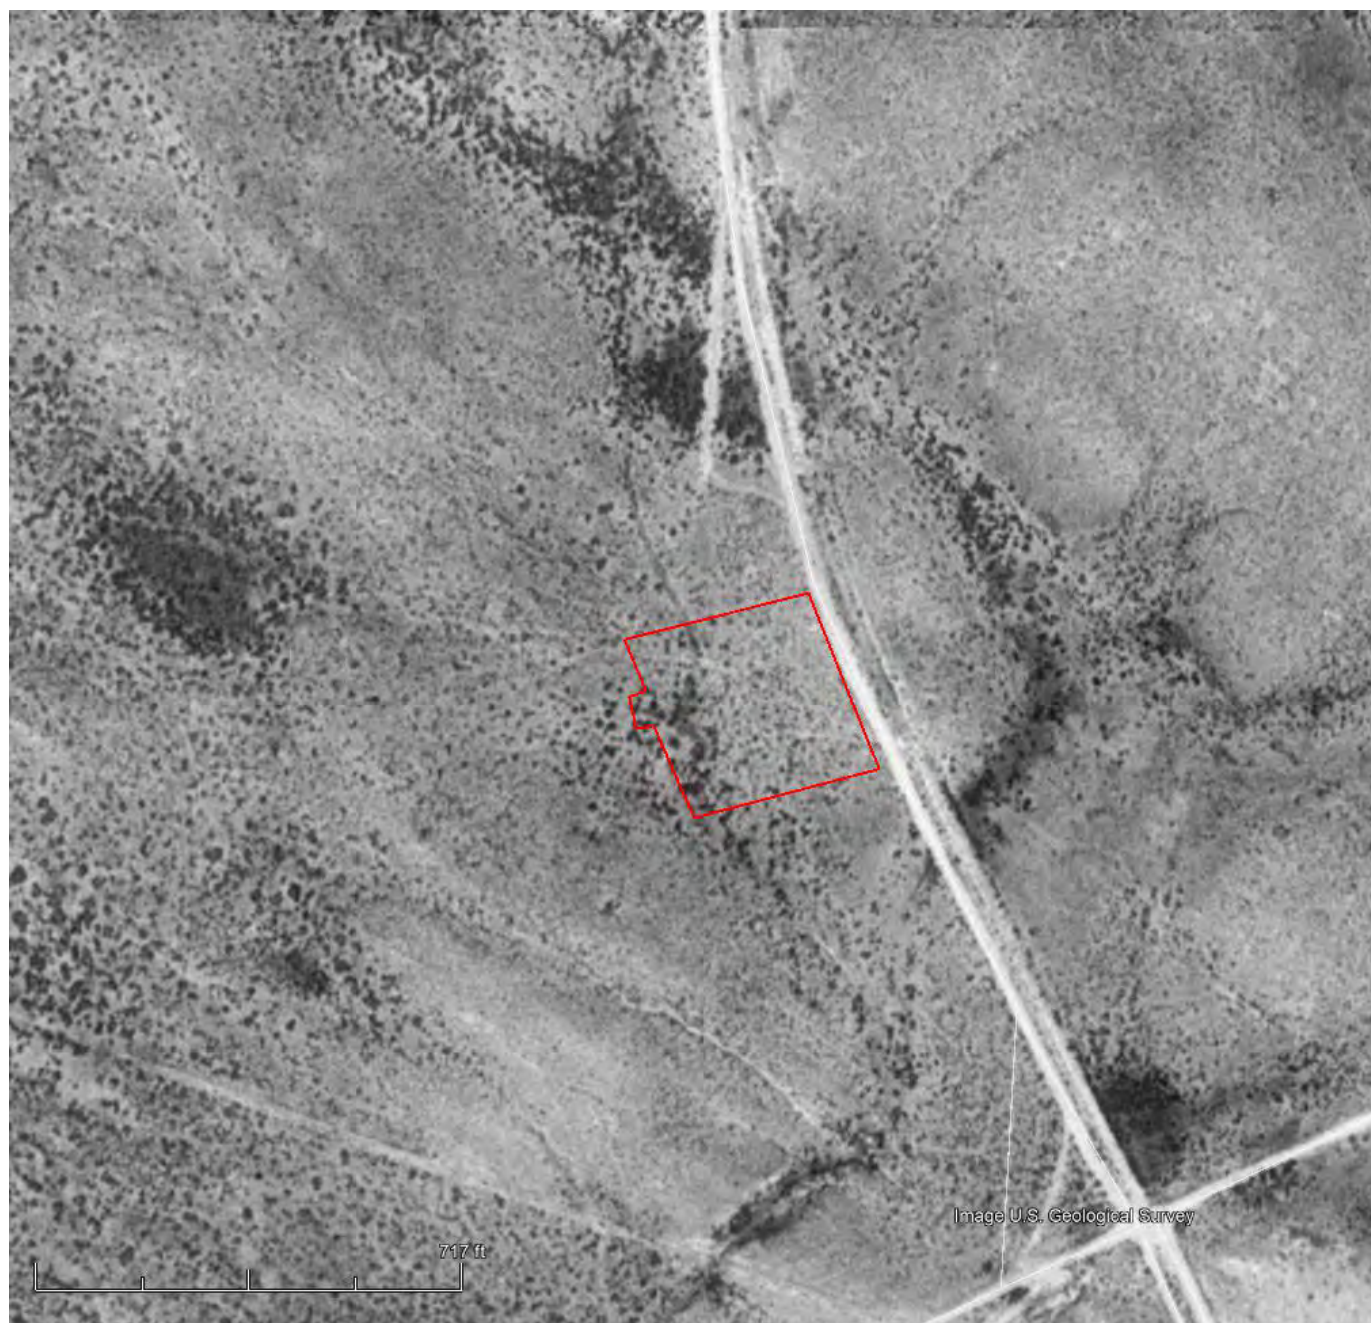
This image taken 10/31/1997 shows the area prior to the development of the well and production pad. This expanded scale identifies the nature of the original drainage and the diversion of the drainage on the west side of the road.

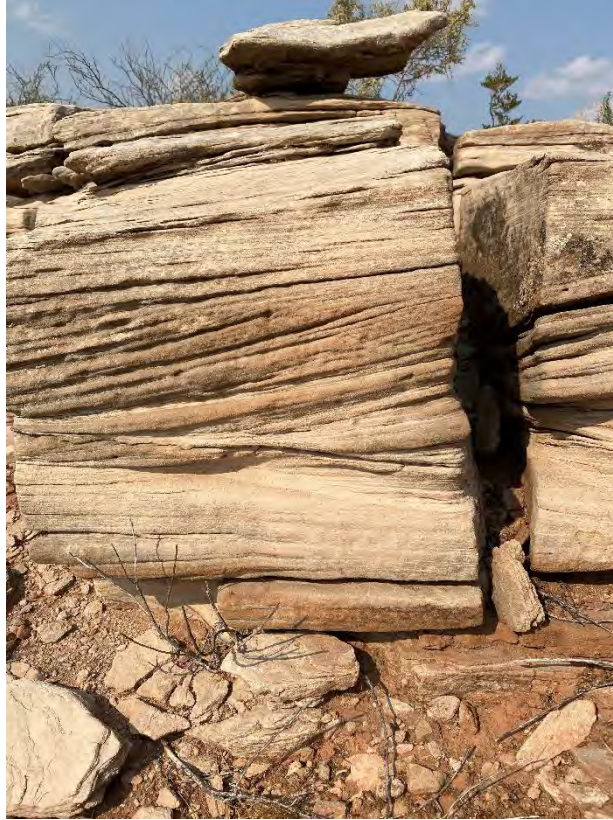
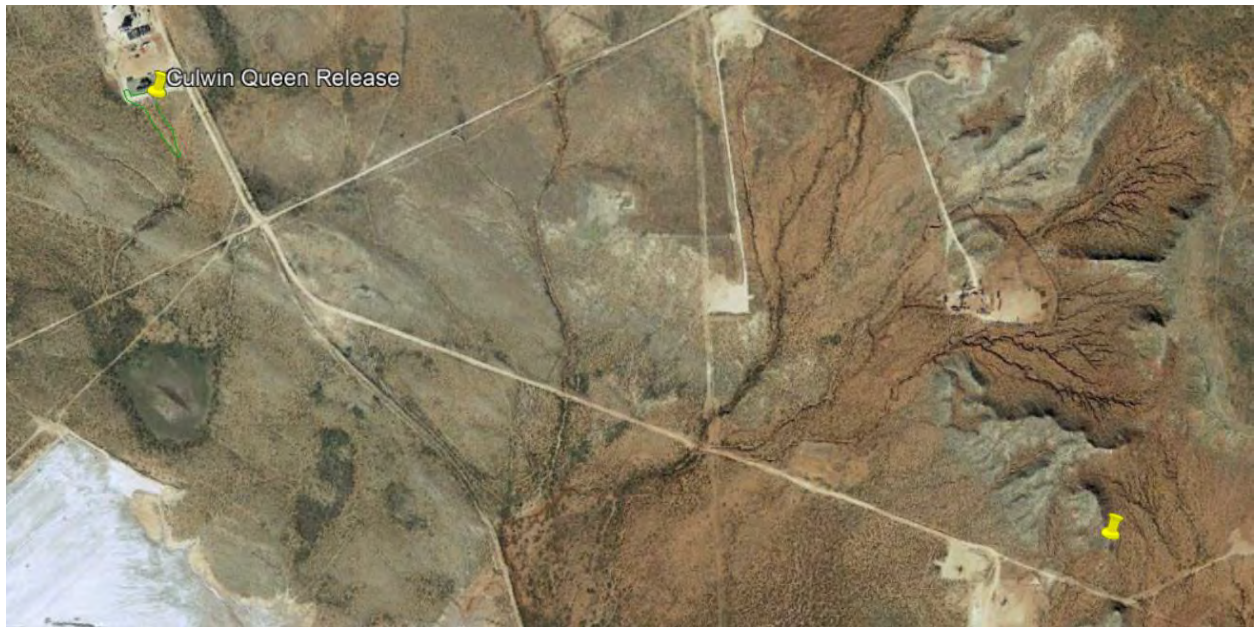
The top image is a tan sandstone with very defined crossbeds. Scale from top to bottom of the sandstone block is ~20 inches. The bottom image shows the proximity of the sandstone to the Culwin Queen site. We believe this sandstone is a part of the Quartermaster formation.

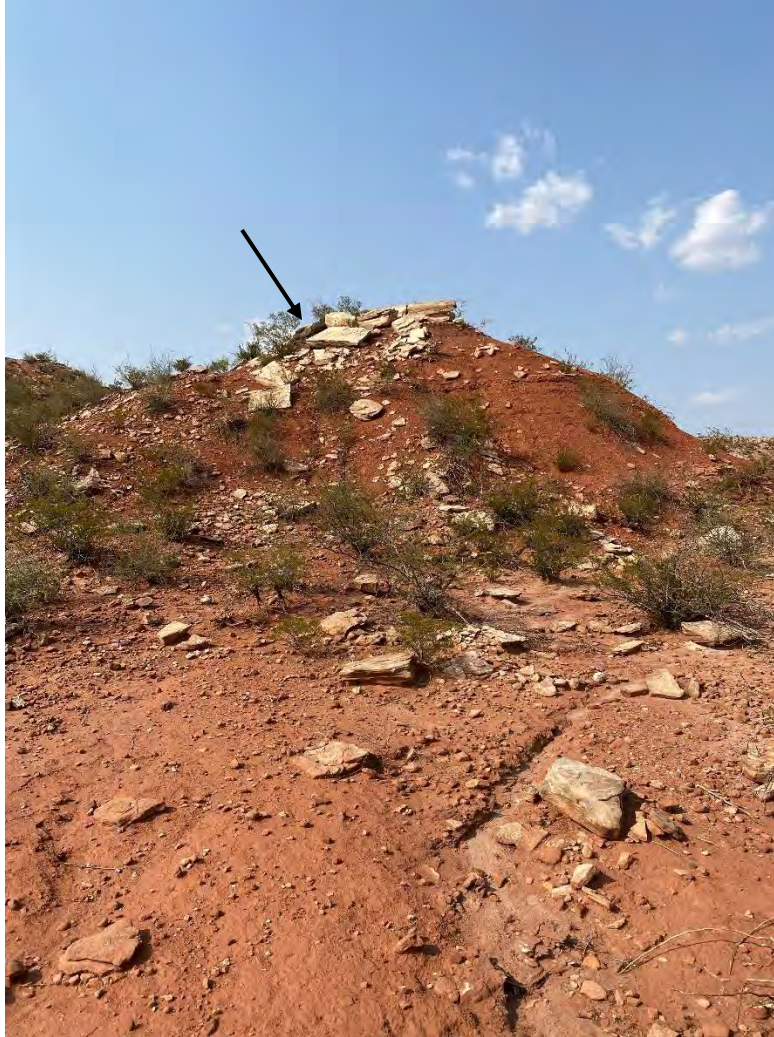
The above image shows the strata that underlies the previous photo of the tan sandstone. The black arrow shows the location of the previous photo. The underlying strata is a red sandstone that is not well consolidated. We believe this to be a part of the Quartermaster formation.

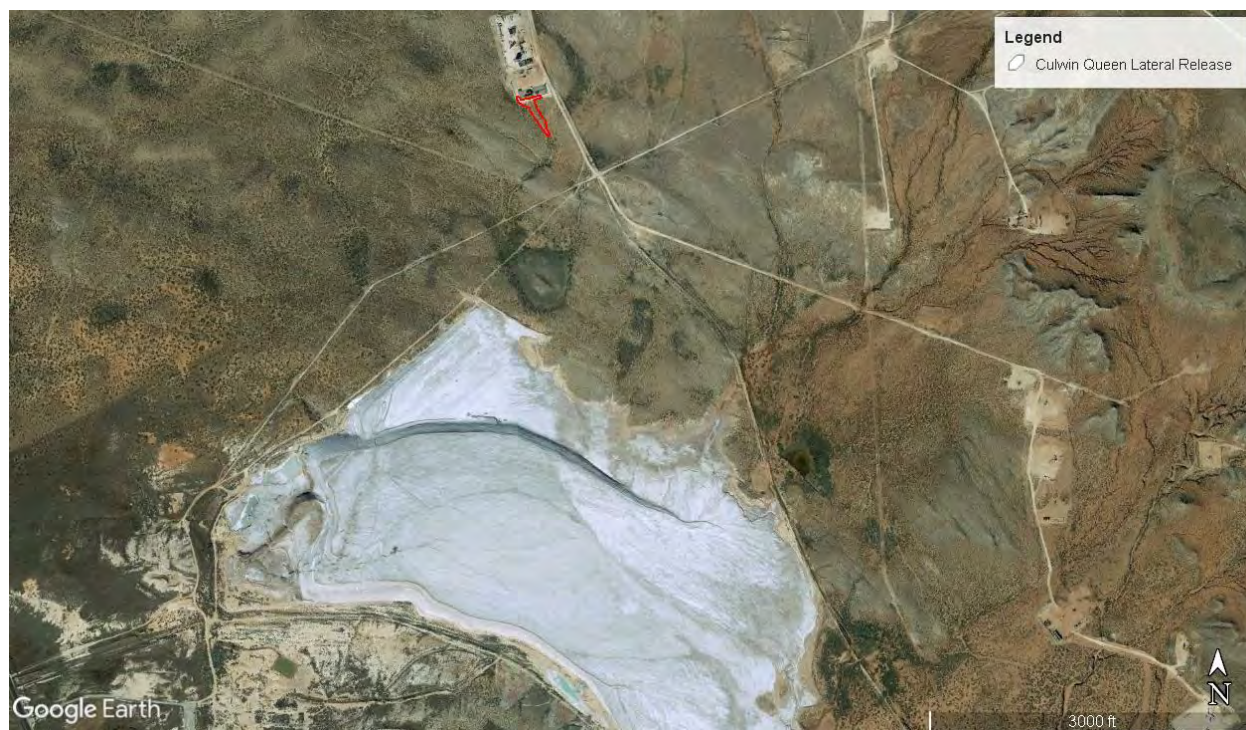
Google Earth image illustrates the proximity of the potash tailings pile to the Culwin Queen release.

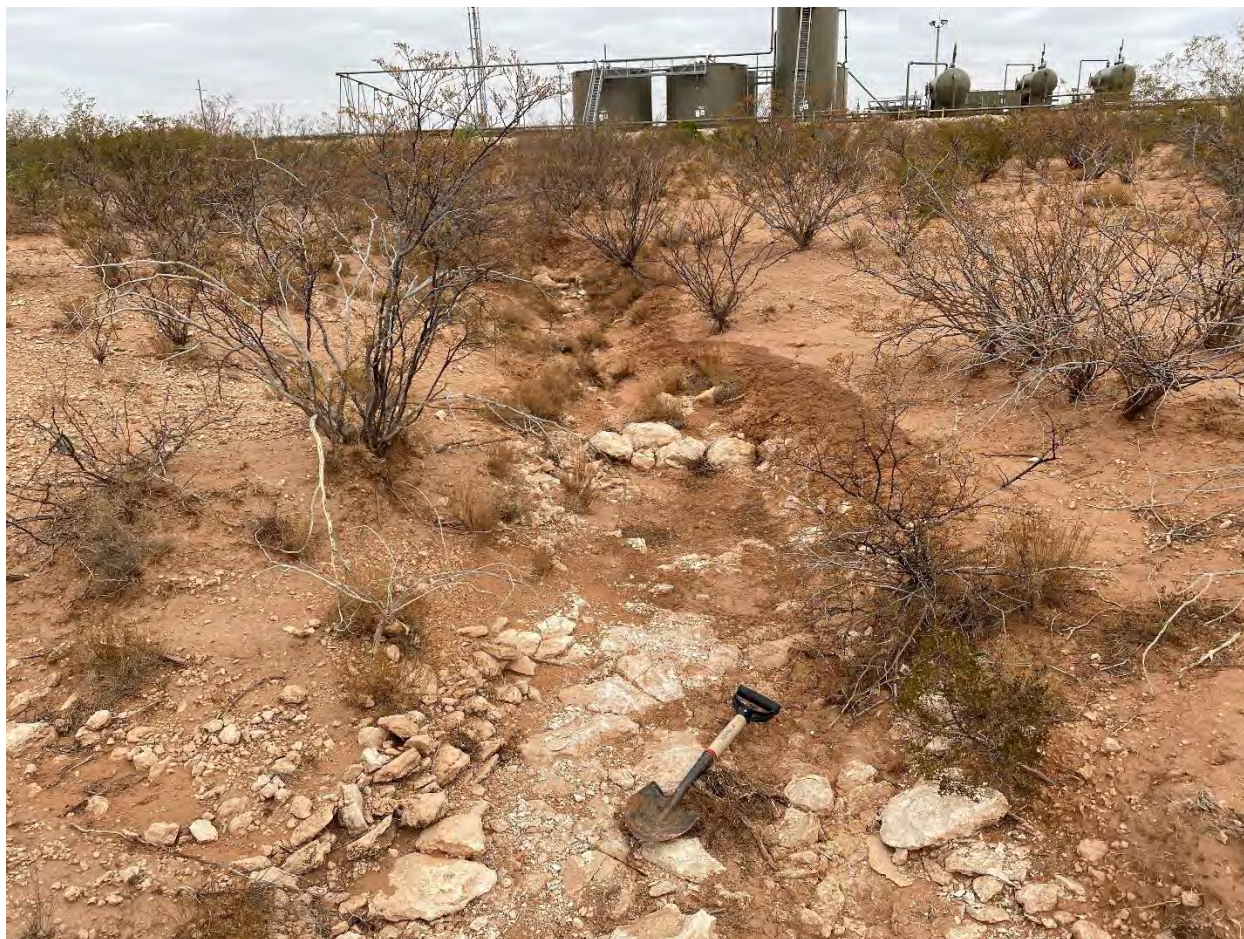
The above image depicts the western drainage that the Culwin Queen release is contained to. Shovel in the foreground is approximately 2 feet in length. Caliche can also be seen in exposed at the surface. View is north.

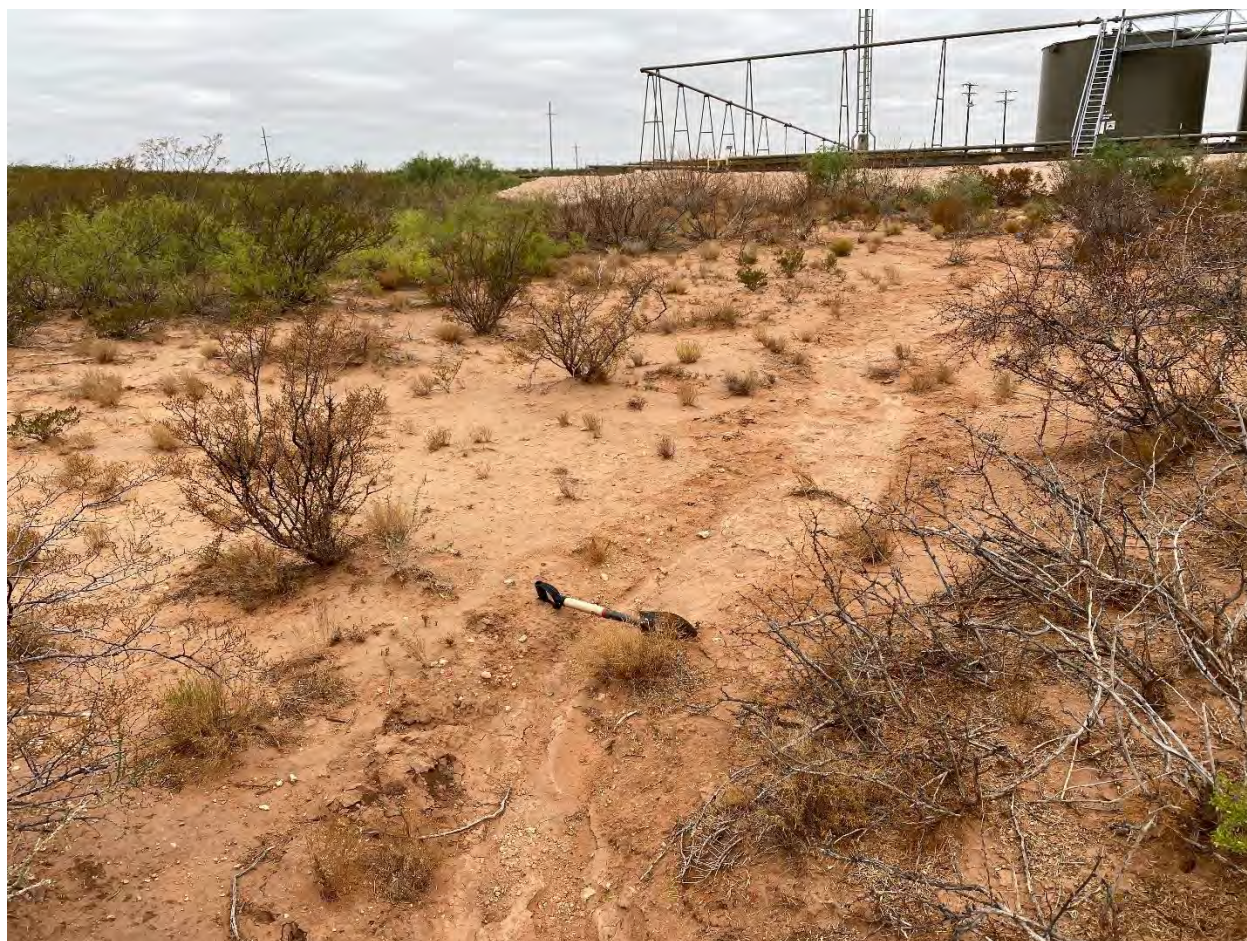
Upstream of western drainage, nearer to the tank battery. View is north.

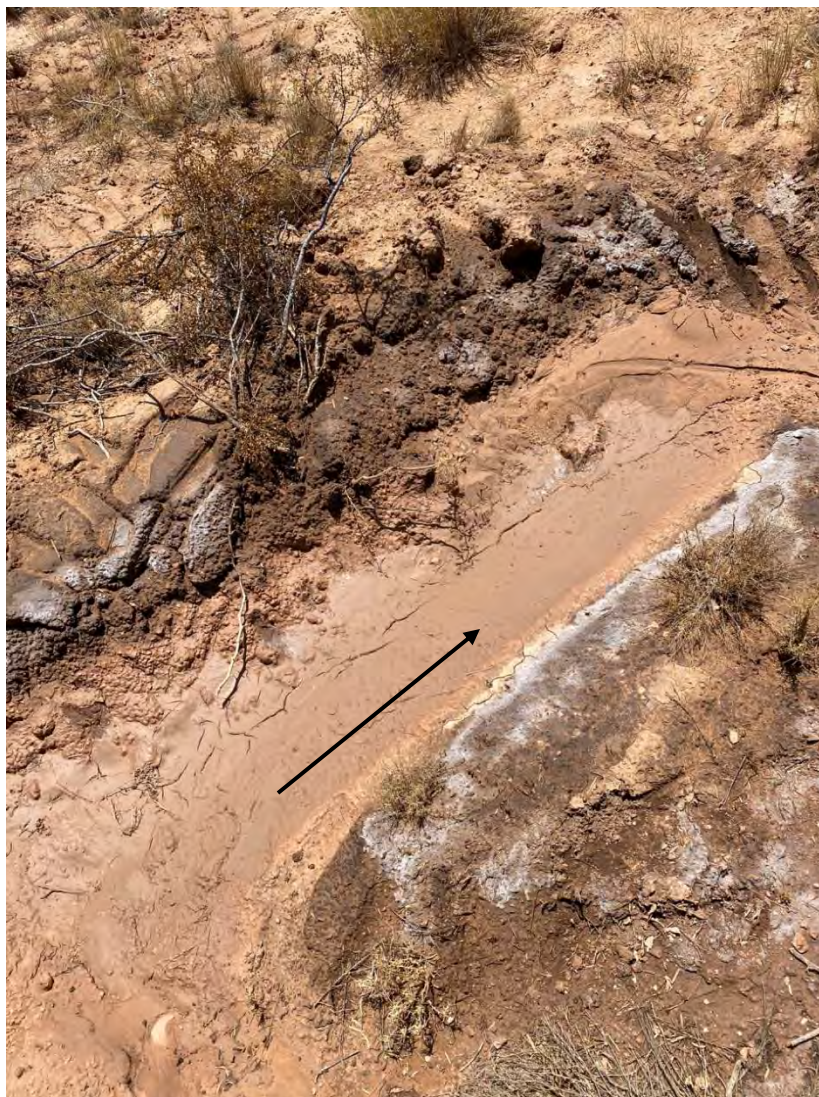
The above image shows the eastern drainage, closer to the tank battery. Black arrow shows downhill/flow direction. Some wick salt can be seen on the edges of the drainage.

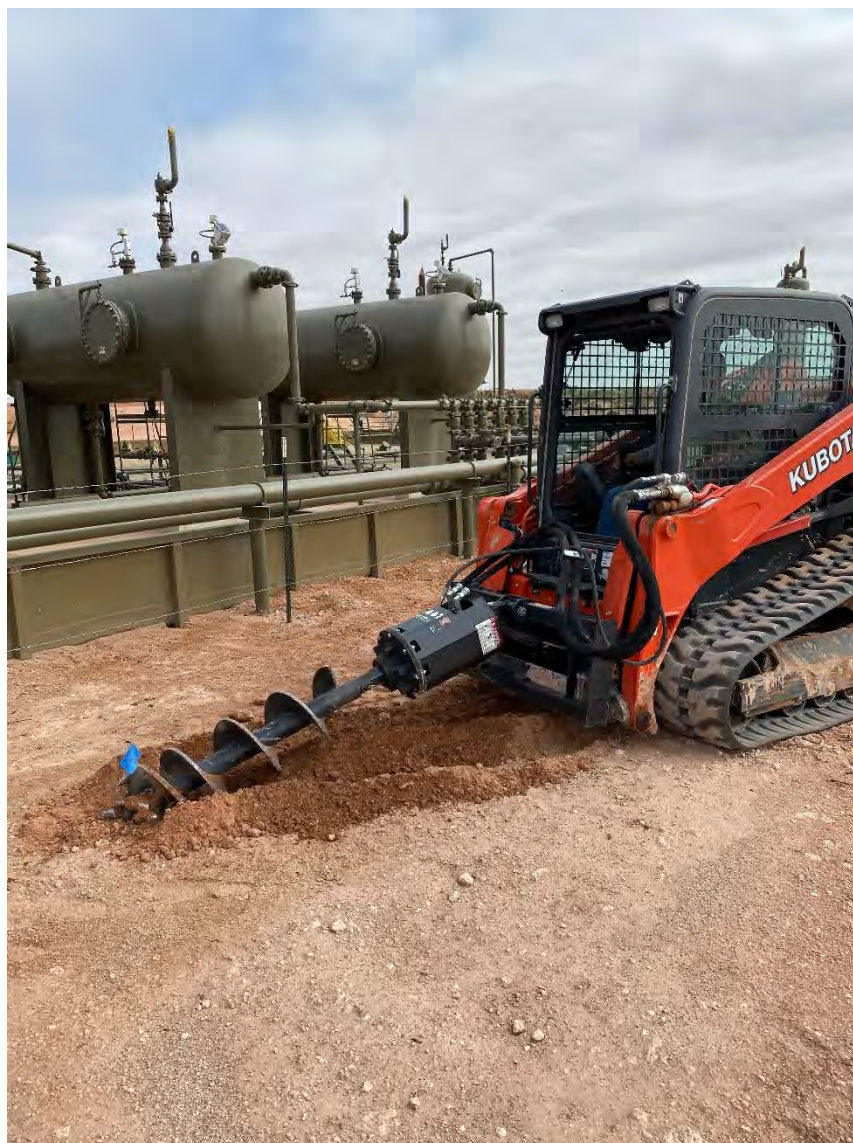
The mechanical auger used to obtain deeper samples on the pad and in the pasture.
