SMA #5E29133, BG65

**RE: LINER INSPECTION REPORT  
TRIONYX 6 FEDERAL #001H BATTERY (NRM2025328272)**

Souder, Miller & Associates (SMA) is pleased to submit this letter report on behalf of Devon Energy Production (Devon) summarizing the liner inspection that occurred due to the Trionyx 6 Federal #001H Battery release. The site is located in Section 6, T25S, R32E (N32.152470 /W-103.720017) Lea County, New Mexico, on Federal land.

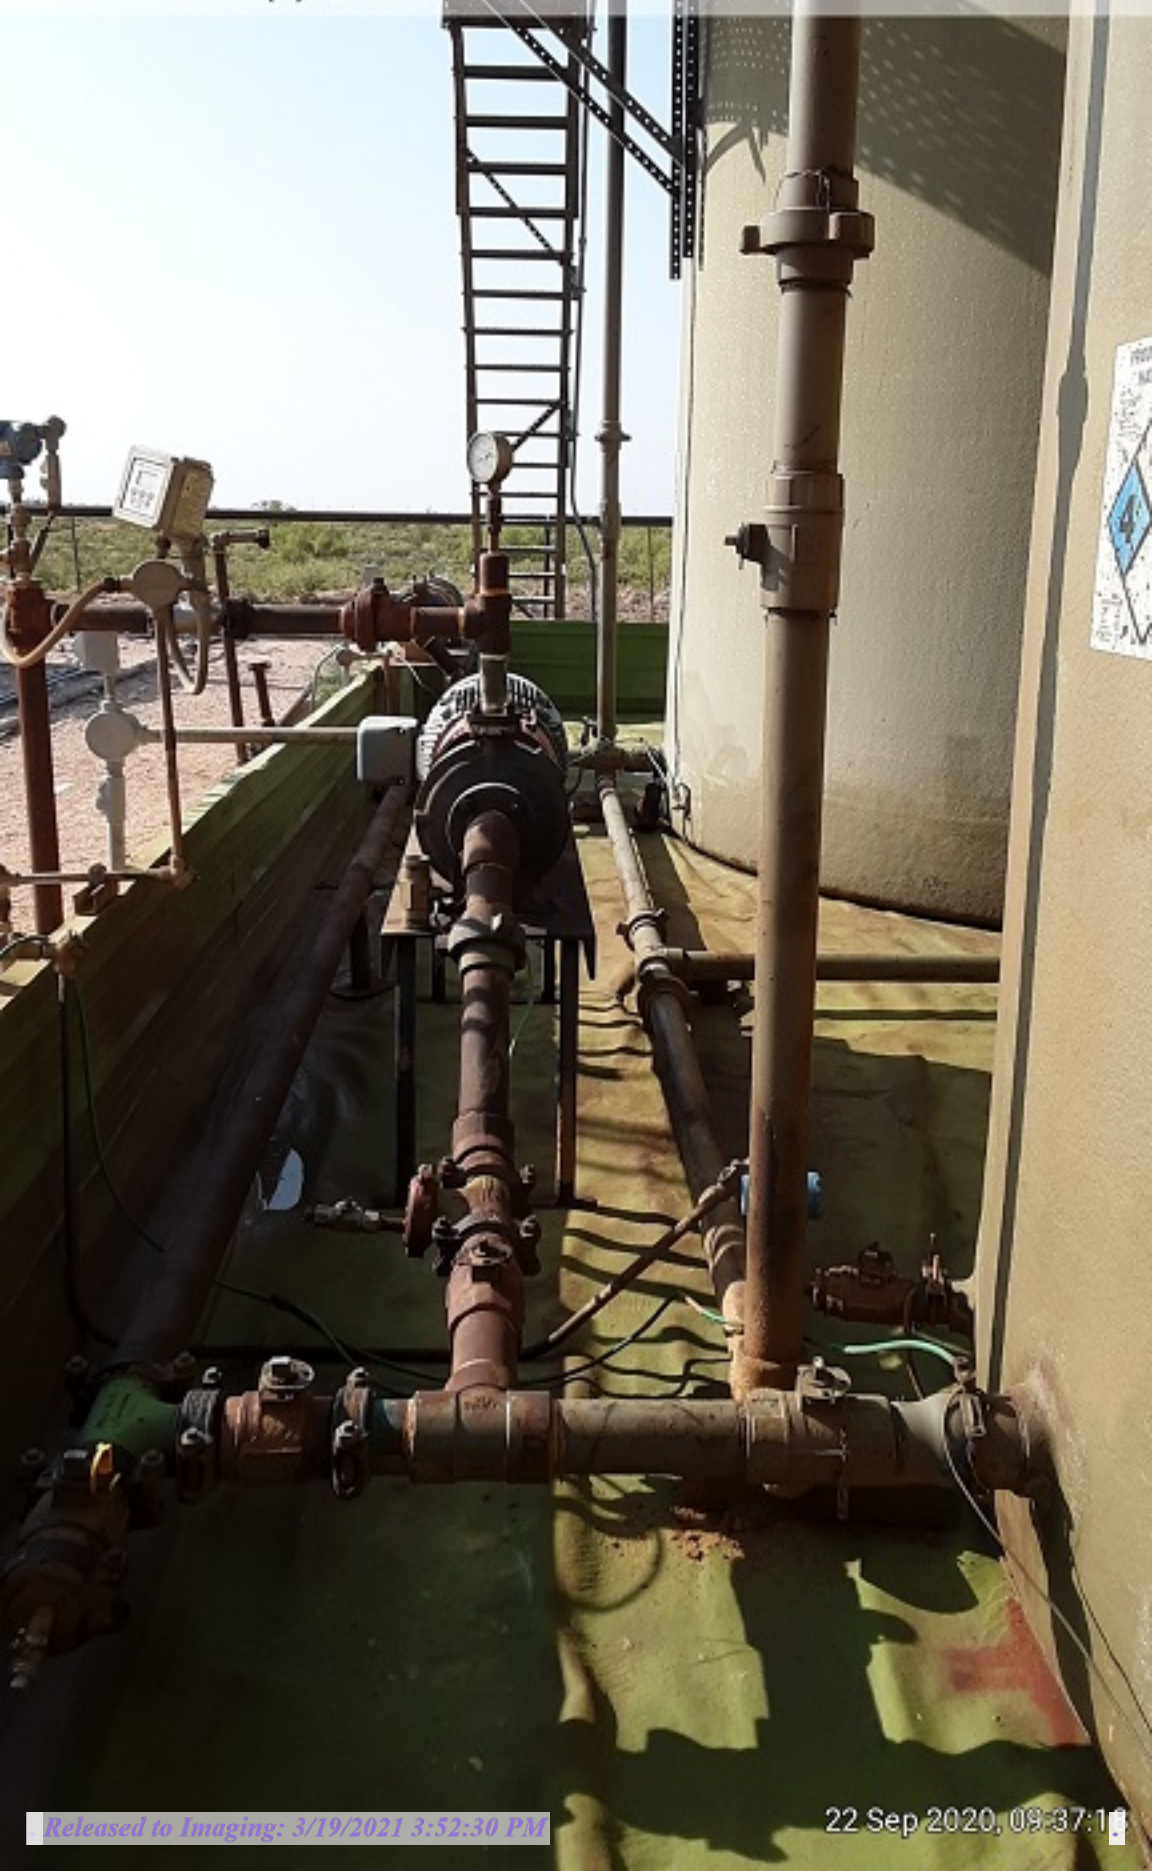
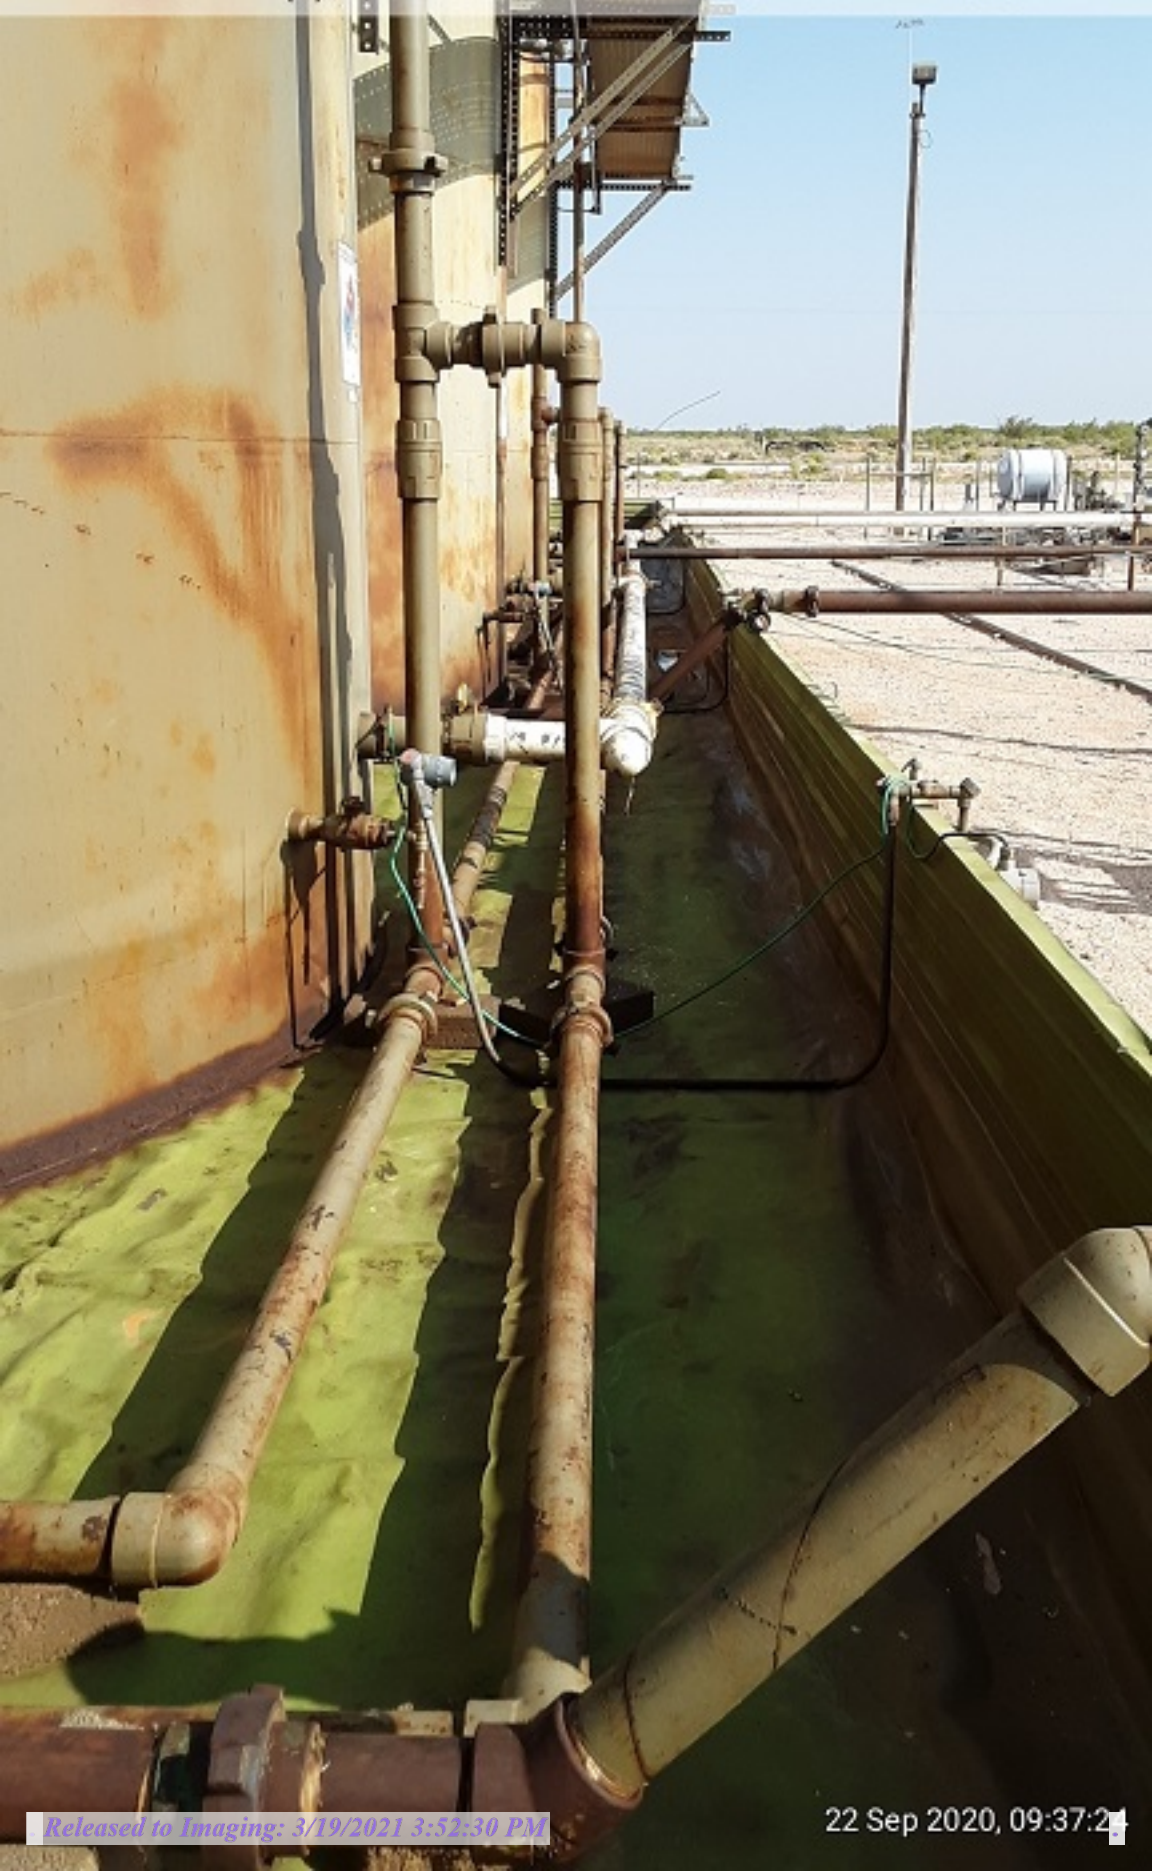
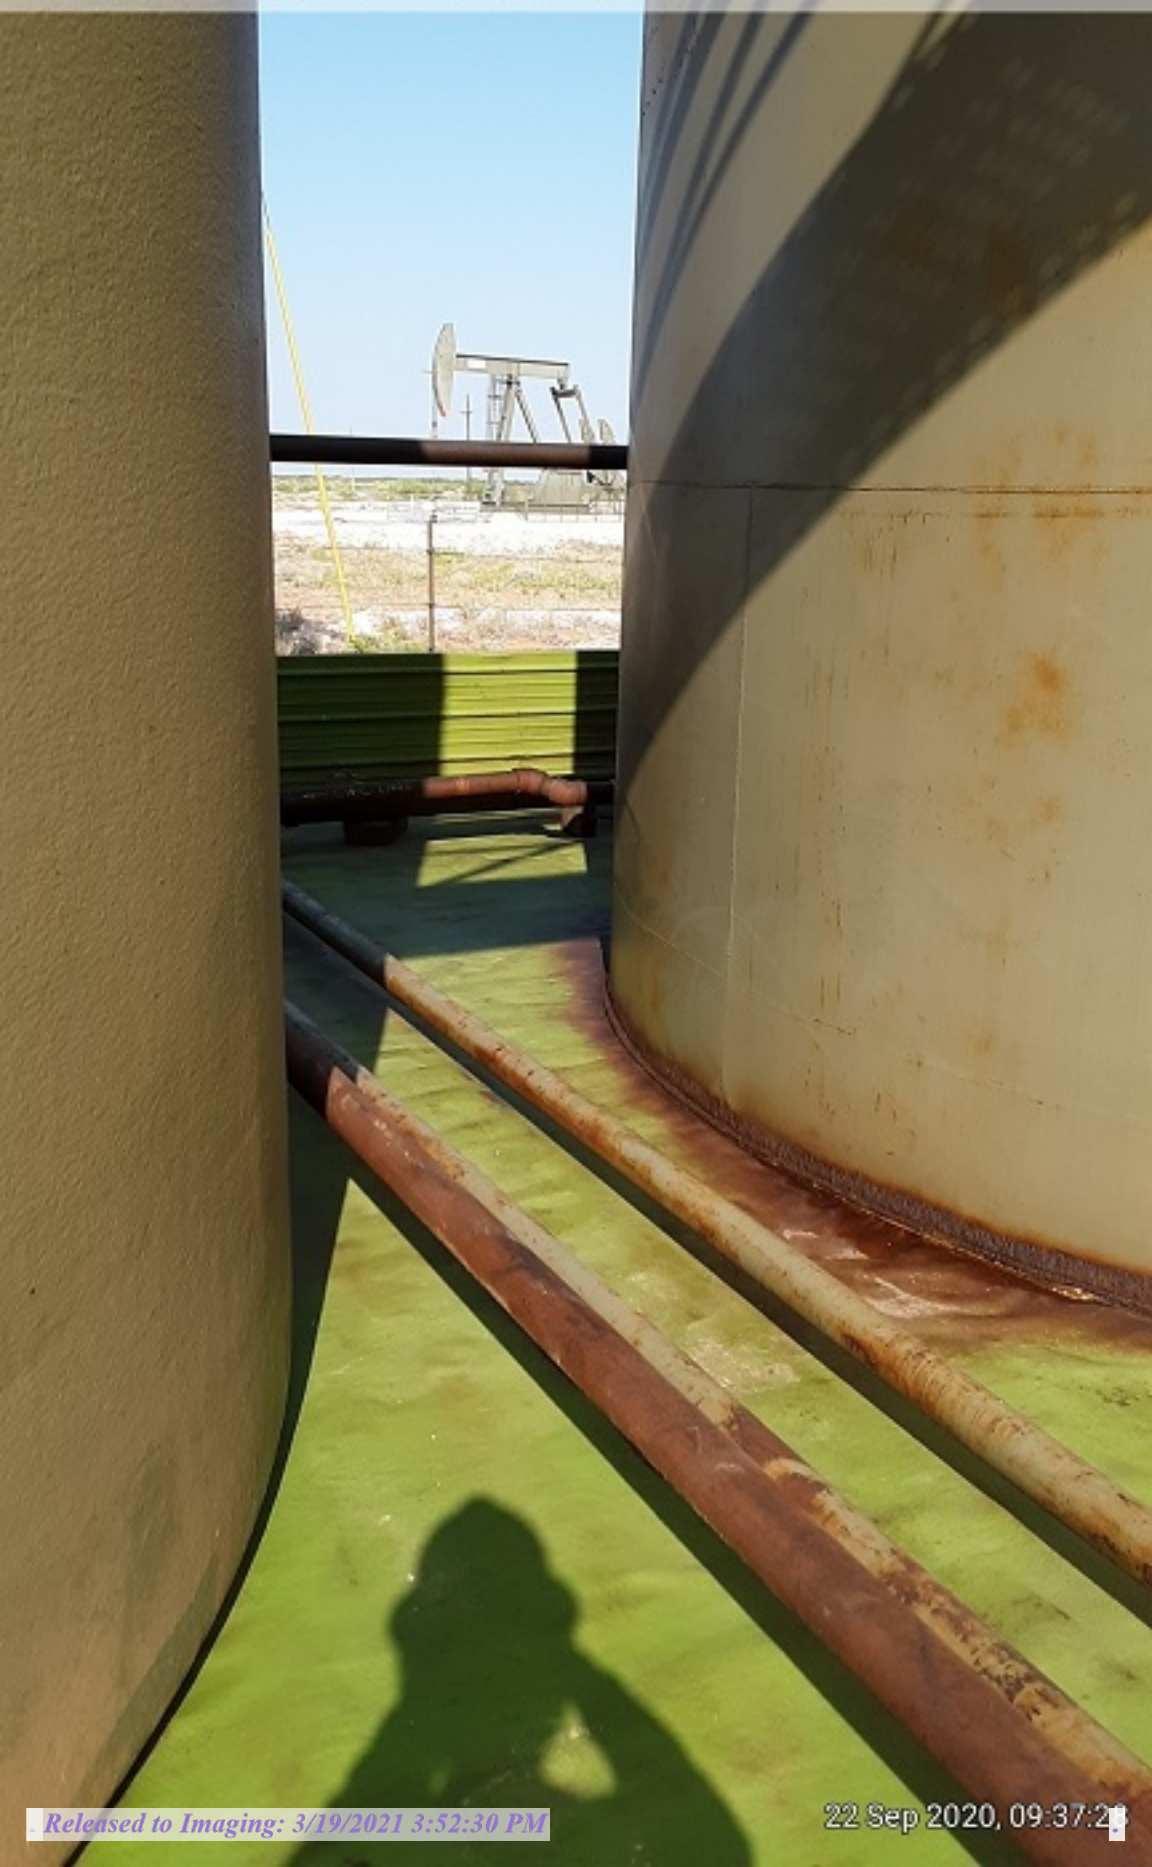
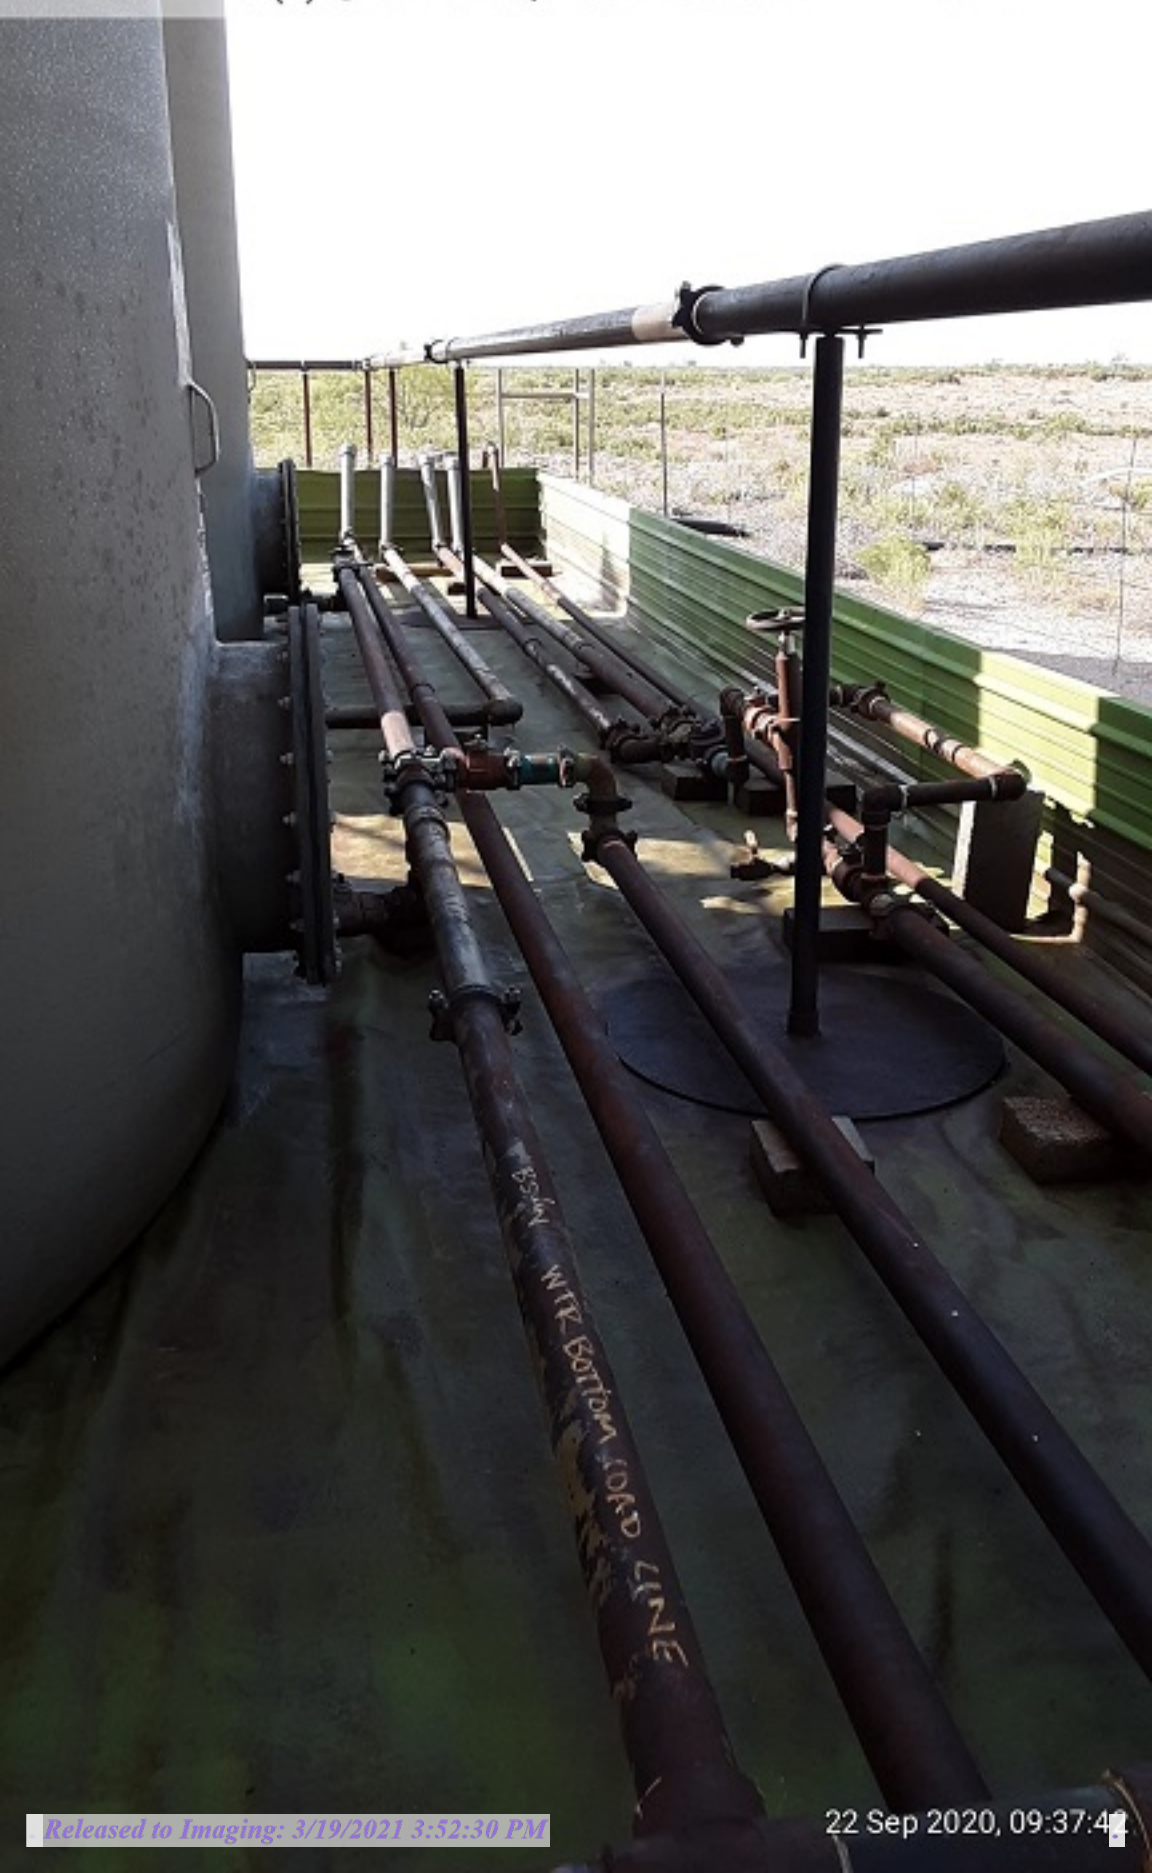
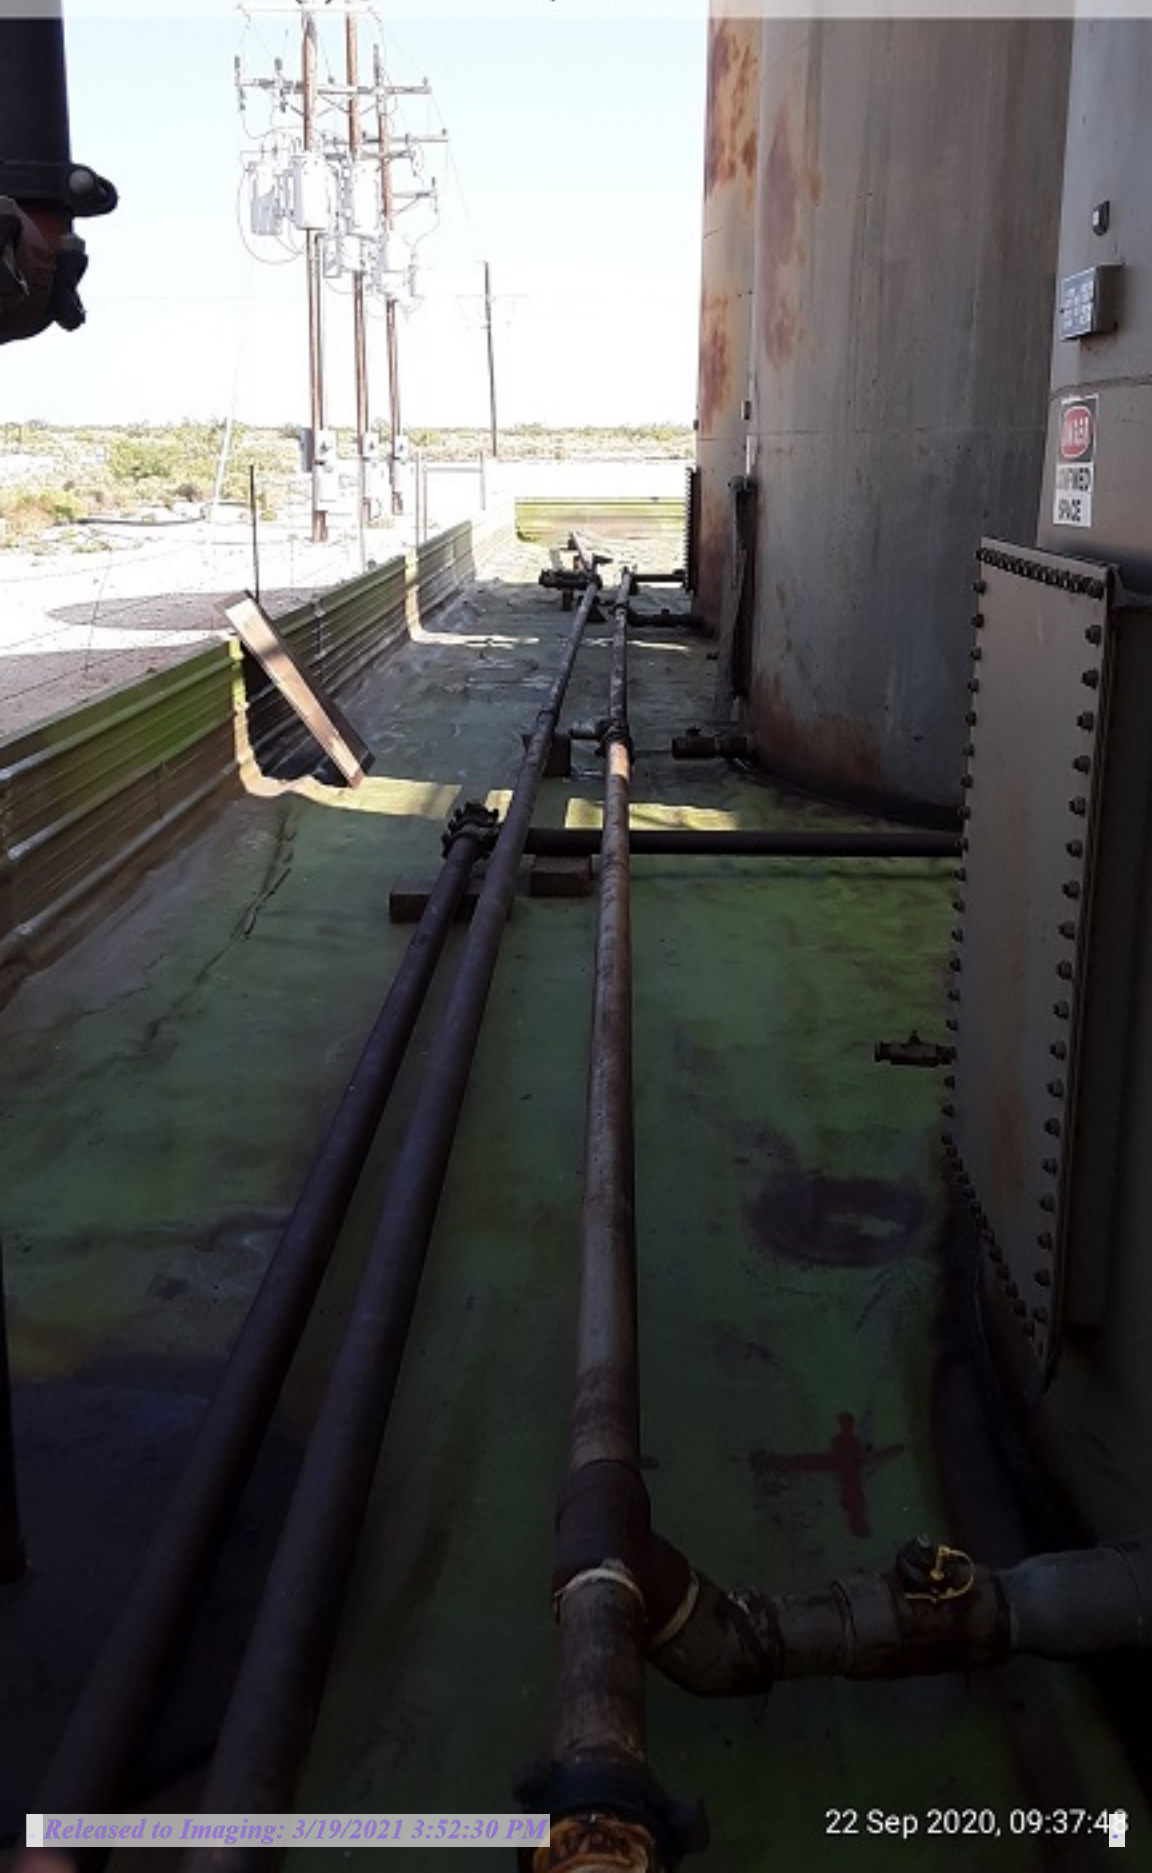
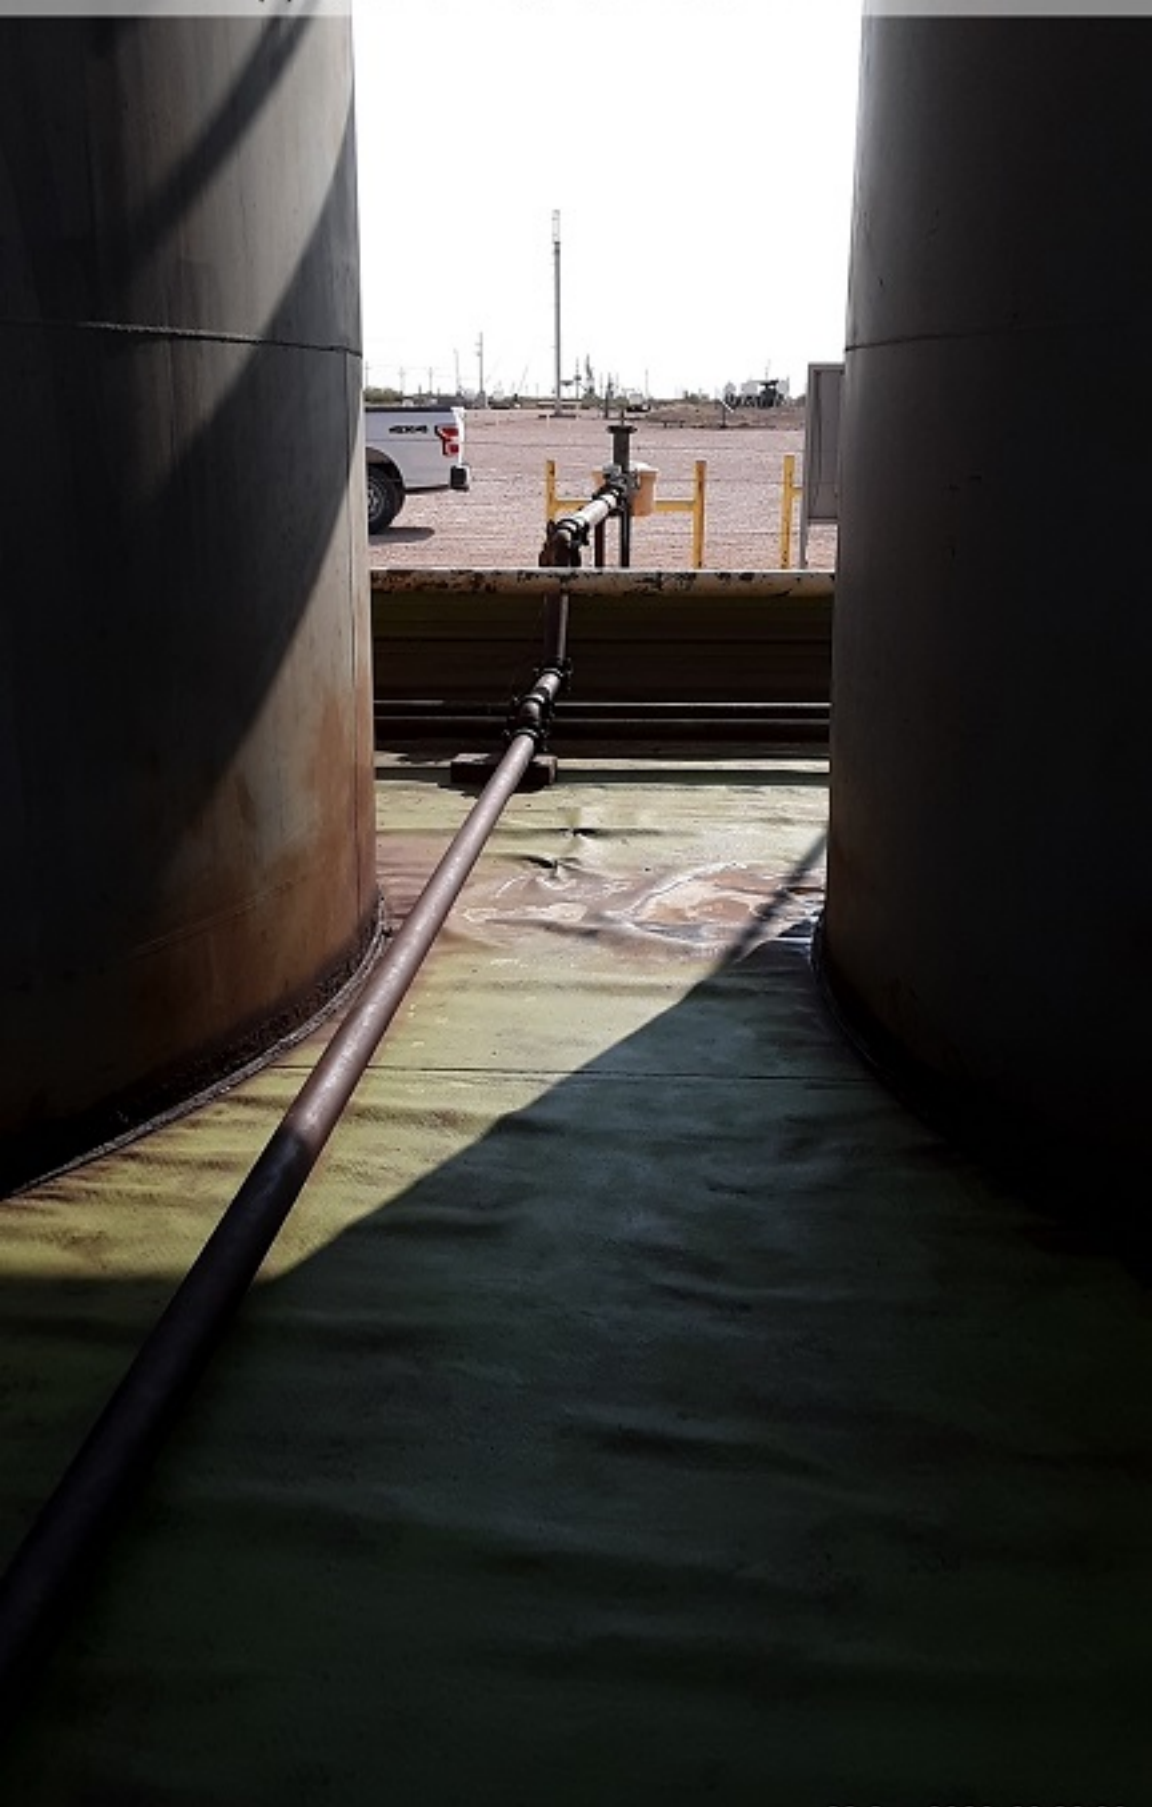
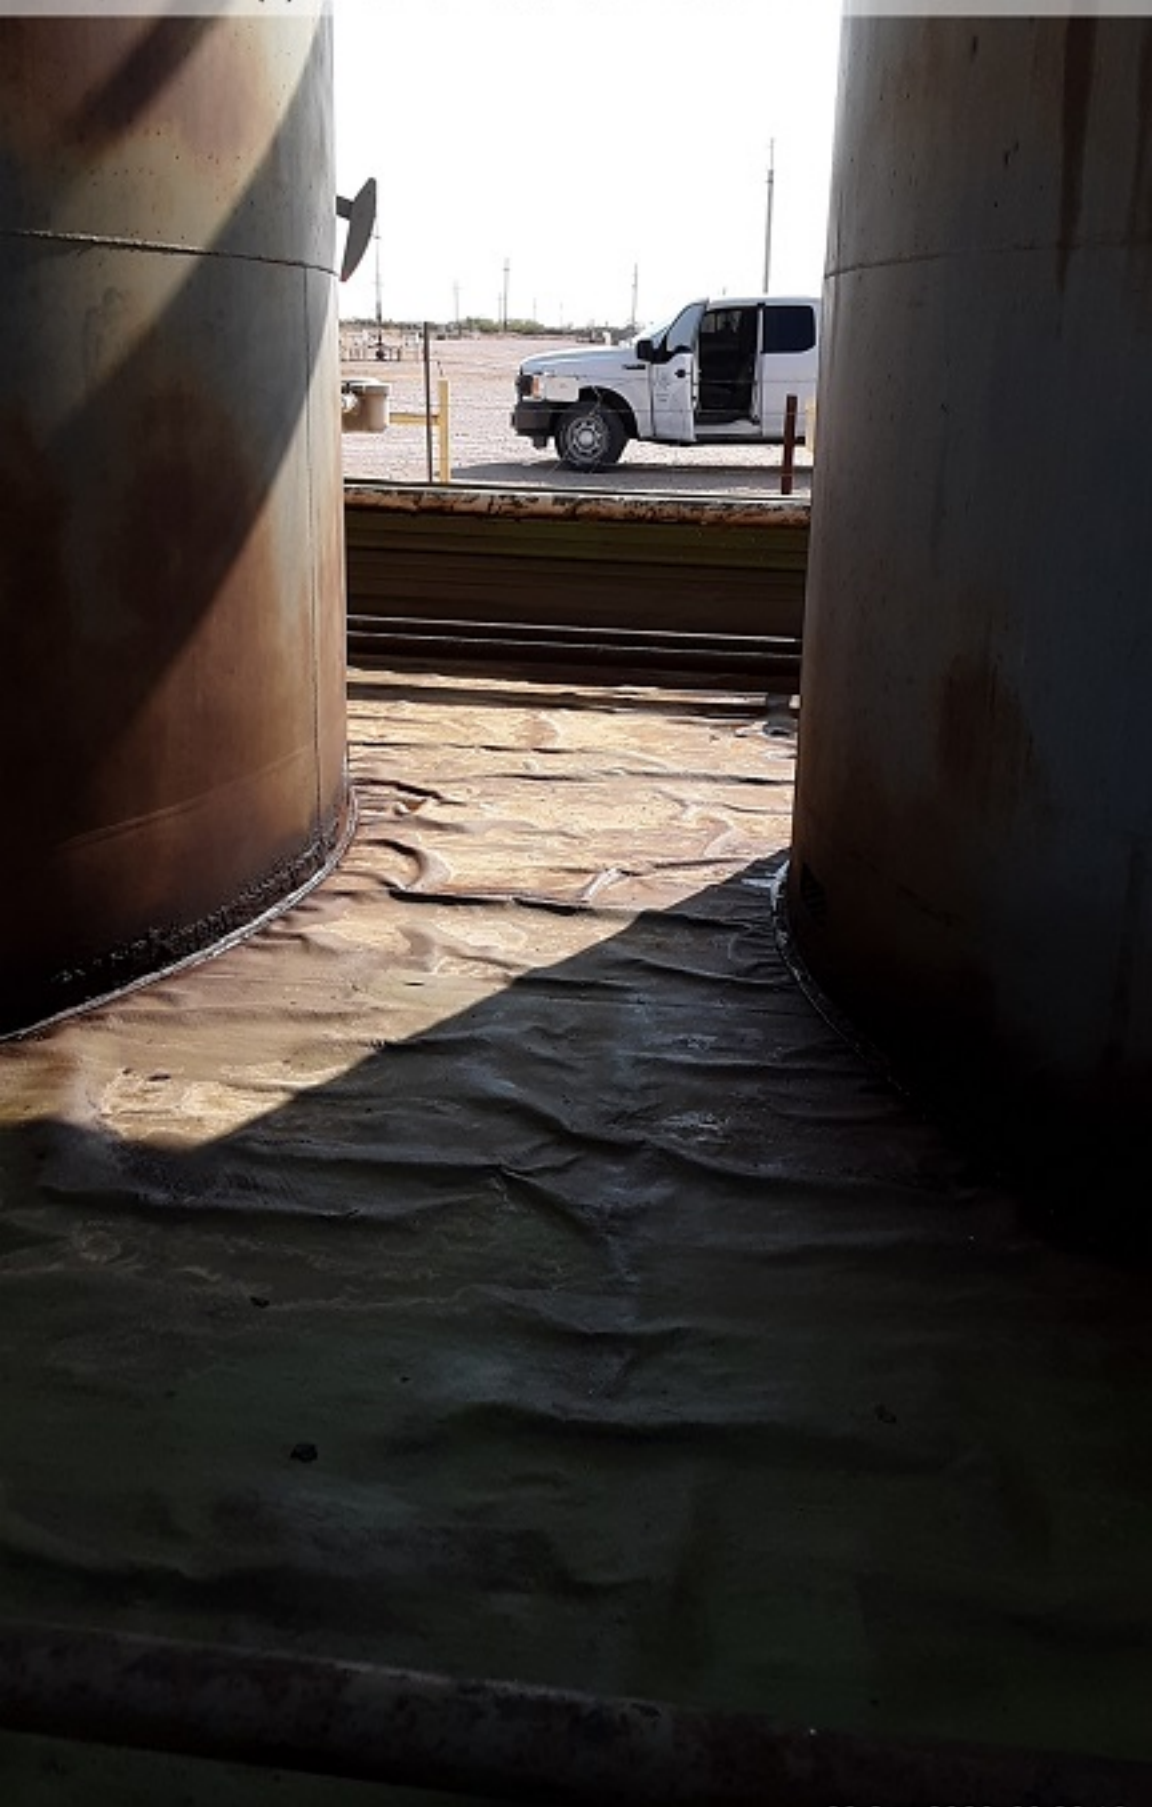
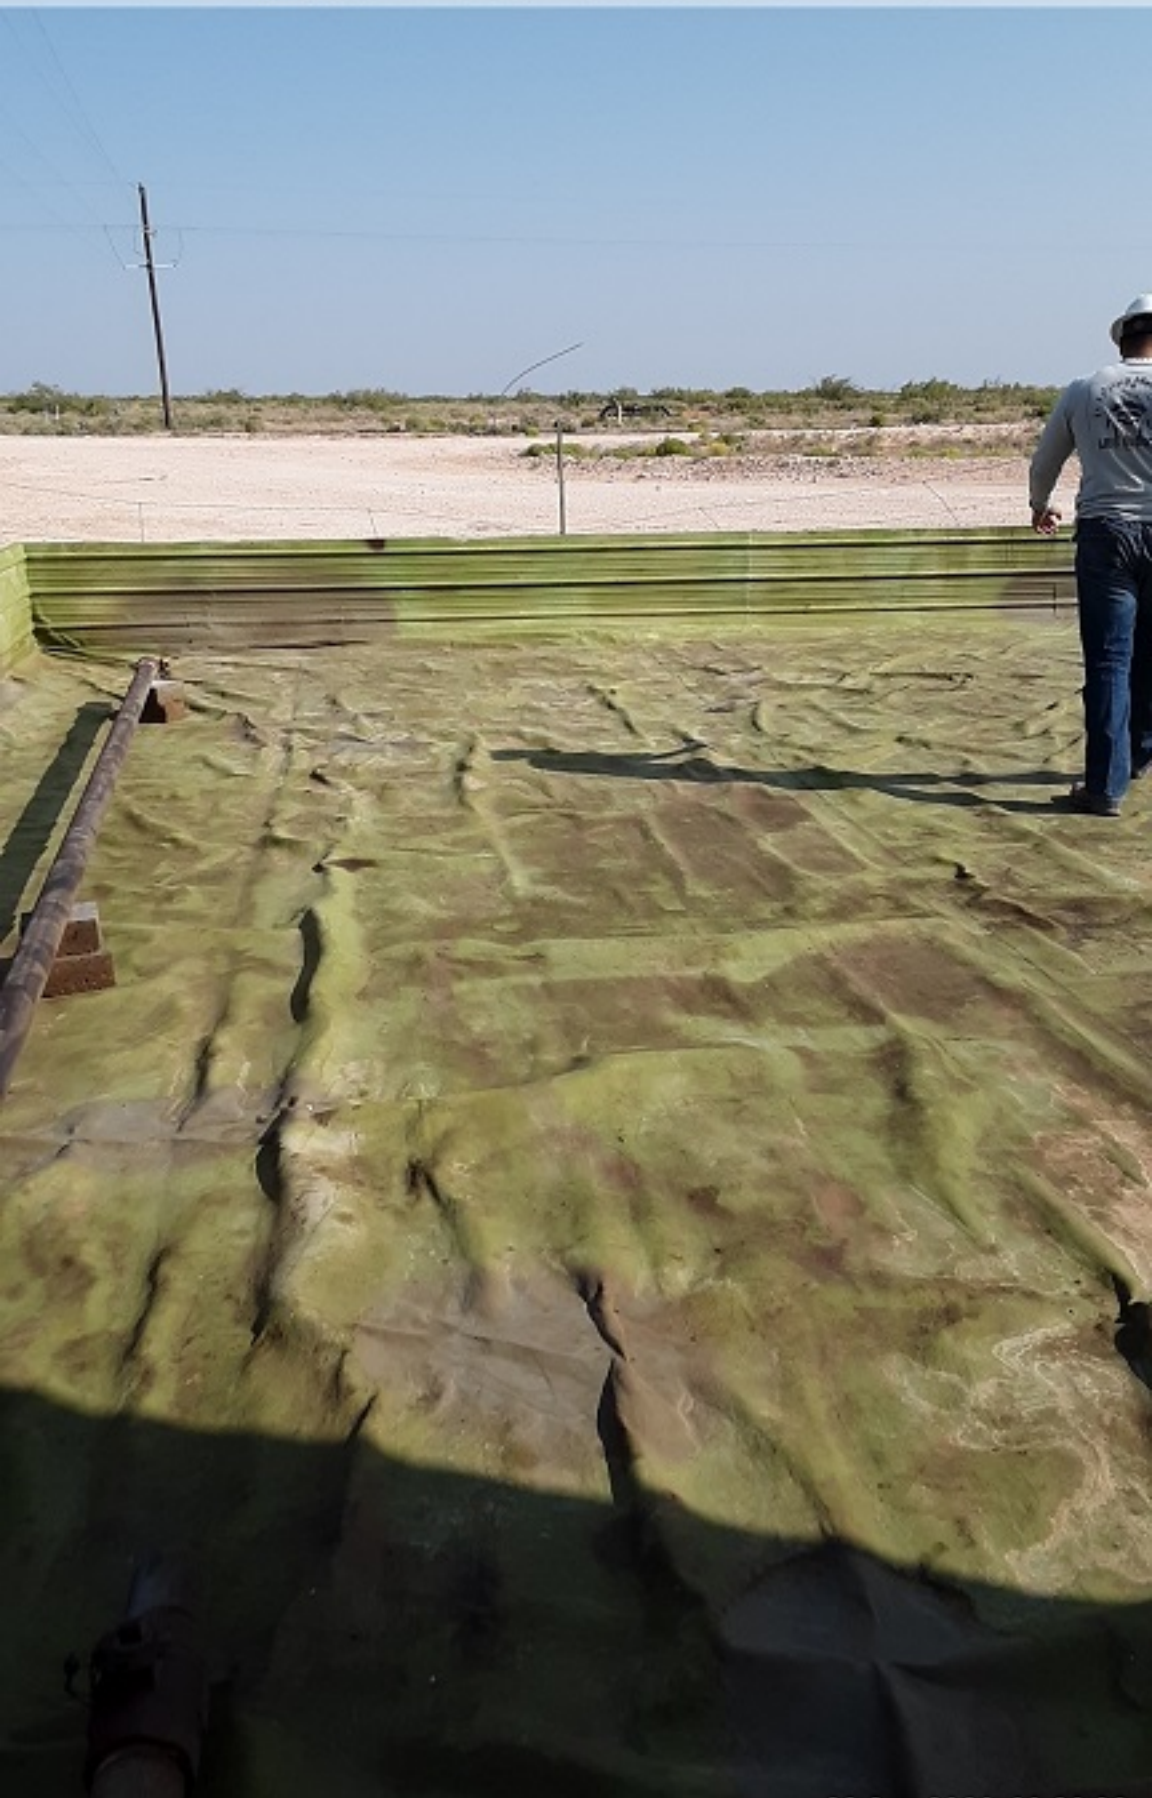
# **Appendix A LINER INSPECTION FORM & PHOTO LOG**

At the request of Devon, SMA conducted a liner integrity inspection per requirements of 19.15.29.11.A(5)(a) NMAC. NMOCD was notified on September 18, 2020 that the liner inspection was to occur, and the inspection was conducted on September 22, 2020. After a thorough visual inspection of the liner within the tank battery containment, the liner appeared to be intact and had the ability to contain the leak in question. The location where the release occurred was identified, and SMA verified that the release did not occur outside of the lined containment. A photo log of the inspection is included in Appendix A.

Liner Integrity Was Maintained (per SMA Inspection)

Release Was Contained to Lined Containment Area

Liner Was Able to Contain the Leak

SMA recommends no further action for this release.
