Release Notification

Site Name	Hat Mesa 32 State #2	Site Type	Well Location
Date Release Discovered	10/21/2019	API# (if applicable)	30-025-34819 (Hat Mesa 32 State #002)

**RE: Closure Request
Hat Mesa 32 State #2
Incident Number NRM1935430604
Lea County, New Mexico**

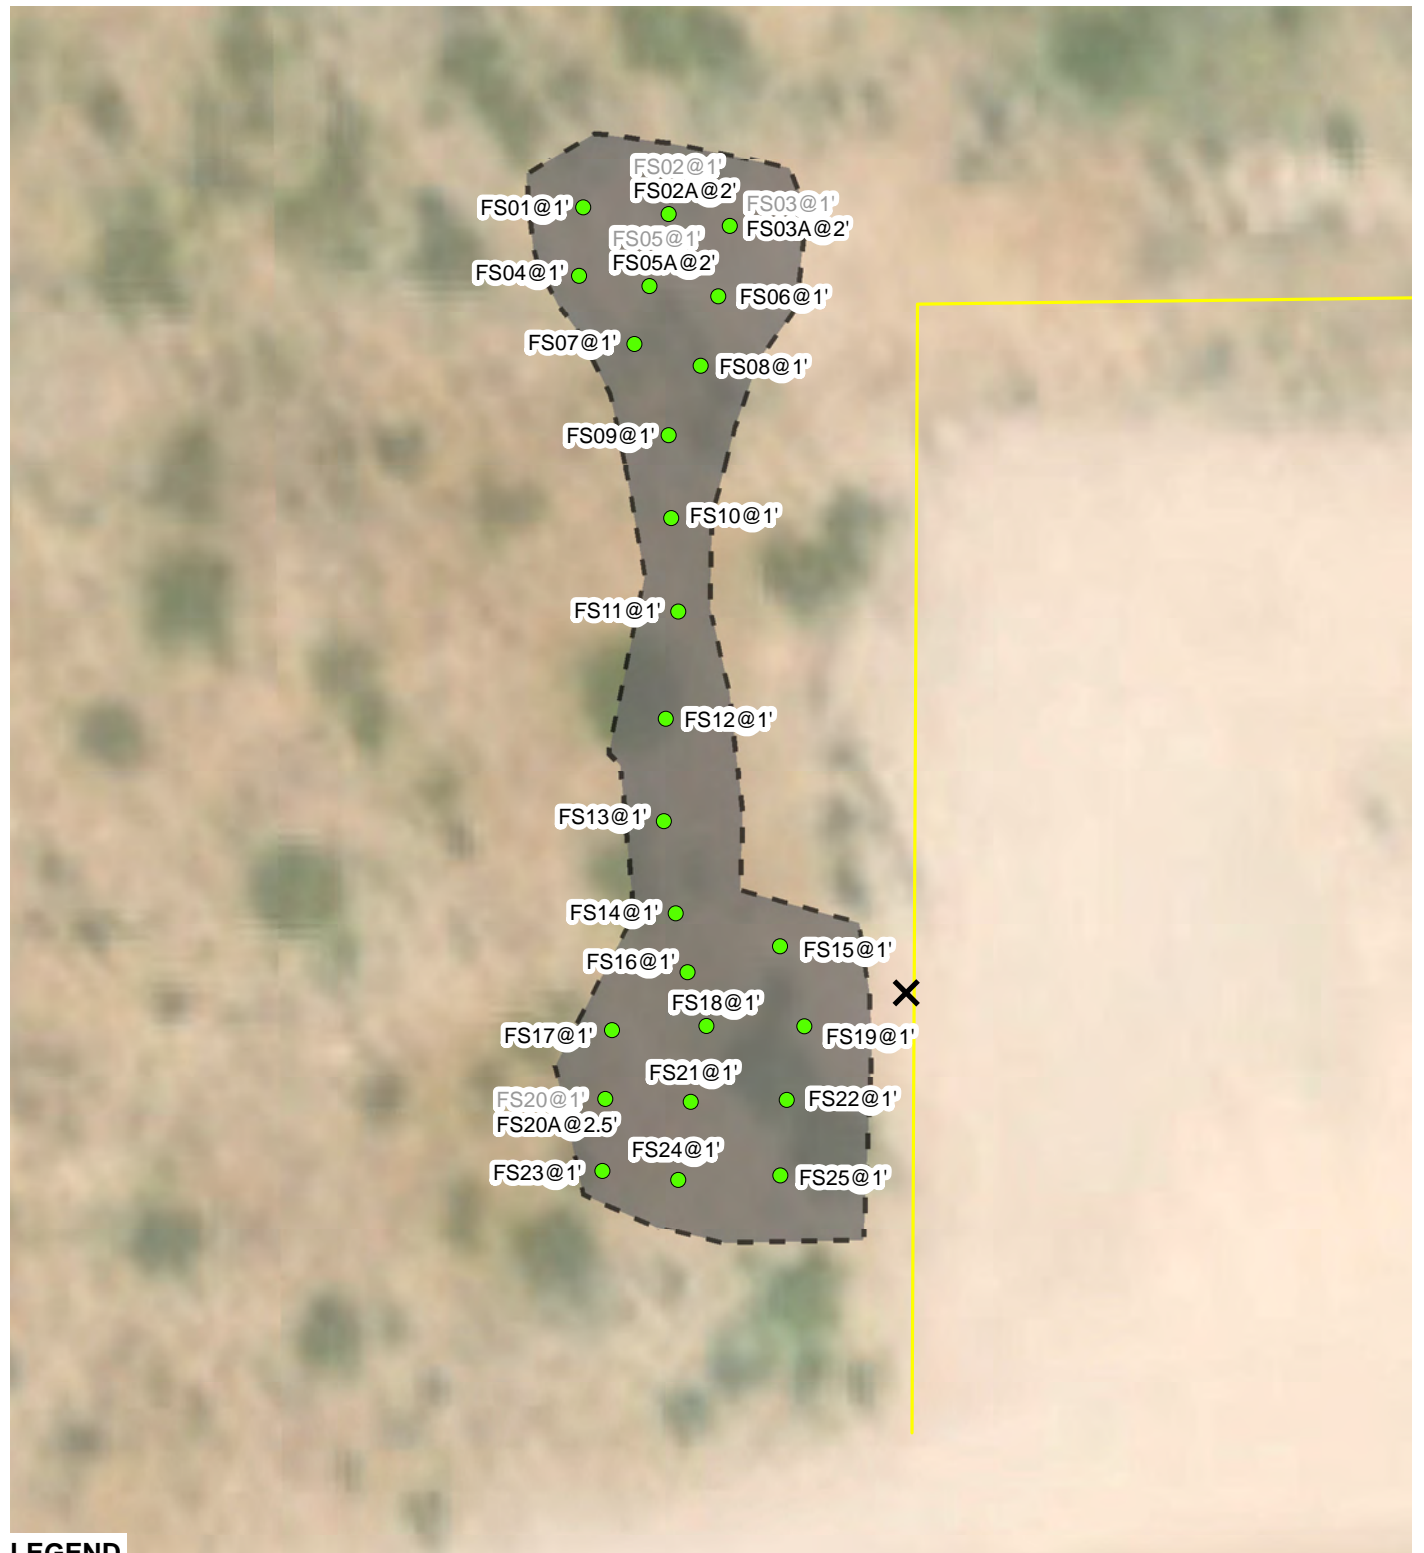
FIGURE 3
DELINEATION SOIL SAMPLE LOCATIONS
HAT MESA 32 STATE #2
UNIT C SEC 32 T20S R33E
LEA COUNTY, NEW MEXICO
XTO ENERGY, INC.

Two potholes (PH01 and PH02) were advanced via trackhoe to depths ranging from 1 foot to 2 feet bgs in the southern portion of the excavation to confirm the absence of impacted soil near preliminary soil sample SS01. Discrete delineation soil samples were collected from each pothole at depths ranging from 1 foot to 2 feet bgs. Soil from the potholes was field screened for volatile aromatic hydrocarbons and chloride utilizing a PID and Hach® chloride QuanTab® test strips, respectively. Field screening results and observations for each pothole were logged on lithologic/soil sampling logs, which are included in Attachment 2. The potholes and delineation soil sample locations are presented on Figure 3. The delineation soil samples were collected, handled, and analyzed as described above at Xenco in Carlsbad, New Mexico.

Based on field screening activities and laboratory analytical results for the preliminary and delineation soil samples, excavation activities were completed to remove impacted soil in the area surrounding preliminary soil samples SS02 through SS06. To direct excavation activities, LTE screened soil for volatile aromatic hydrocarbons and chloride utilizing a PID and Hach® chloride QuanTab® test strips, respectively. The excavation was completed to depths ranging from 1 foot to 2.5 feet bgs. Following removal of impacted soil, LTE collected 5-point composite soil samples at least every 200 square feet from the excavation. The 5-point composite samples were collected by placing five equivalent aliquots of soil into a 1-gallon, resealable plastic bag and homogenizing the samples by thoroughly mixing. Composite samples FS01 through FS25, FS02A, FS03A, FS05A, and FS20A were collected from the floor of the excavation from depths ranging from 1 foot to 2.5 feet bgs. Due to the shallow depth of the excavation, the soil samples represented the floor and sidewalls of the excavation. The excavation soil samples were collected, handled, and analyzed as described above. The excavation extent and excavation soil sample locations are presented on Figure 4. Photographic documentation was conducted during the visits to the Site. A photographic log is included in Attachment 3.

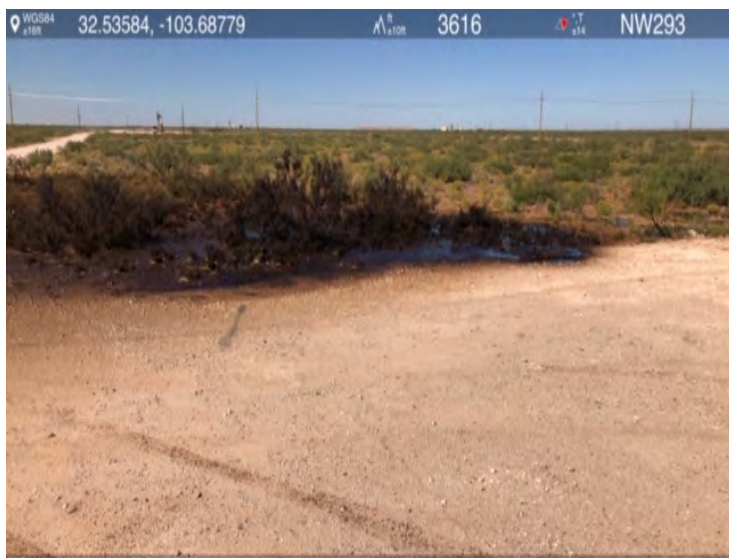
Photograph 1: Western view of spill area.

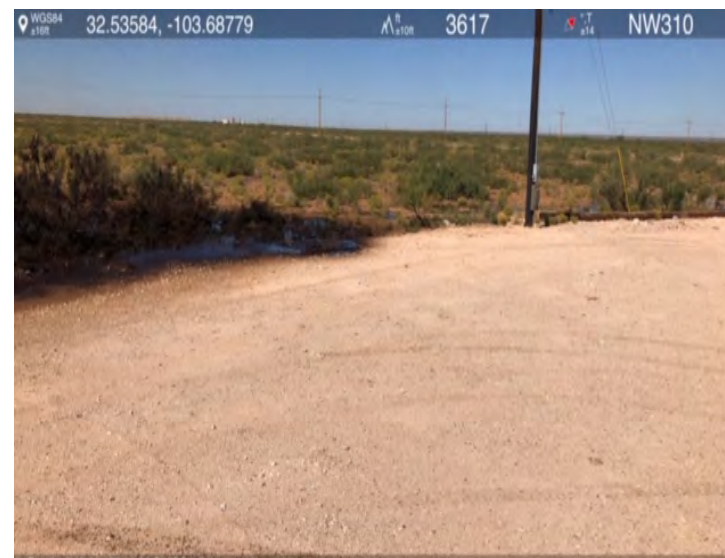
Photograph 2: Northwestern view of spill and pad.

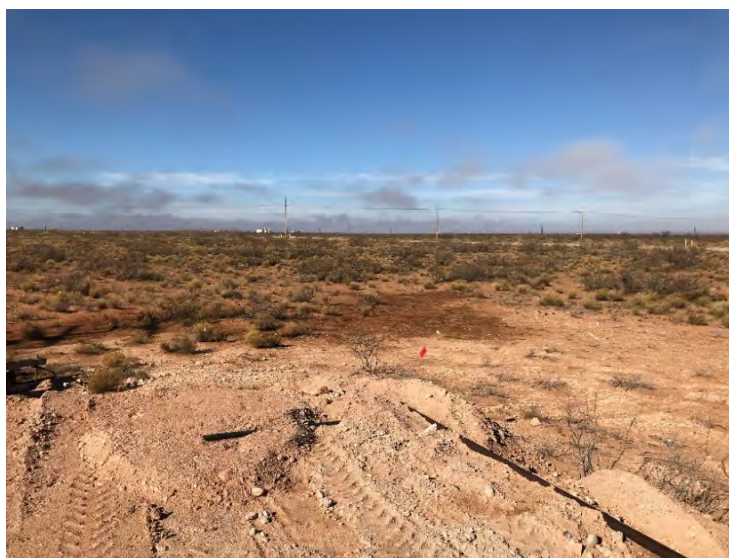
Photograph 3: Northwestern view of spill area.

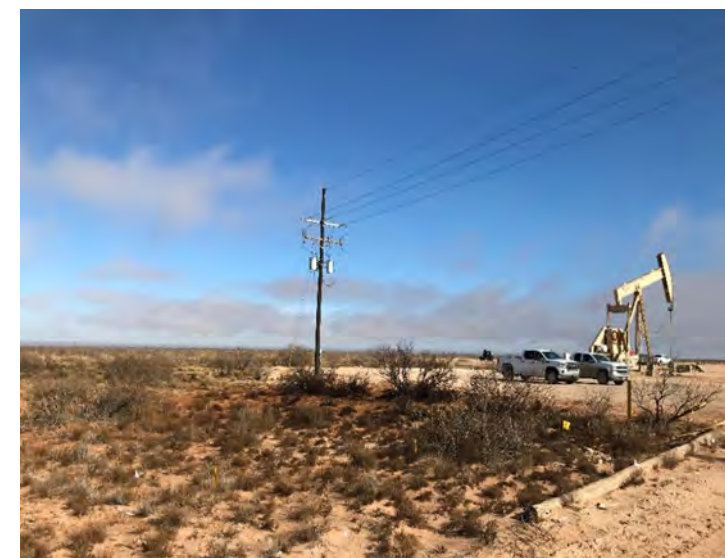
Photograph 4: Northeastern view of spill and pad.

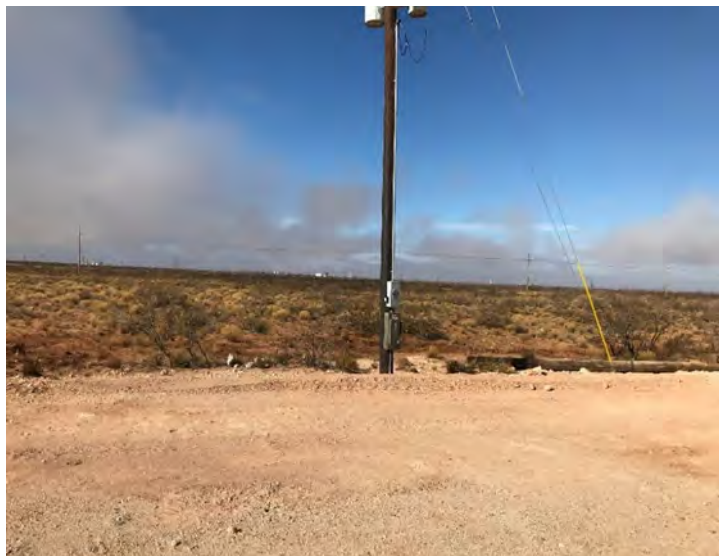
Photograph 5: Western view of spill area.

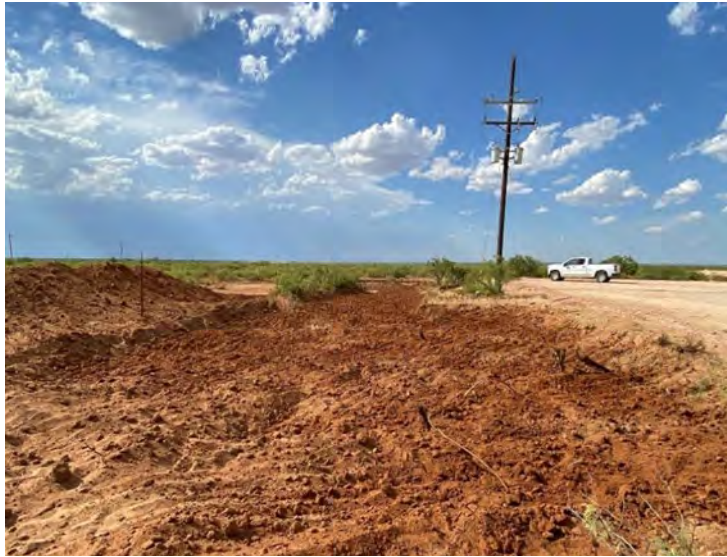
Photograph 9: Northern view of excavation area.

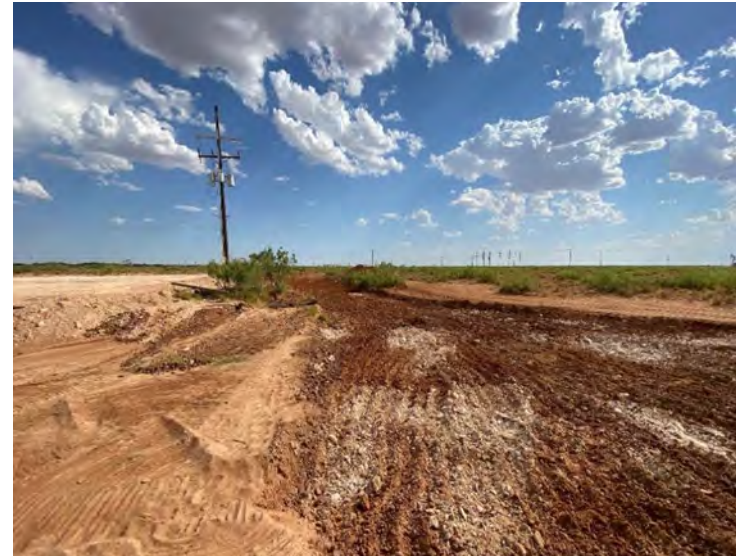
Photograph 10: Southern view of excavation area.

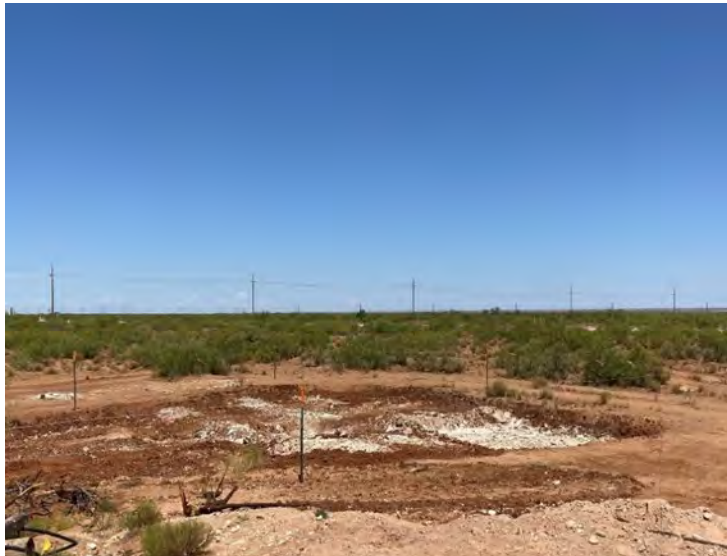
Photograph 11: Western view of excavation near FS02-FS05.
