October 23, 2020

Spill Closure Report: Arena Roja Federal Unit #15H/16H (CTB 2)
Unit I, Section 15, Township 26 South, Range 35 East
County: Lea
Tracking Number: NOY1823236138

Prepared For: Devon Energy Production Company
6488 Seven Rivers Highway
Artesia, New Mexico 88210

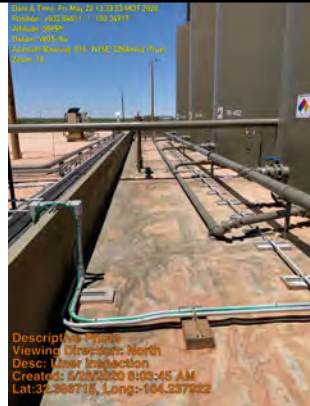
Viewing Direction: North

Liner inspection

- 1 No tears, cracks or leaking areas identified in liner. No remediation necessary.
- 2 Upload photos and notes for closure report.
- 3 Complete closure report.

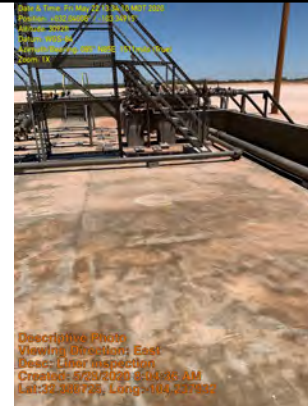
Viewing Direction: East

Liner inspection

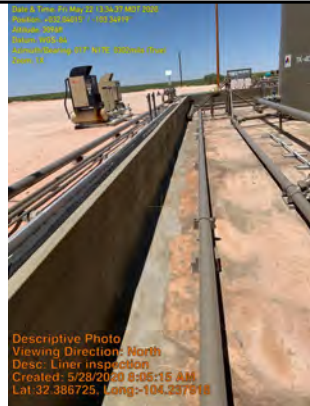
Viewing Direction: North

Liner inspection

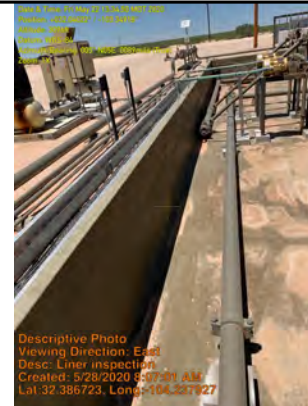
Viewing Direction: East

Liner inspection

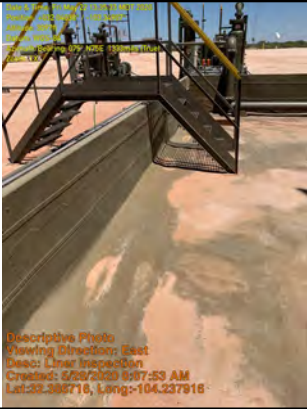
<p>Viewing Direction: East</p>

<p> <small> Date & Time: 30 May 22 12:58:40 PM Position: 432.58811, -104.237916 Altitude: 3794 Datum: WGS-84 Azimuth Bearing: 077° 00' 00" Magnetic True Zoom: 14 </small> </p> <p> <small> Descriptive Photo Viewing Direction: East Desc: Liner Inspection Created: 5/28/2020 9:57:53 AM Lat:32.386716, Long:-104.237916 </small> </p>	<p>Viewing Direction: South</p>

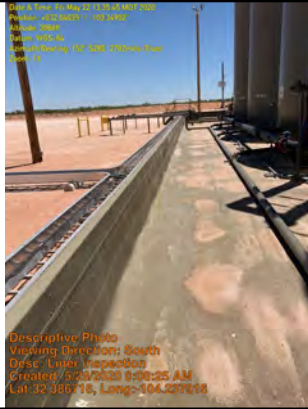
<p> <small> Date & Time: 30 May 22 12:58:40 PM Position: 432.58811, -104.237916 Altitude: 3794 Datum: WGS-84 Azimuth Bearing: 077° 00' 00" Magnetic True Zoom: 14 </small> </p> <p> <small> Descriptive Photo Viewing Direction: South Desc: Liner Inspection Created: 5/28/2020 9:58:25 AM Lat:32.386716, Long:-104.237916 </small> </p>
Liner inspection	Liner inspection
<p>Viewing Direction: North</p>

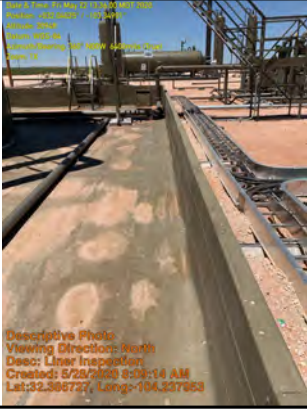
<p> <small> Date & Time: 30 May 22 12:58:40 PM Position: 432.58811, -104.237916 Altitude: 3794 Datum: WGS-84 Azimuth Bearing: 077° 00' 00" Magnetic True Zoom: 14 </small> </p> <p> <small> Descriptive Photo Viewing Direction: North Desc: Liner Inspection Created: 5/28/2020 9:59:14 AM Lat:32.386722, Long:-104.237953 </small> </p>	<p>Viewing Direction: North</p>

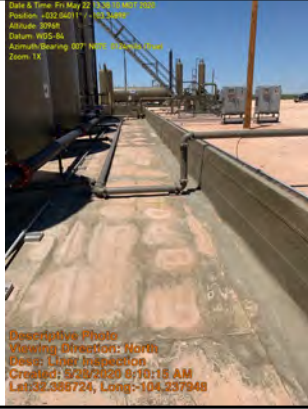
<p> <small> Date & Time: 30 May 22 12:58:40 PM Position: 432.58811, -104.237916 Altitude: 3794 Datum: WGS-84 Azimuth Bearing: 077° 00' 00" Magnetic True Zoom: 14 </small> </p> <p> <small> Descriptive Photo Viewing Direction: North Desc: Liner Inspection Created: 5/28/2020 9:59:15 AM Lat:32.386724, Long:-104.237948 </small> </p>

Liner inspection	Liner inspection

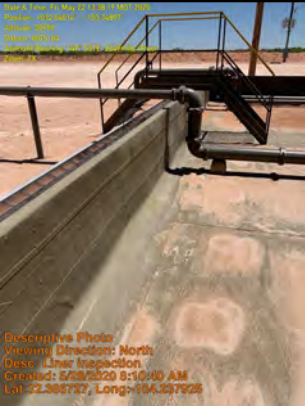
<p>Viewing Direction: North</p>

<p>Descriptive Photo Viewing Direction: North Desc: Liner inspection Created: 5/28/2020 8:10:40 AM Lat: 32.385737, Long: -104.237925</p> <p>Liner inspection</p>	<p>Viewing Direction: West</p>

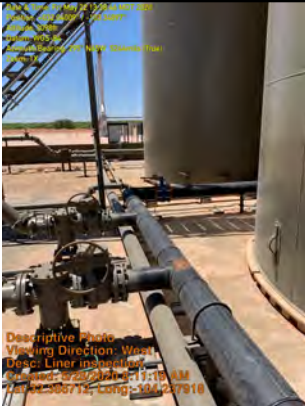
<p>Descriptive Photo Viewing Direction: West Desc: Liner inspection Created: 5/28/2020 8:17:18 AM Lat: 32.385713, Long: -104.237918</p> <p>Liner inspection</p>
<p>Viewing Direction: West</p>

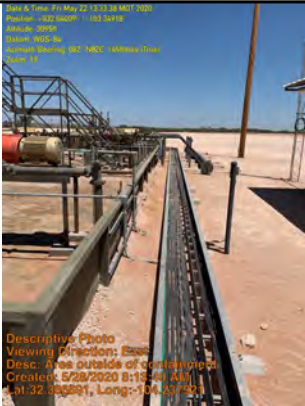
<p>Descriptive Photo Viewing Direction: East Desc: Area outside of containment Created: 5/28/2020 8:18:45 AM Lat: 32.385891, Long: -104.237931</p> <p>Area outside of containment</p>

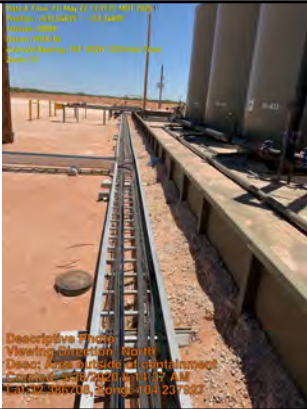
<p>Descriptive Photo Viewing Direction: North Desc: Area outside of containment Created: 5/20/2020 8:10:27 AM Lat:32.308719, Long:-101.237927</p>

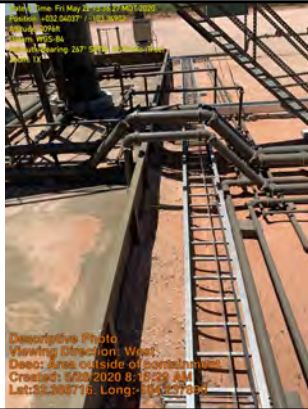
<p>Descriptive Photo Viewing Direction: West Desc: Area outside of containment Created: 5/20/2020 8:10:29 AM Lat:32.308719, Long:-101.237927</p>
Area outside of containment	Area outside of containment
