Pima Environmental Services, LLC
1601 N. Turner Ste 500
Hobbs, NM 88240
575-964-7740

October 26, 2020

Re: Site Remediation and Closure Report
Helios 6 Fed Com #2H
API No. 30-015-38483
GPS: Latitude 32.6831284 Longitude -103.9065475
UL "O", Sec. 6, T19S, R31E
Eddy County, NM
NMOCD Ref. No. 2RP-5715

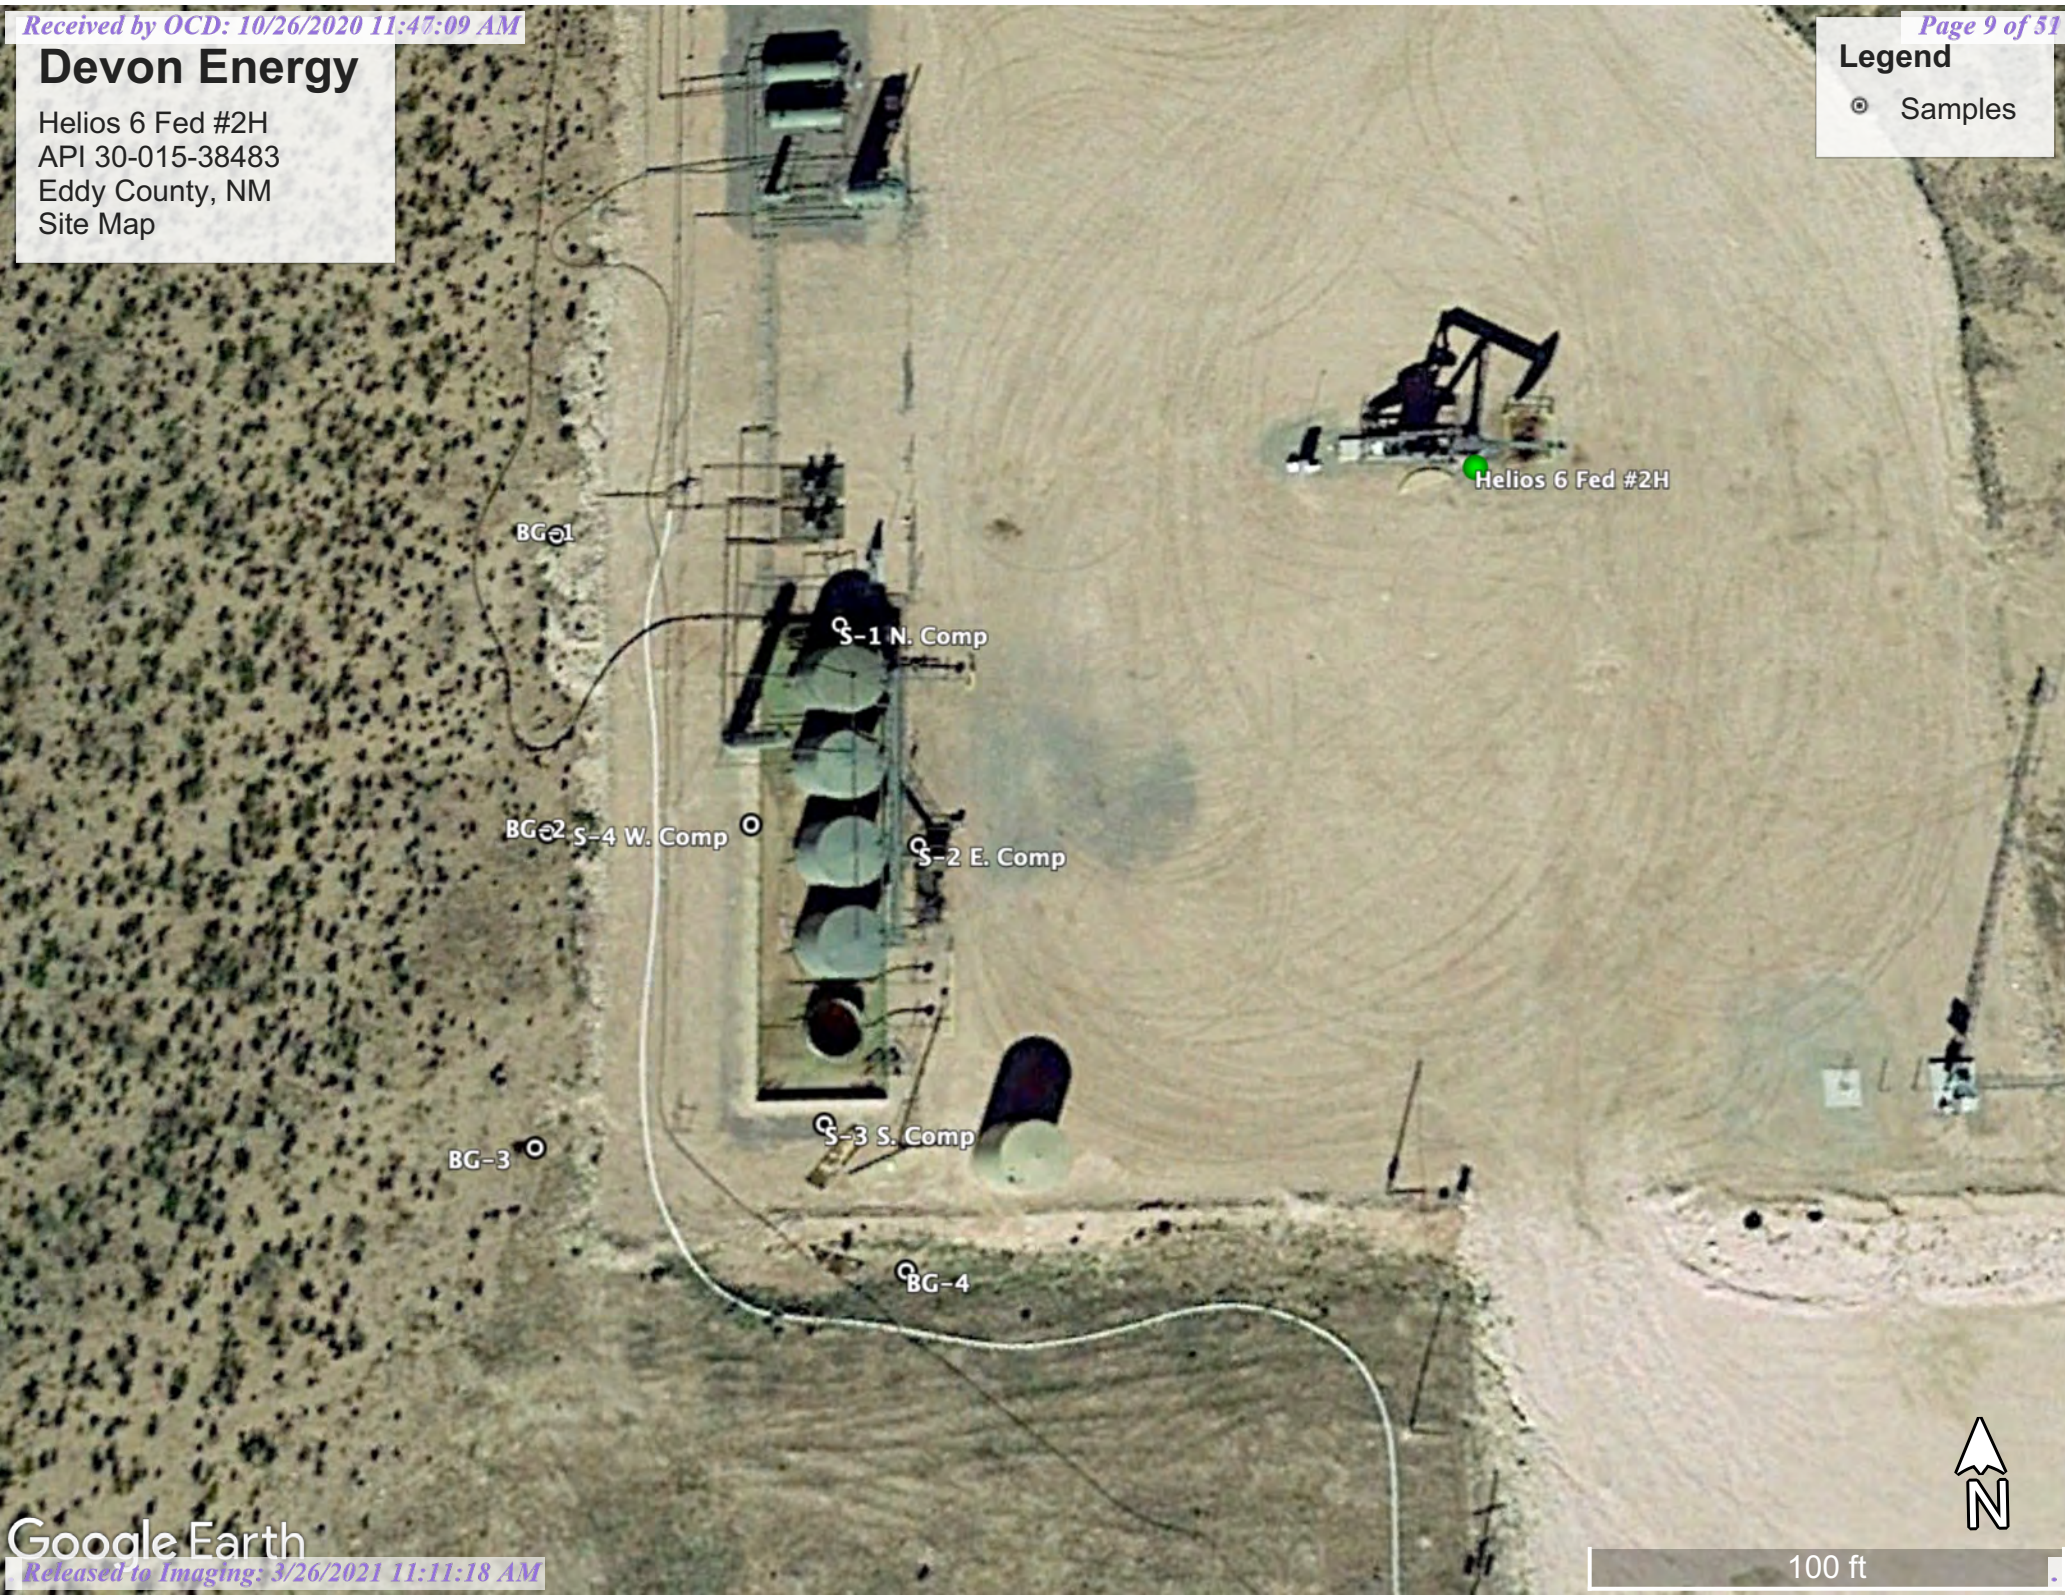
Helios 6 Fed #2H
API 30-015-38483
Eddy County, NM
Site Map

On October 1, 2020, Pima mobilized personnel and equipment to conduct remedial activities. The area in the vicinity of the north side of the containment was excavated to a depth of 1 foot deep and extended horizontally from the containment 3-feet. Confirmation bottom and sidewall composite samples were obtained to ensure that the vertical and horizontal extents of the contamination had been removed. Each composite sample was representative of no more than 200 square feet. The laboratory results of this sampling event can be found in the following data table.

The contaminated material was transported to Lea Land, an NMOCD approved disposal site. The excavation was then backfilled with clean like material, machine compacted and contoured to match the surrounding terrain.
