## Remediation and Closure Report

Turkey 4 State 2  
Eddy County, New Mexico  
30-015-36433  
Incident # Nab1819933371

Subject: **Remediation and Closure Report**  
Turkey 4 State 2  
Eddy County, NM  
API 30-015-36433  
**Incident #Nab1819933371**

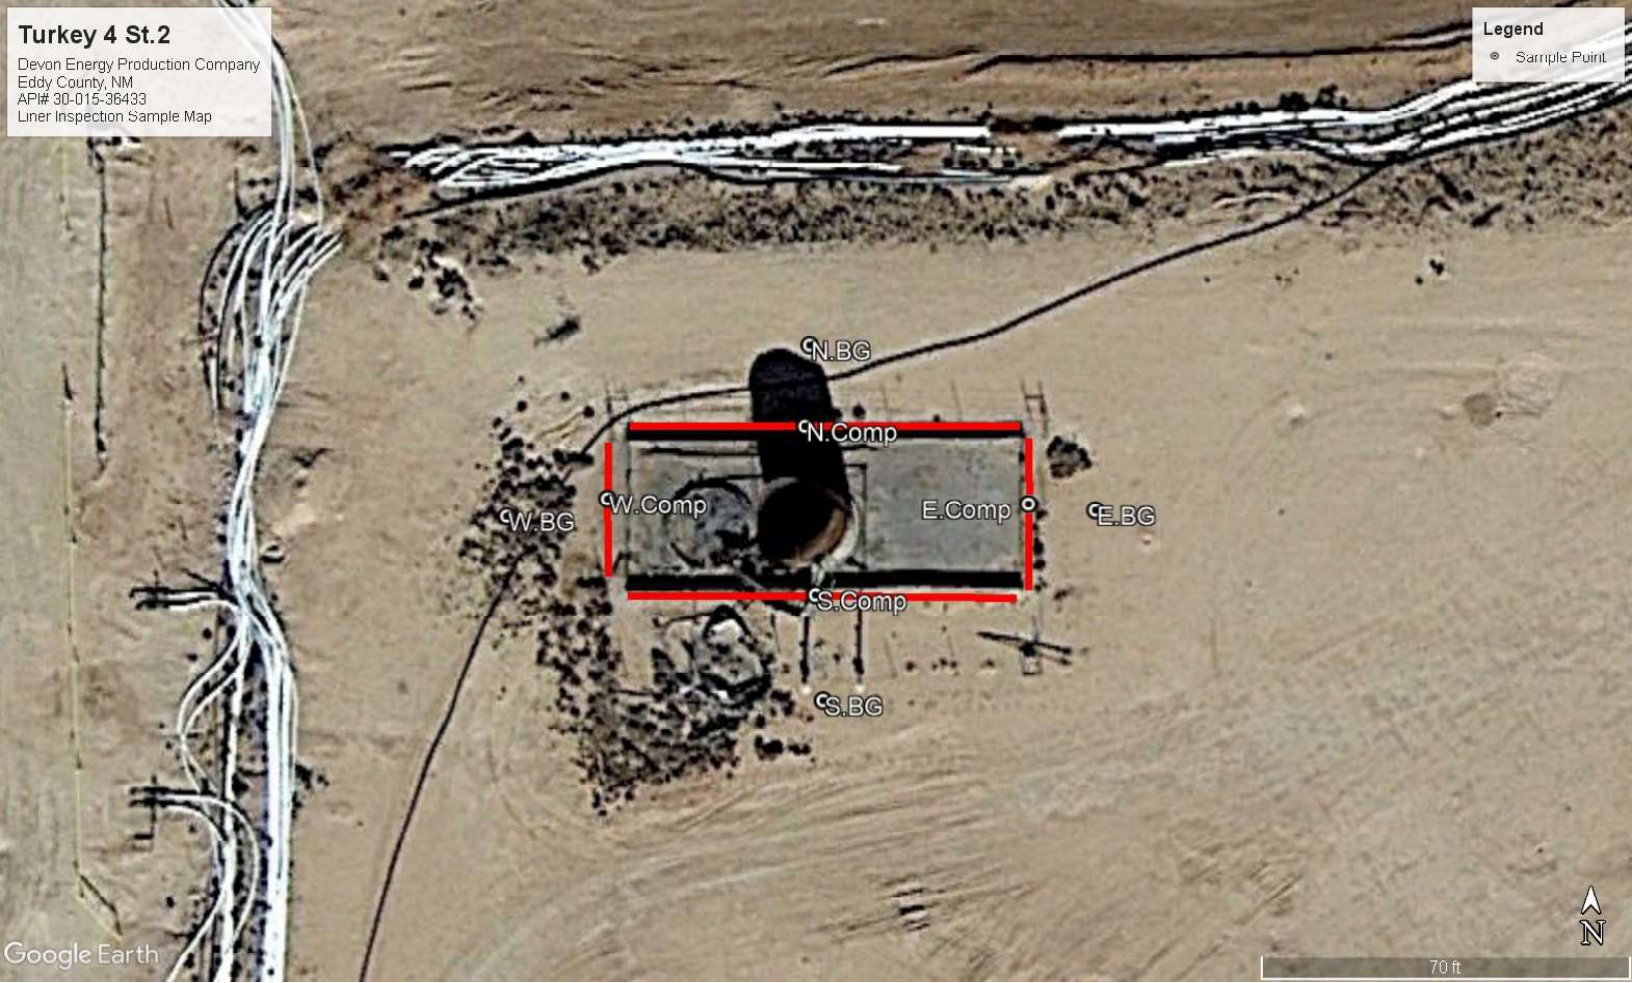
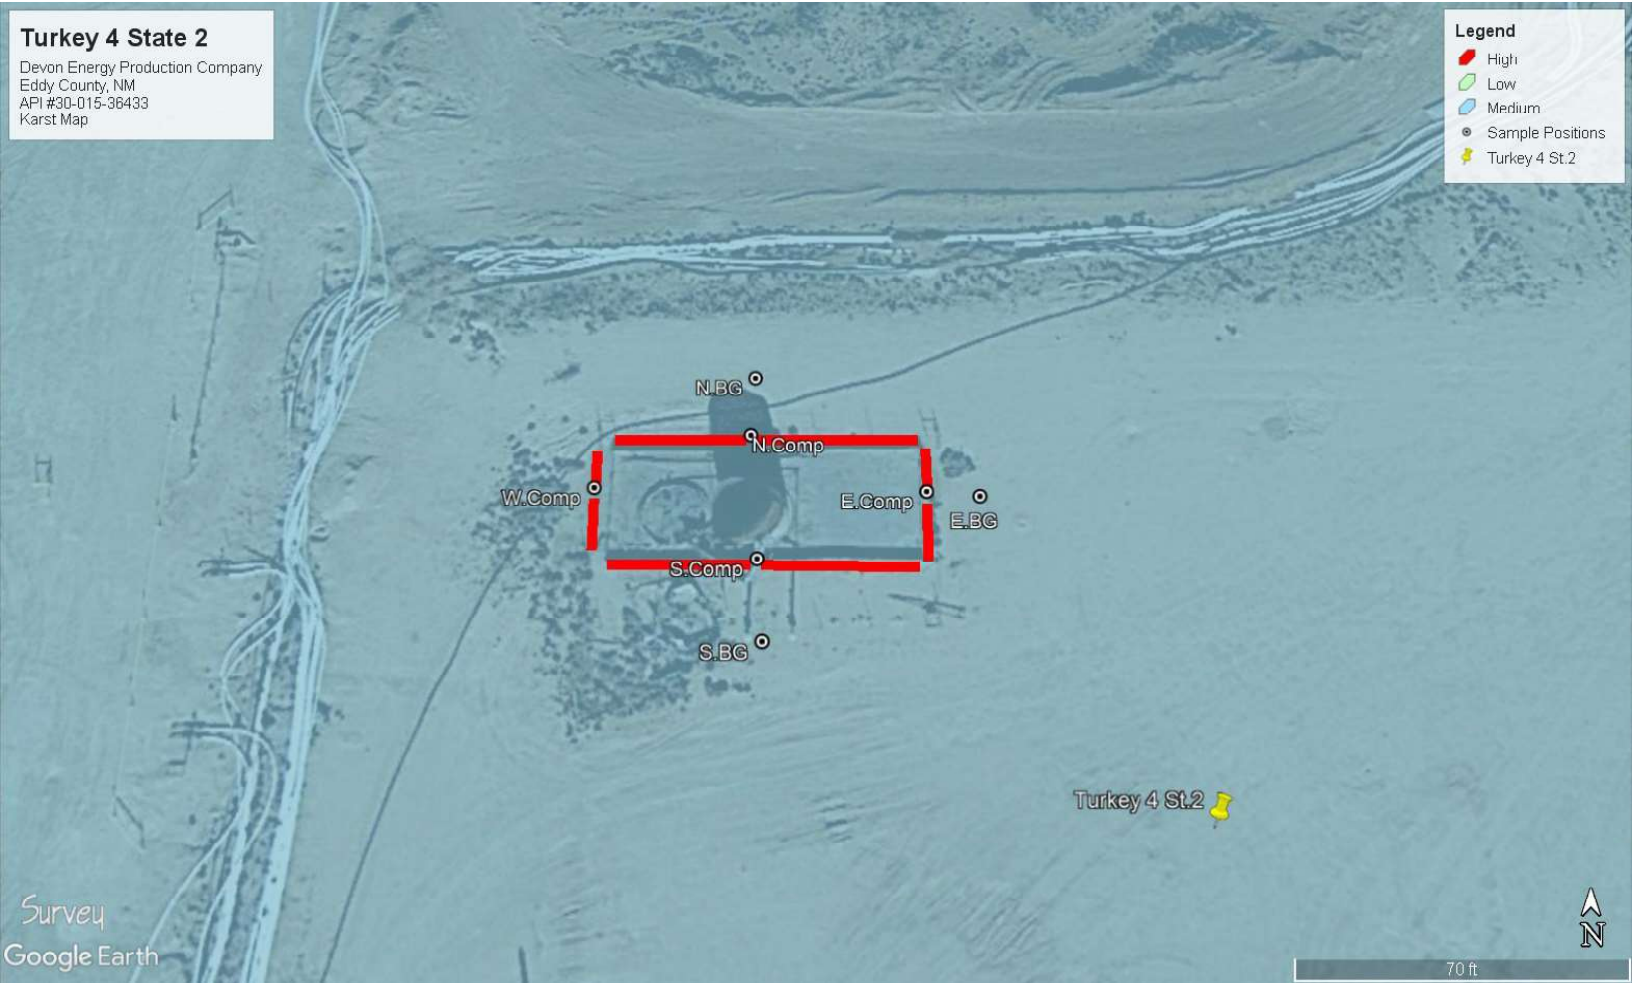
## SITE MAPS

The Turkey 4 State 2 is located approximately twenty-six (26) miles southeast of Artesia, New Mexico. The legal location for this release is Unit Letter L, Section 04, Township 19 South and Range 29 East in Eddy County, New Mexico. More specifically the latitude and longitude for the release are 32.6861992 North and -104.0862122 West. A Site Map is presented in [Appendix I](#).

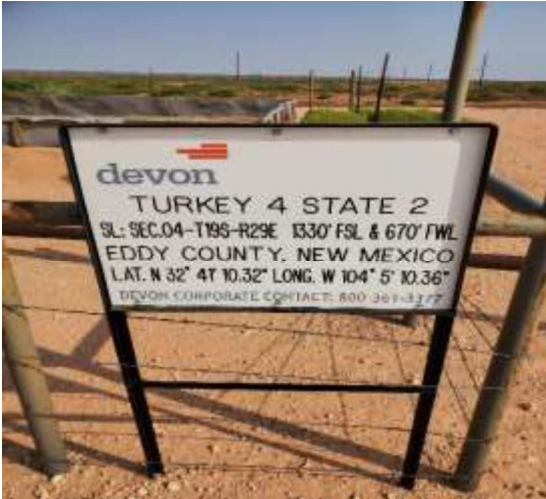
Location Signage

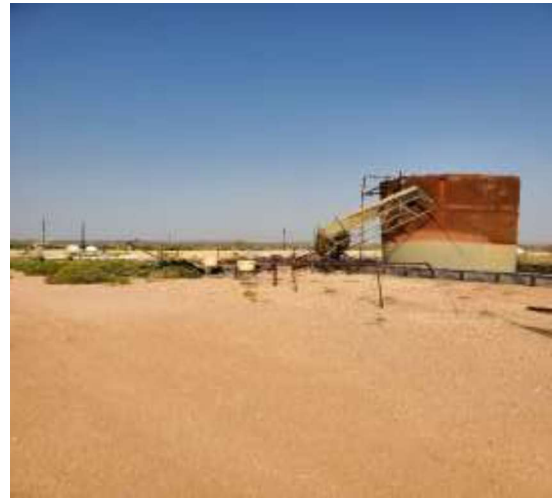
Site Photo

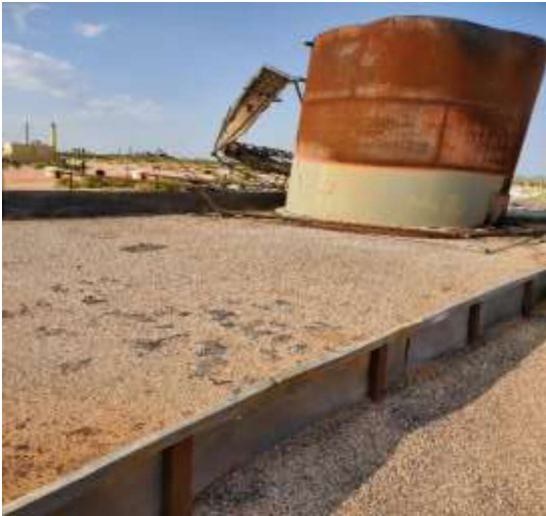
Interior of Containment

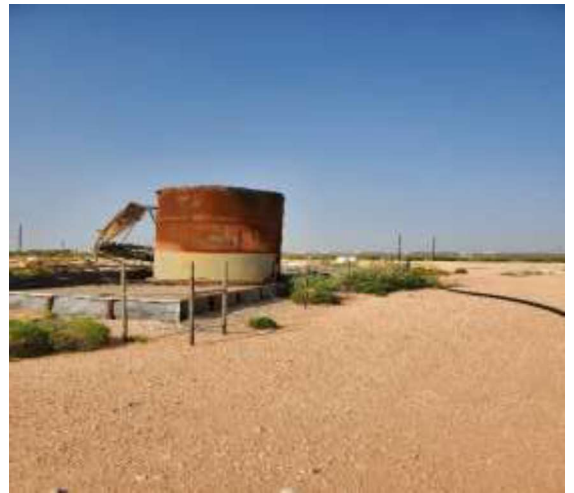
Pasture Area

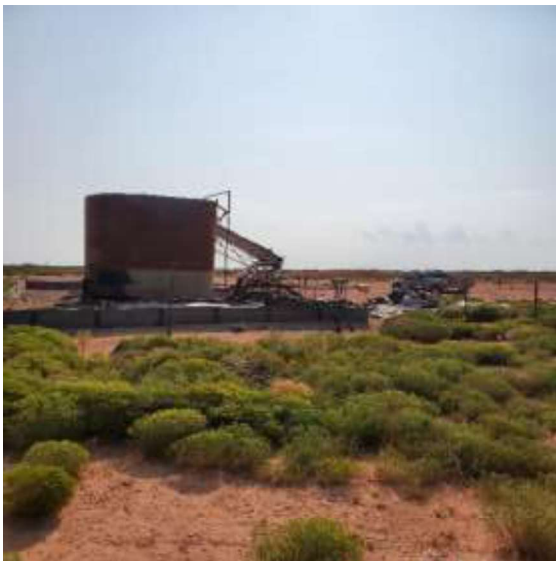
South side of containment

On January 14, 2021, Talon personnel mobilized to the site in order to hand excavate the south side and east side exterior area of the containment. These areas were excavated to approximately 1' bgs. Composite soil samples were taken of the south and east sides of the excavated areas respectively. All soil samples were properly contained, preserved, and transported to Hall Environmental Analysis Laboratory, Inc. Sample locations are shown on the attached site plan and the results of our sampling event are presented in the following data table.

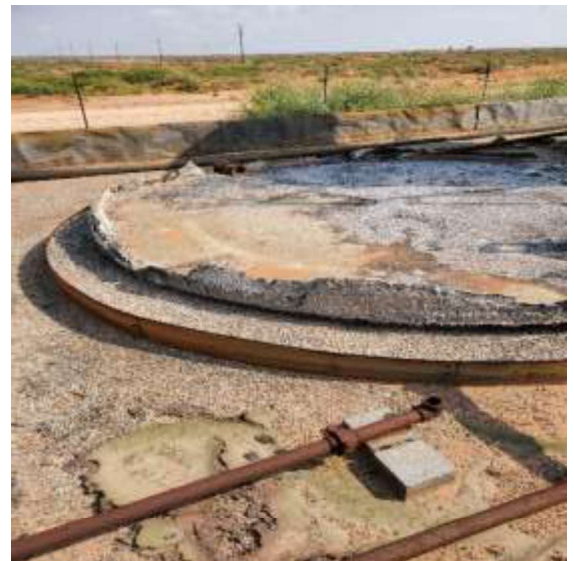
On July 2, 2018, a lightning strike occurred at this facility. A tank was stuck causing a fire to erupt. The fire was extinguished by the fire department. The release occurred on the pad area and no fluid traversed to the pasture area. All fluid was vaporized in the fire. The site map is presented in [Appendix I](#).

Remnant of tank bottom post lightning strike

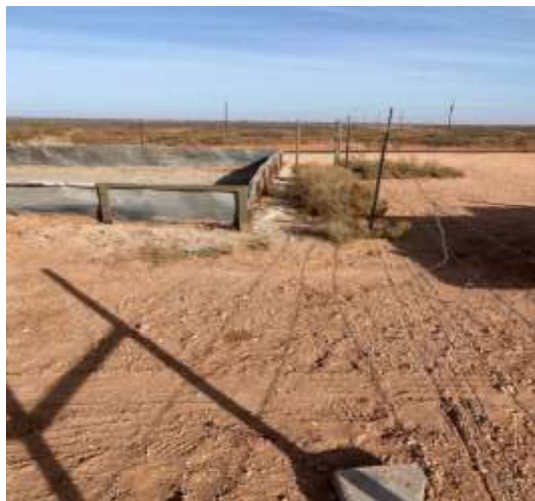
Hand excavation South SW (1')

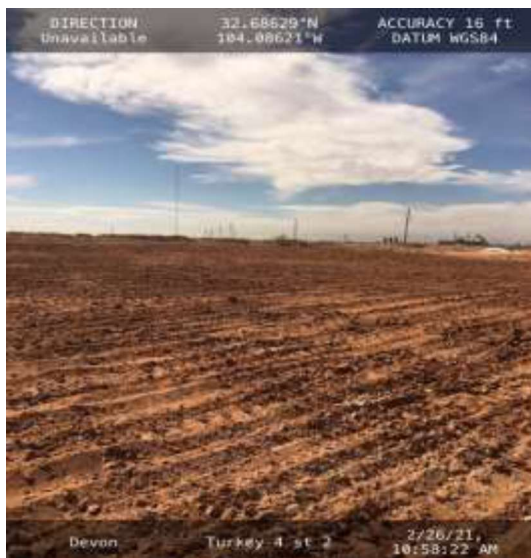
Pad reclaimed 4' of topsoil re-seeded

- All surface impact as well as staining was excavated from the exterior of the containment and disposed of at a NMOCD approved solid waste disposal facility.
- Confirmation soil samples were collected and verified analyte levels were below NMOCD remediation guidelines.
- Work completed by others, revealed by photo documentation that all debris and infrastructure has been removed. The site has been reclaimed.
