**FALABELLA 31 FEE #008H BATTERY
CLOSURE REPORT**

**API NO. 30-015-39515
U/L P, SECTION 31, TOWNSHIP 18S, RANGE 26E
EDDY COUNTY, NEW MEXICO**

**RELEASE: 8/24/2020
INICIDENT ID: NRM2023855625**

Subject: Closure Report for Spur Energy Partners – Falabella 31 Fee #008H Battery

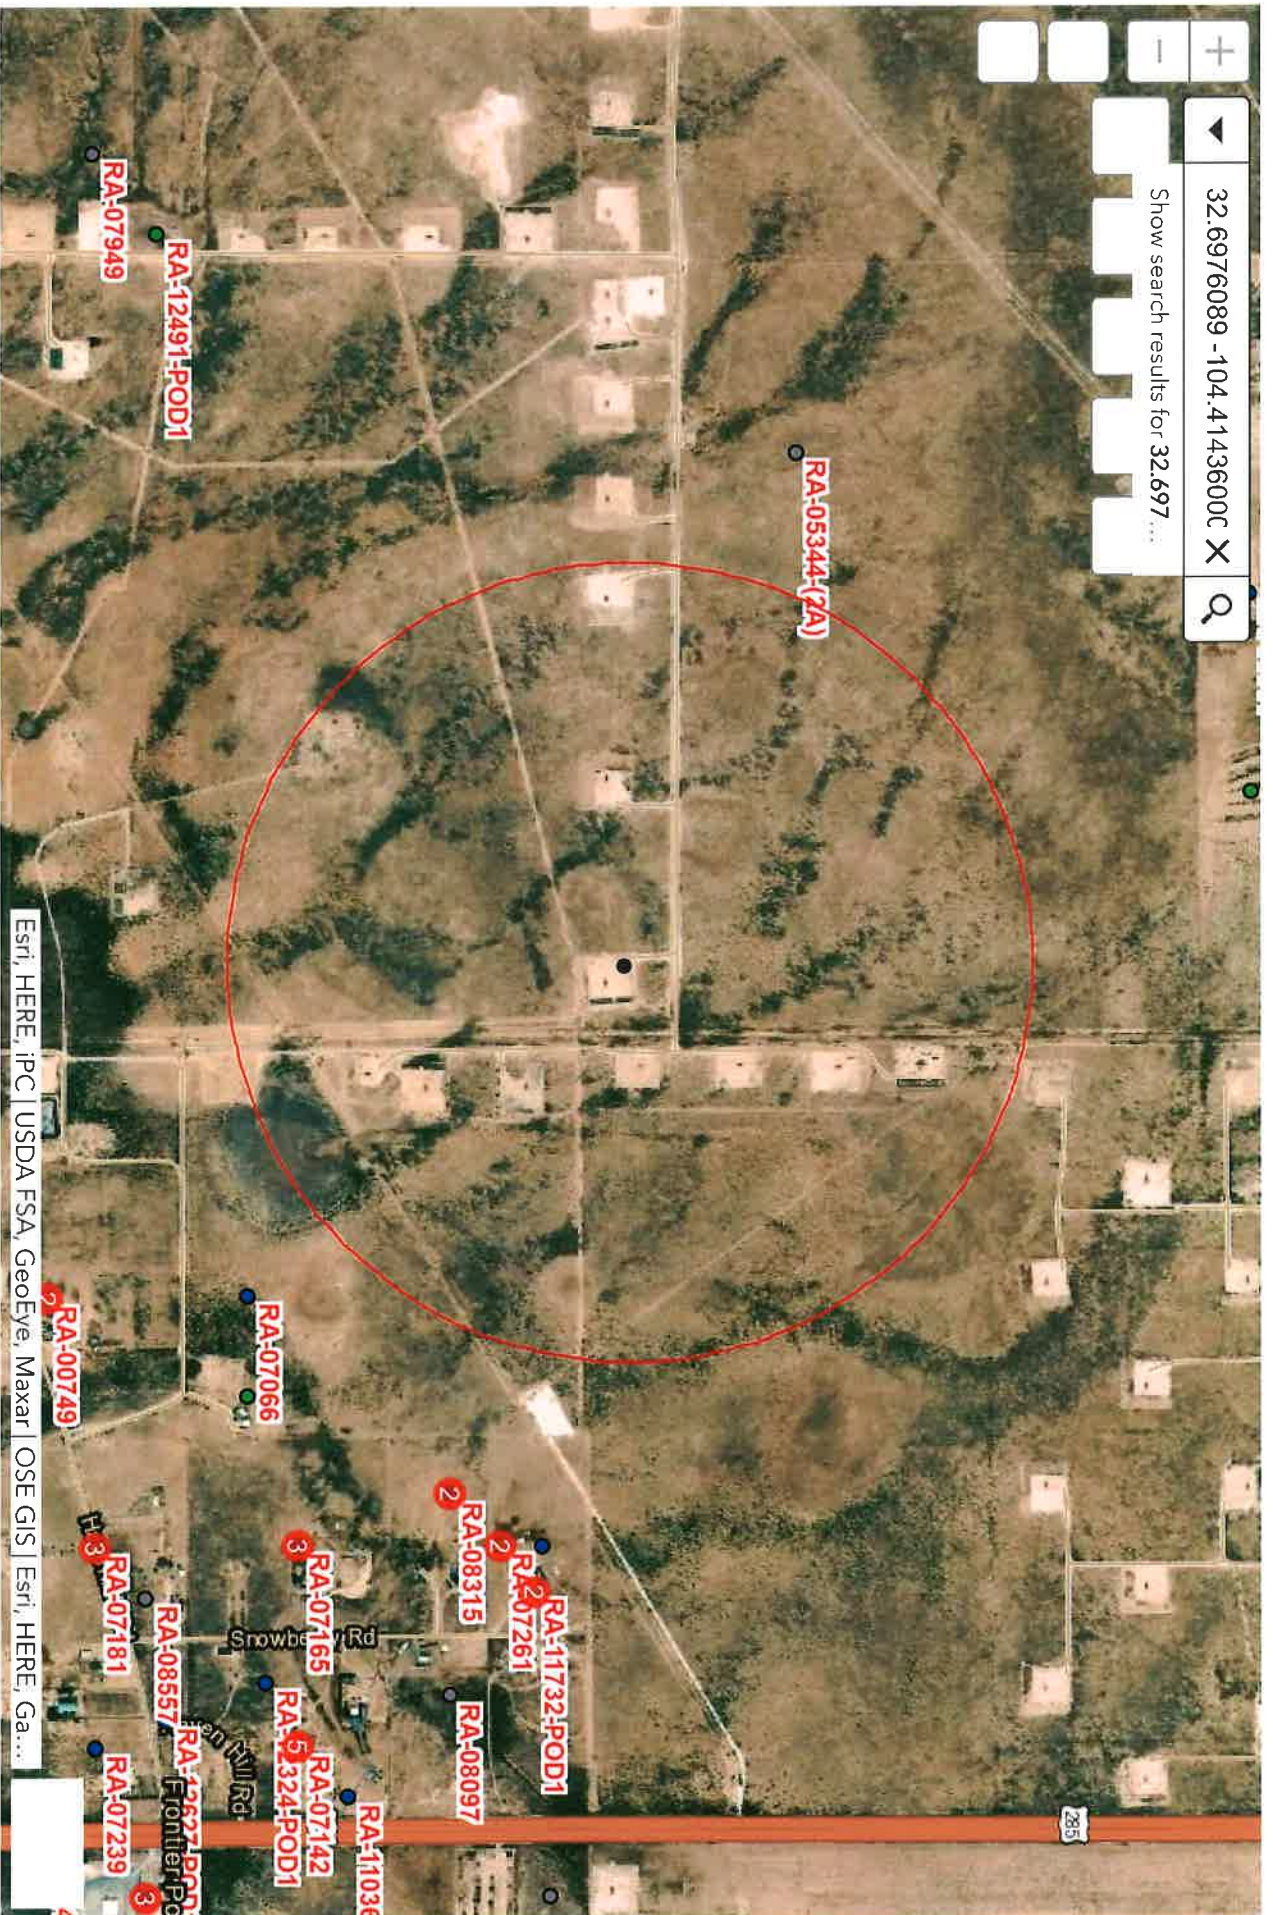
FALABELLA 31 FEE #008H
GROUND WATER MAP
100' DGW

The nearest recent water well to the site according to the *New Mexico Office of the State Engineer* is RA 07066, which is located 1,003' from the site and was drilled in 1992. Groundwater in this area is 100' bgs (below ground surface). Please find the ground water data attached herein. An extended groundwater search was conducted using the *OSE POD Location Mapping System* and it was determined that no ground water was found within a ½ of a mile from the Falabella. Although the NMOSE database shows that the RA 07066 well is .18 of a mile from the site but is actually measured at .62 mile. Please refer to the ground water data that is included in this report.
