Re: Remediation Plan Apache Corporation WS MARSHALL B-011 1RP-5456

RXSoil, Inc. is pleased to submit the remediation plan for the on-site remediation of impacted soil for the above release in Lea County, New Mexico.

On behalf of Apache Corporation ("Apache"), RXSoil, Inc. ("RXSoil") has prepared this work plan that describes remediation of the release of crude oil at the W.S. Marshall B-011 battery.

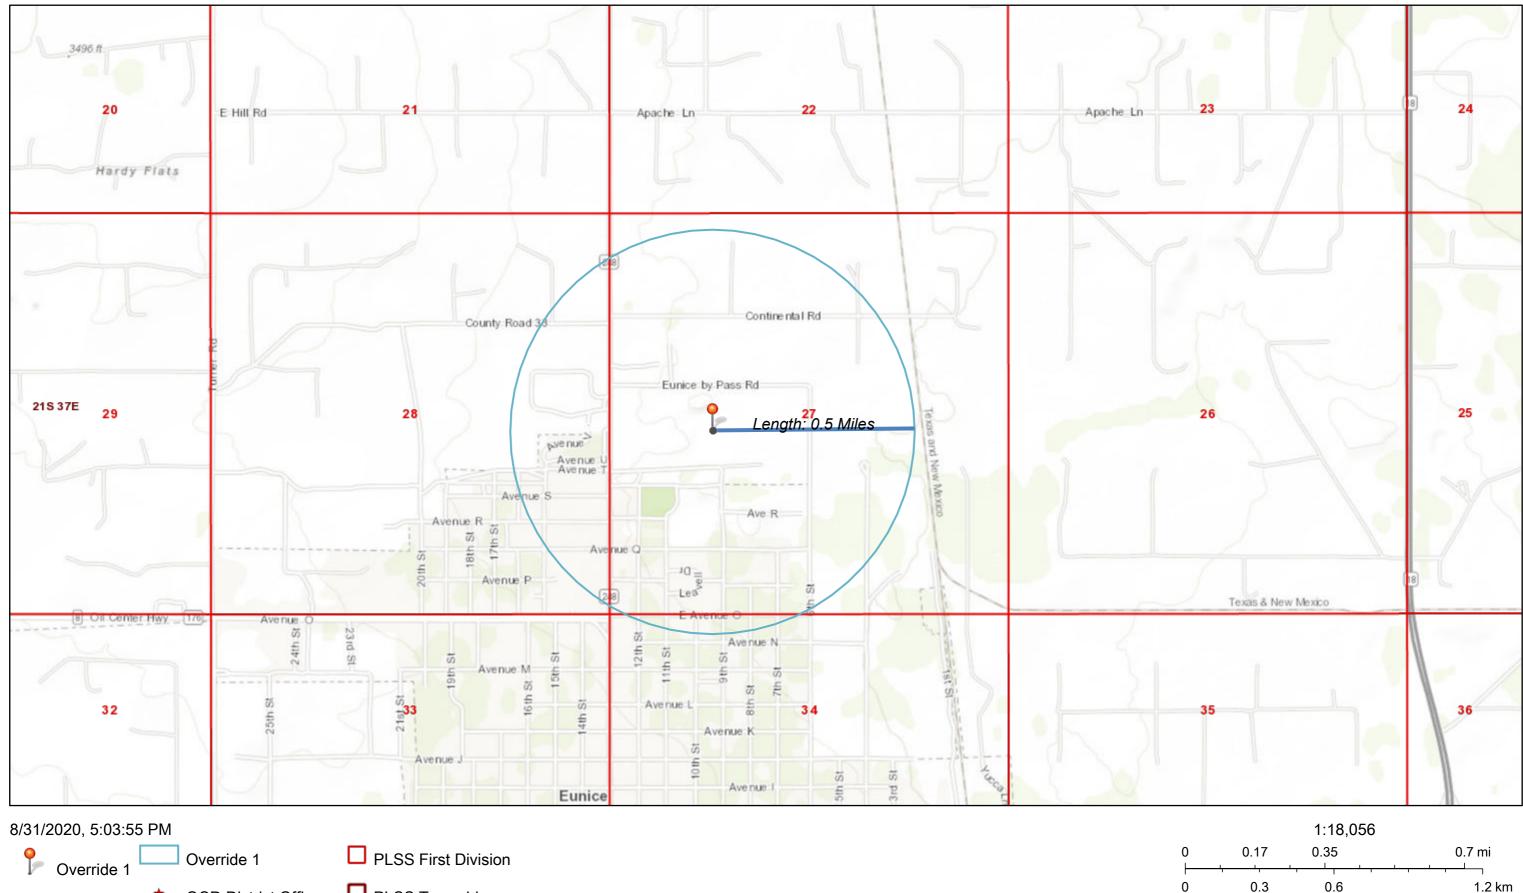
# Figure 3 - Hydrology Map

- 1. Site Map See Figure 2
- 2. **Depth to ground water** Remediation standards for <50 feet will be used on this remediation project, based on the minimum depth to water of nearby wells (CP 01001 POD1) at 40' BGS (*Appendix*
- 3. Wellhead protection area There are no known wellheads in the area.
- 4. **Distance to nearest significant watercourse** There is no significant watercourse within a half-mile of any horizontal boundary of the release (see *Figure 3*).
- 5. **Soil/waste characteristics** Samples were collected inside of the battery at various depths. The sample locations are shown in *Figure 2* with results summarized in *Appendix A*.

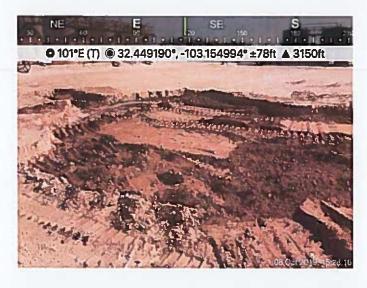
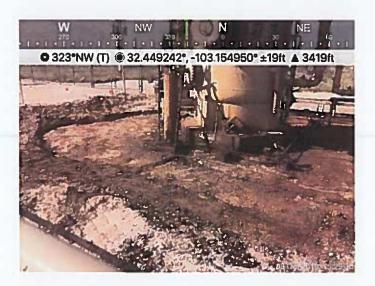
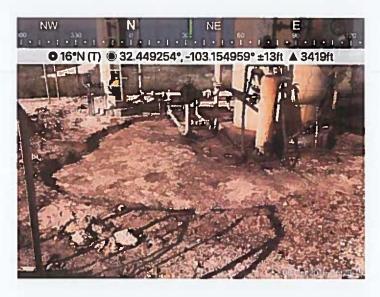
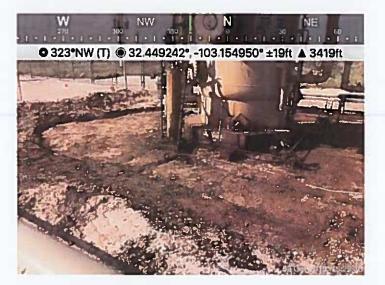
**PHOTO PAGE**

In the fall of 2019, soils on the pad were excavated to NMOCD Table I standards and hauled to an NMOCD approved disposal facility. Soils inside of the battery were excavated by hand shovels to a depth of 6" and hauled to an NMOCD approved disposal facility. Samples were collected and tested above Table I standards but due to the proximity to infrastructure, excavation was stopped. A deferment request was submitted in February 2020 and denied in May.
