**Re: Release Characterization and Deferral Request
ConocoPhillips
Tomahawk 19 State Battery Release
Unit Letter H, Section 19, Township 17 South, Range 34 East
Lea County, New Mexico
Incident ID: nRM2028029792**

**TOMAHAWK 19 STATE BATTERY RELEASE
OVERVIEW MAP**

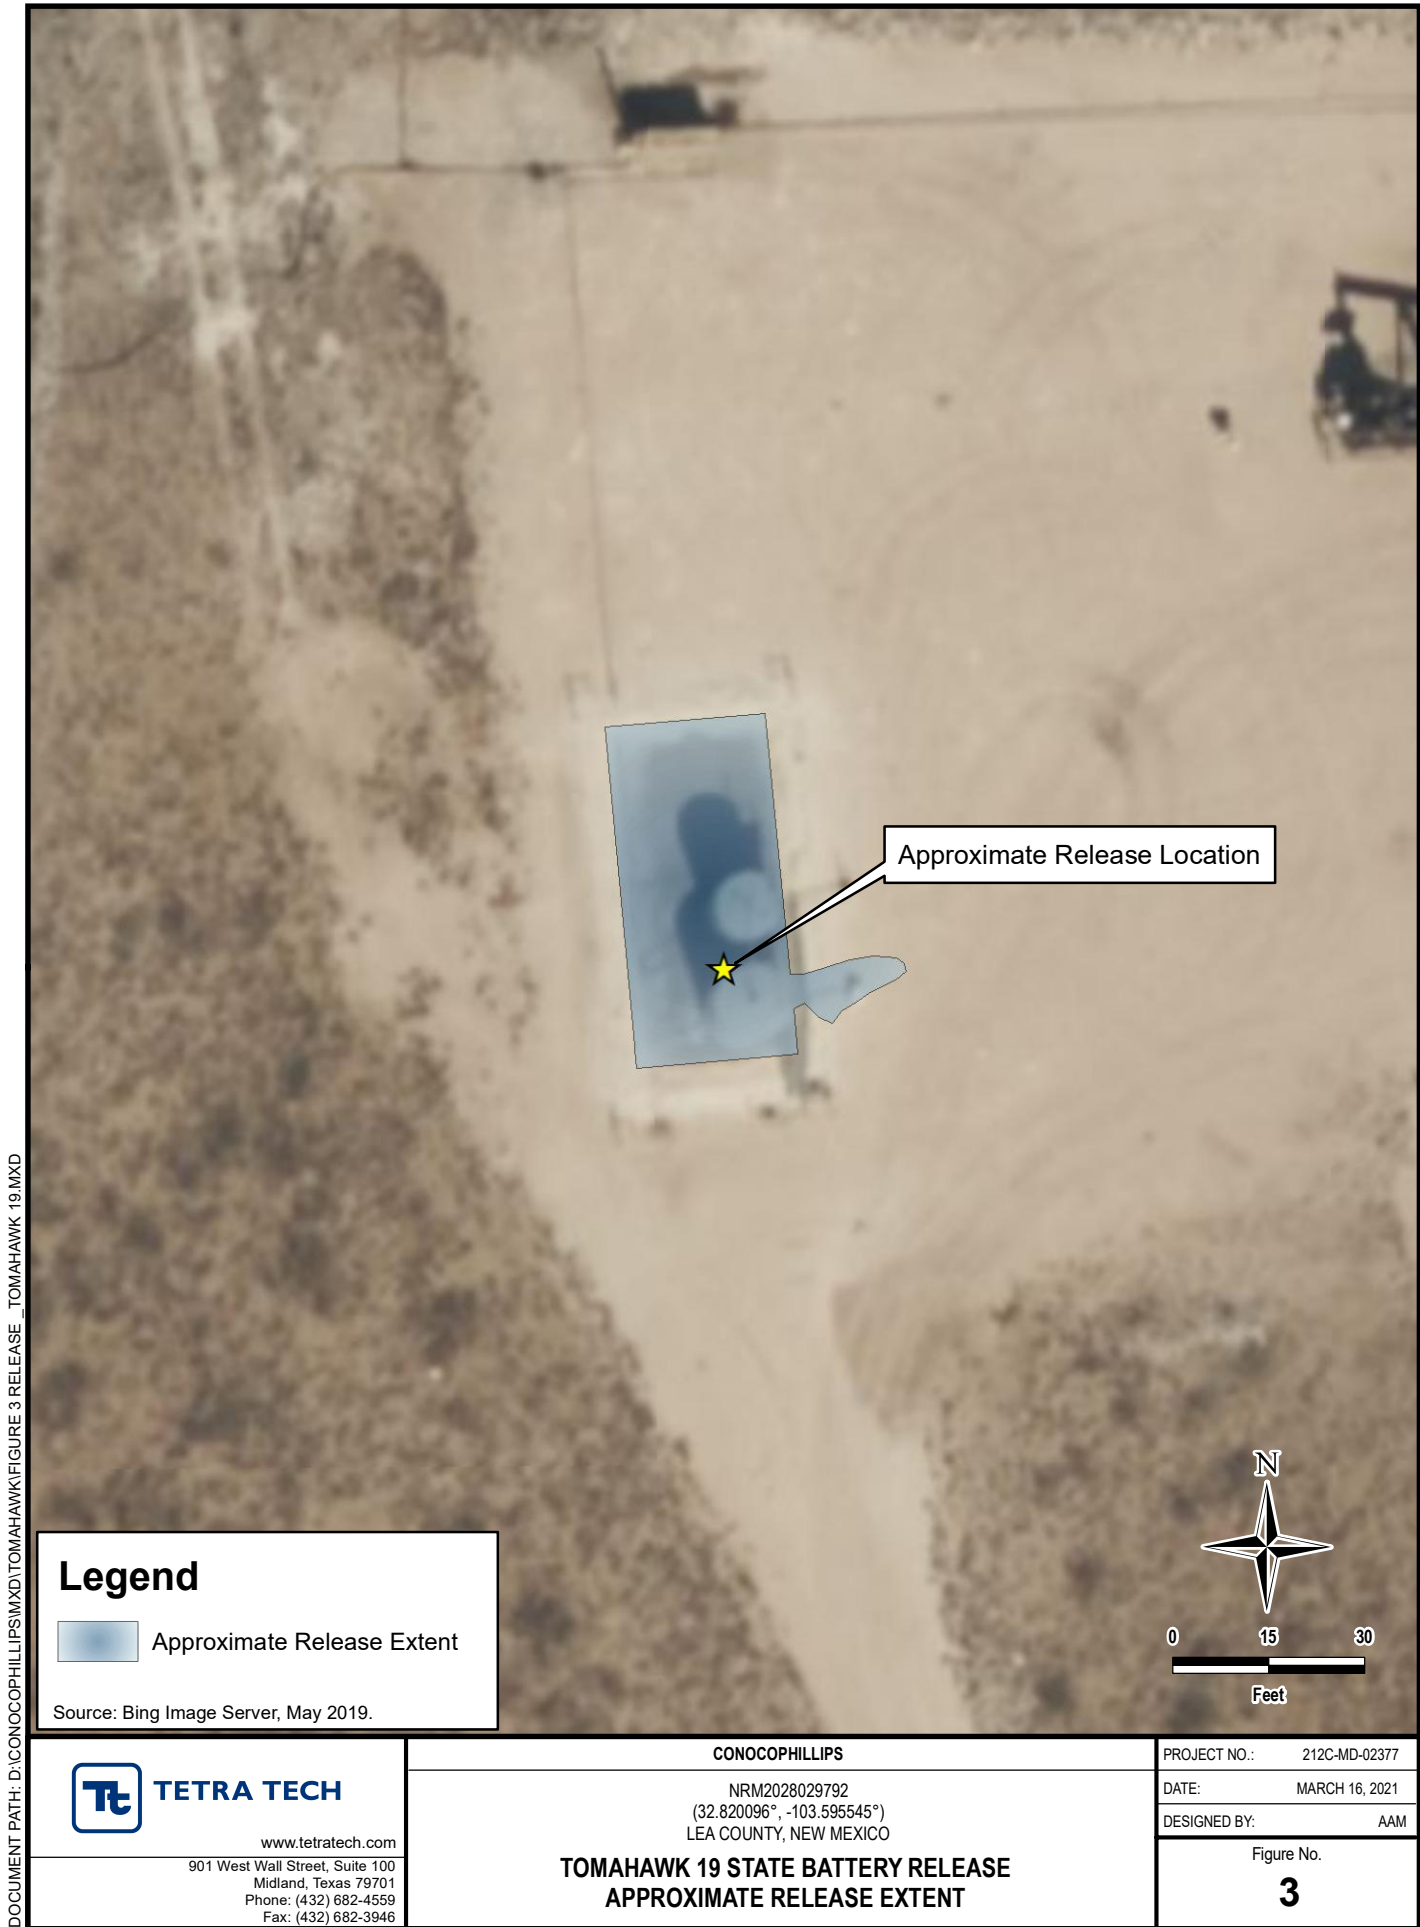
According to the State of New Mexico C-141 Initial Report, the release was discovered on September 25, 2020, and approximately 28 barrels (bbls) of crude oil were released due to a tank failure. The reported release footprint was largely contained within the earthen berm of the tank battery. Vacuum trucks were dispatched to remove the freestanding fluids, recovering approximately 10 bbls of oil. The API# listed in the C-141 is for the Tomahawk 19 State #001 well. New Mexico Oil Conservation Division (NMOCD) was notified of the release on September 26, 2020. NMOCD received the initial C-141 on October 5, 2020. The incident ID for this release is nRM2028029792. The initial C-141 Form is included in Appendix A.

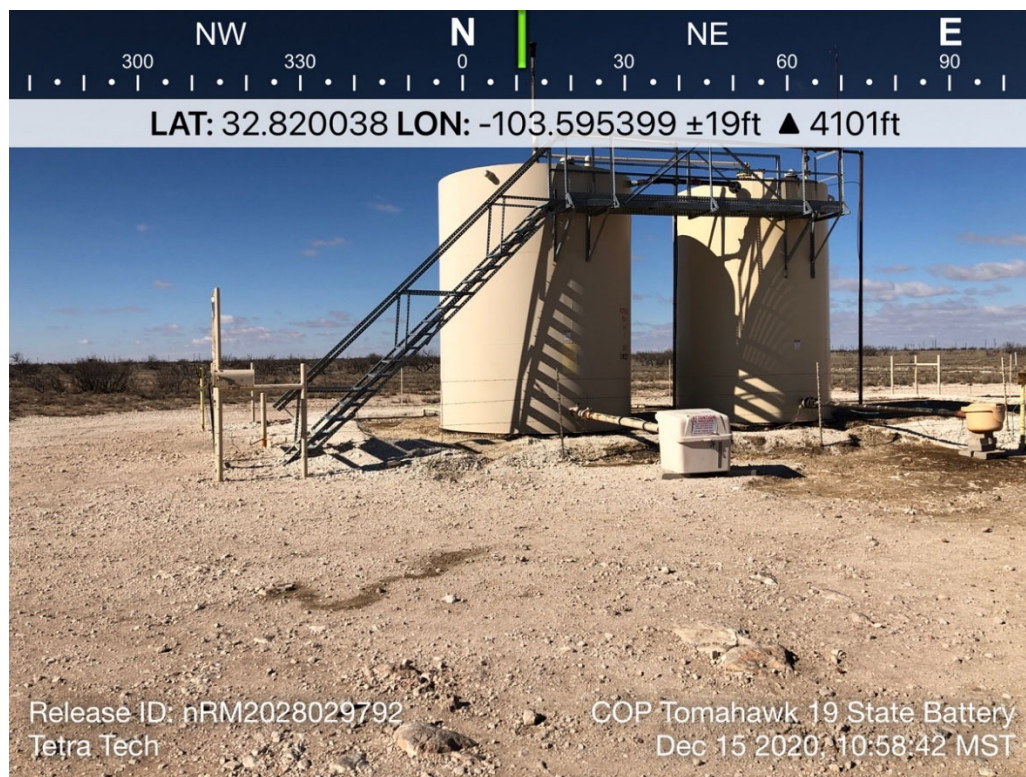
TETRA TECH, INC. PROJECT NO. 212C-MD-02377	DESCRIPTION	View of Tomahawk 19 Battery and the breached area of berm, looking north.	2
	SITE NAME	ConocoPhillips Tomahawk 19 Battery Release	12-15-2020

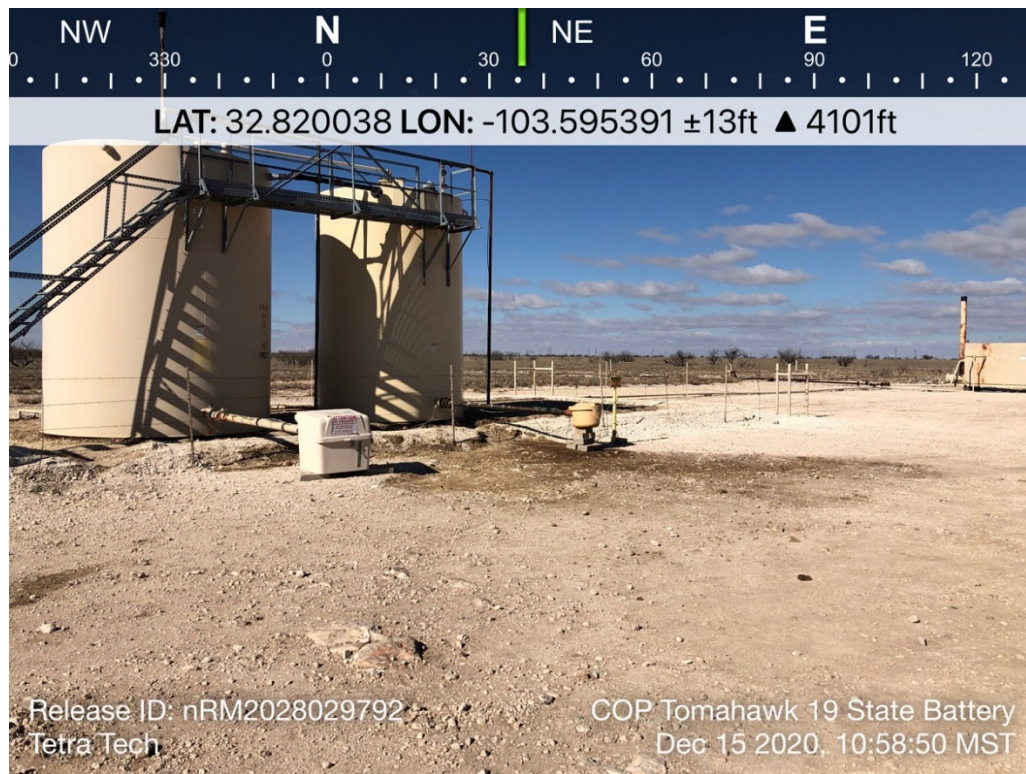
TETRA TECH, INC. PROJECT NO. 212C-MD-02377	DESCRIPTION	View of Tomahawk 19 Battery and the breached area of berm, looking northeast.	3
	SITE NAME	ConocoPhillips Tomahawk 19 Battery Release	12-15-2020

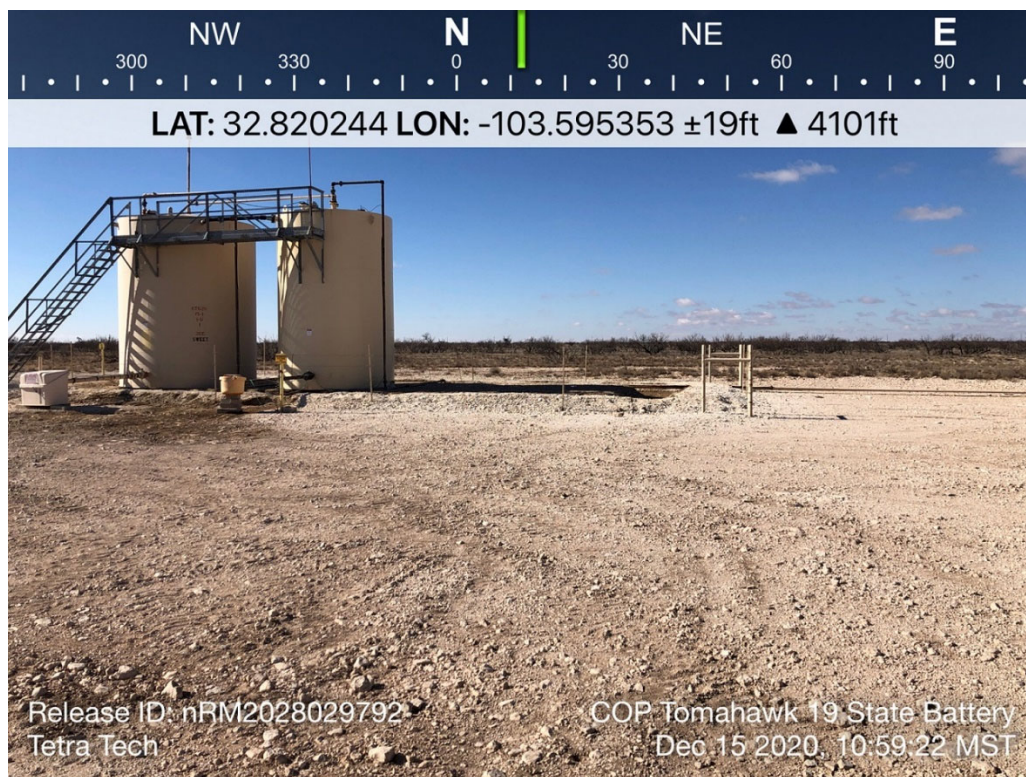
TETRA TECH, INC. PROJECT NO. 212C-MD-02377	DESCRIPTION	View of Tomahawk 19 Battery and the breached area of berm, looking north.	4
	SITE NAME	ConocoPhillips Tomahawk 19 Battery Release	12-15-2020
