GOODMAN 22 #4H
CLOSURE REPORT

API NO. 30-015-44366
RELEASE DATE: 05/20/2018
2RP-4787
INCIDENT ID: NAB1815939152
U/L K, SECTION 22, TOWNSHIP 19S, RANGE 25E
EDDY COUNTY

RE: Goodman 22 #4H – Closure Request
Date of Release: May 20, 2018
API No. 30-015-44366
U/L K, Section 22, Township 19S, Range 25E

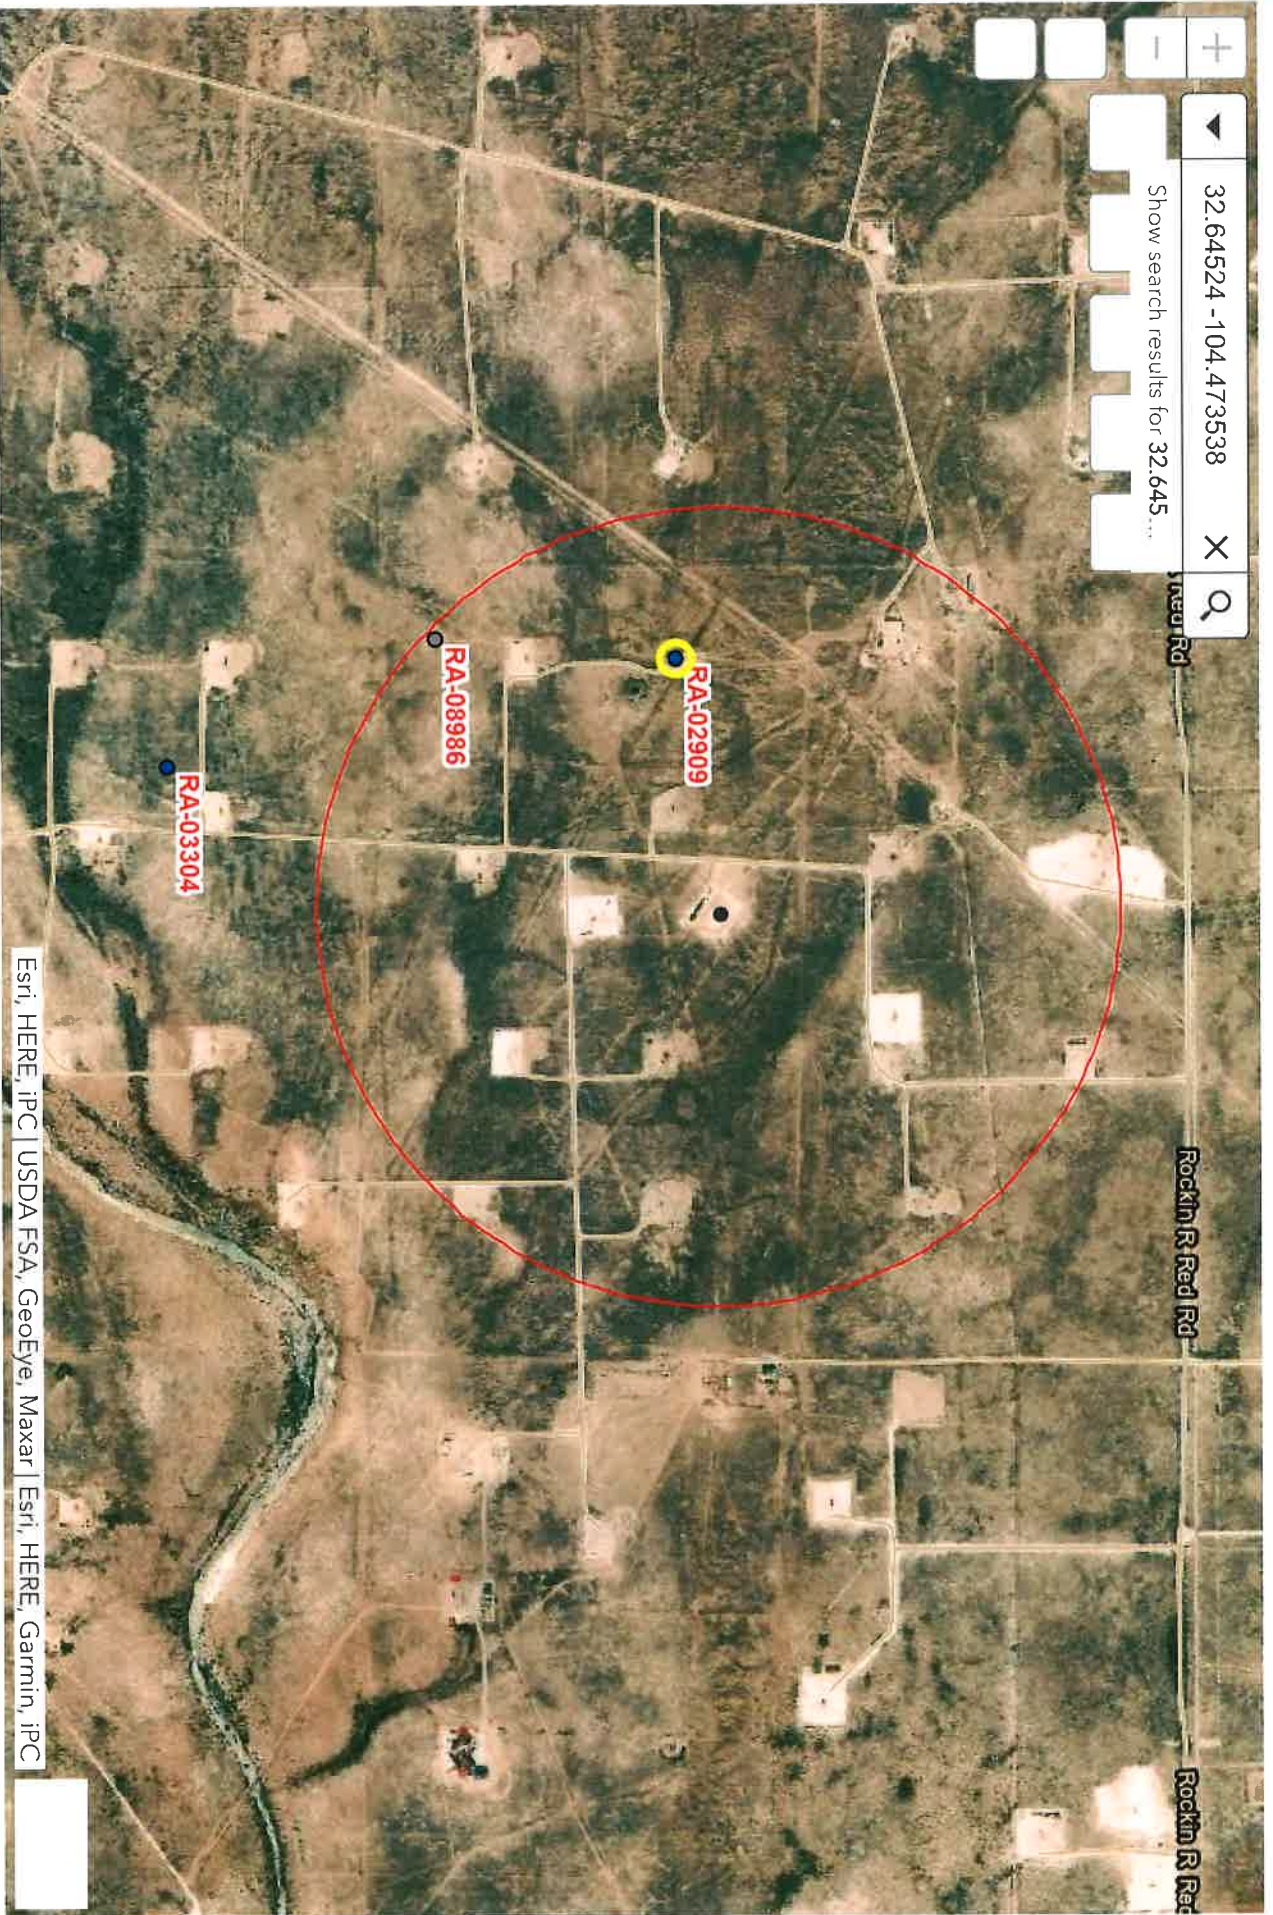
Although the measurements from the NMOSE and OSE Pod Map are different these wells still fall within the ½ mile radius of the Goodman 22 #4H. With the information provided, it is safe to say that groundwater will not be a factor this site. Please see the OSE Map attached to this report.

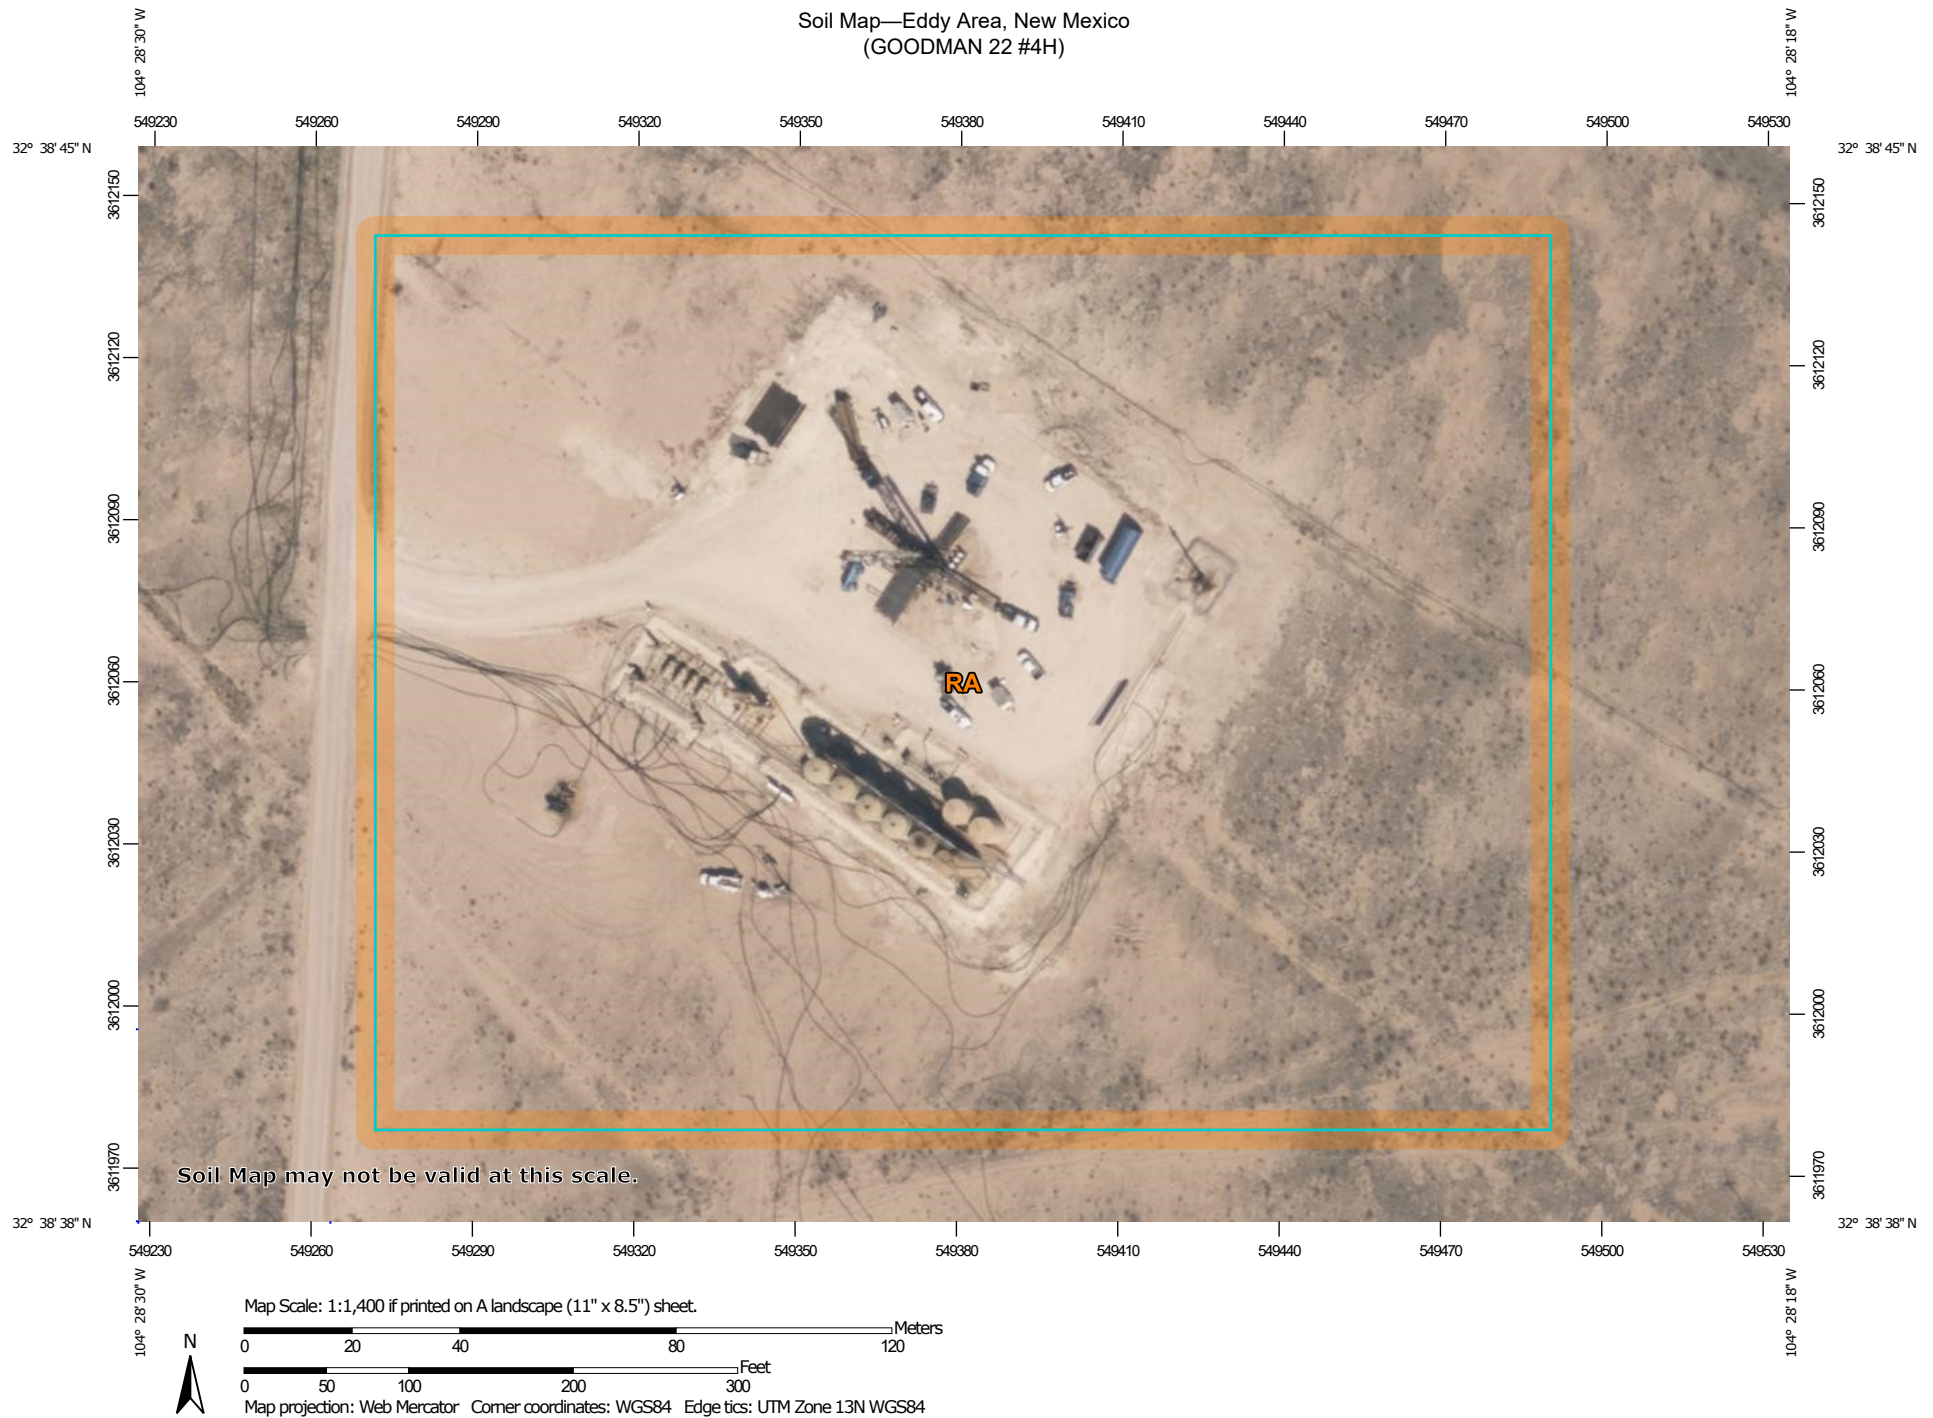
Soil Map—Eddy Area, New Mexico
(GOODMAN 22 #4H)

According to the USDA Resources Conservation Service, the soil survey indicates the following (please see the soil map attached):

9.0% Reagan Loam, 0 to 3 percent slopes
