Re: Site Assessment and Closure Report
Capella 14 Fed Com #1H
API No. 30-015-39416
GPS: Latitude 32.6668701 Longitude -103.8344955
UL "A", Sec. 14, T19S, R31E
Eddy County, NM
NMOCD Ref. No. 2RP-4876

Pima Environmental Services, LLC (Pima) has been contracted by Devon Energy Production Company (Devon) to perform a spill assessment and has prepared this Closure Report for a produced water and oil release that occurred at the Capella 14 Fed Com #1H (Capella). The initial C-141 was submitted on July 23, 2018 (Appendix C). This incident was assigned 2RP-4876, Incident ID NAB1821142740, by the New Mexico Oil Conservation Division (NMOCD).

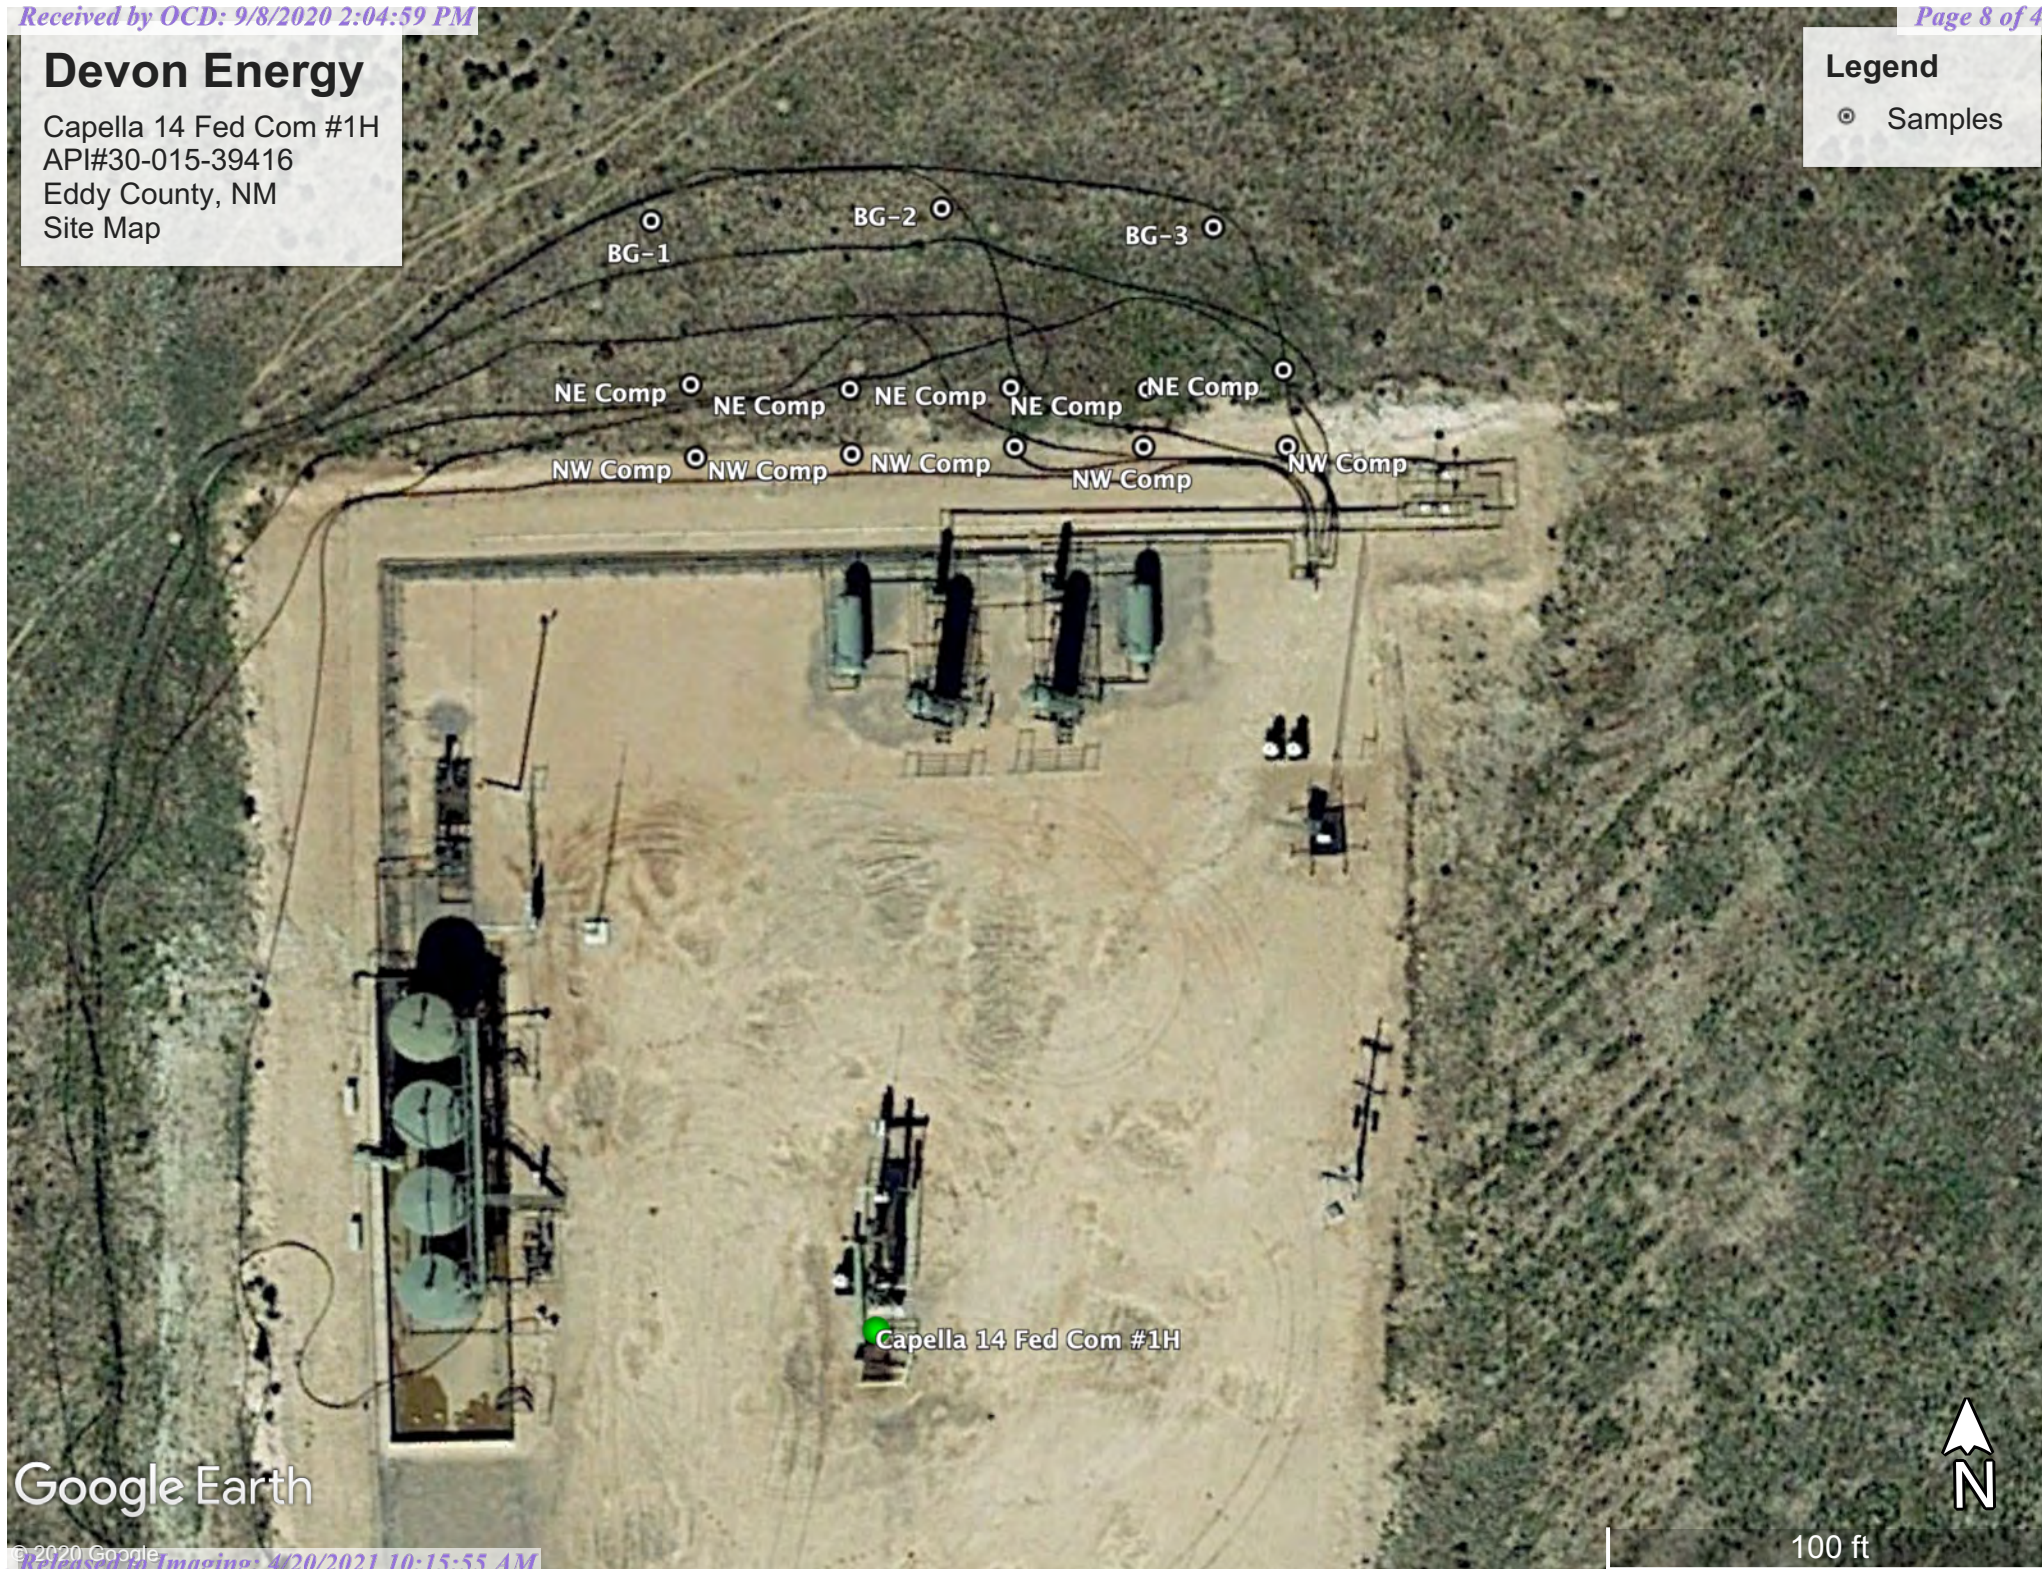
Capella 14 Fed Com #1H
API#30-015-39416
Eddy County, NM
Site Map

On August 21, 2020, Pima Environmental conducted a site assessment and obtained soil samples. The laboratory results of this sampling event can be found in the following data table.
