**RE: Closure Request
Bronco CDP
Incident Number nAPP2100546416
Eddy County, New Mexico**

WSP USA Inc. (WSP) on behalf of XTO Energy, Inc. (XTO), presents the following Closure Request detailing site assessment and soil sampling activities at the Bronco CDP (Site) in Unit E, Section 19, Township 23 South, Range 30 East, in Eddy County, New Mexico (Figure 1). The purpose of the site assessment and soil sampling activities was to assess for the presence or absence of impacts to soil following a fire at the Site. Based on field observations, field screening activities, and soil sample laboratory analytical results, XTO is submitting this Closure Request, and requesting no further action (NFA) for Incident Number nAPP2100546416.

FIGURE 2
SOIL SAMPLE LOCATIONS
BRONCO CDP
UNIT E SEC 19 T23S R30E
EDDY COUNTY, NEW MEXICO
XTO ENERGY, INC.

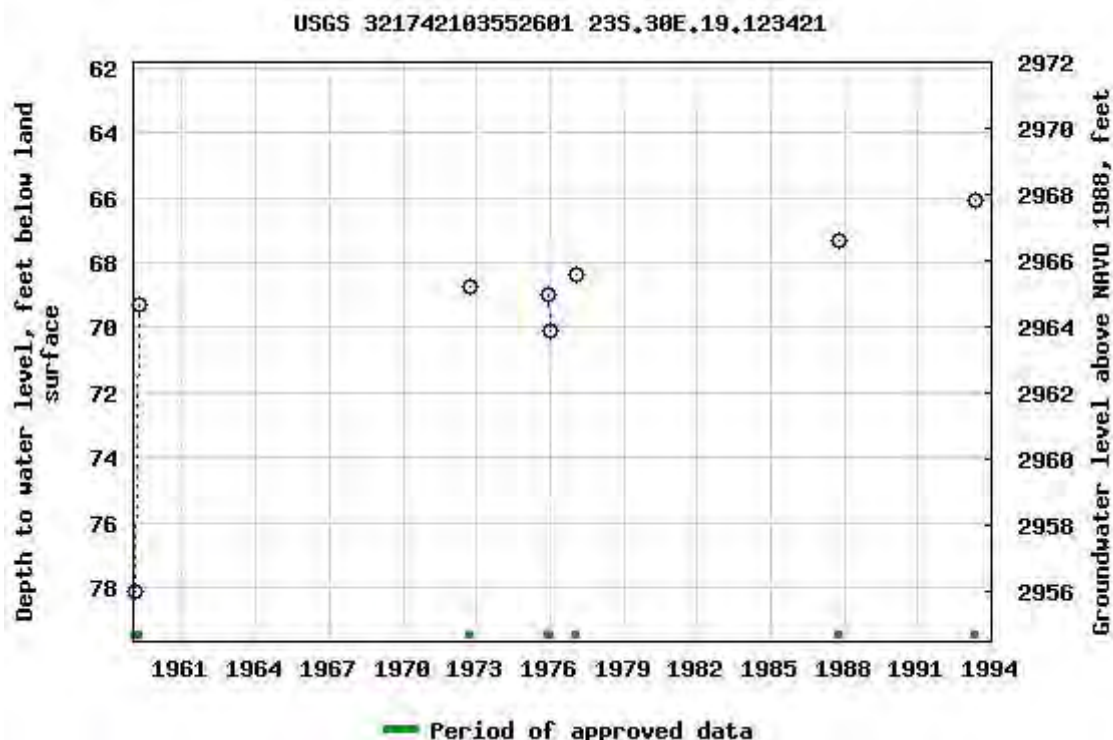
USGS 321742103552601 23S.30E.19.123421

The depth of the well is 100 feet below land surface.

This well is completed in the Rustler Formation (312RSLR) local aquifer.

the Site. There are three additional groundwater wells within a 2-mile radius of the Site that indicate regional depth to groundwater is between 50 and 100 feet bgs. All wells used for depth to groundwater determination are depicted on Figure 1. The referenced well records are included in Attachment 1.

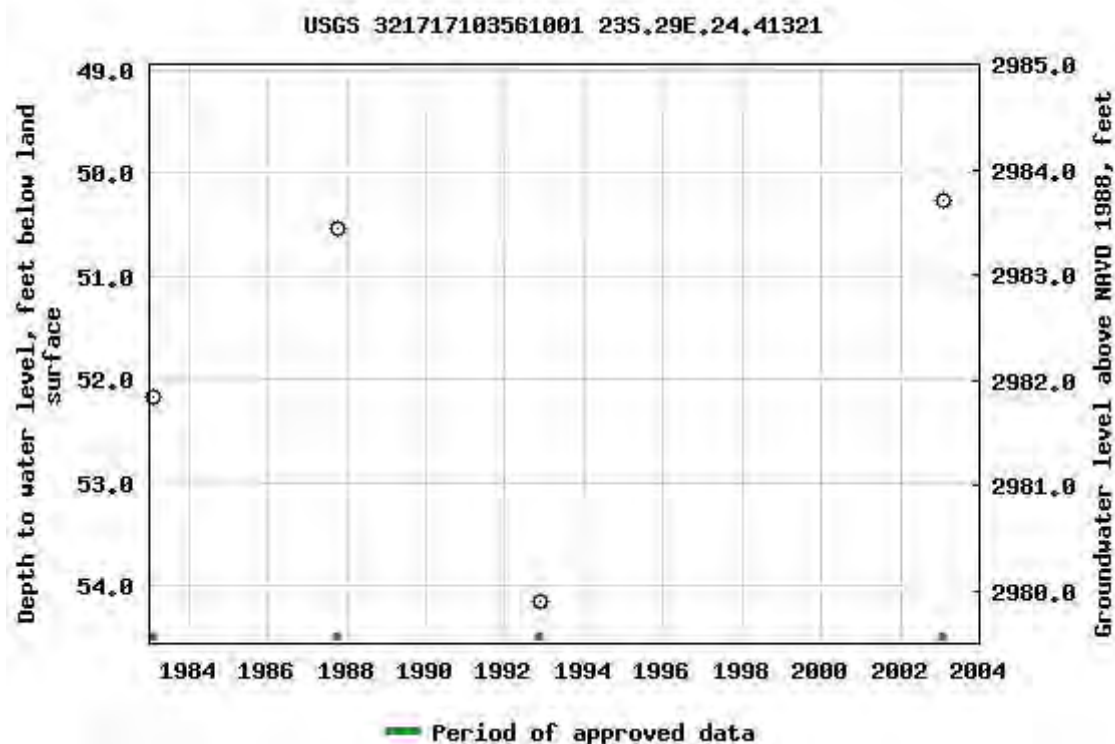
USGS 321717103561001 23S.29E.24.41321

This well is completed in the Rustler Formation (312RSLR) local aquifer.

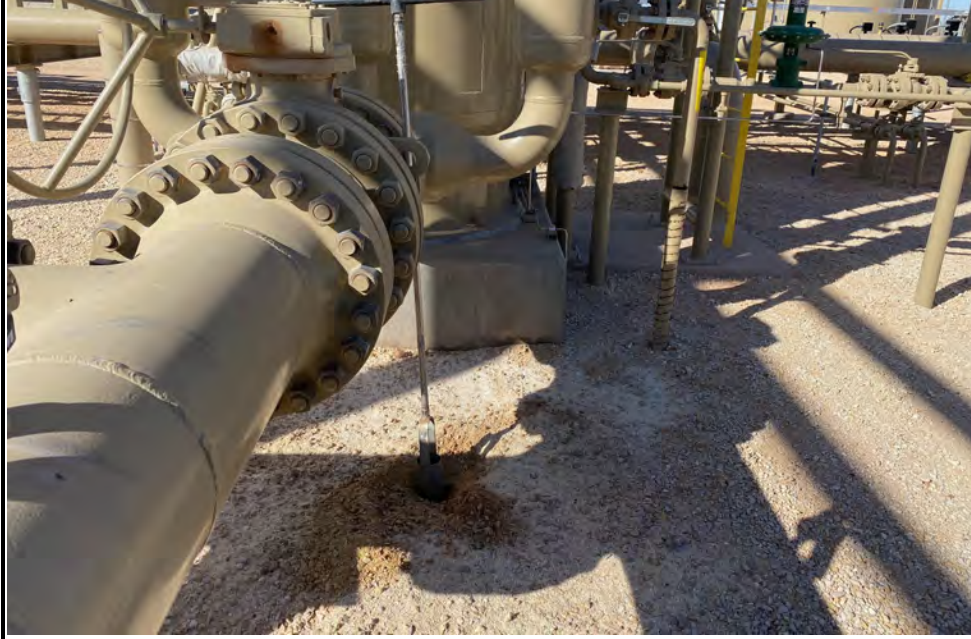
Photo No.	Date	
2	February 1, 2021	
View of location of soil sample.

A close-up photograph of industrial equipment. In the foreground, there is a large, horizontal, light-colored metal pipe with a flange. To the right, there is a large, vertical, light-colored metal tank or vessel. The ground is covered in gravel, and there are shadows cast by the equipment. In the background, other industrial structures and a yellow ladder are visible.

Soil samples SS01 and SS02 were collected from the area beneath the vessel where the fire occurred to assess for the presence or absence of soil impacts resulting from the December 22, 2020 fire. Laboratory analytical results for the soil samples indicated that benzene, BTEX, TPH, and chloride concentrations were compliant with the Closure Criteria.

Based on soil sample laboratory analytical results compliant with the Closure Criteria, no impacted soil was identified, and no excavation was warranted as a result of the fire. As such, XTO respectfully requests no further action for Incident Number nAPP2100546416. If you have any questions or comments, please do not hesitate to contact Ms. Ashley Ager at (970) 385-1096.
