CLOSURE REPORT

LOTUS C FEDERAL 907

NMOCD 2RP #3644

RE: Closure Report
Chevron USA – Lotus C Federal 907
UL-B of Section 9, T 24 S, R 31 E
Longitude: 32.2379913; Latitude: -103.7795563
NMOCD 2RP #3644

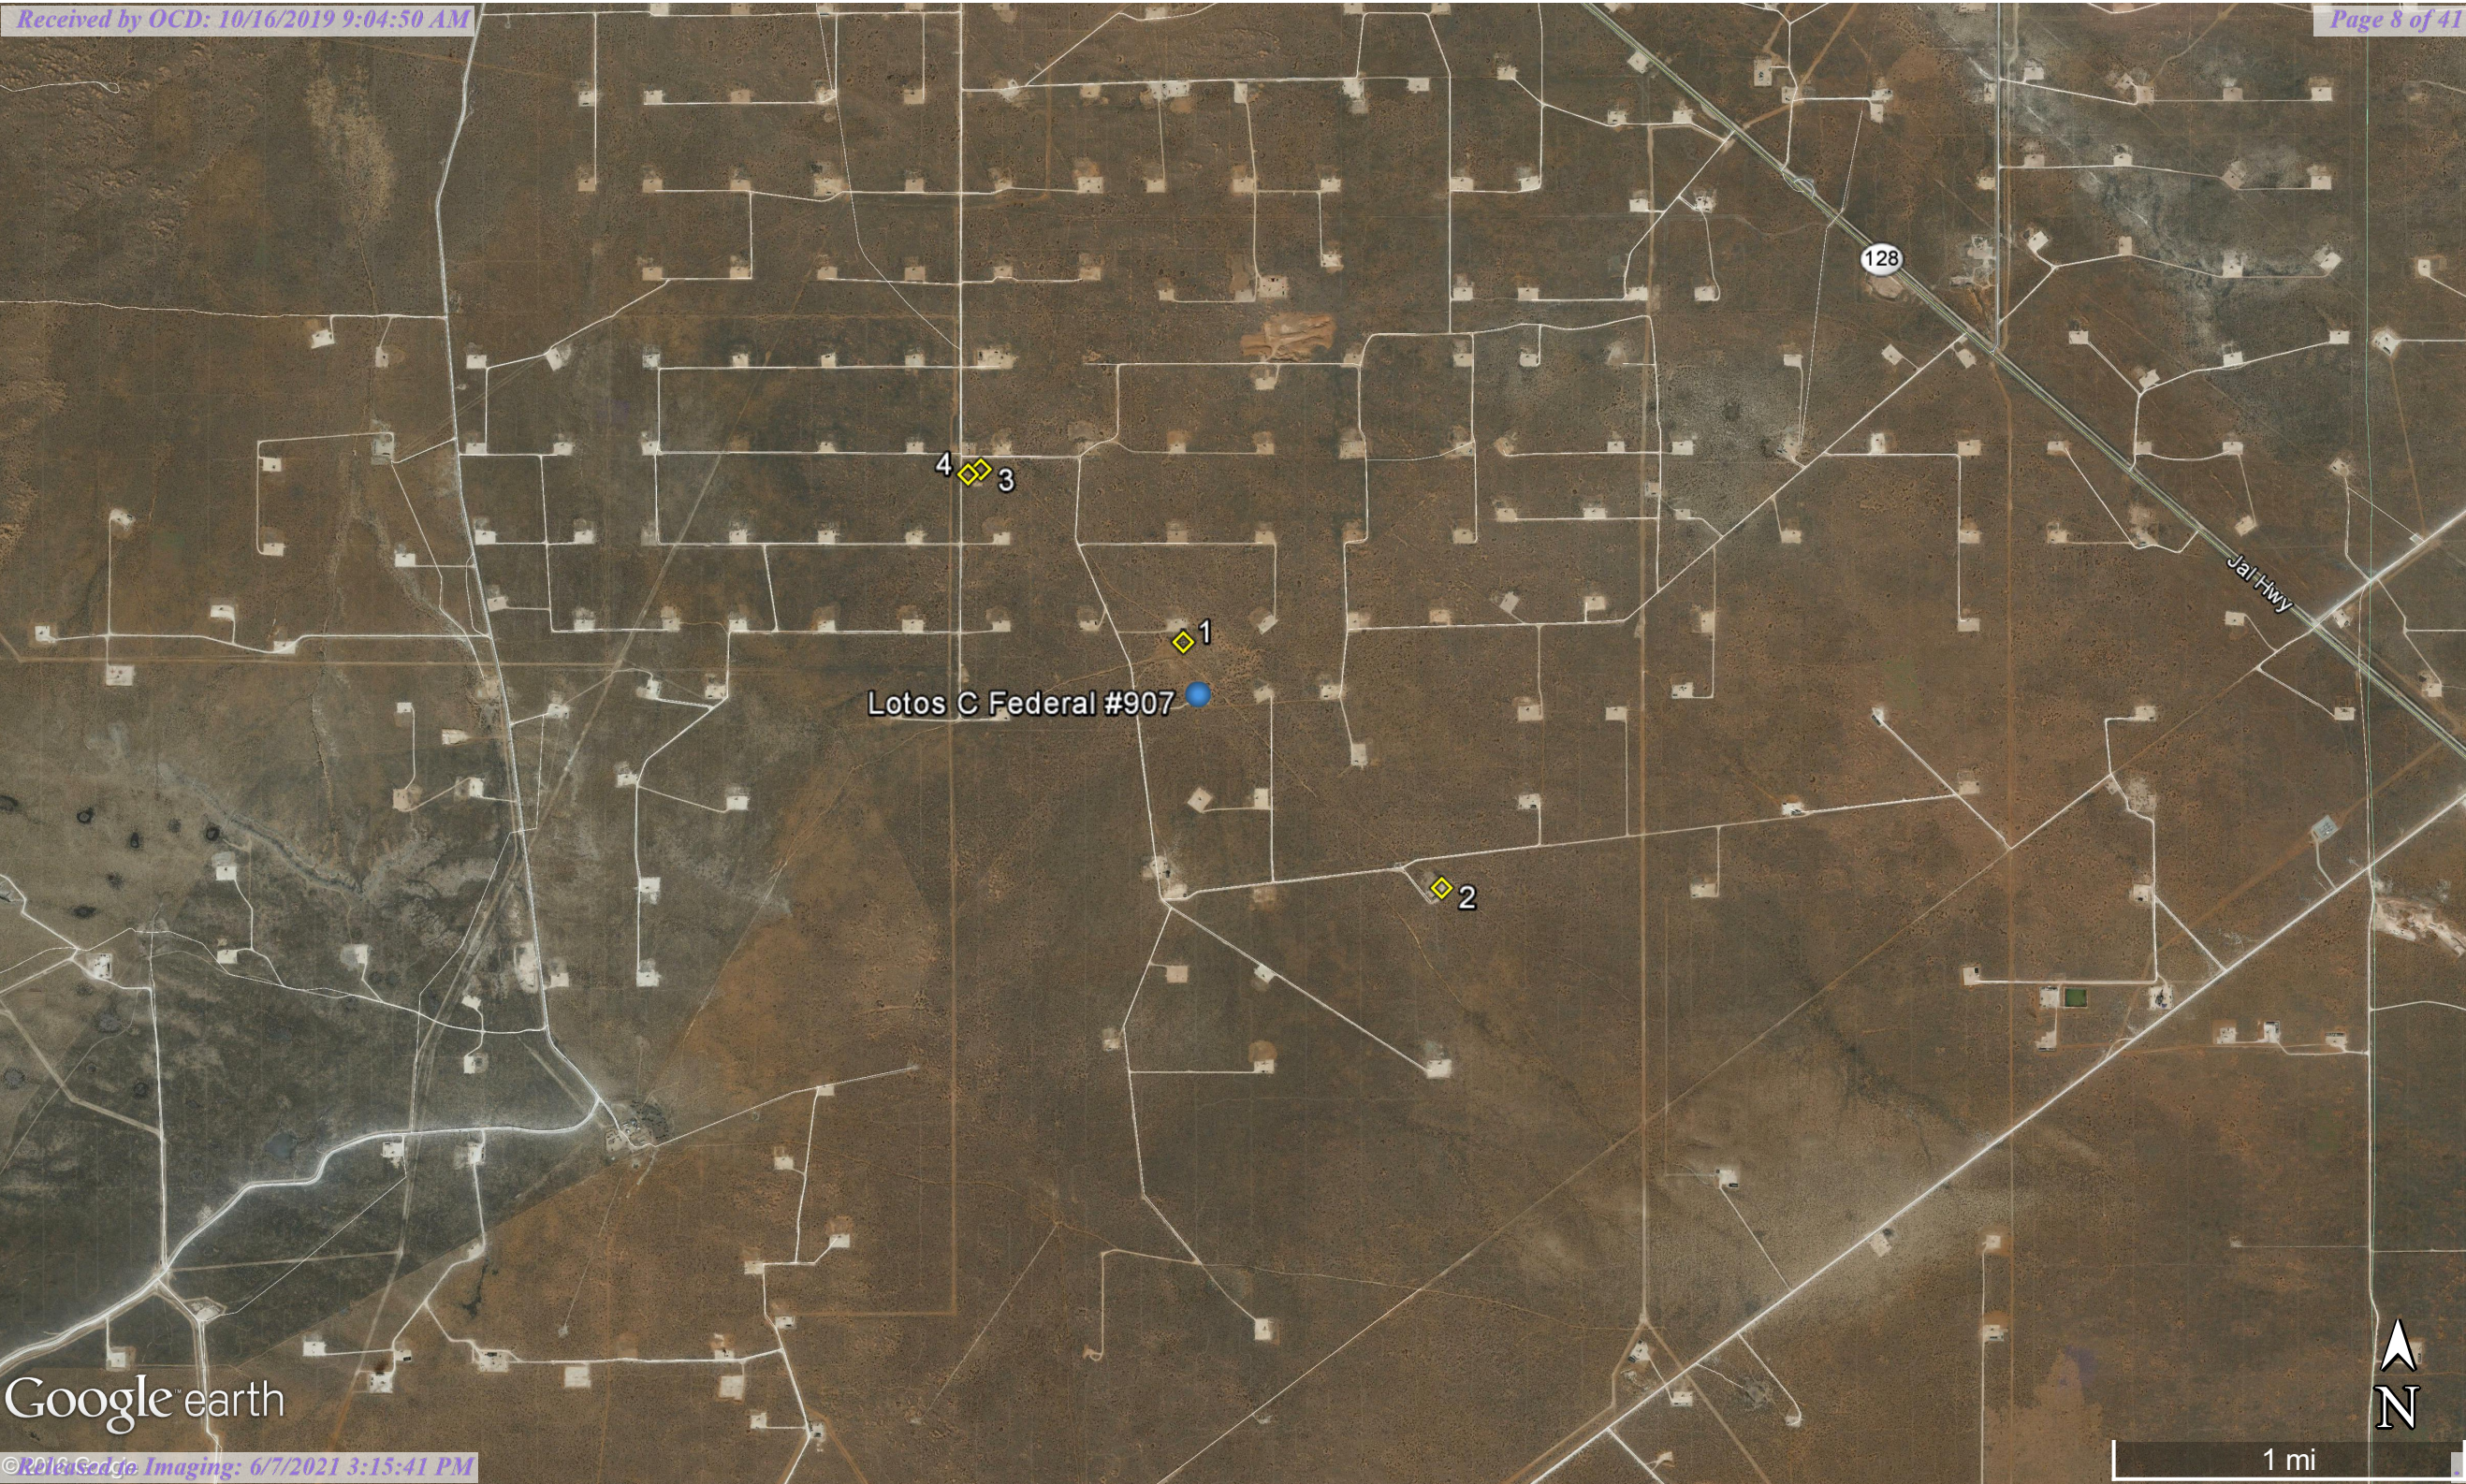
Lotos C Federal #907

Release Area ~3,000 sq ft
-

Sample Location

Laboratory analysis indicated TPH constituent concentrations ranged from <20 mg/Kg to 13,300 mg/Kg. BTEX and Sulfate concentrations were reported below NMOCD remedial threshold goals. Chloride concentrations ranged from 48 mg/Kg to 38,400 mg/Kg (reference *Table 2* and *Figure 3*).

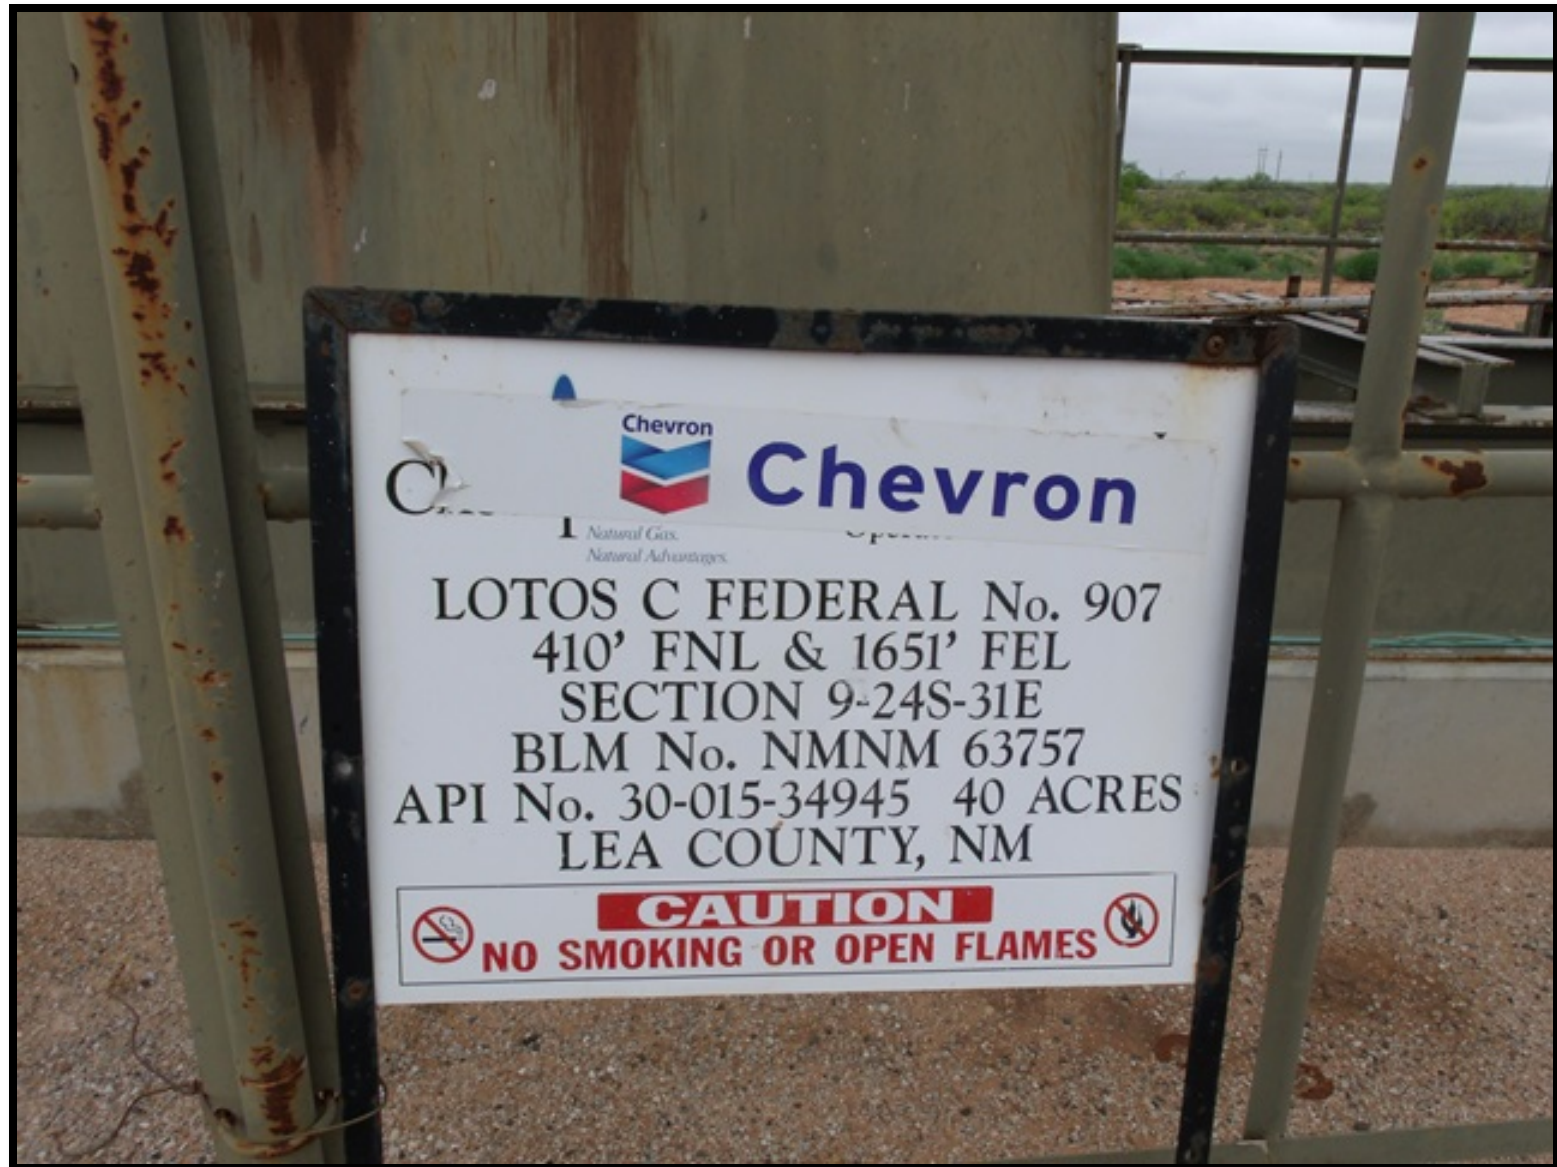
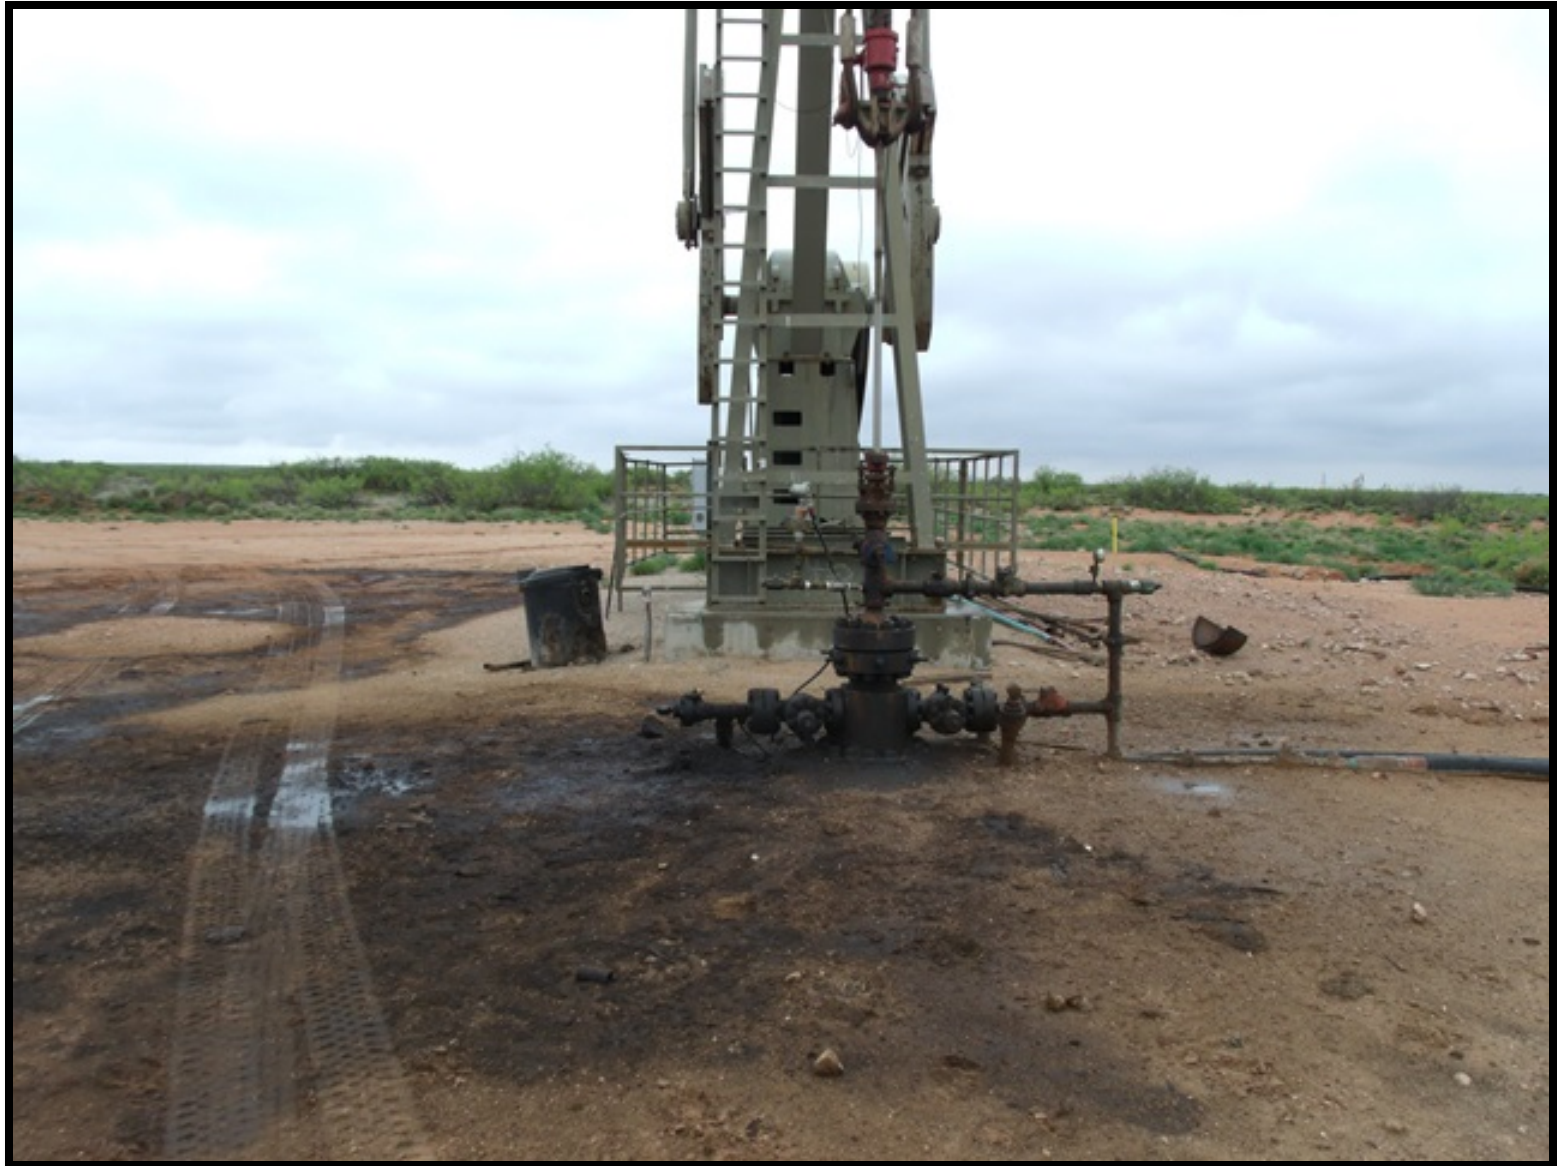
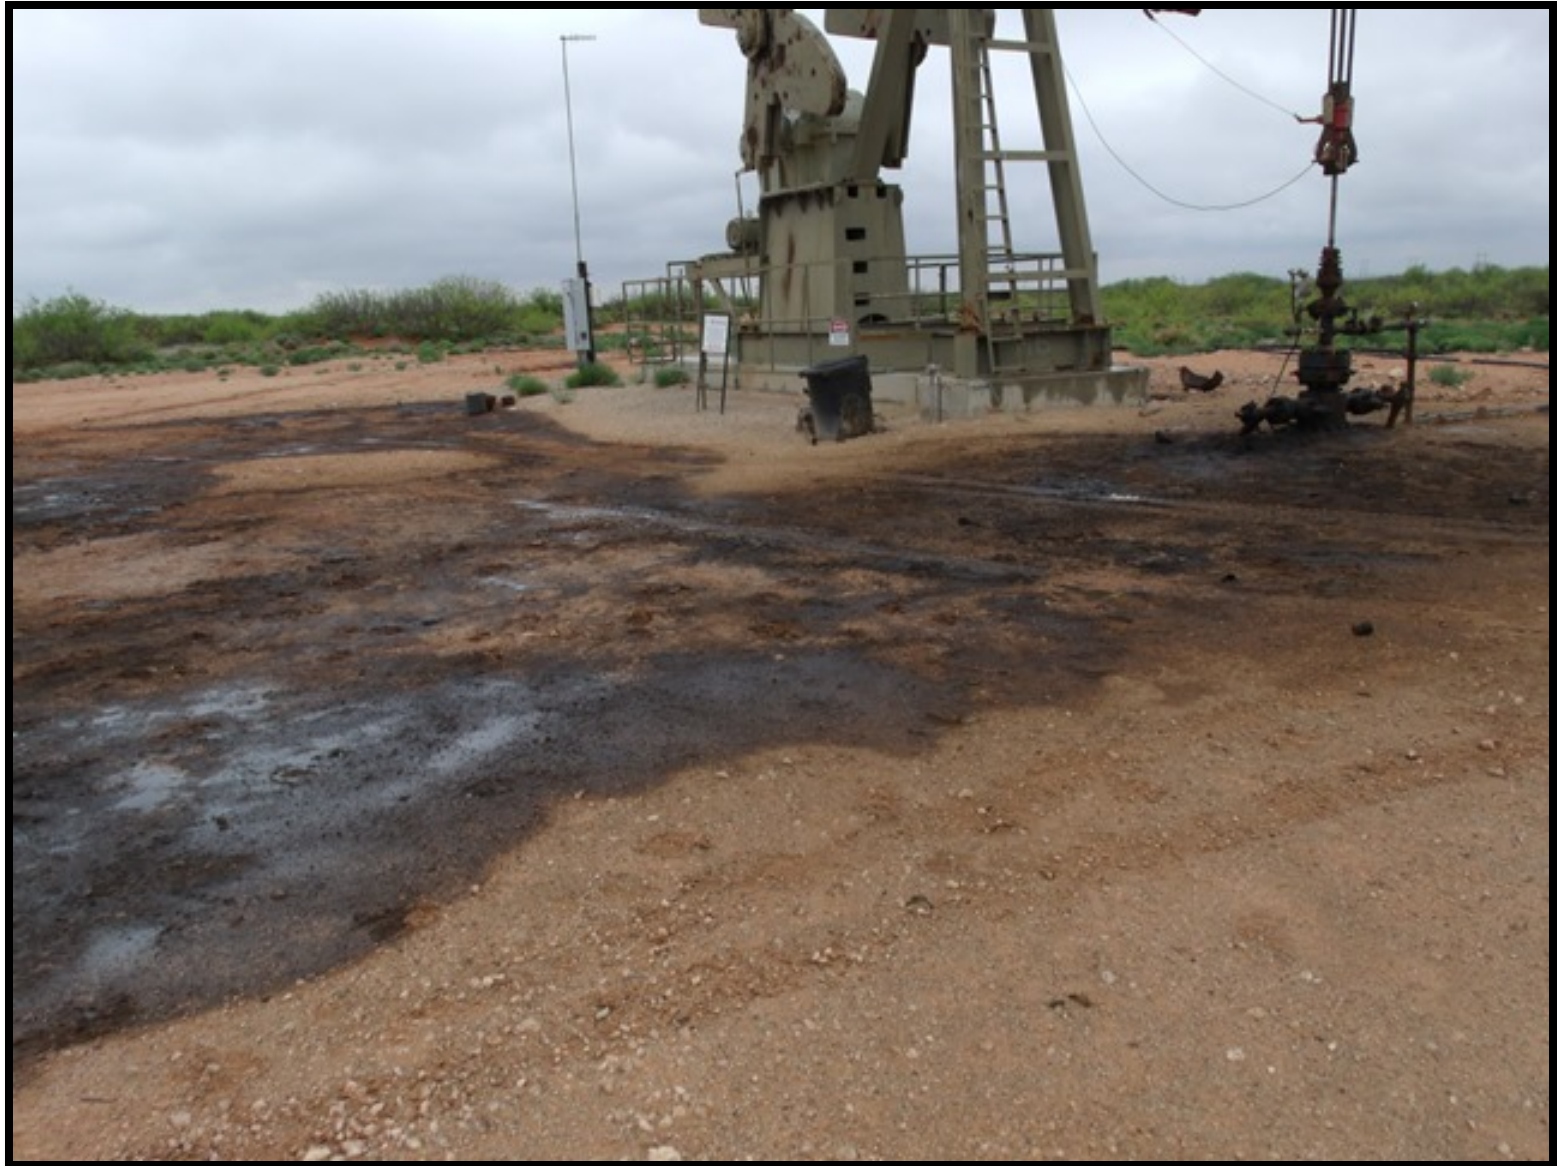
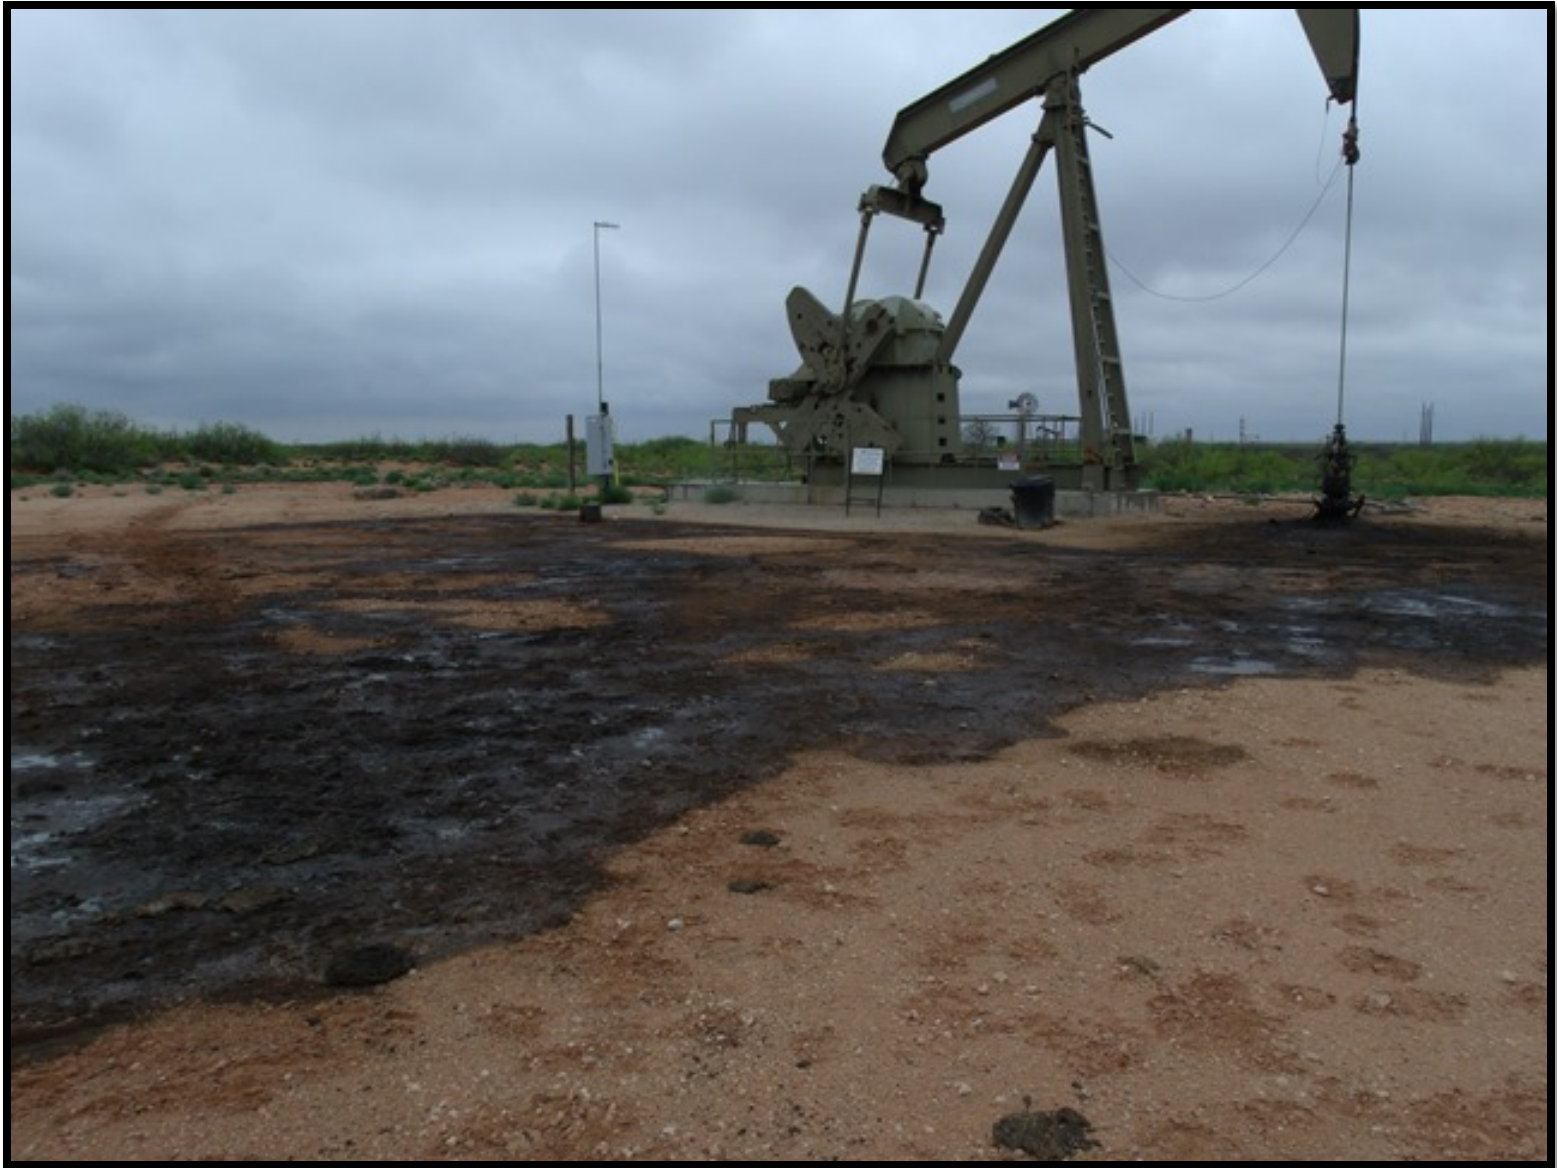
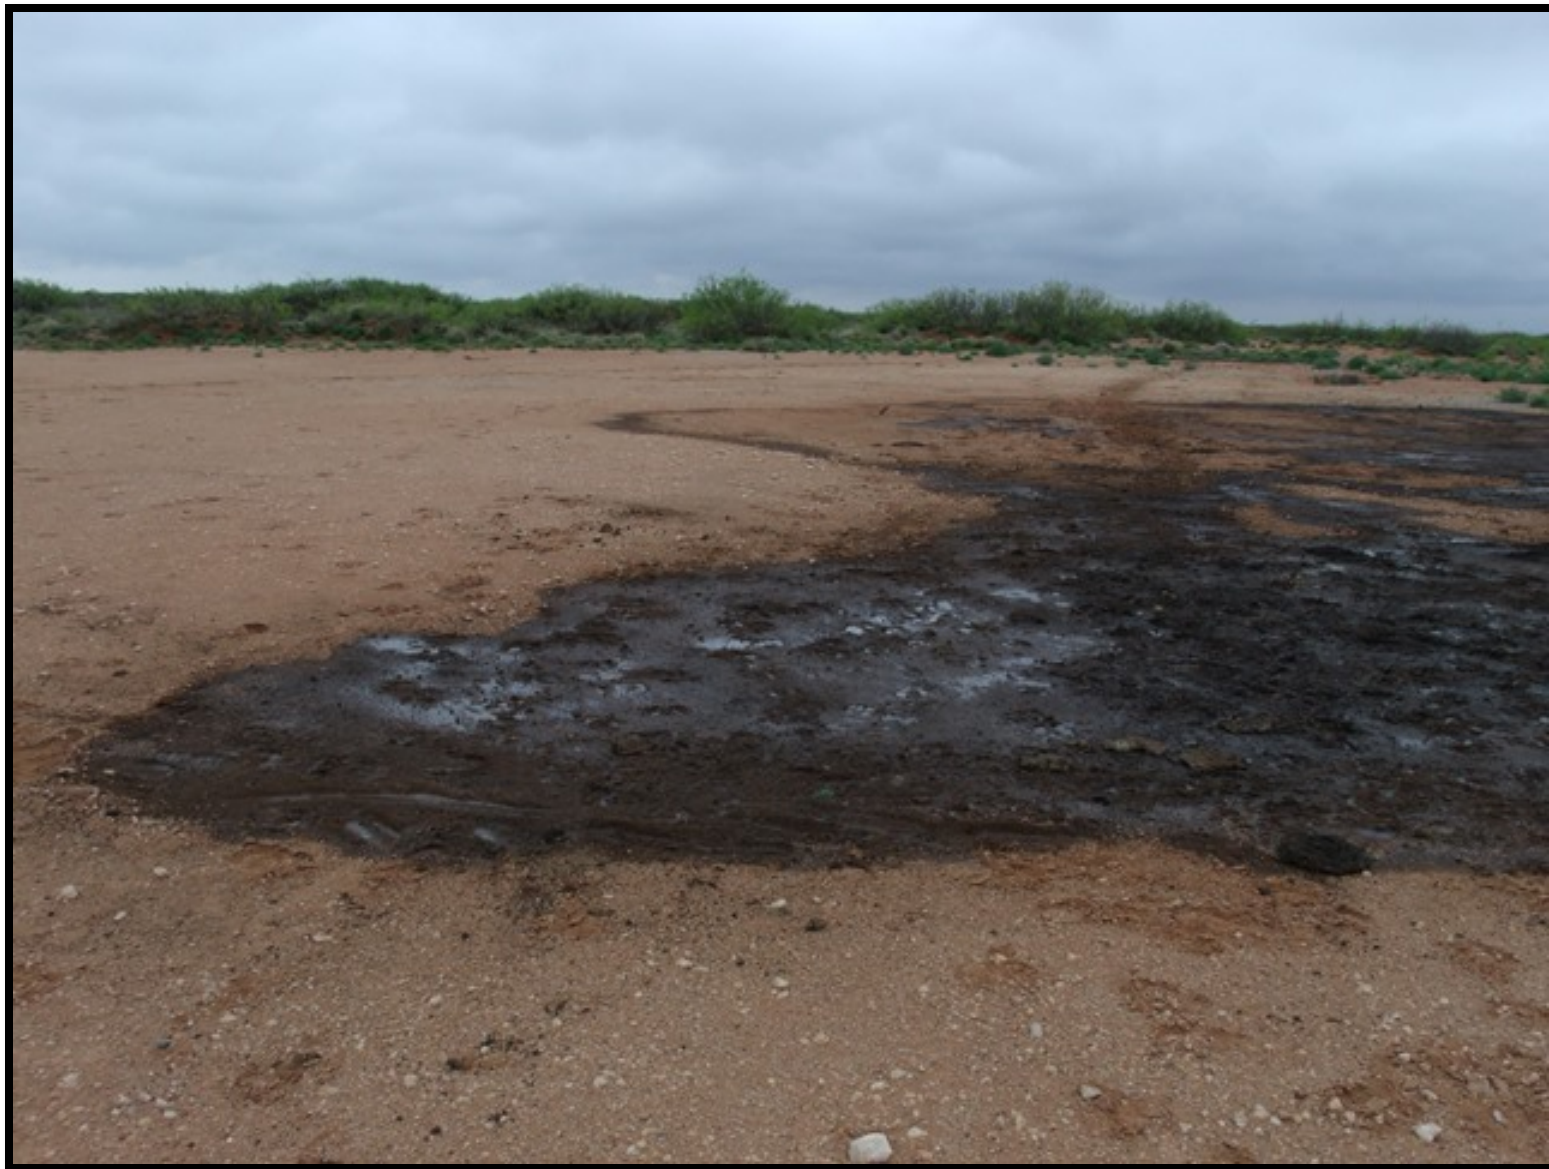
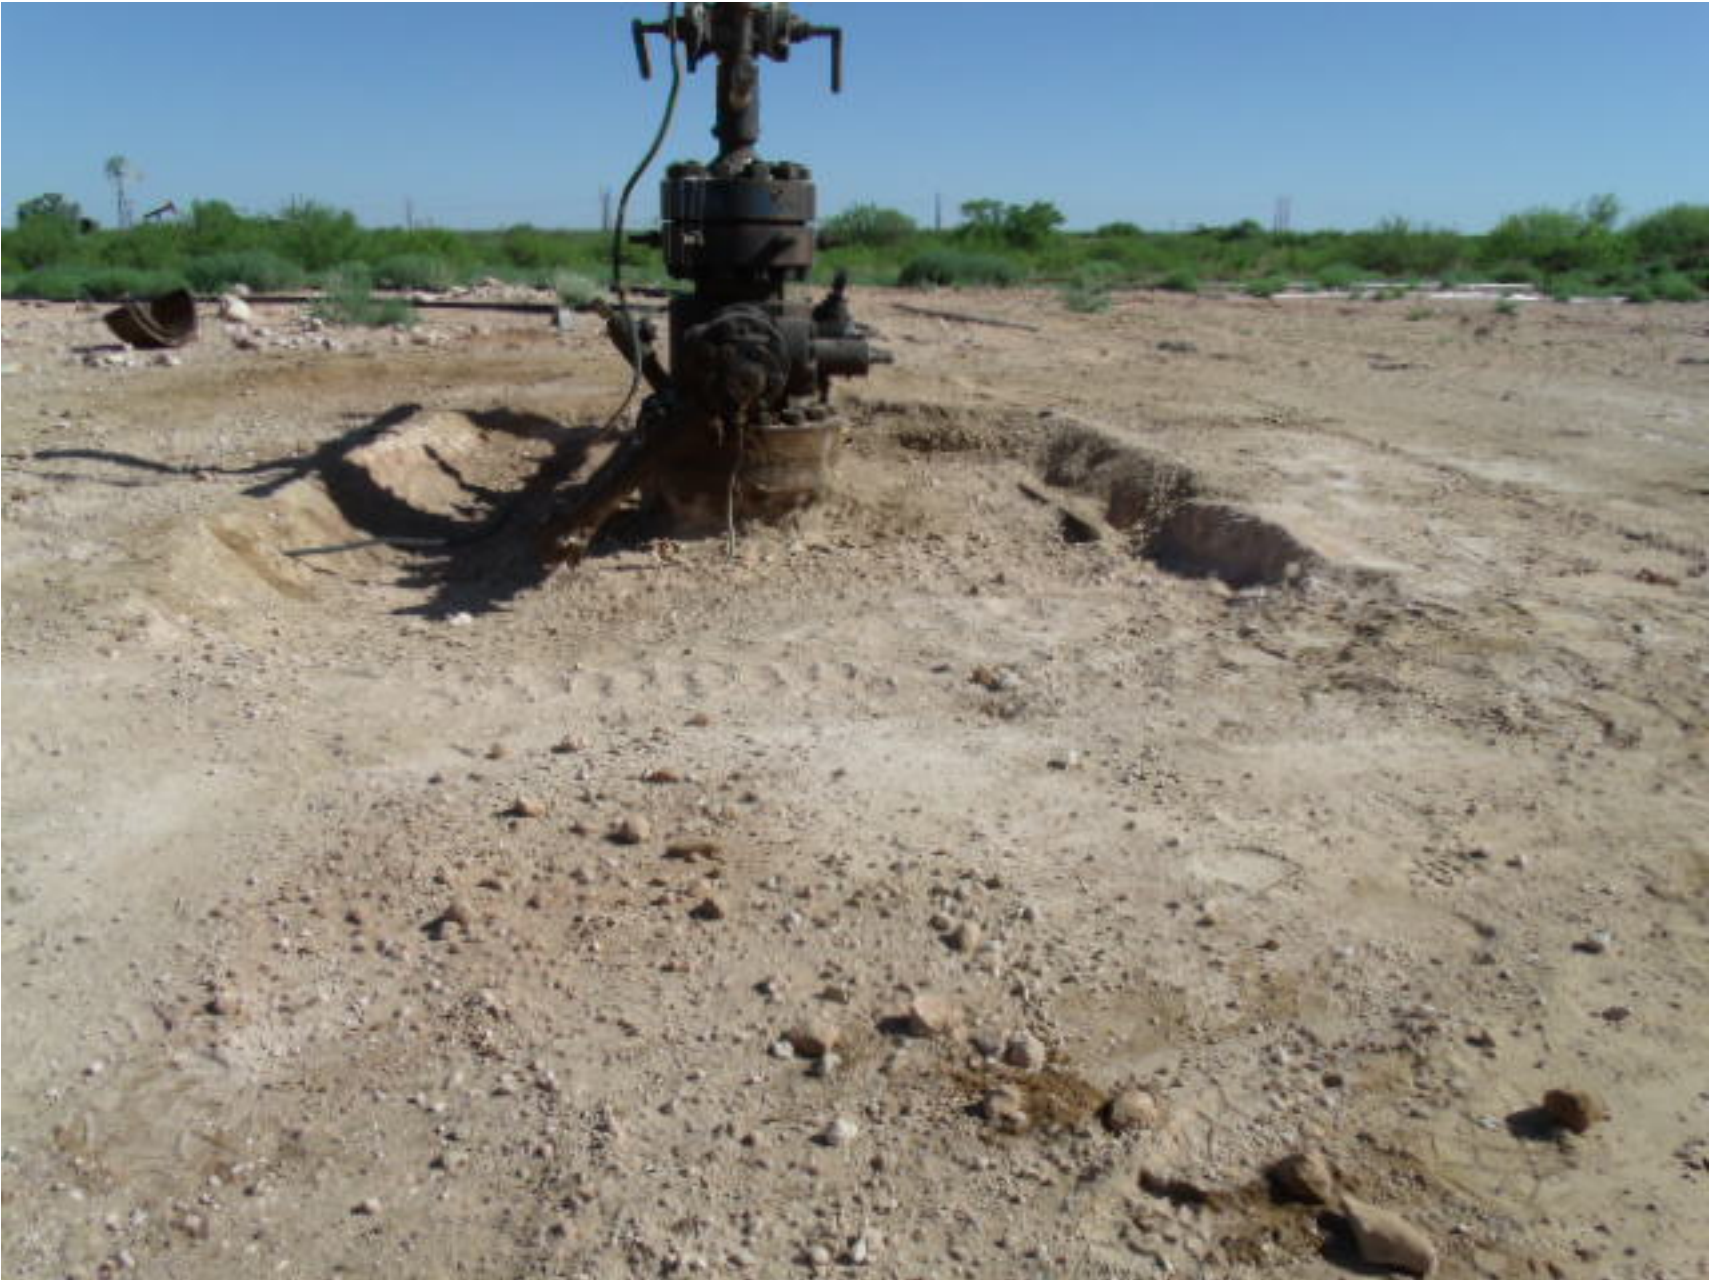
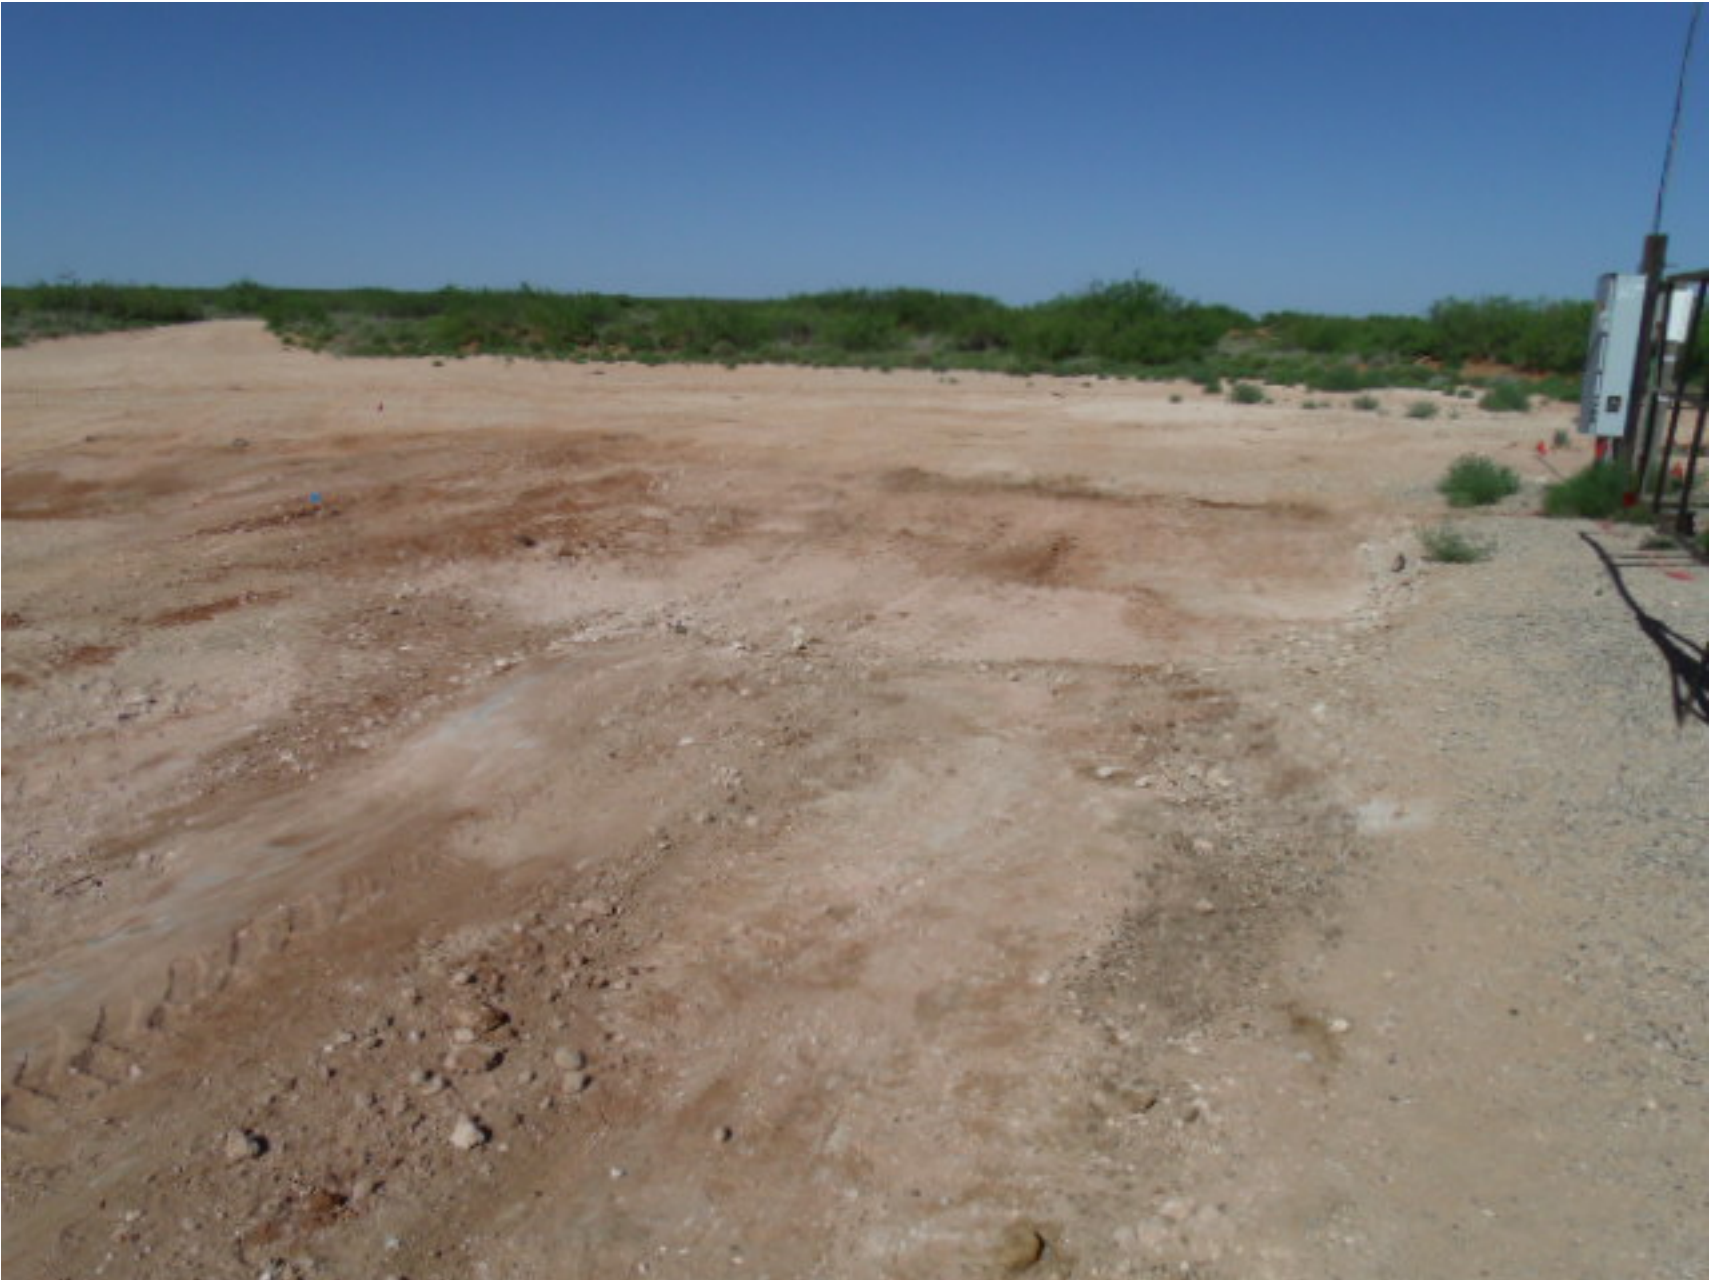
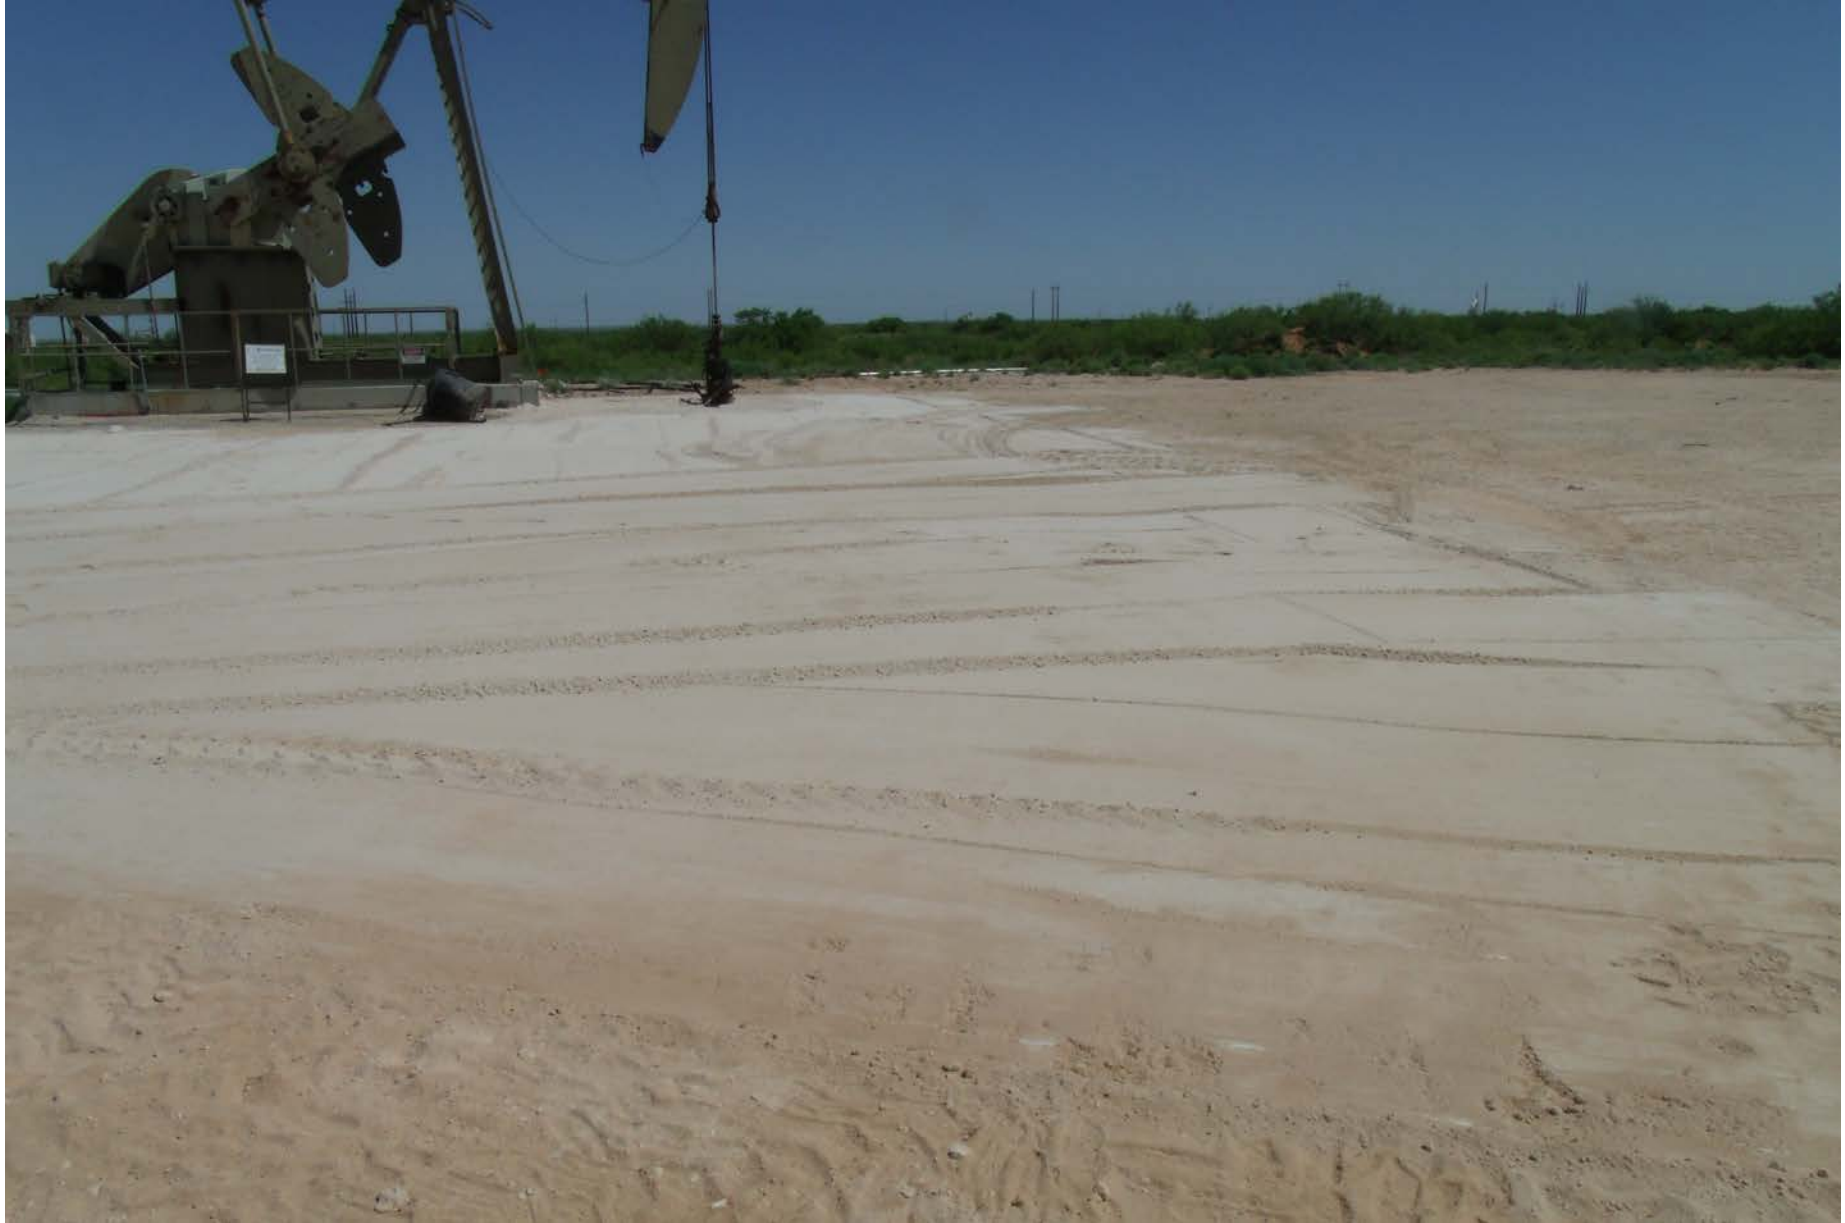
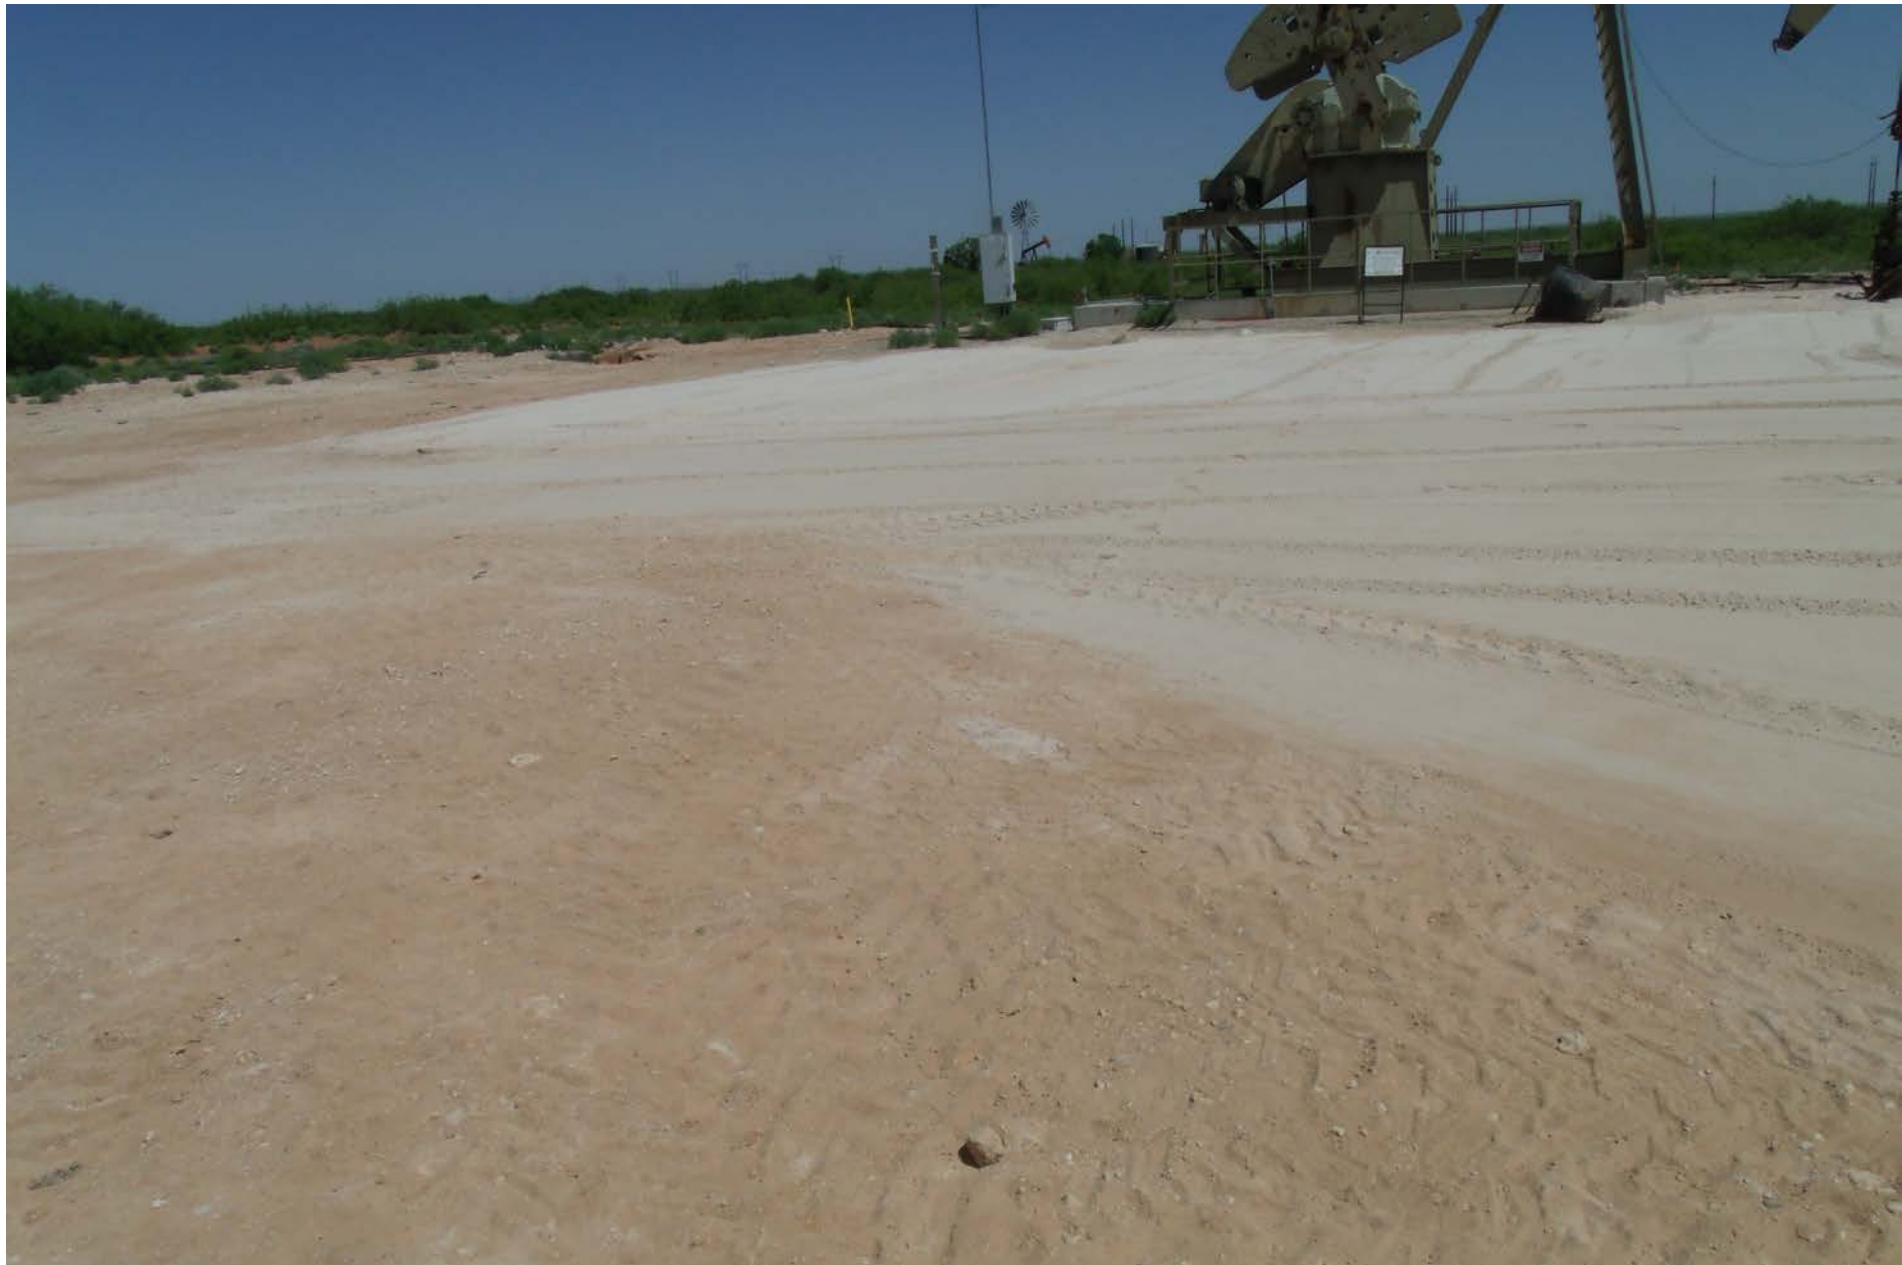
ATTACHMENT I
SITE PHOTOGRAPHS

Evidence of final soil samples are not available but in lieu of those results, please see attachment III. E-mail sent to Mike Bratcher from EPI on April 27, 2016 asking for permission to backfill and e-mail from Mike Bratcher to EPI on May 2, 2016 giving permission to backfill. Please also see attachment I, site photos. Beginning with picture #6 through Picture #9, is evidence of cleanup and backfill.

From April 2016 through May 2016 contaminated soils were removed and transported to a Chevron approved third party disposal. From April 2016 through May 2016 the excavation was backfilled with clean caliche clean topsoil. After completing backfilling activities the disturbed areas were contoured to allow natural drainage.
