SUBJECT: Remediation Closure Report for the MINIS FED COM EAST PAD Release (1RP-5698),
 Lea County, New Mexico

Minis Fed Com East Pad Remediation Closure Report (1RP-5698)
February 1, 20219

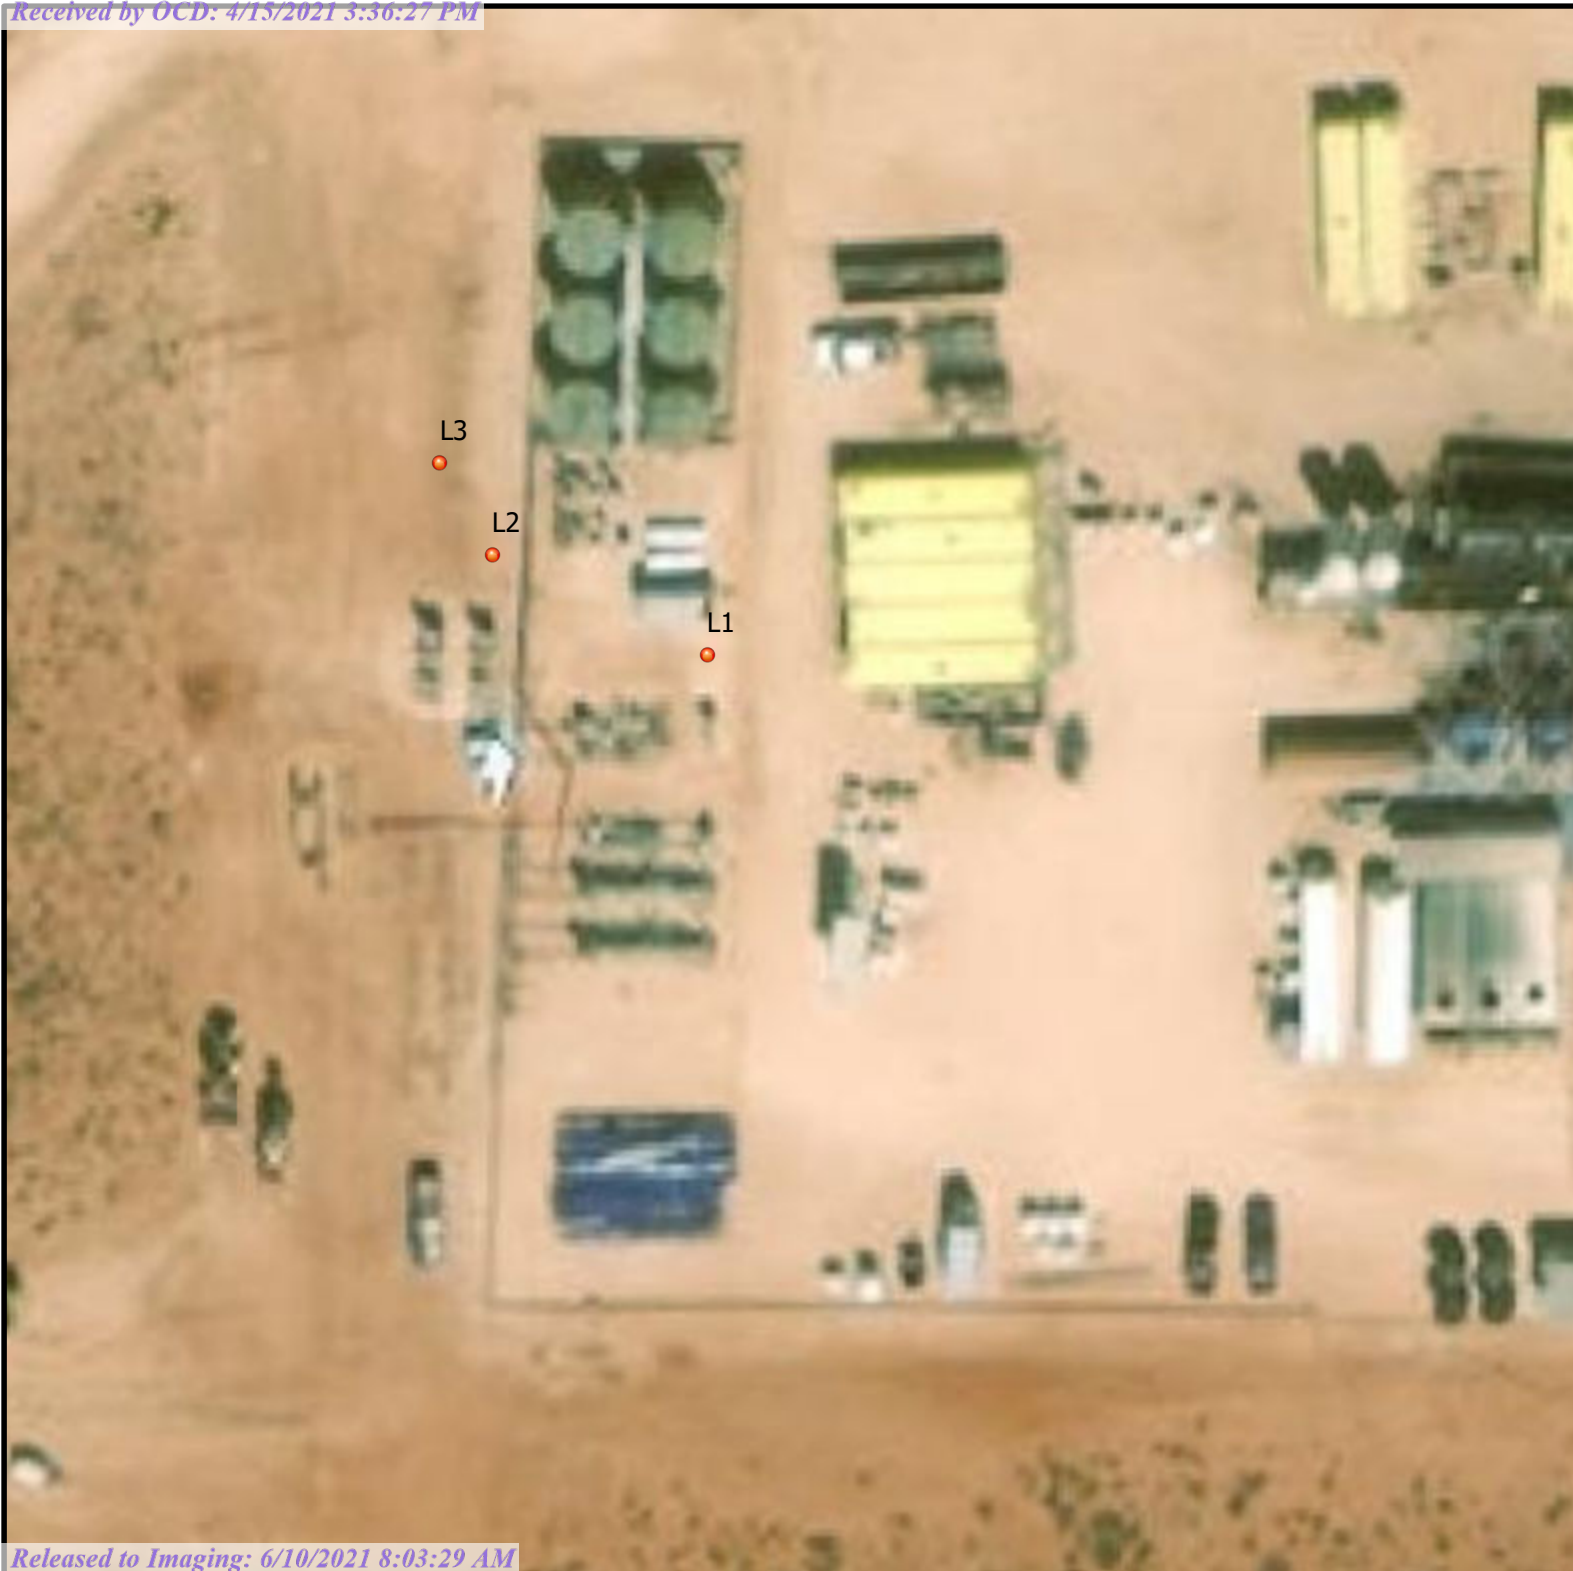
FIGURE 2-
Karst and NMOSE PODs
Minis fed 1

Based upon the New Mexico Office of the State Engineers (NMOSE) online water well database, (Appendix B), depth to groundwater in the area is estimated to be 102-340 feet below grade surface (bgs). There are no known water sources within ½-mile of the location, according to the NMOSE database. (https://gis.ose.state.nm.us/gisapps/ose_pod_locations/; accessed 4/10/2019). The nearest significant watercourse is unnamed Salt Lake, located approximately 4 miles south of the location. Figure 1 illustrates the site with 200 and 300-foot radii to indicate that it does not lie within a sensitive area as described in 19.15.29.12.C(4) NMAC.

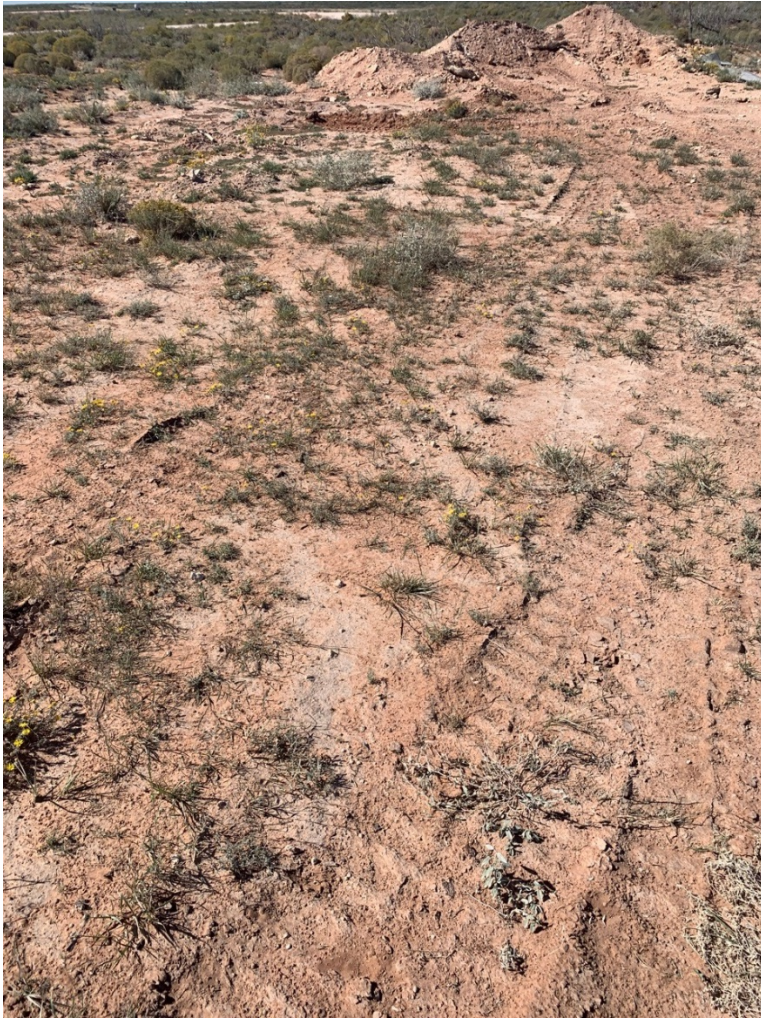
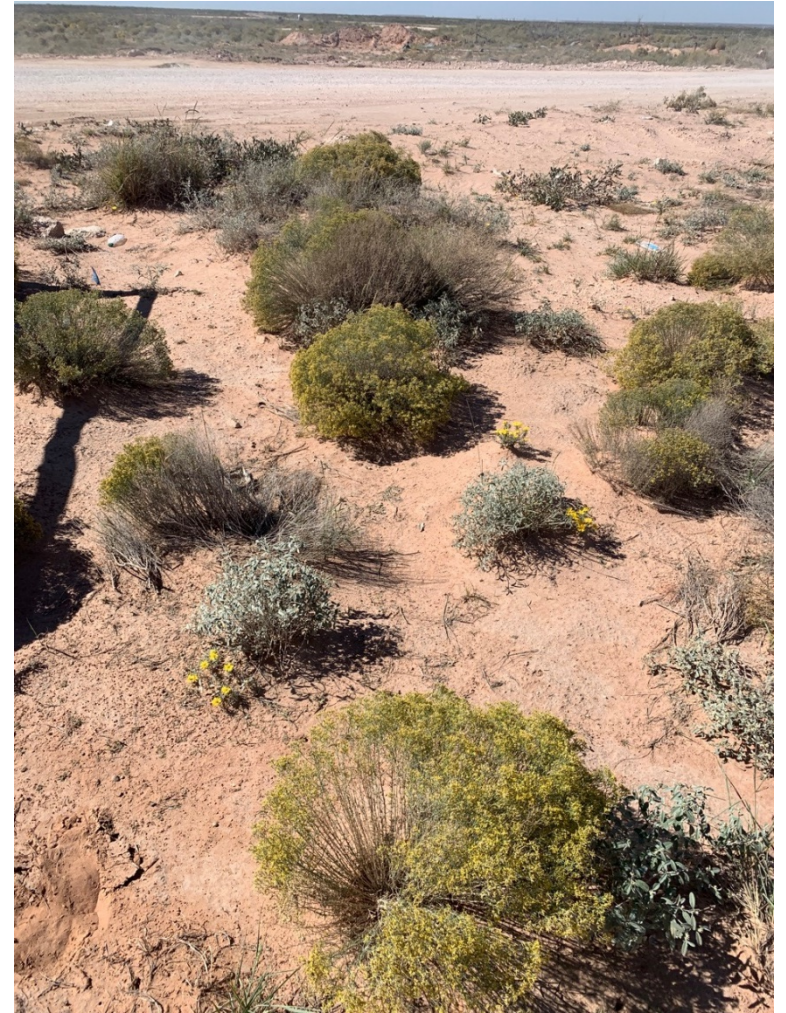
Minis 1 Photos Sample
Locations L2-L3

On October 20, 2019 AEA began conducting confirmation sampling. The areas around sample locations. The confirmation samples were collected from within the mist area in accordance with a systematic sampling approach as defined by SW846 using Gilbert, 1987 equation 5.2.3 for Stratified Random Sampling which is detailed in Appendix C. This systematic method meets the EPAs data quality assessment standards (DQA) for composite sampling as defined by (Myers 1997) Using Confirmation samples were comprised of five-point composites of the area (L1-L3).
