# **CLOSURE REPORT**

## **BRUNSON ARGO TANK BATTERY #1**

**EPI REF: #200129  
NMOCD 1RP #1295**

13 February, 2008

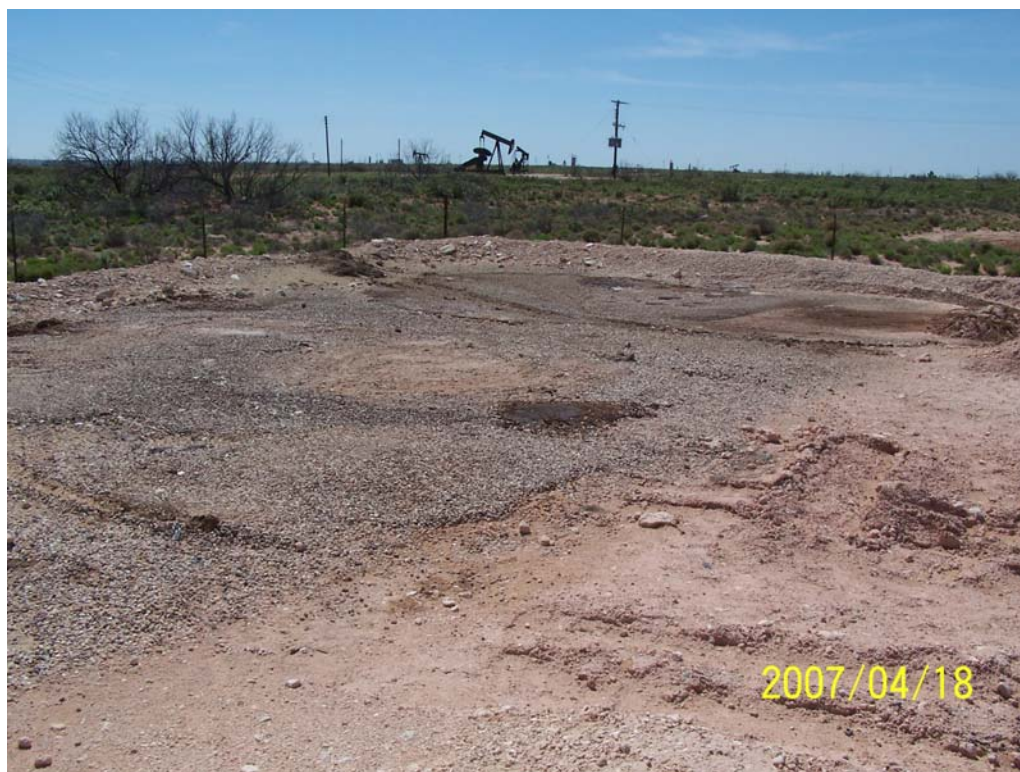
Photograph No. 2 – Looking northeasterly at interior of bermed area

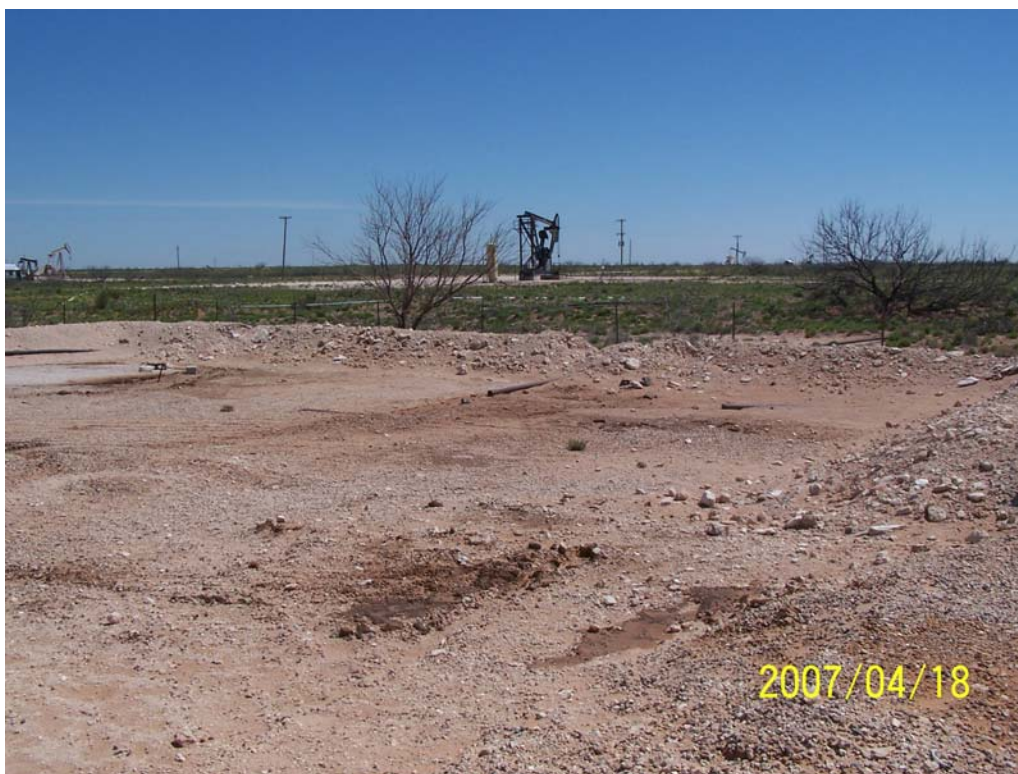
Photograph No. 3 – Looking northeasterly at interior of bermed area

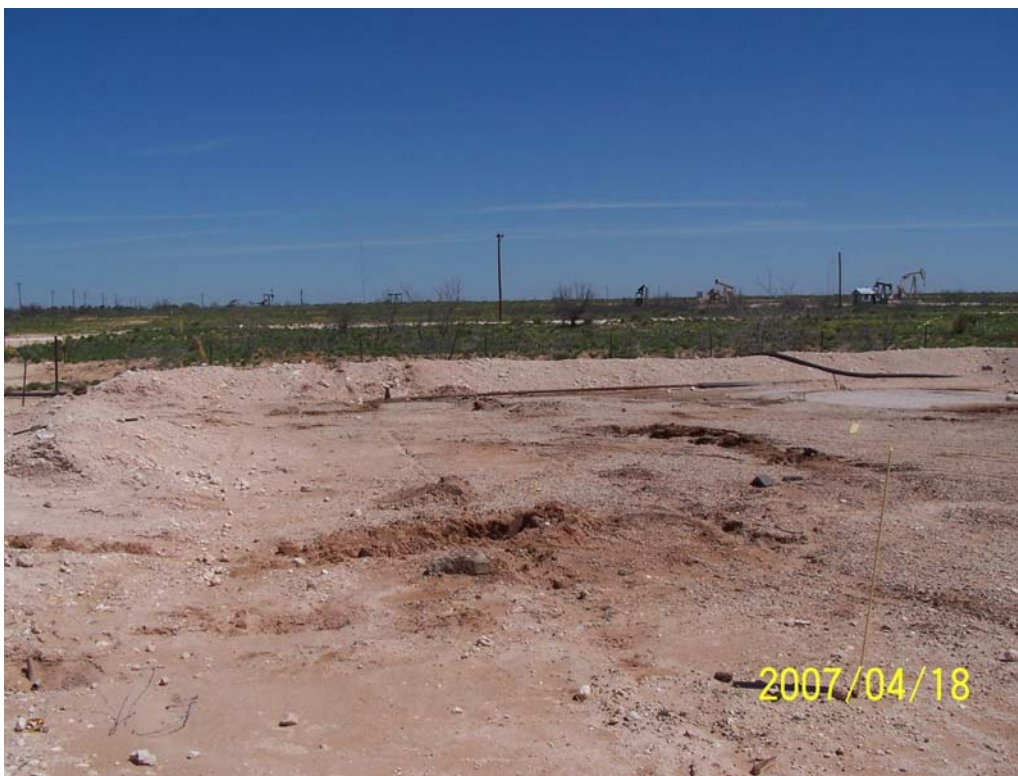
Photograph No. 4 – Looking northerly at interior of bermed area

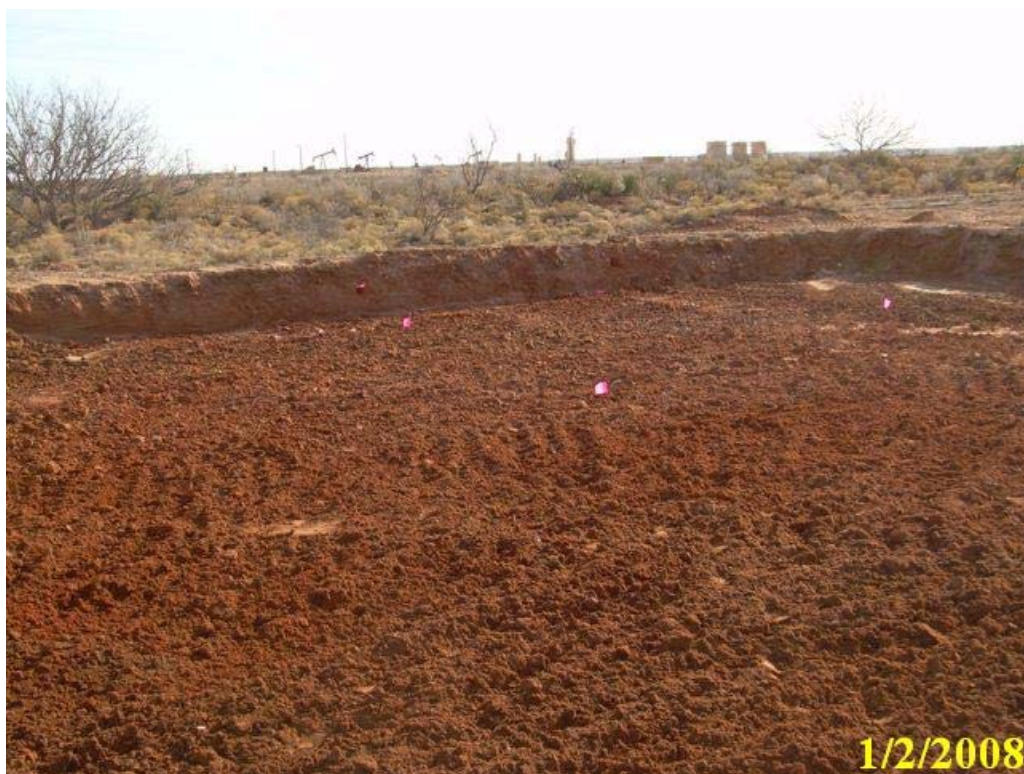
Photograph No. 5 – Looking easterly across excavation.

From December 26, 2007 through January 23, 2008 approximately 8,492 tons of contaminated soils were removed and transported to Sundance Services Inc., and 714 tons transported to EPI Land Farm. From January 29 through February 7, 2008 the excavation was backfilled with 1,536 yds<sup>3</sup> of caliche and 5,858 yds<sup>3</sup> of clean topsoil. On February 1, 2008 EPI installed 40-mil polyethylene liners over the northern and central deep excavations and a 20-mil polyethylene liner over the entire excavation. After completing backfilling activities the disturbed areas were contoured to allow natural drainage, disked, will be seeded with a blend approved by the property owner. To prevent wind and water erosion, a winter cover (wheat or rye) will be applied over the disturbed area. This application will be followed by re-seeding the disturbed area in late spring 2008 when moisture levels are high and survival of newly emerged grass is greater.

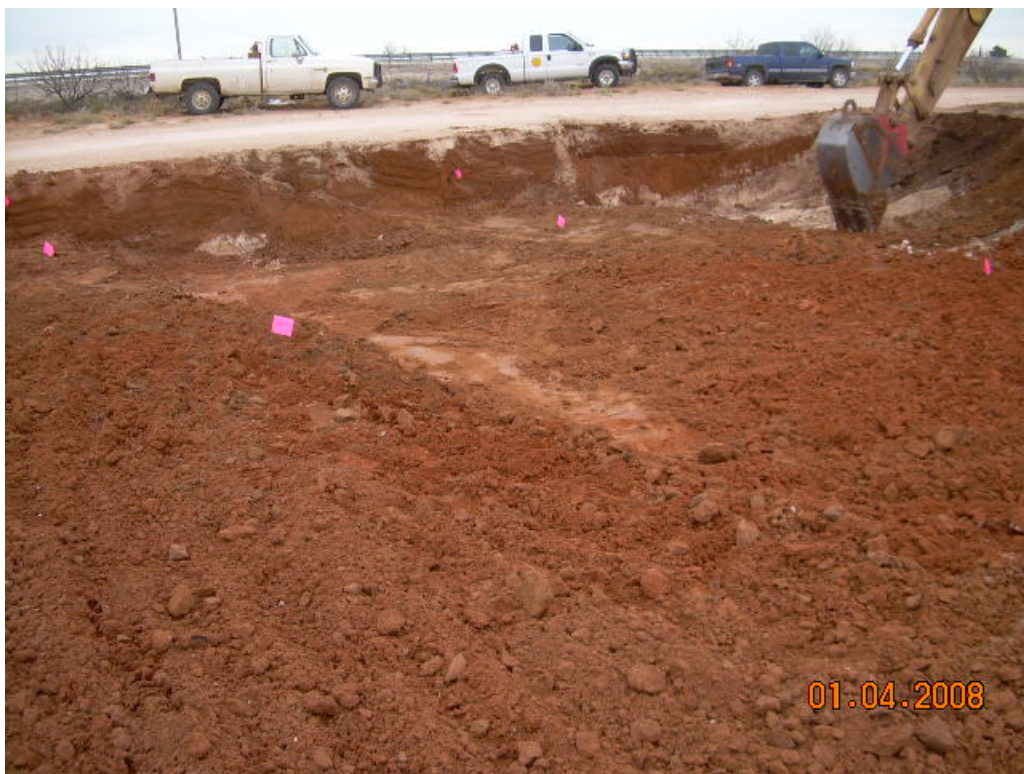
Photograph No. 6 – Looking west across excavation.

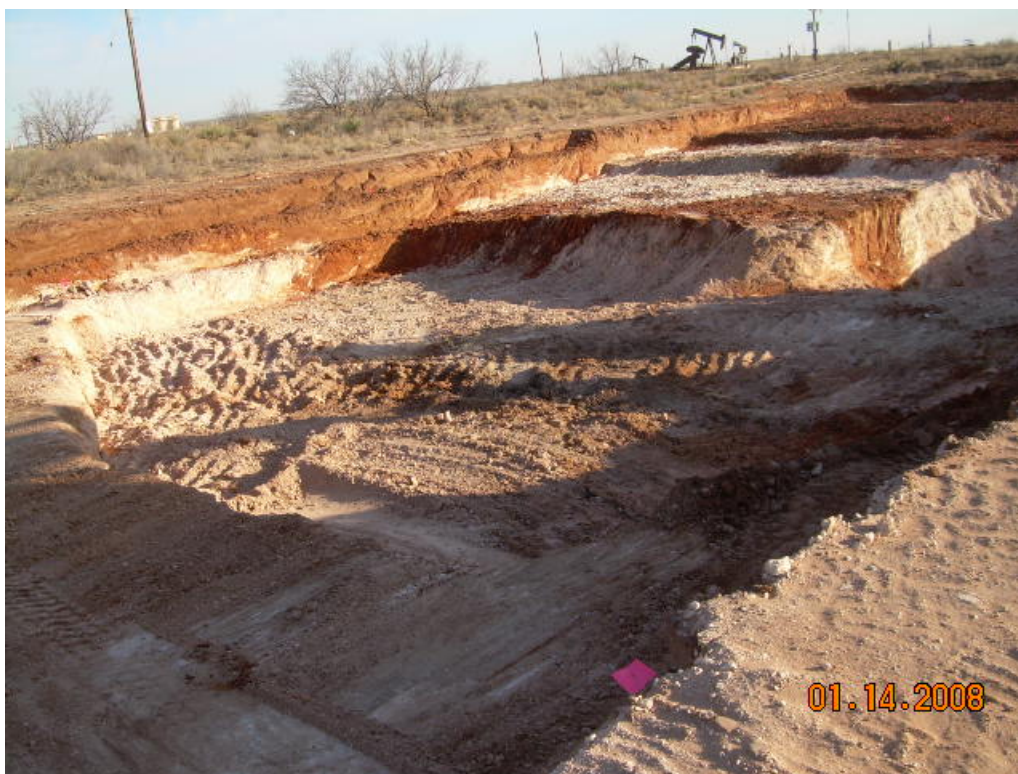
Photograph No. 7 – Looking easterly across excavation.

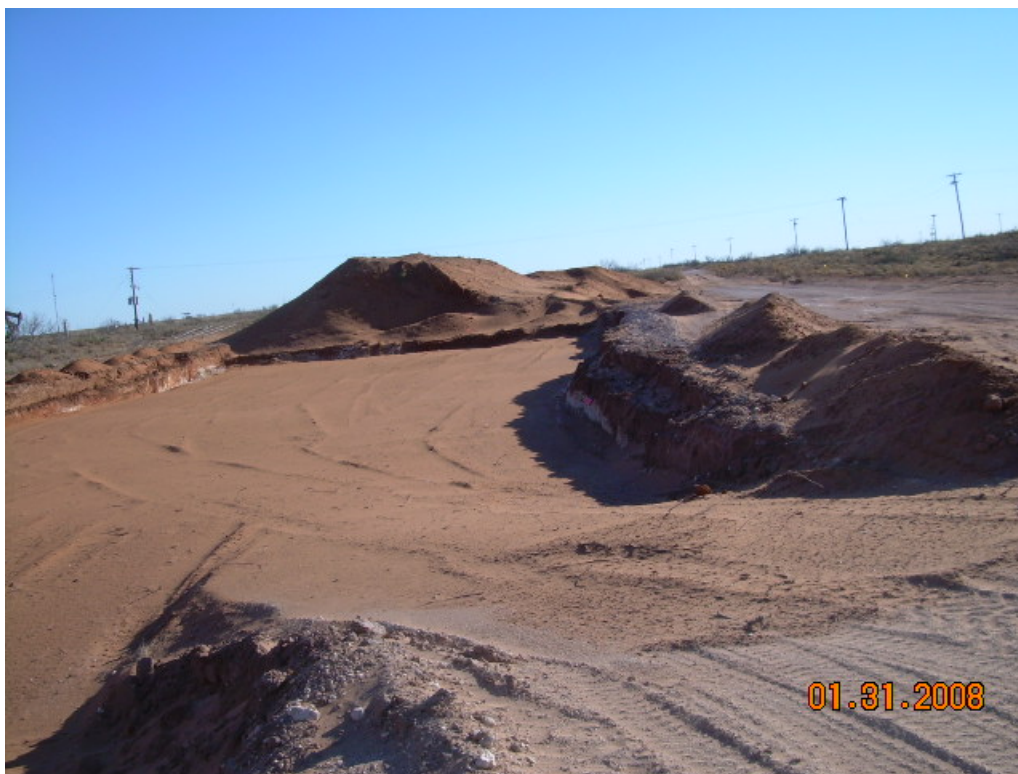
Photograph No. 8 – Looking southerly across excavation prepped for liner.

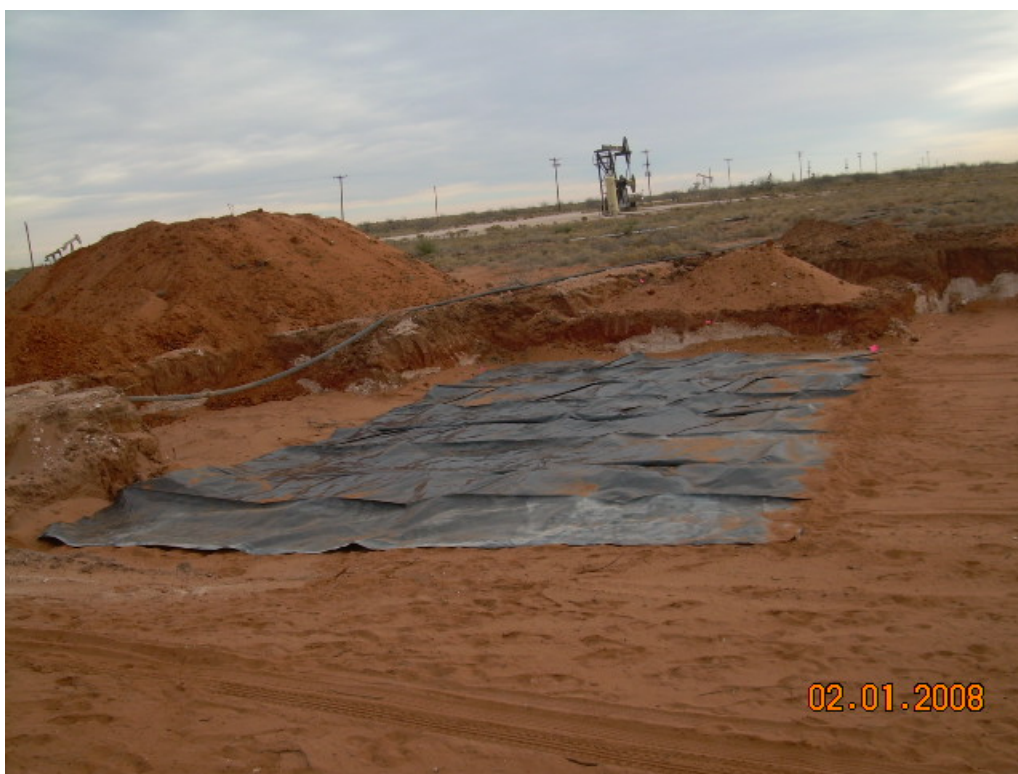
Photograph No. 9 – Installation of 40-mil liner over northern deep excavation.

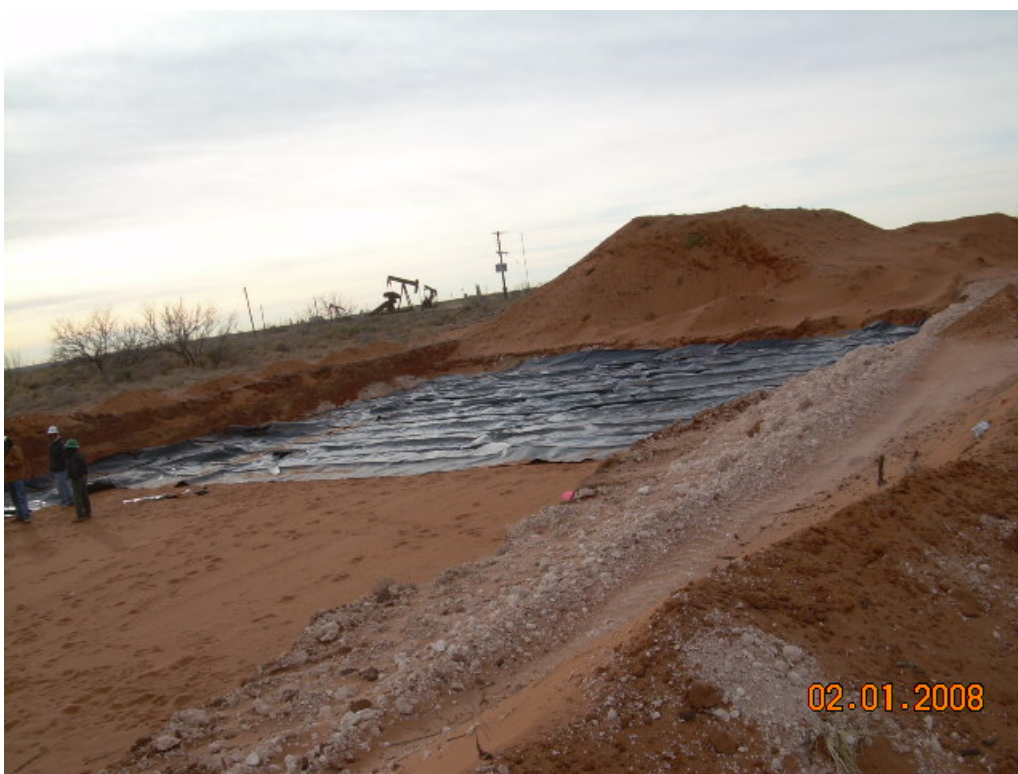
Photograph No. 10 – Installation of 40-mil liner over central deep excavation.

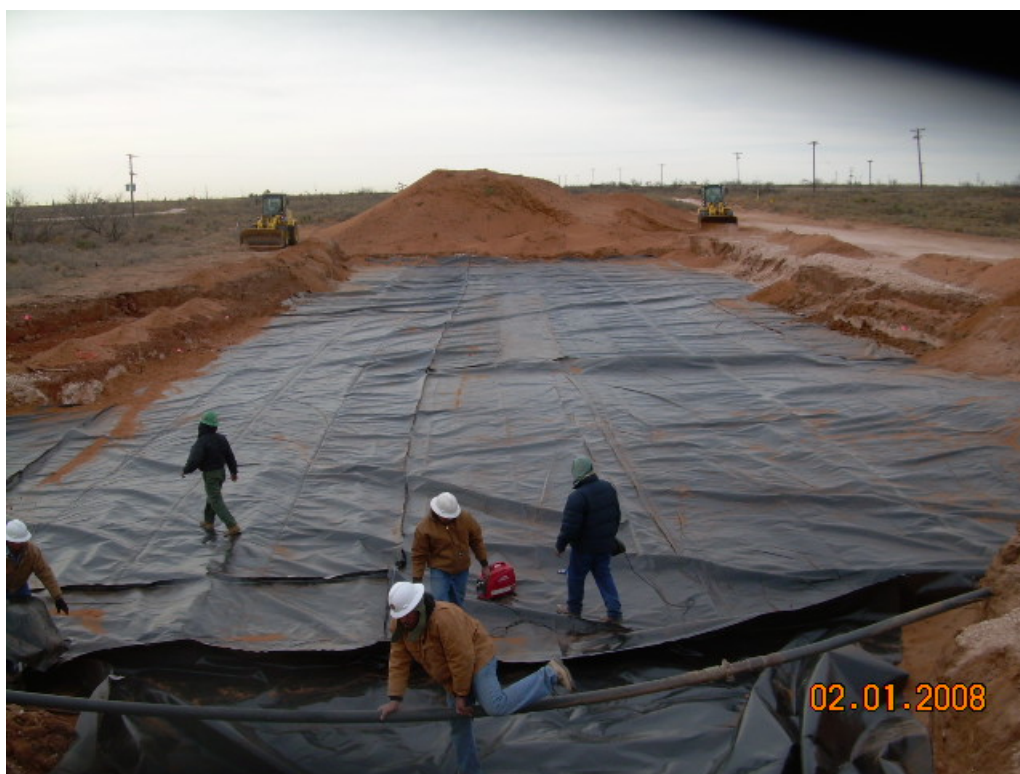
Photograph No. 11 – Installation of 20-mil liner over entire excavation.

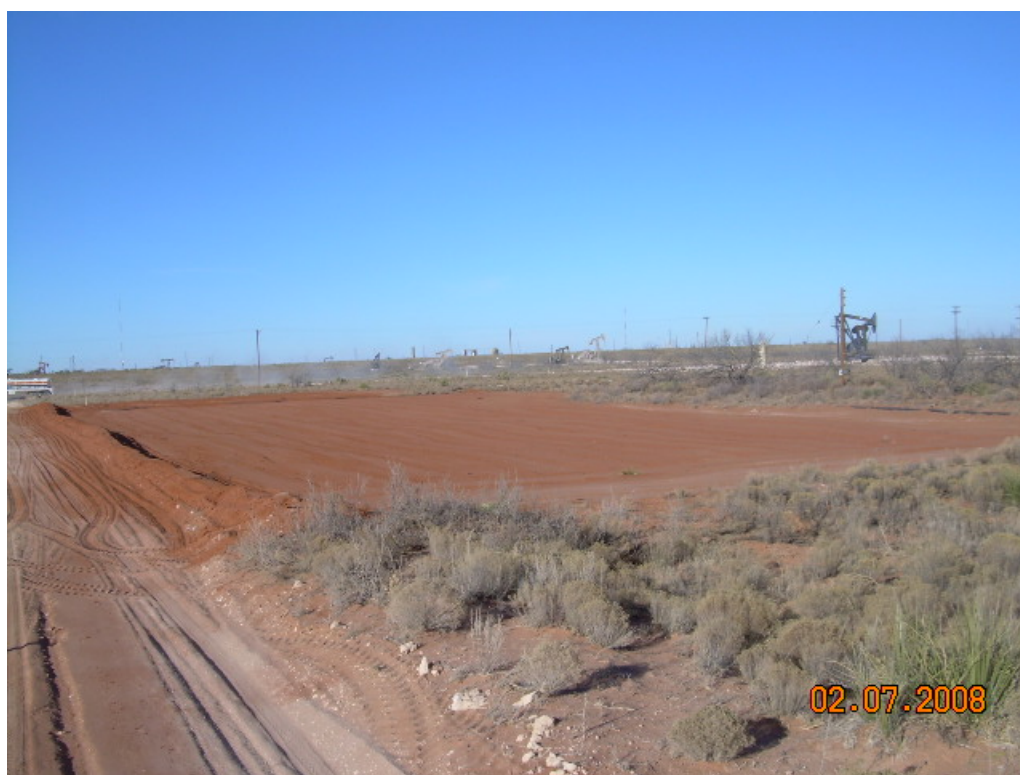
Photograph No. 12 – Remediated site.
