**Re: Work Plan
Dodd Federal Unit #980H (3/23/19)
RP#: 2RP-5334
Incident # NAB1909540096
GPS: 32.85542, -104.06603
Unit Letter C, Section 10, Township 17 South, Range 29 East
Eddy County, New Mexico**

COG Operating, LLC (COG) is pleased to submit the following work plan in response to a release that occurred at the Dodd Federal Unit #980H located in Unit Letter C, Section 10, Township 17 South and Range 29 East in Lea County, New Mexico.

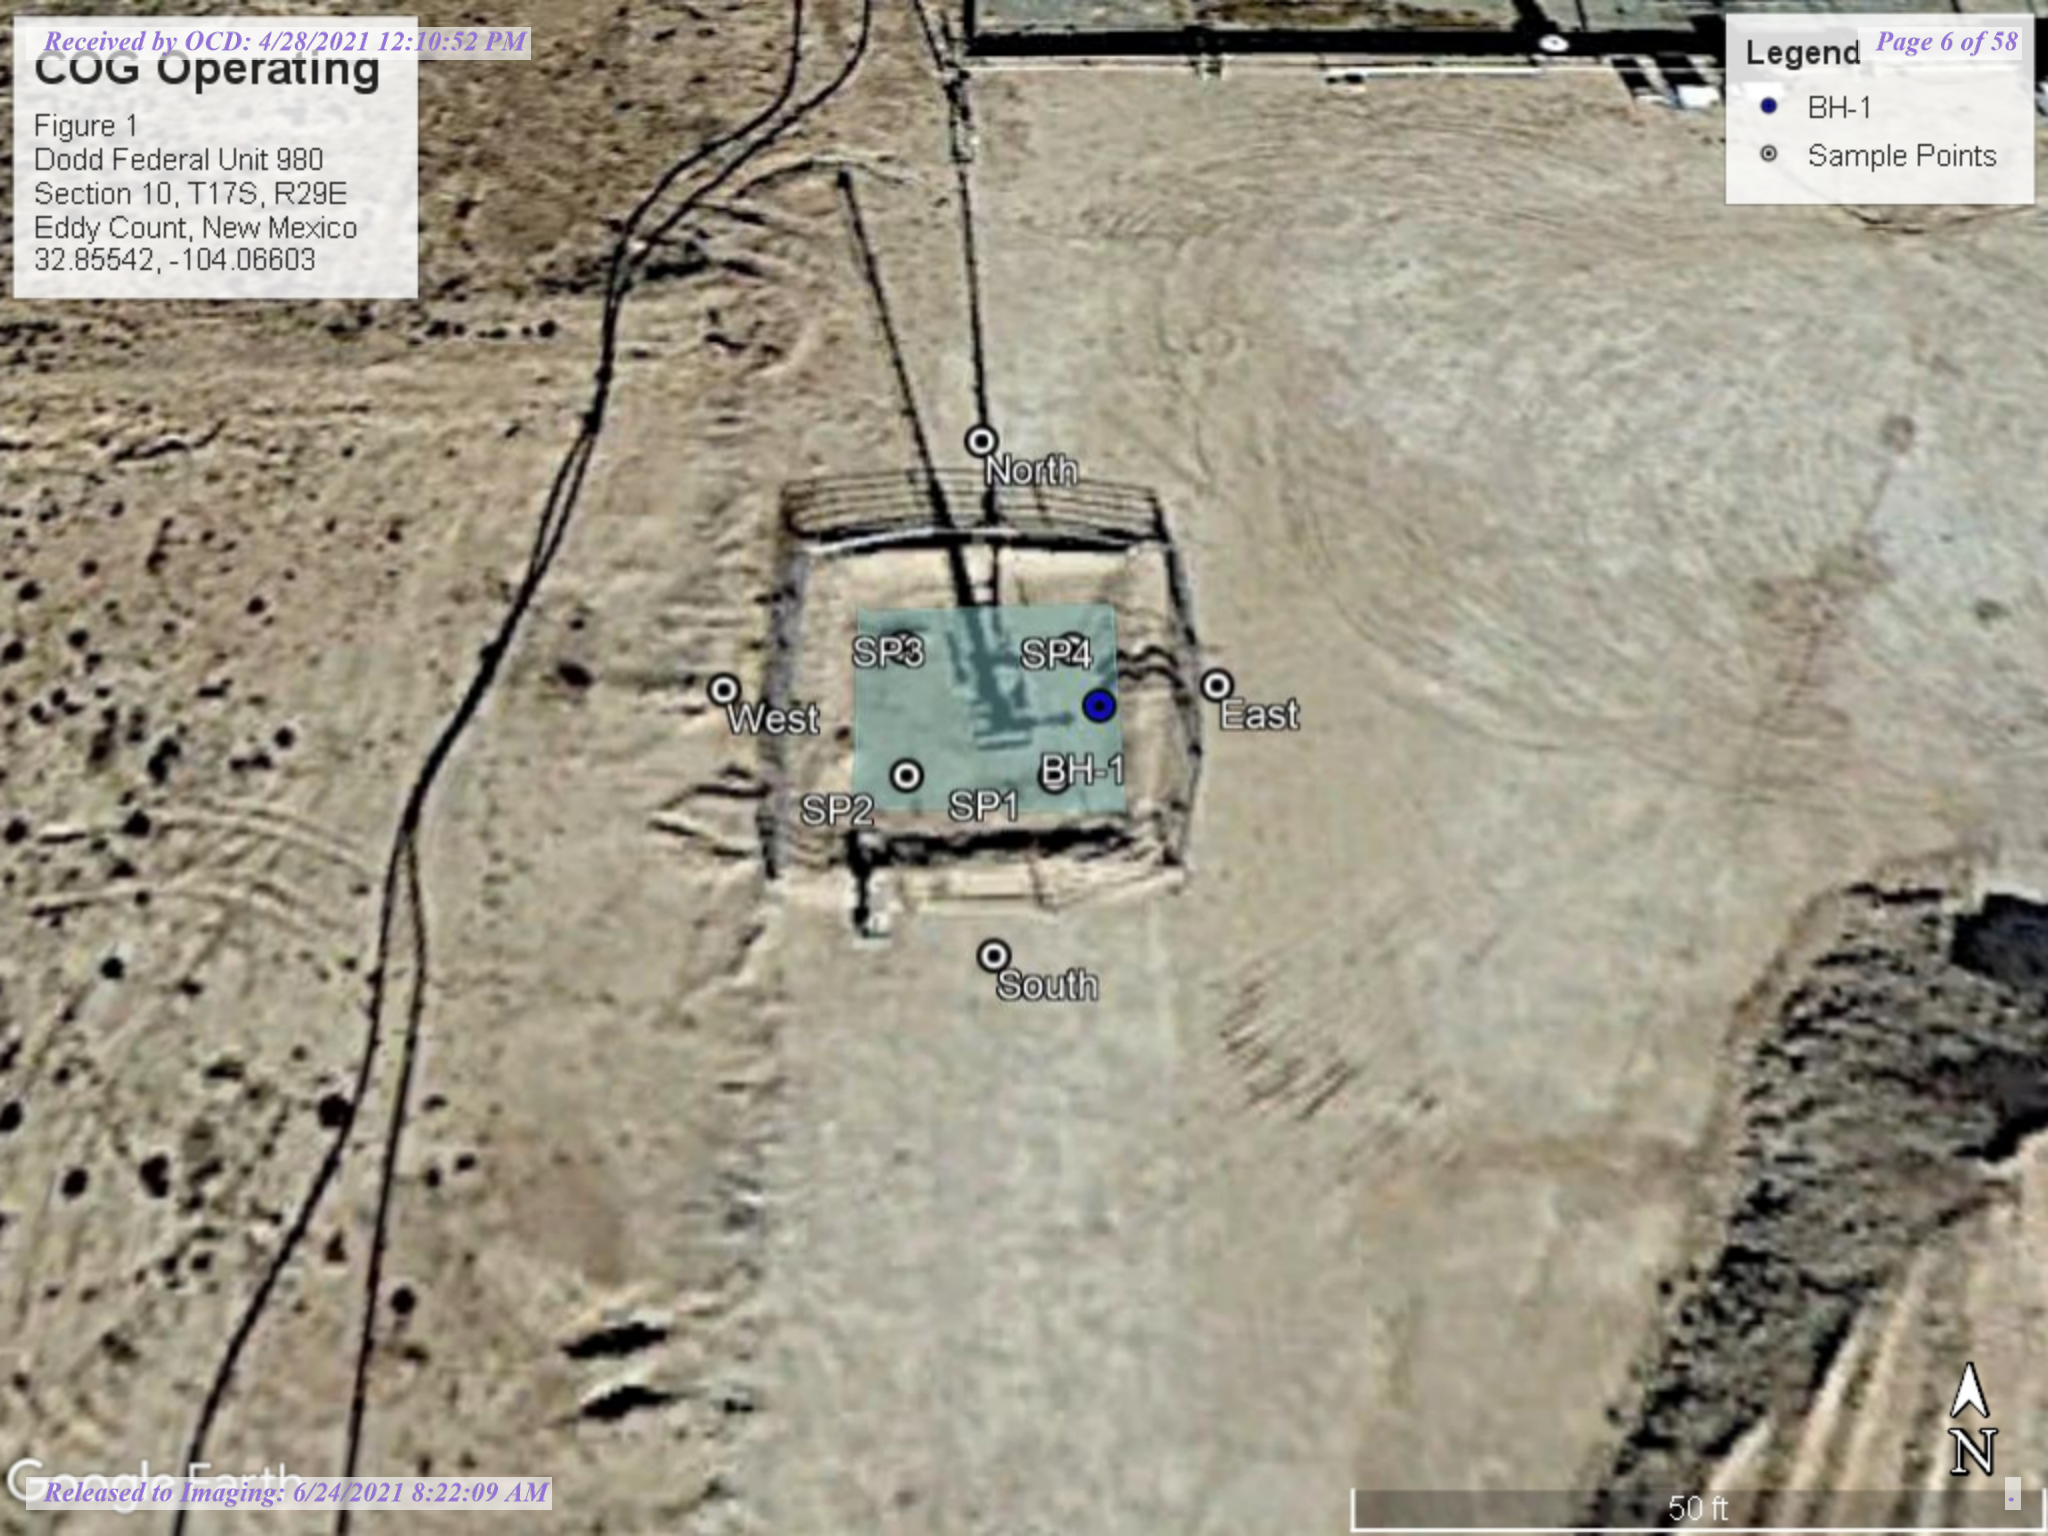
Figure 1
Dodd Federal Unit 980
Section 10, T17S, R29E
Eddy Count, New Mexico
32.85542, -104.06603

After excavating the impacted area, a total of four (4) composite samples were collected from the area in September 24, 2019. The sample locations are shown in Figure 1. Referring to Table 1, all the samples were below the Table 1 Closure Criteria concentrations for TPH and BTEX. However, the areas of B-1 and B-4 exceeded the closure criteria concentrations for chlorides at 2.0' below surface, with chloride concentrations of 1,650 mg/kg and 2,800 mg/kg, respectively. These areas were not vertically defined. The areas of B-2 and B-3 were all below the Table 1 Closure Criteria concentrations for chlorides.

COG submitted a work plan to excavate the impacted areas, dated May 18, 2020. COG had proposed excavation of the impacted soil in the areas of B-1 and B-4. However, if deeper impact was encountered, a liner variance was requested for the impacted area of B-1 and B-4 due to safety concerns. The NMOCD denied the Variance request to install the liner.

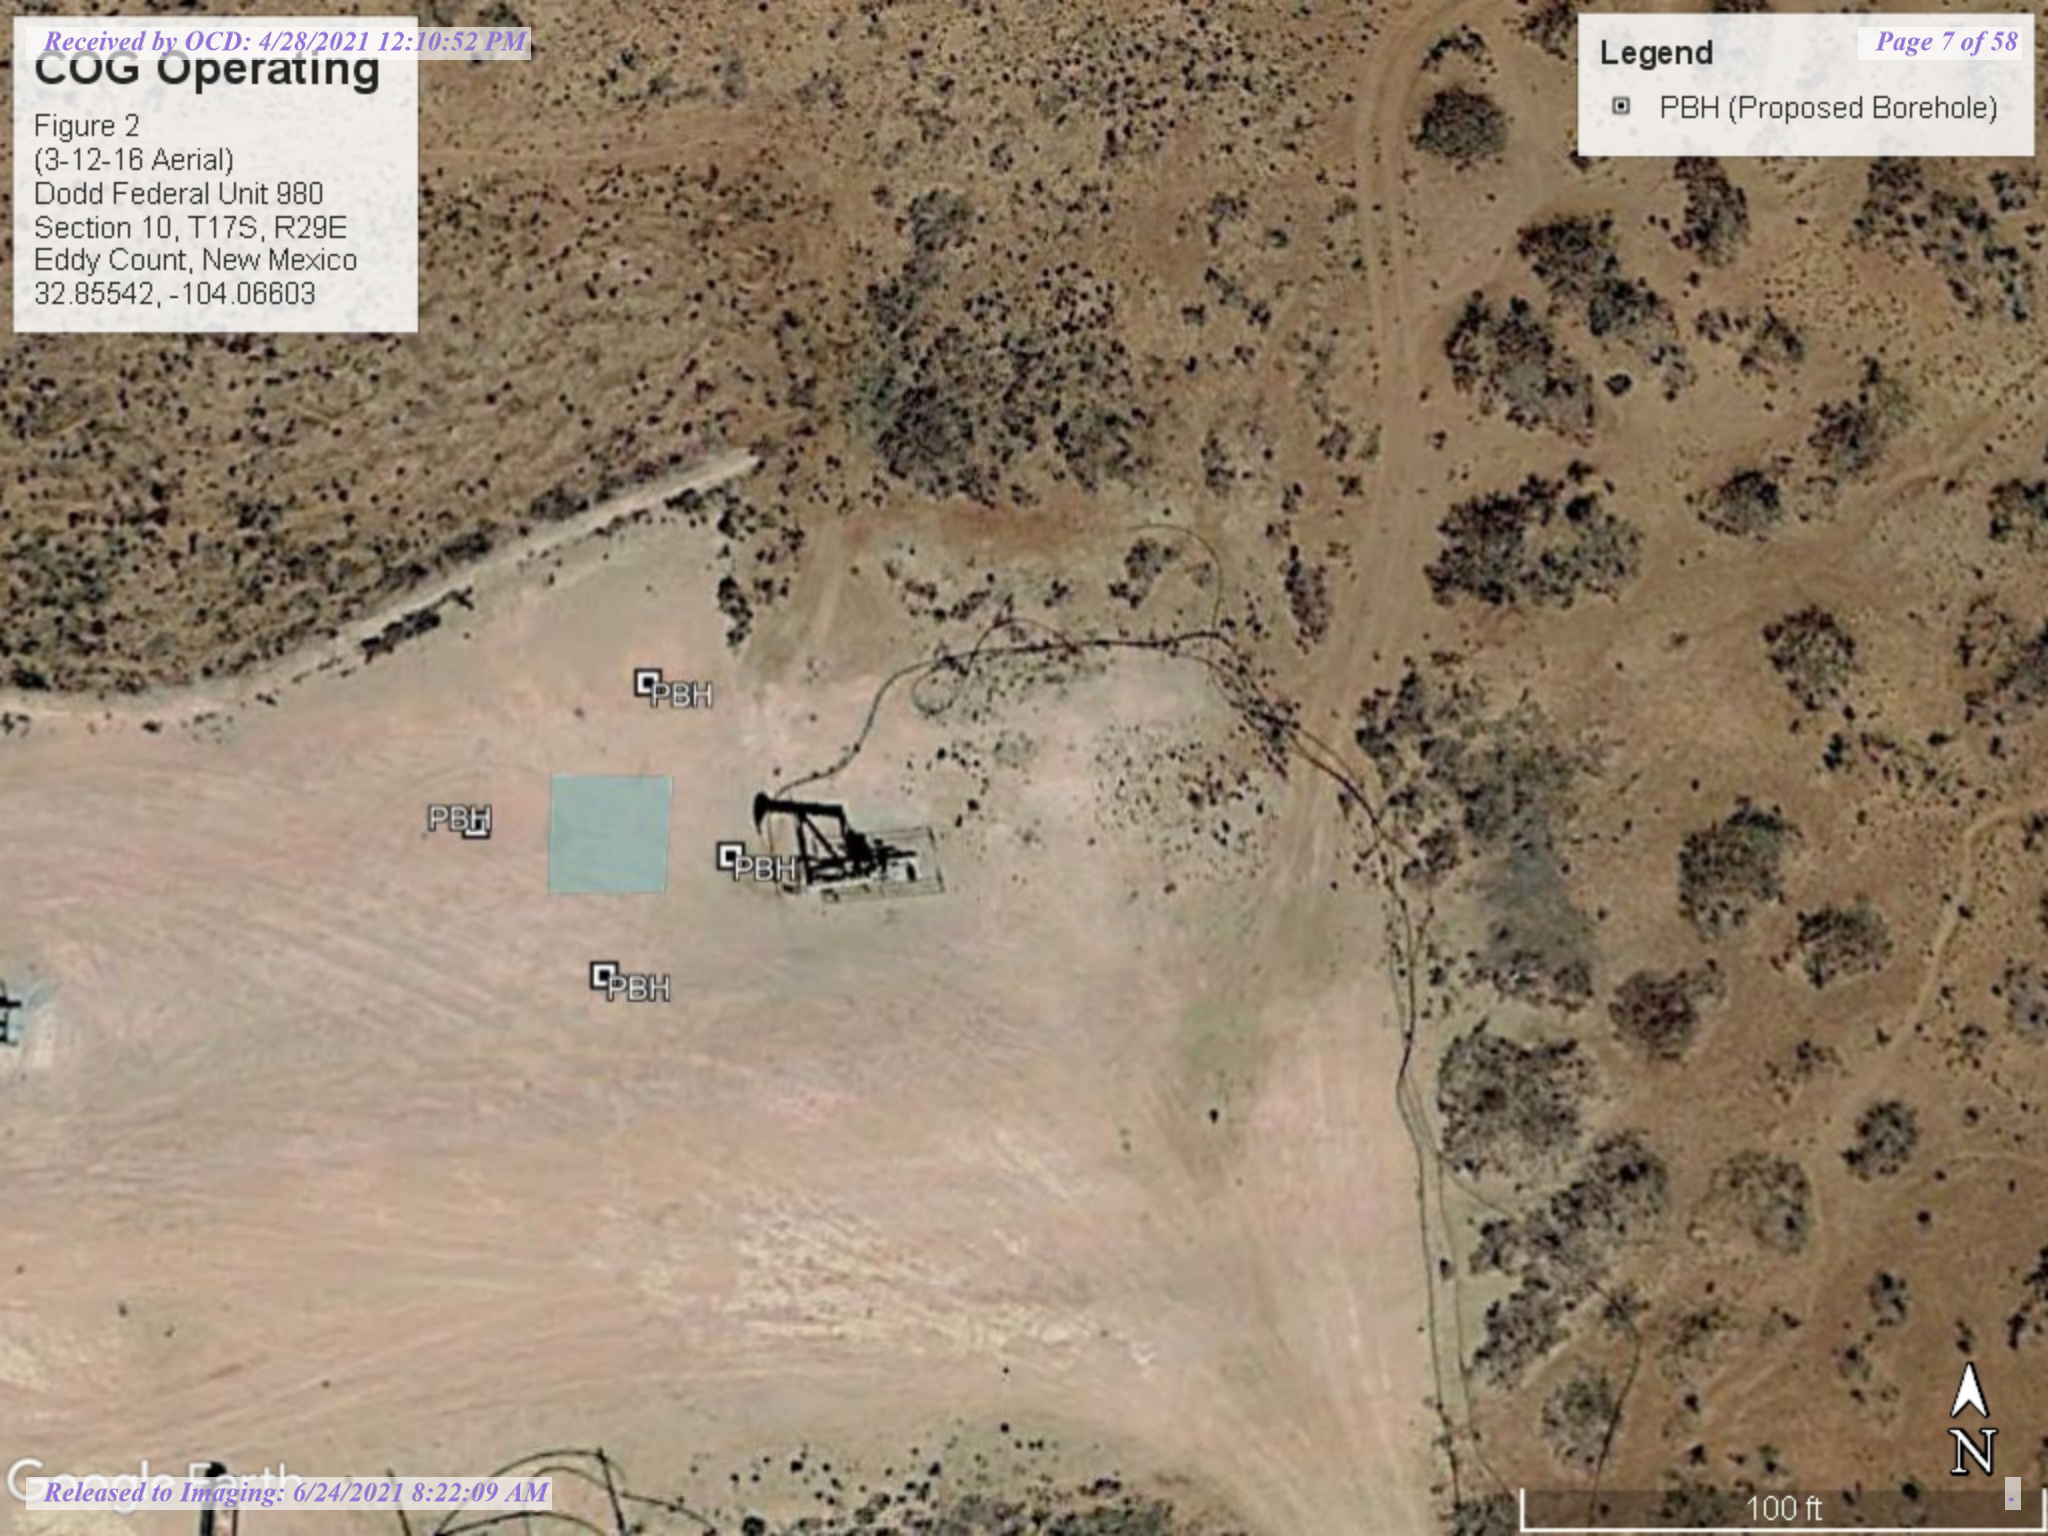
Figure 2
(3-12-18 Aerial)
Dodd Federal Unit 980
Section 10, T17S, R29E
Eddy Count, New Mexico
32.85542, -104.06603

On December 7, 2020, COG installed a borehole (BH-1) between B-1 and B-4 to define the extents of the chloride impact. The borehole location is shown in Figure 2. Referring to Table 1, the chlorides were vertically defined at 45' below surface. Based on the results, it appears that the deeper impact may not be related to the flare release incident and may be historical or other possible sources near the area. The impacted area measures approximately 8'x 30' and appears to be limited and confined inside the flare firewalls.

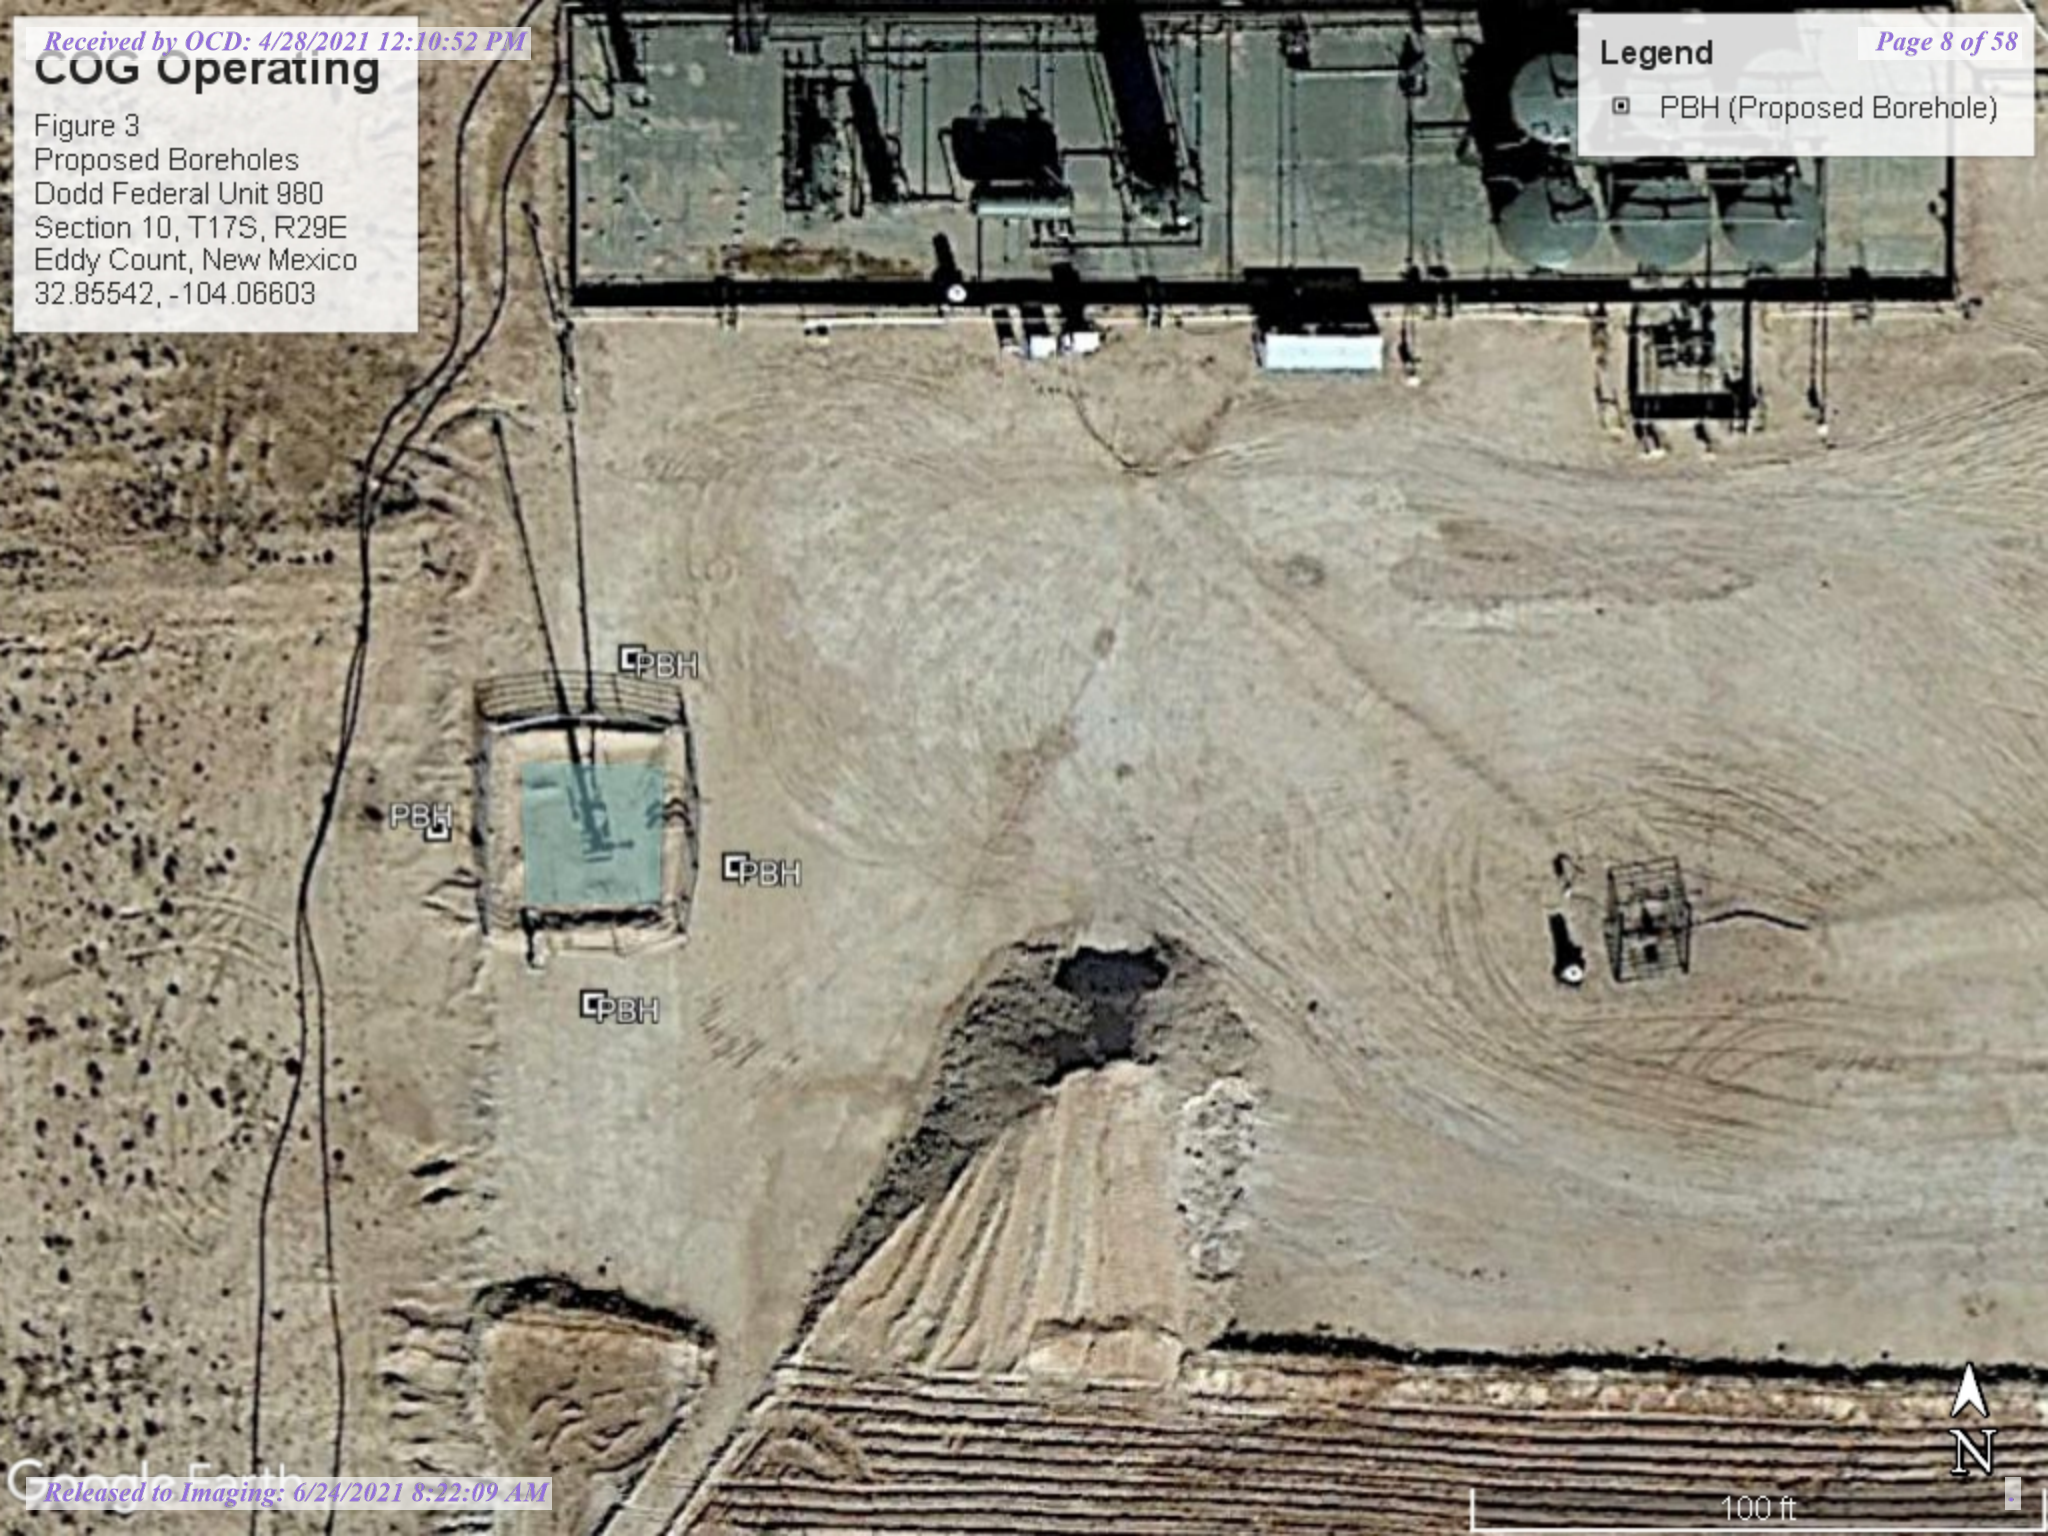
Figure 3
Proposed Boreholes
Dodd Federal Unit 980
Section 10, T17S, R29E
Eddy Count, New Mexico
32.85542, -104.06603

- Boreholes will be installed in the area north, south, west and east of the flare to define the extents of the impacted soil. If needed, additional boreholes will be installed to define the extents. The proposed boreholes are shown in the attached Figure 2.
- According to published data and relative elevation, the groundwater at the site appears to be greater than 100 feet below surface. COG will install a deeper borehole to a depth of 105' below surface to establish the Depth to Water (DTW) for the area.

Based on our conversation, the NMOCD requested COG to submit a work plan to continue the assessment at the site to define the horizontal extents of the impact around the flare. The proposed work plan is shown below.
