### Report Type: Closure Report NRM2029543600

| Site: | Lomas Rojas 26 State Com CTB 501H Separator | | | | | |

**Re: Closure Report for the EOG Resources, Lomas Rojas 26 St Com CTB 501H Separator, Unit P, Section 26, Township 25 South, Range 33 East, Lea County, New Mexico.  
NRM2029543600.**

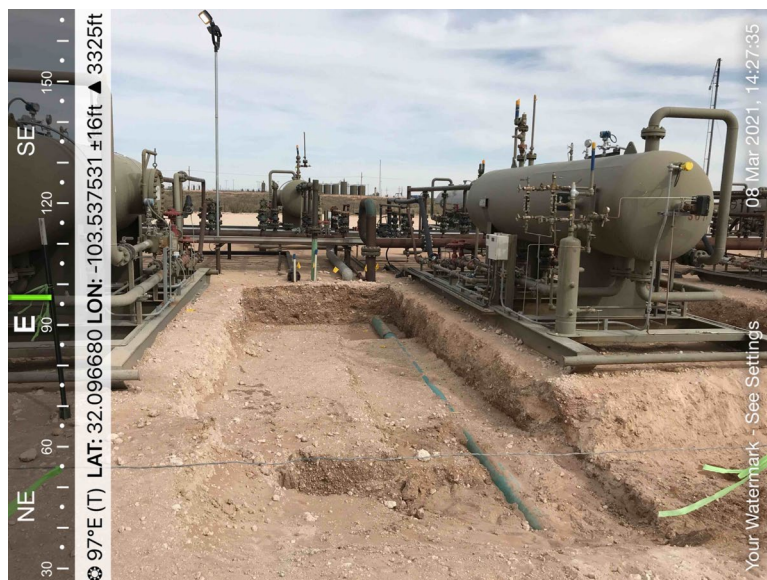
View of Remediation Activities – View East

Tetra Tech personnel were onsite March 1, 2021 through March 10, 2021, to supervise the remediation and reclamation activities as well as to collect confirmation samples. The impacted areas were excavated to depths ranging from 2.0'-3.0' below surface, as shown on Figure 4 and Table 2. Due to equipment and safety concerns, the entire impacted area was hand dug.

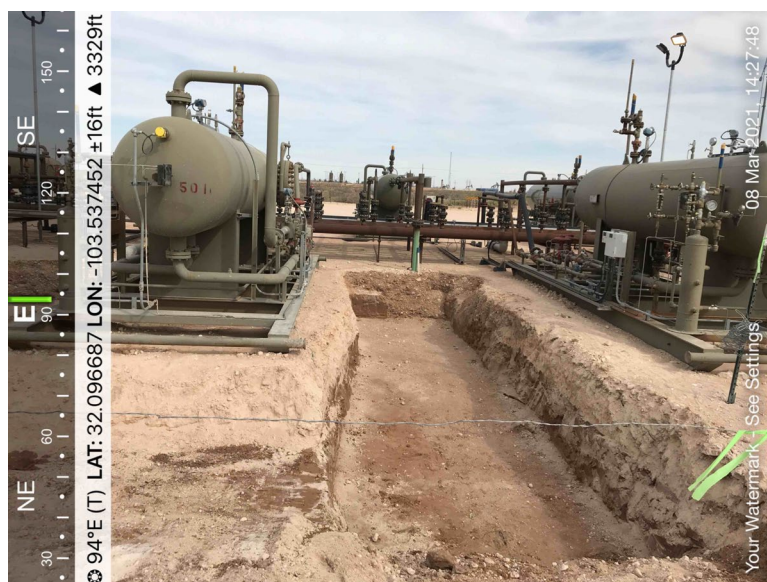
View of Remediation Activities – View East

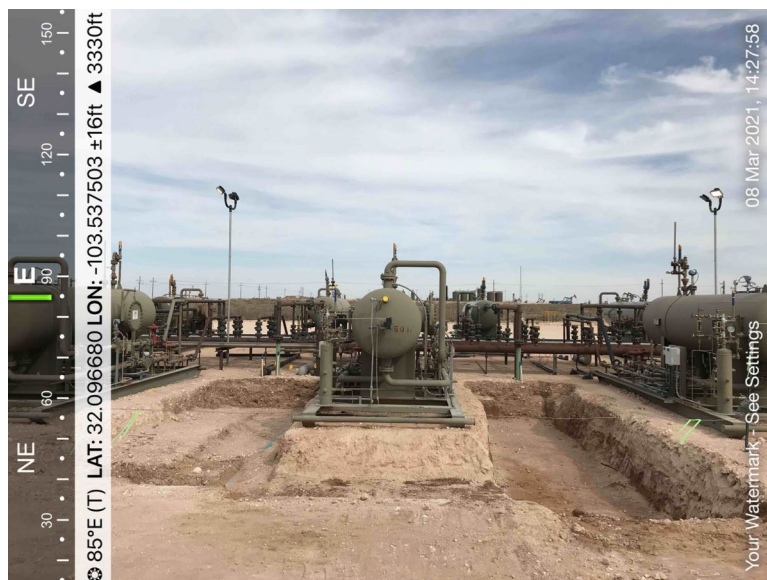
View of Remediation Activities – View East
