Release Notification

Site Name	STATE N BATTERY	Site Type	OIL PIPELINE
Date Release Discovered	12/07/2020	API# (if applicable)

Remediation Work Plan

Cross Timbers Energy, LLC
nAPP2035151755
K-11-17S-34E
32.847516,-103.532247
04/27/2021

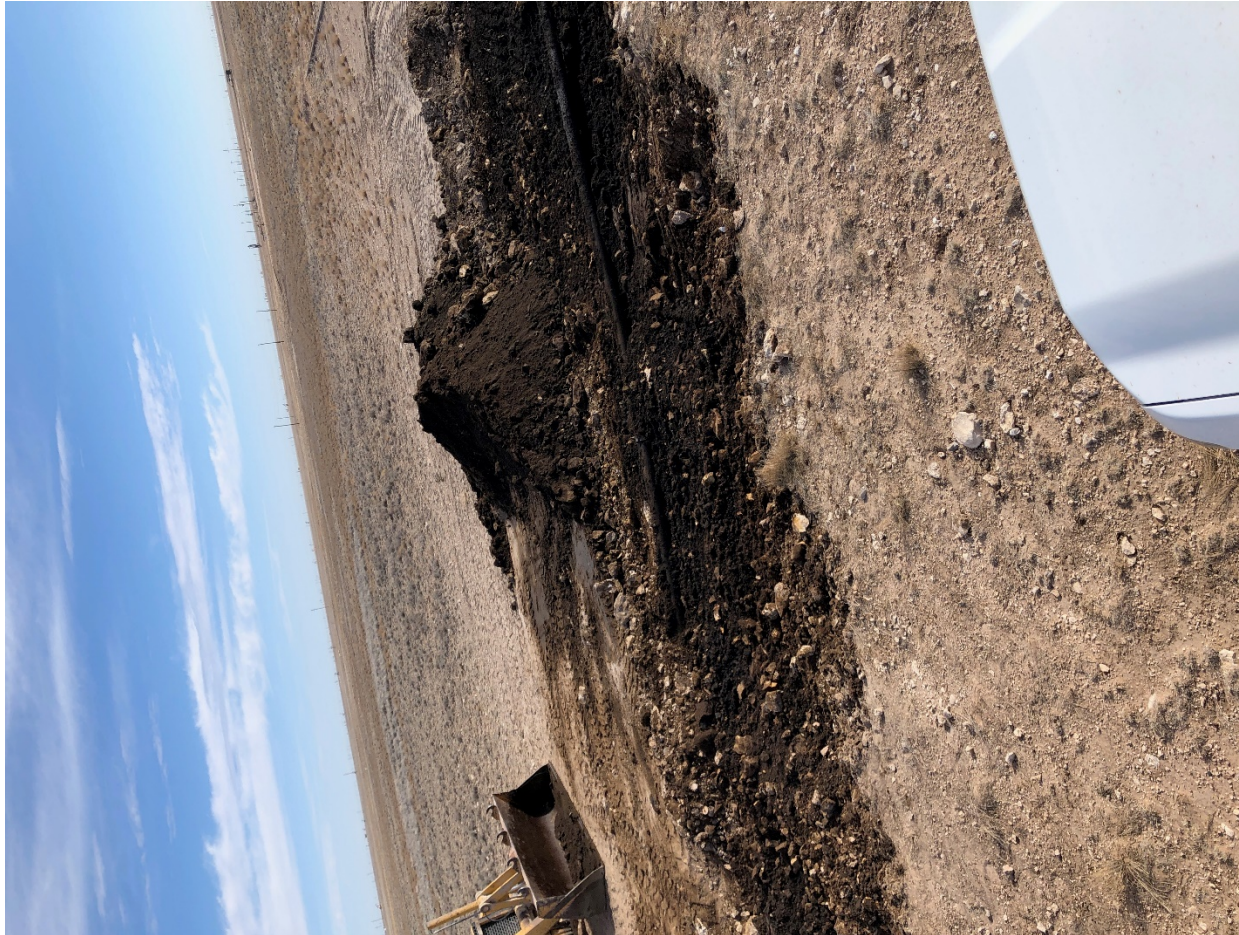
CROSS TIMBERS ENERGY, LLC
STATE N BTY
12/10/2020 IMAGE #1

Cross Timbers Energy, LLC discovered the spill on December 07, 2020. The leak resulted from corrosion on a 3" steel pipeline. The 3" steel line was clamped. A vacuum truck was called to location for cleanup. The initial C-141 report was submitted to your office on December 17, 2020, see attached. Attachment 1.

The entire contaminated surface area is approximately 27' x 48'. The vertical depth of the hydrocarbon contamination is approximately 2'-3' with the exception of the soil adjacent to the leaking pipeline. Area of approximately 27' x 48' has been excavated ranging from 2'-3' before reaching clean soil to allow for vertical delineation. The hydrocarbon saturated soil, approximately 71 yards was removed from location using a backhoe and trucked to Gandy Marley disposal site.
