| Incident ID | NRM2034645955 |

| Site Name | Ross Draw 30-31 | Site Type | CTB |

**Re: Closure Request  
Ross Draw 30-31  
Incident Number NRM2034645955  
Eddy County, New Mexico**

WSP USA Inc. (WSP) on behalf of XTO Energy, Inc. (XTO), presents the following Closure Request detailing site assessment and soil sampling activities at the Ross Draw 30-31 (Site) located in Unit H, Section 31, Township 26 South, Range 30 East, in Eddy County, New Mexico (Figure 1). The purpose of the site assessment and soil sampling activities was to assess for the presence or absence of impacts to soil following the release of produced water within lined containment at the Site. Based on field observations, field screening activities, and soil sample laboratory analytical results, XTO is submitting this Closure Request and requesting no further action (NFA) for Incident Number NRM2034645955.

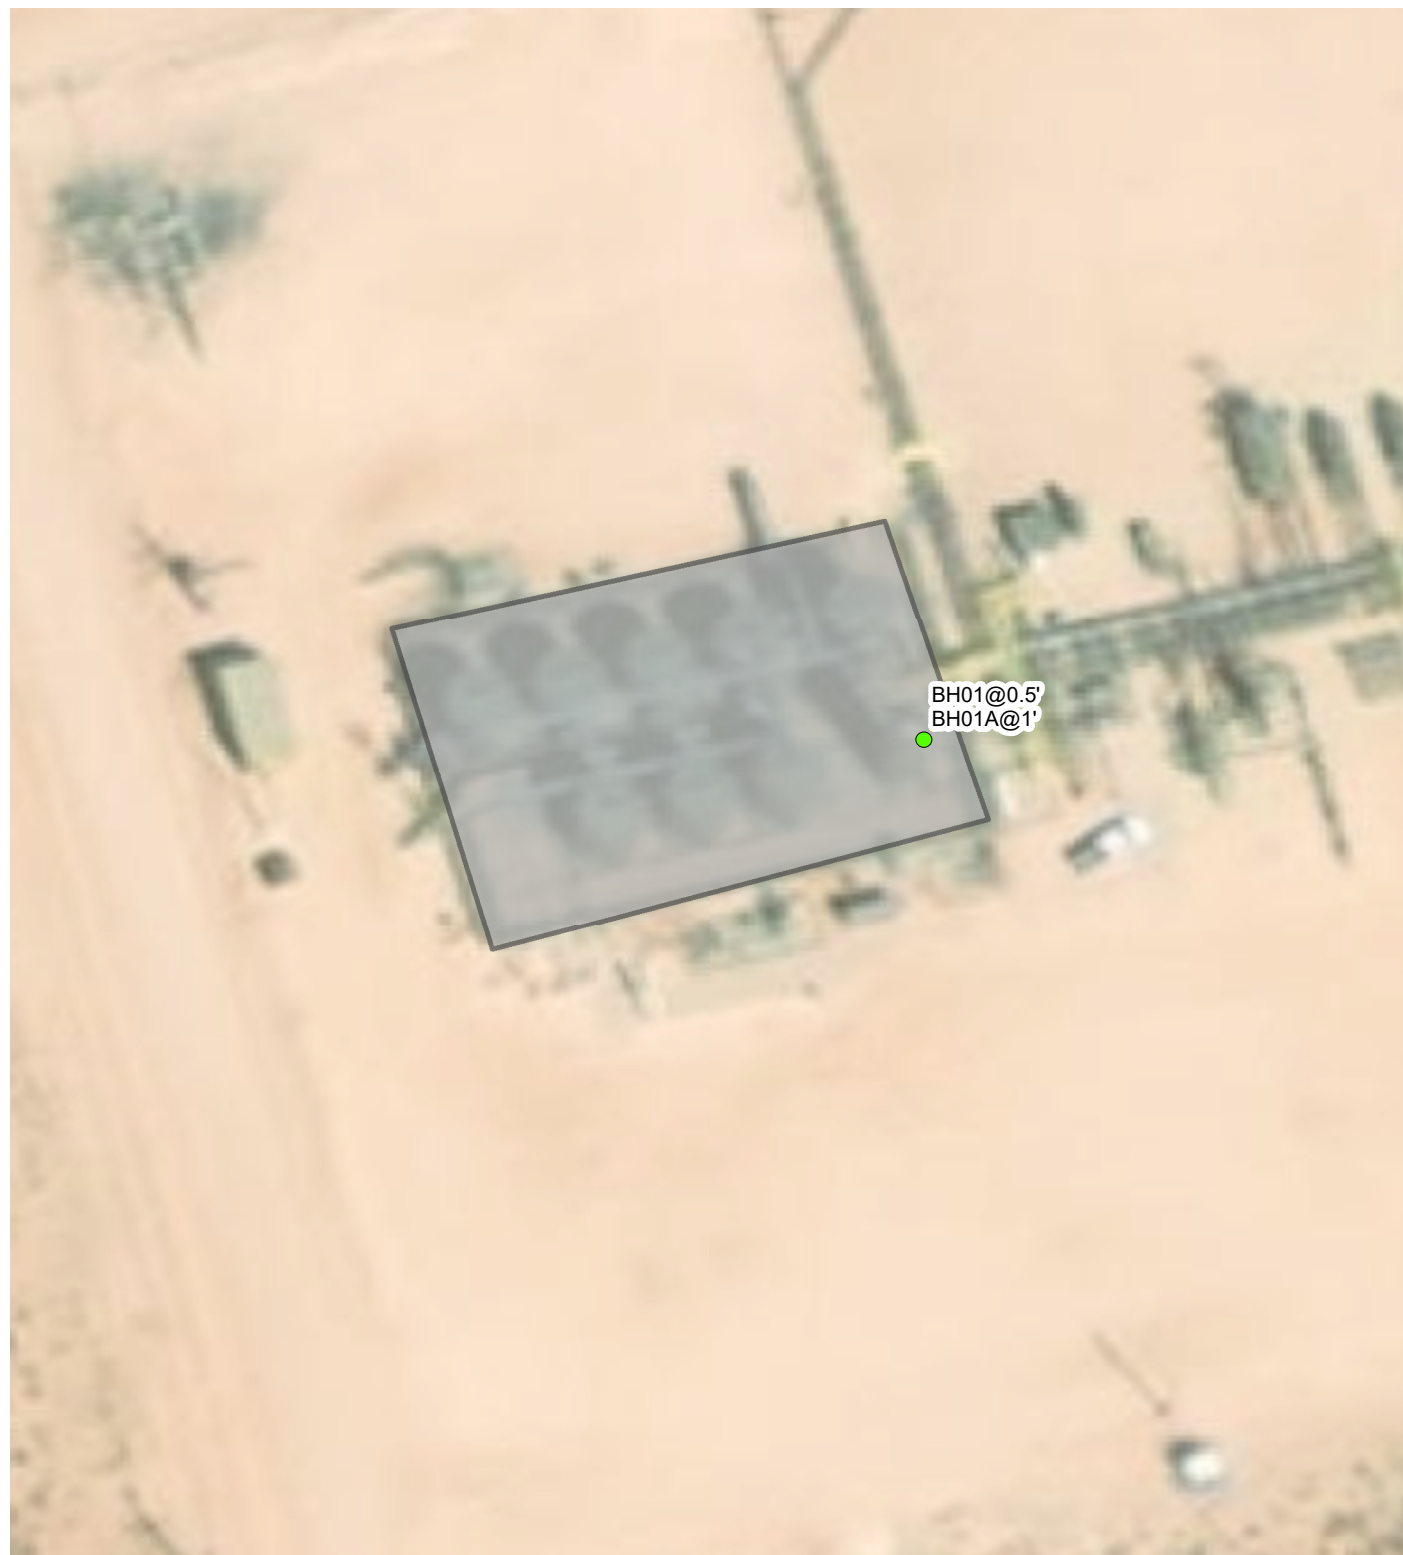
**FIGURE 2**  
**DELINEATION SOIL SAMPLE LOCATIONS**  
ROSS DRAW 30-31  
UNIT H SEC 31 T26S R30E  
EDDY COUNTY, NEW MEXICO  
**XTO ENERGY, INC.**

On January 4, 2021, WSP personnel were at the Site to evaluate the release extent based on information provided on the Form C-141 and visual observations. WSP personnel advanced one borehole (BH01) via hand-auger at the location of the tear in the liner identified during the liner integrity inspection. Two soil samples were collected from borehole BH01 at depths of approximately 0.5 feet and 1-foot bgs before encountering auger refusal. Soil from the borehole was field screened for volatile aromatic hydrocarbons and chloride utilizing a calibrated photo-ionization detector (PID) and Hach® chloride QuanTab® test strips, respectively. Field screening results and observations from the borehole were documented on a lithologic/soil sampling log which is included as Attachment 2. The borehole was backfilled with the soil removed and XTO repaired the tear in the liner. The borehole delineation soil sample location is depicted on Figure 2. Photographic documentation was conducted during the Site visit. The photographic log is included in Attachment 3.

Laboratory analytical results for delineation soil samples BH01 and BH01A, collected at depths of approximately 0.5 feet and 1-foot bgs, indicated that benzene, BTEX, TPH, and chloride concentrations were compliant with the Closure Criteria. Laboratory analytical results are summarized in Table 1 and the complete laboratory analytical report is included as Attachment 4.

Following the failed liner integrity inspection at the Site, WSP personnel advanced one borehole (BH01) at the location of the tear in the liner to assess for the presence or absence of soil impacts resulting from the November 19, 2020 produced water release within lined containment. Two delineation soil samples were collected from borehole BH01 at depths of approximately 0.5 feet and 1-foot bgs. Laboratory analytical results indicated that benzene, BTEX, TPH, and chloride concentrations were compliant with the Closure Criteria. Additionally, field screening of soil from the borehole indicated no elevated volatile aromatic hydrocarbons or chloride concentrations beneath the tear in the liner. The release was contained laterally by the lined containment and all released fluids were recovered during initial response activities. The tear in the liner was subsequently repaired.

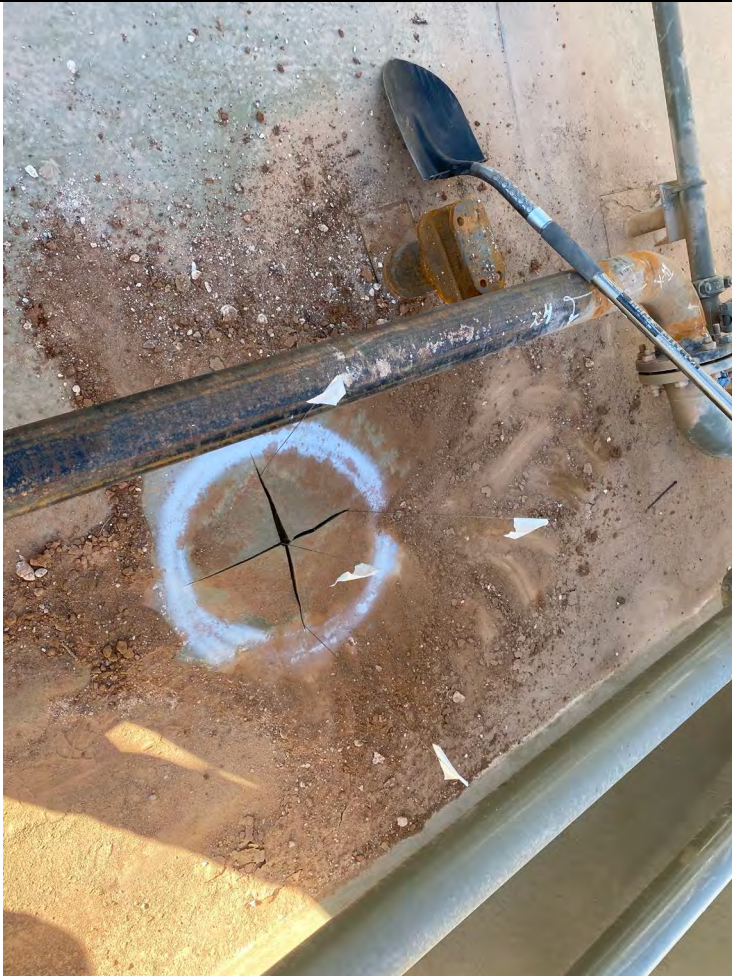
| Photo No. | Date | |
|---|---|---|
| View of liner breach near eastern edge of liner after delineation. | | A photograph showing a circular, light-colored, cracked area on a dark, textured surface, likely a liner. A blue shovel is visible in the upper right corner, and a metal pipe runs horizontally across the middle of the frame. The ground is covered in dirt and debris. |
