**Re: Liner Inspection and Closure Report
Boundary Raider 6 7 Fed Com #213H
(Incident Occurred at the Todd-Apache 6 CTB Facility)
API No. 30-025-44147
GPS: Latitude 32.339818 Longitude -103.720109
UL "D", Sec. 6, T23S, R32E
Lea County, NM
NMOCD Ref. No. NOY1809255038 (1RP-5005)**

Liner Inspection Form

Liner Inspection Photographs

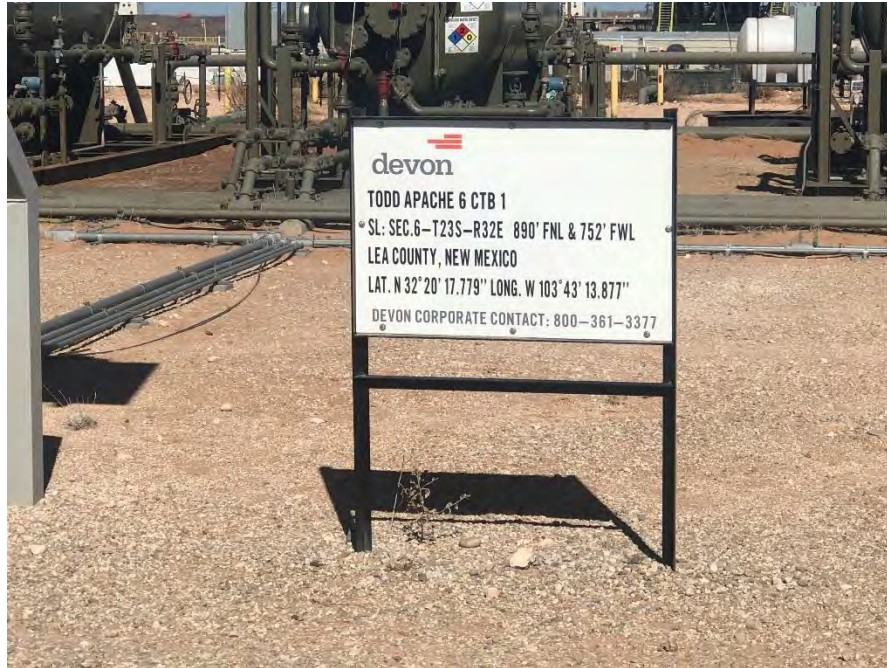
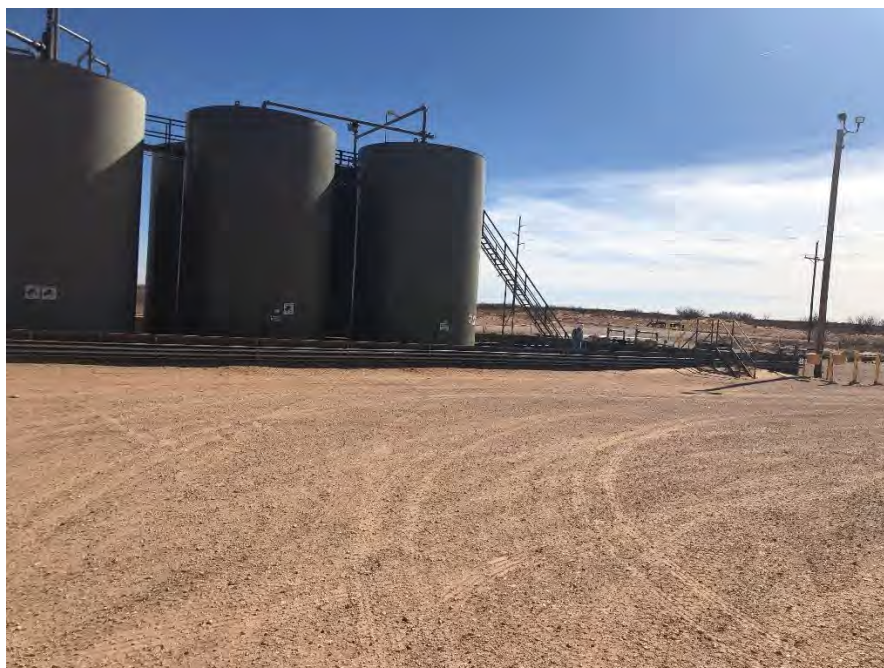
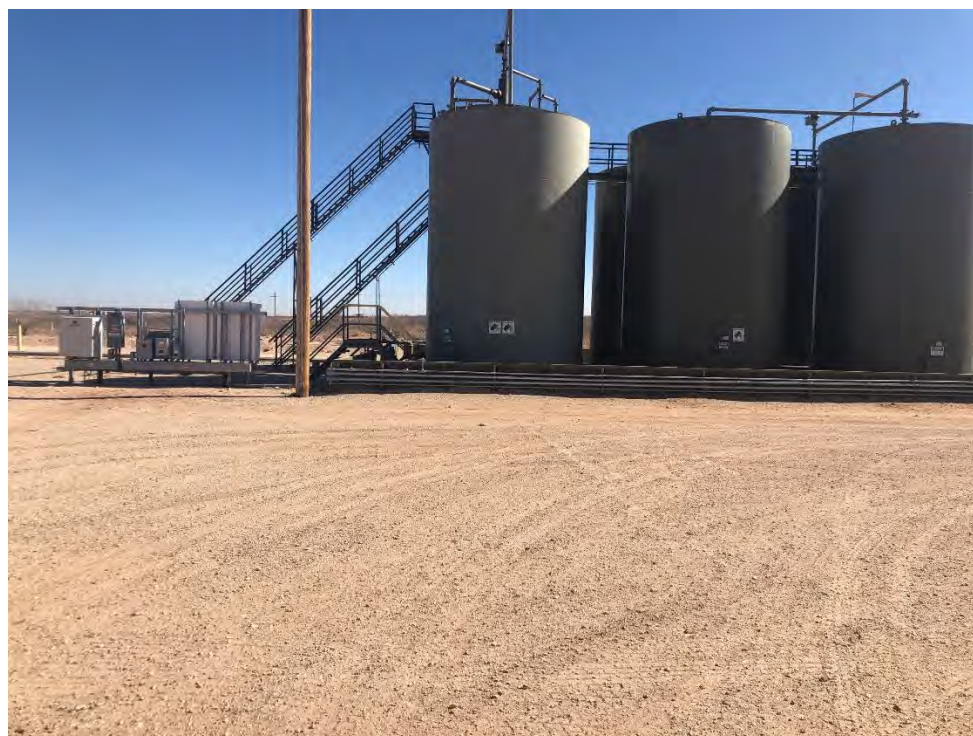
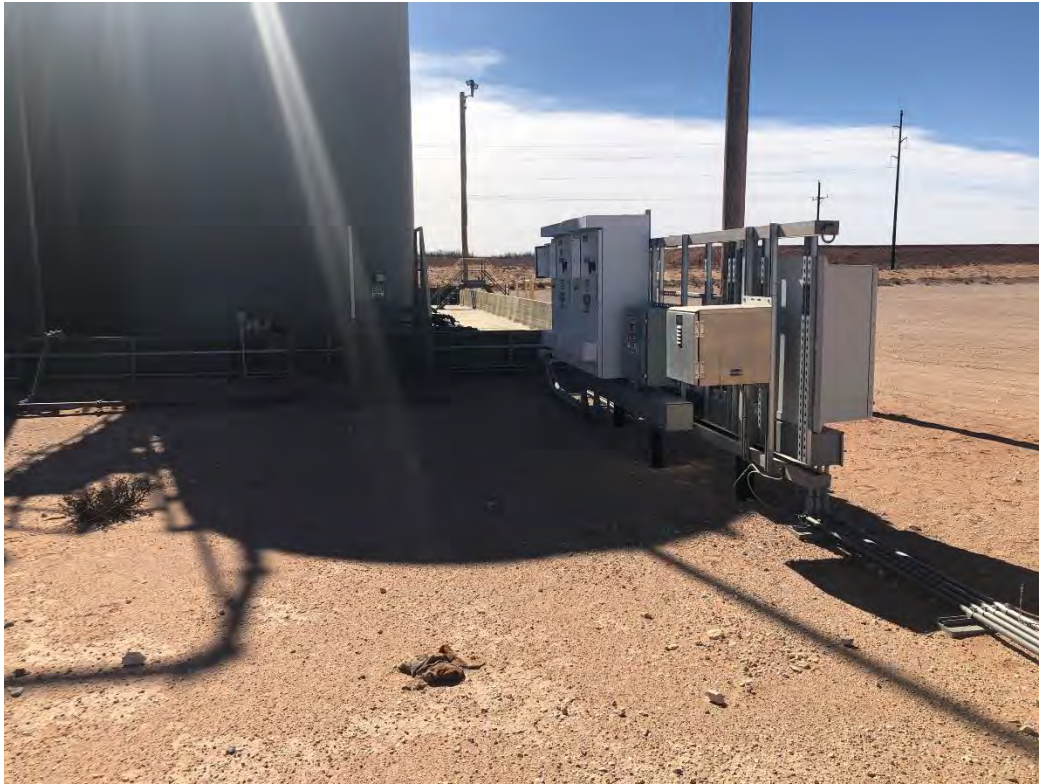
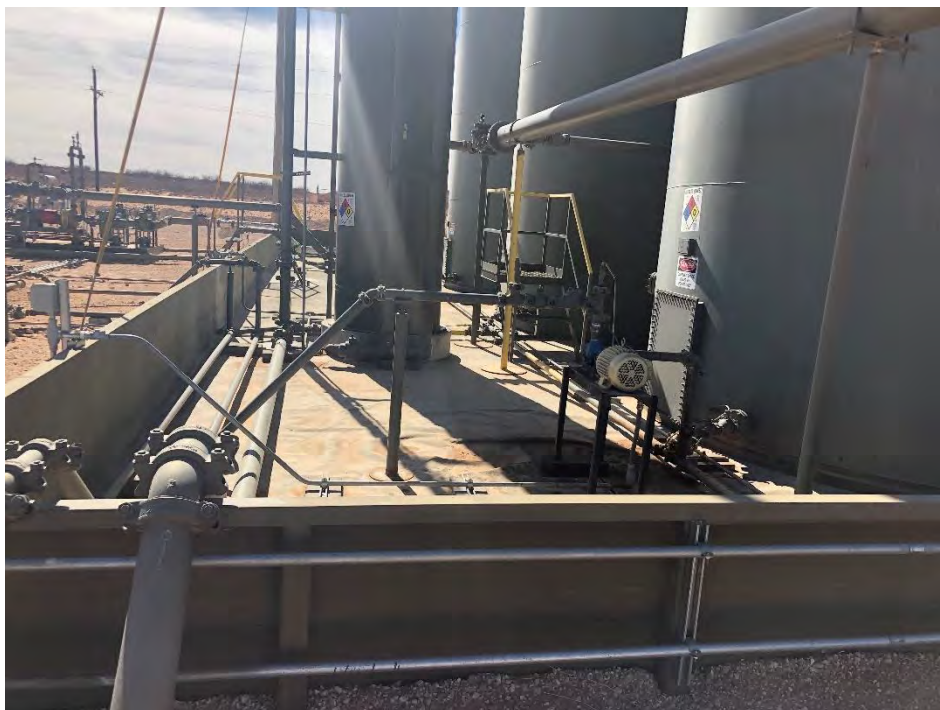
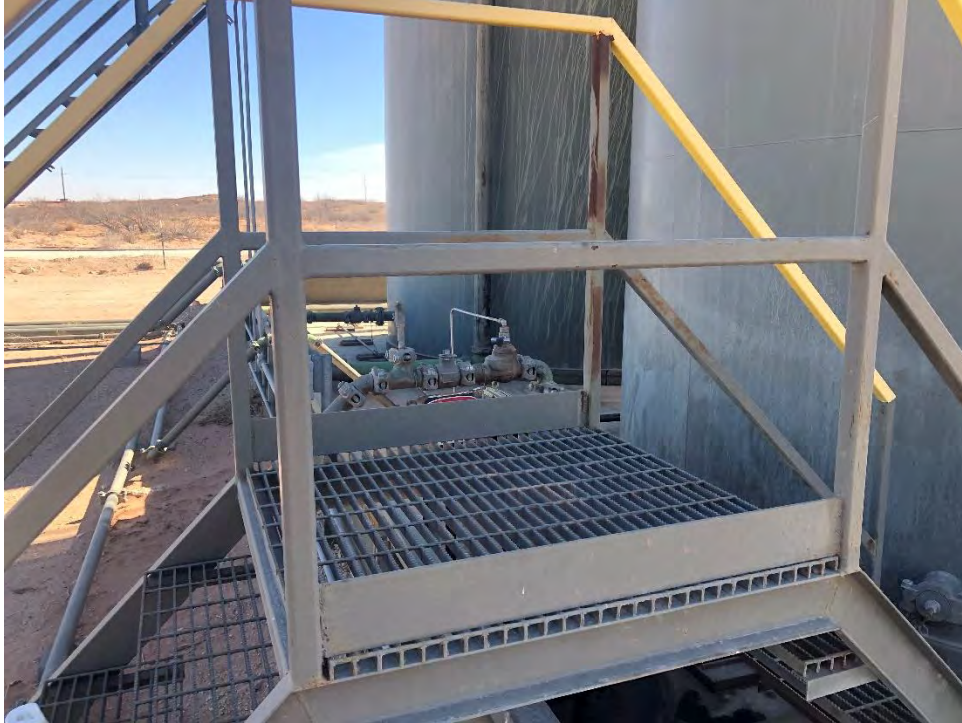
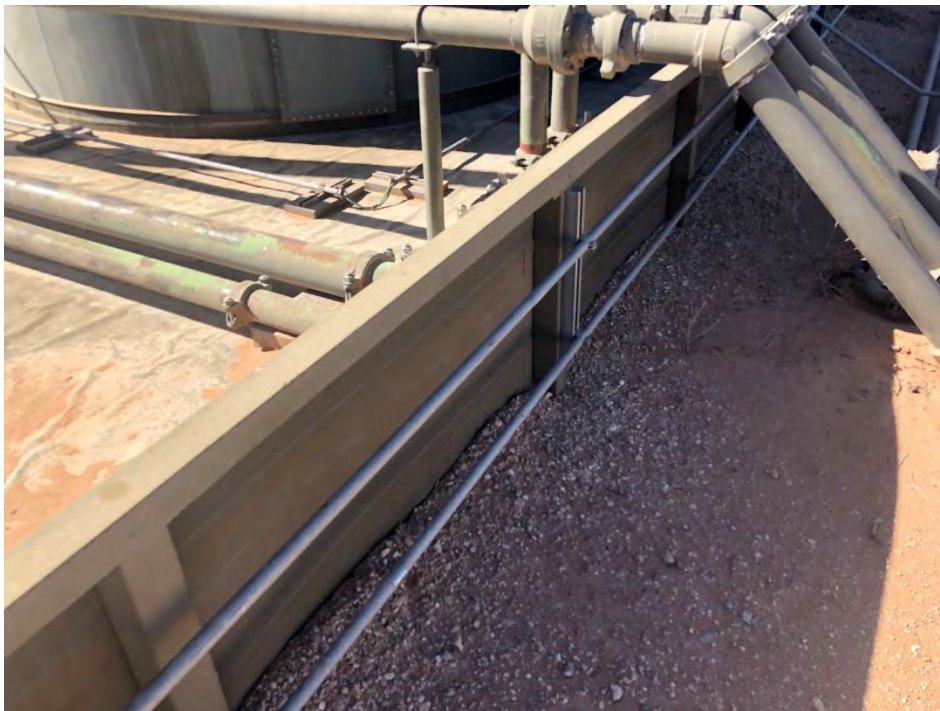
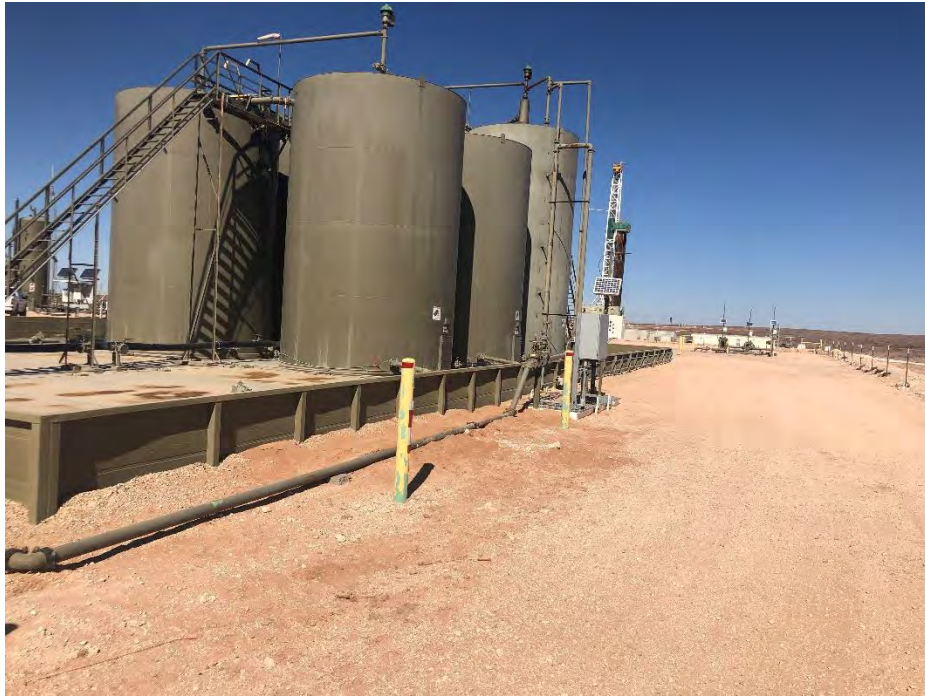
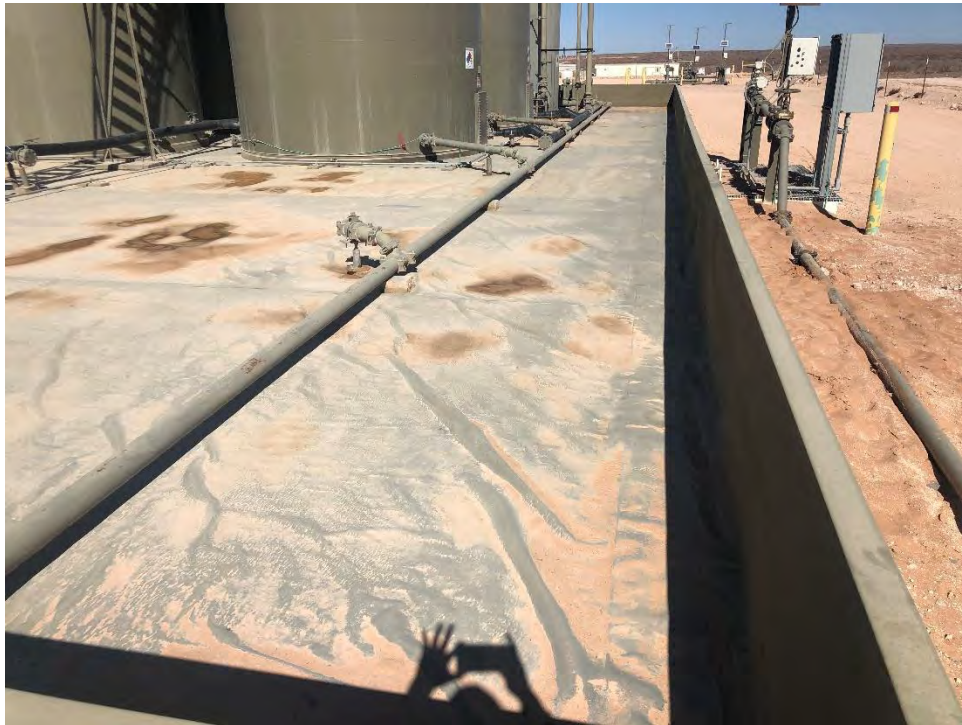
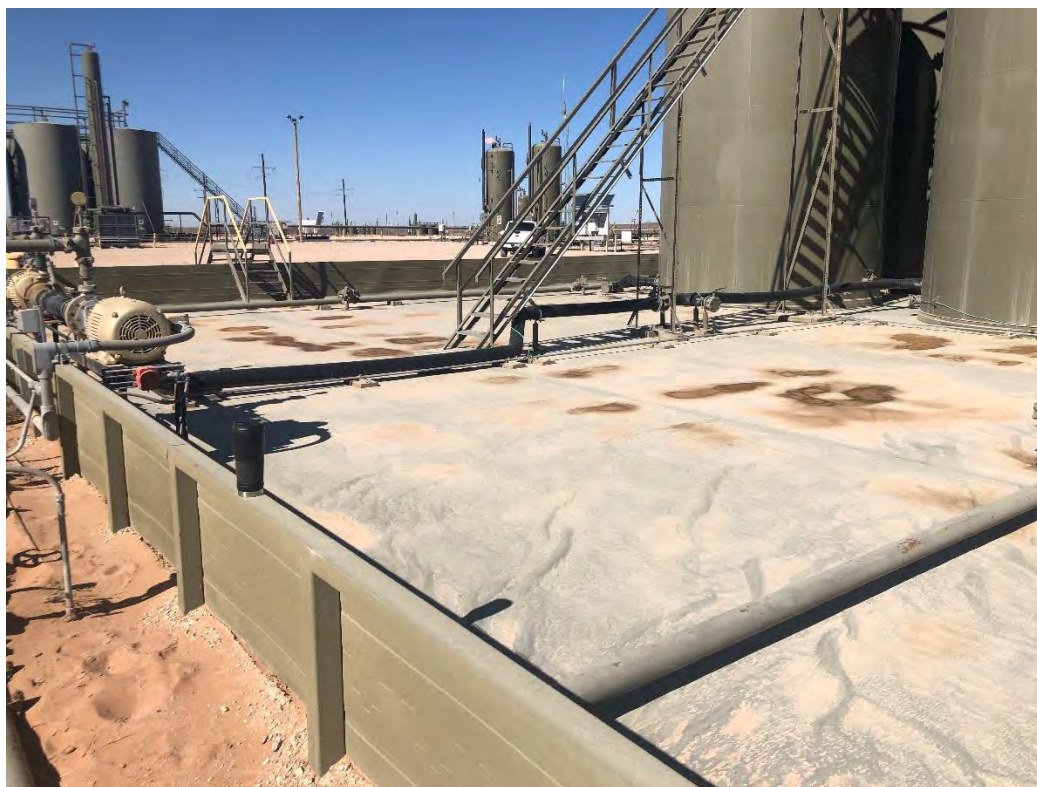
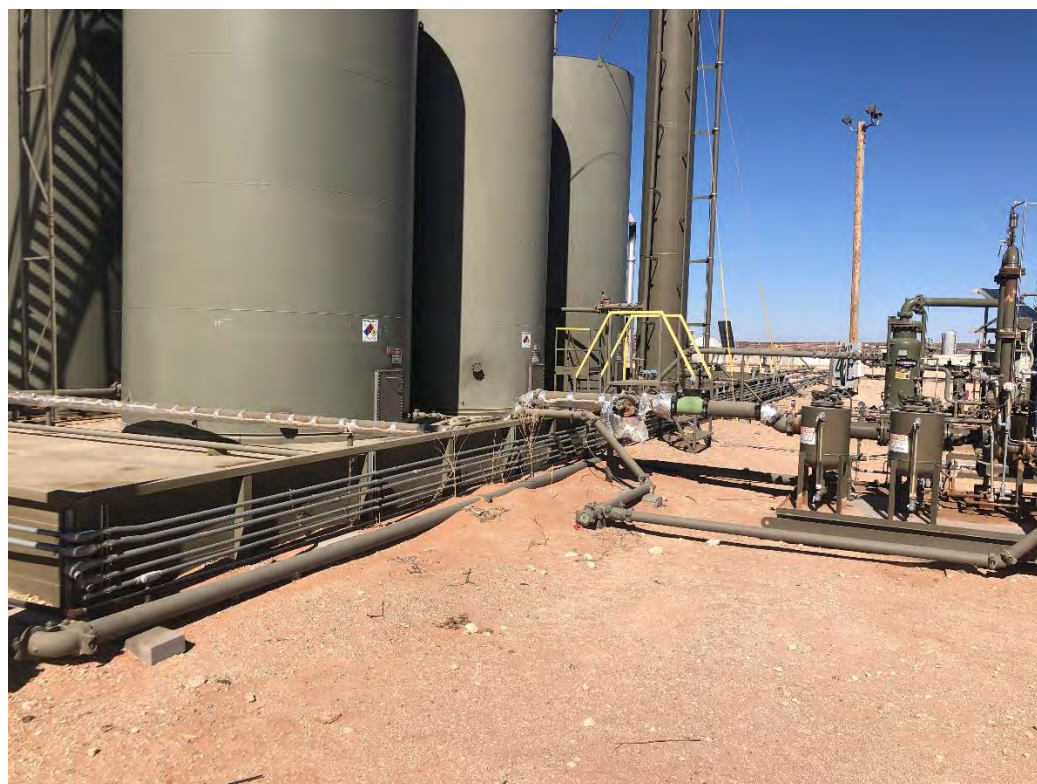
Visualization	Yes	No	Comments
Is there a tear in the liner?		×	
Are there holes in the liner?		×	
Is the liner retaining any fluids?		×	
Does the liner have integrity to contain a leak?	×

Comments: 2 liner locations on site, east side and west sideInspector Name: Robert Carper Inspector Signature:
