Remediation Summary & Deferral Request

Contango Oil & Gas, Inc.

Kersey State Battery

NMOCD Reference No. nRM2004550944

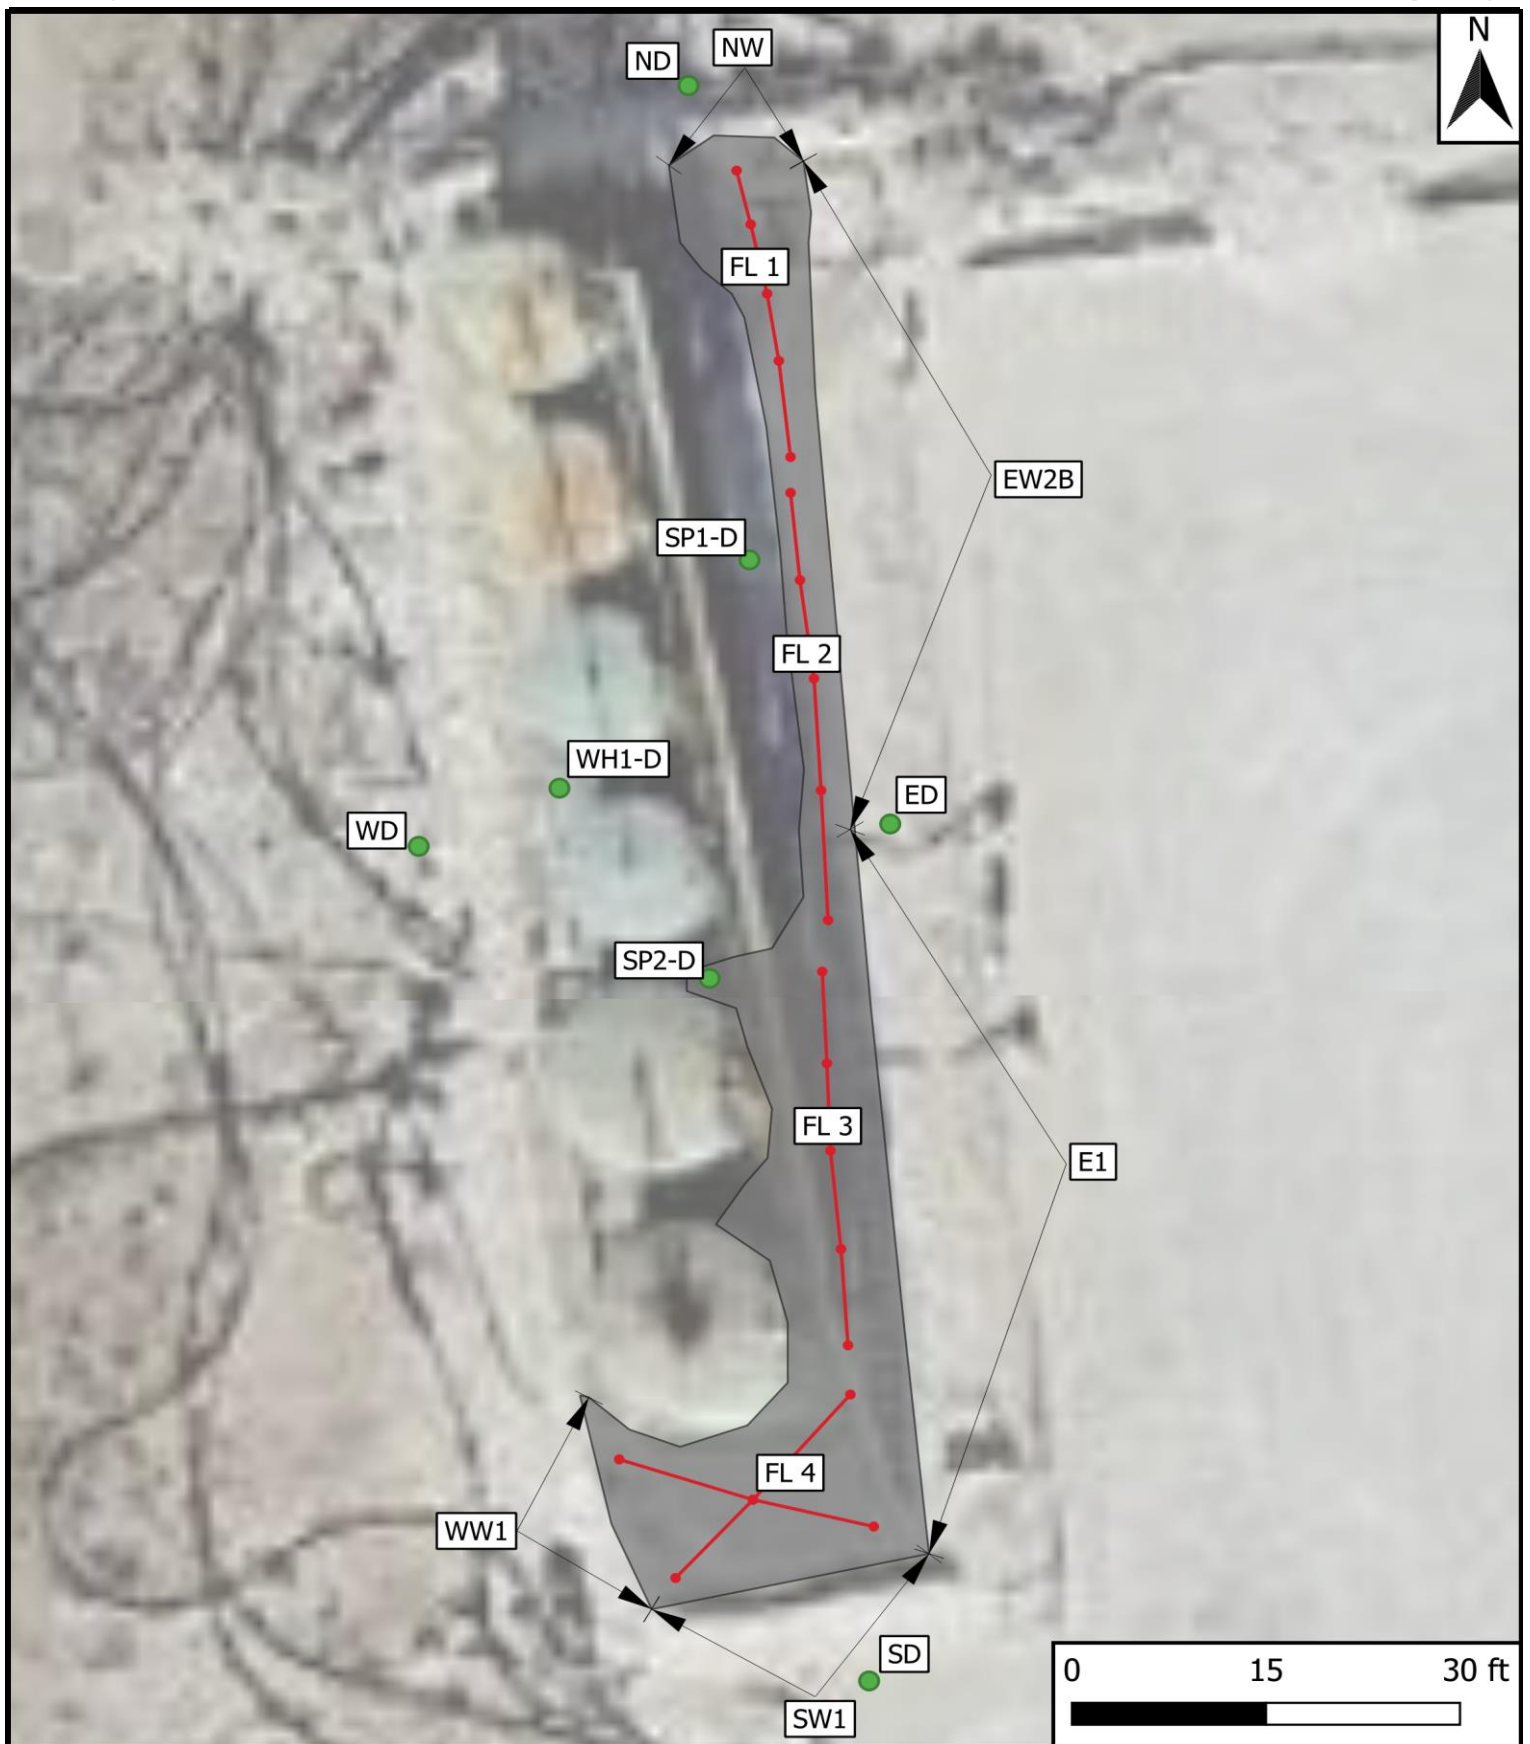
Figure 3

Site & Sample Location Map

- Excavation
- Sample Location
- Composite Floor Sample
- Composite Wall Sample

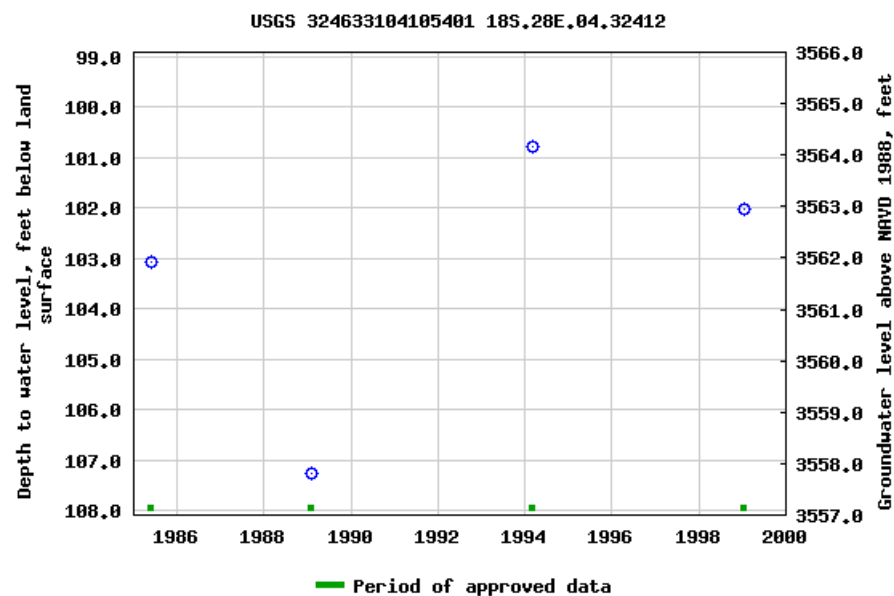
Breaks in the plot represent a gap of at least one year between field measurements.

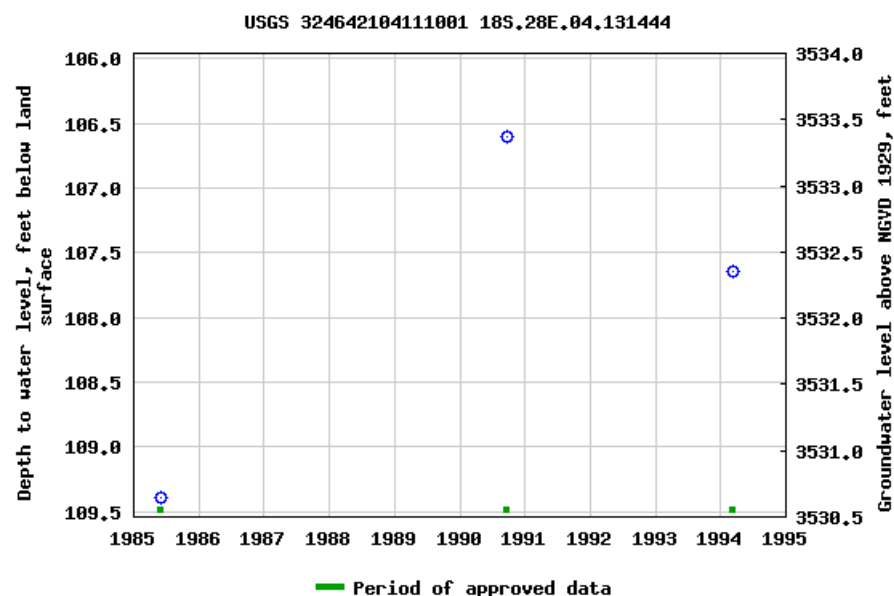
This well is completed in the Rustler Formation (312RSLR) local aquifer.

Breaks in the plot represent a gap of at least one year between field measurements.

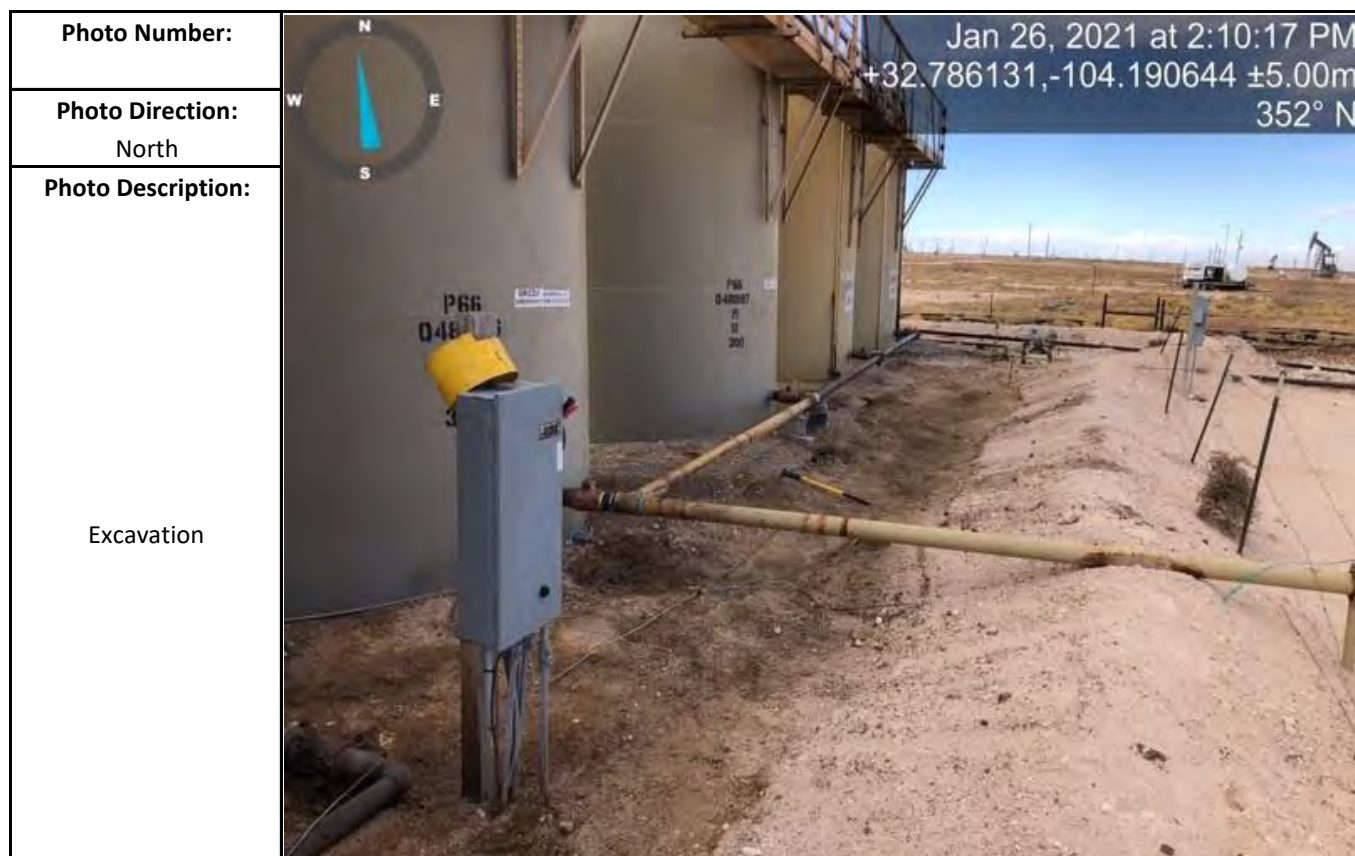
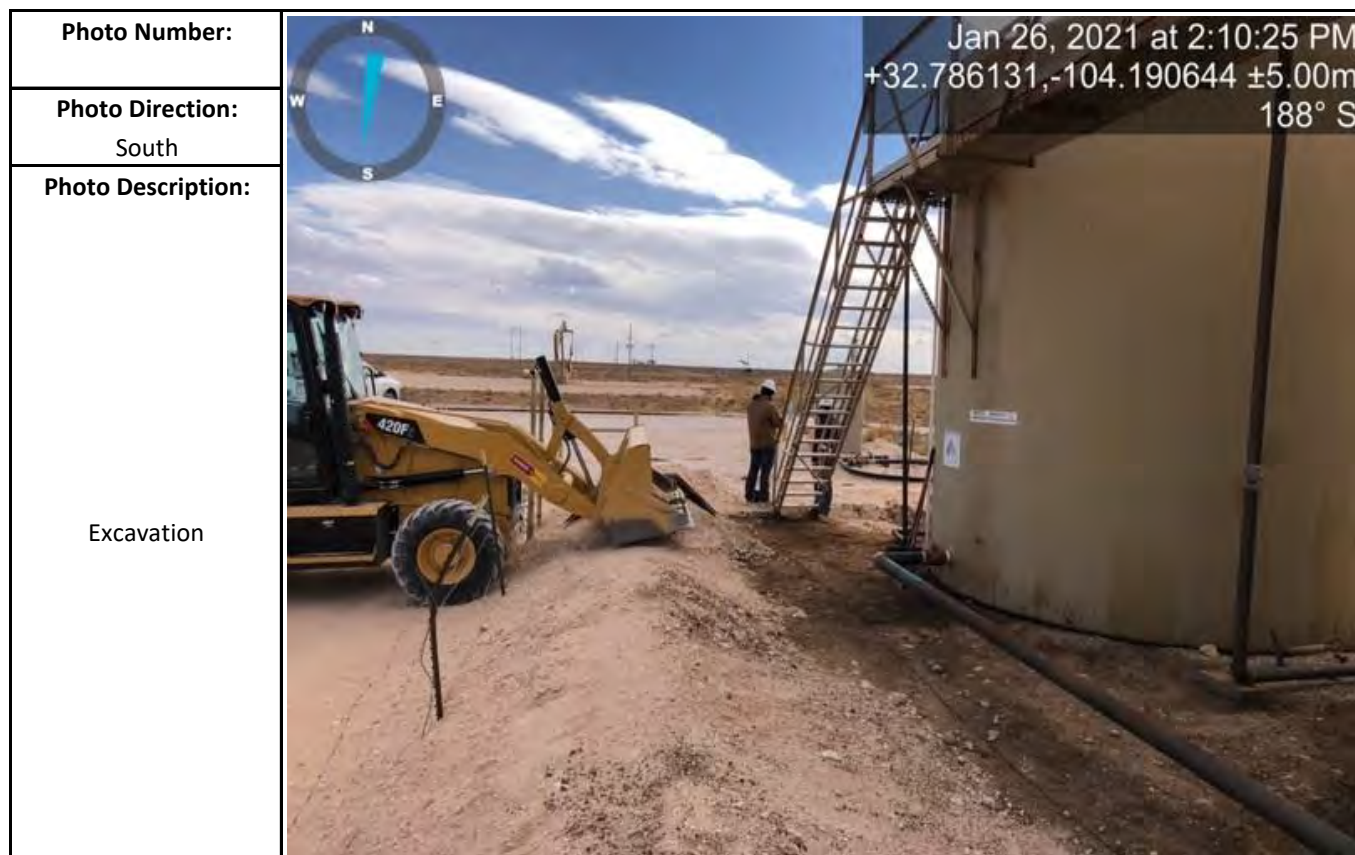
Photographic Log

Photo Number:	
Photo Direction: North	
Photo Description:	
Backfilled Excavation
