Vertex Project #: 21E-00087-008

Spill Closure Report: Young Deep Unit #011
Unit F, Section 09, Township 18 South, Range 32 East
County: Lea
NMOCD Tracking Number: nAPP2107445051

2021 Spill Assessment and ClosureApril 2021

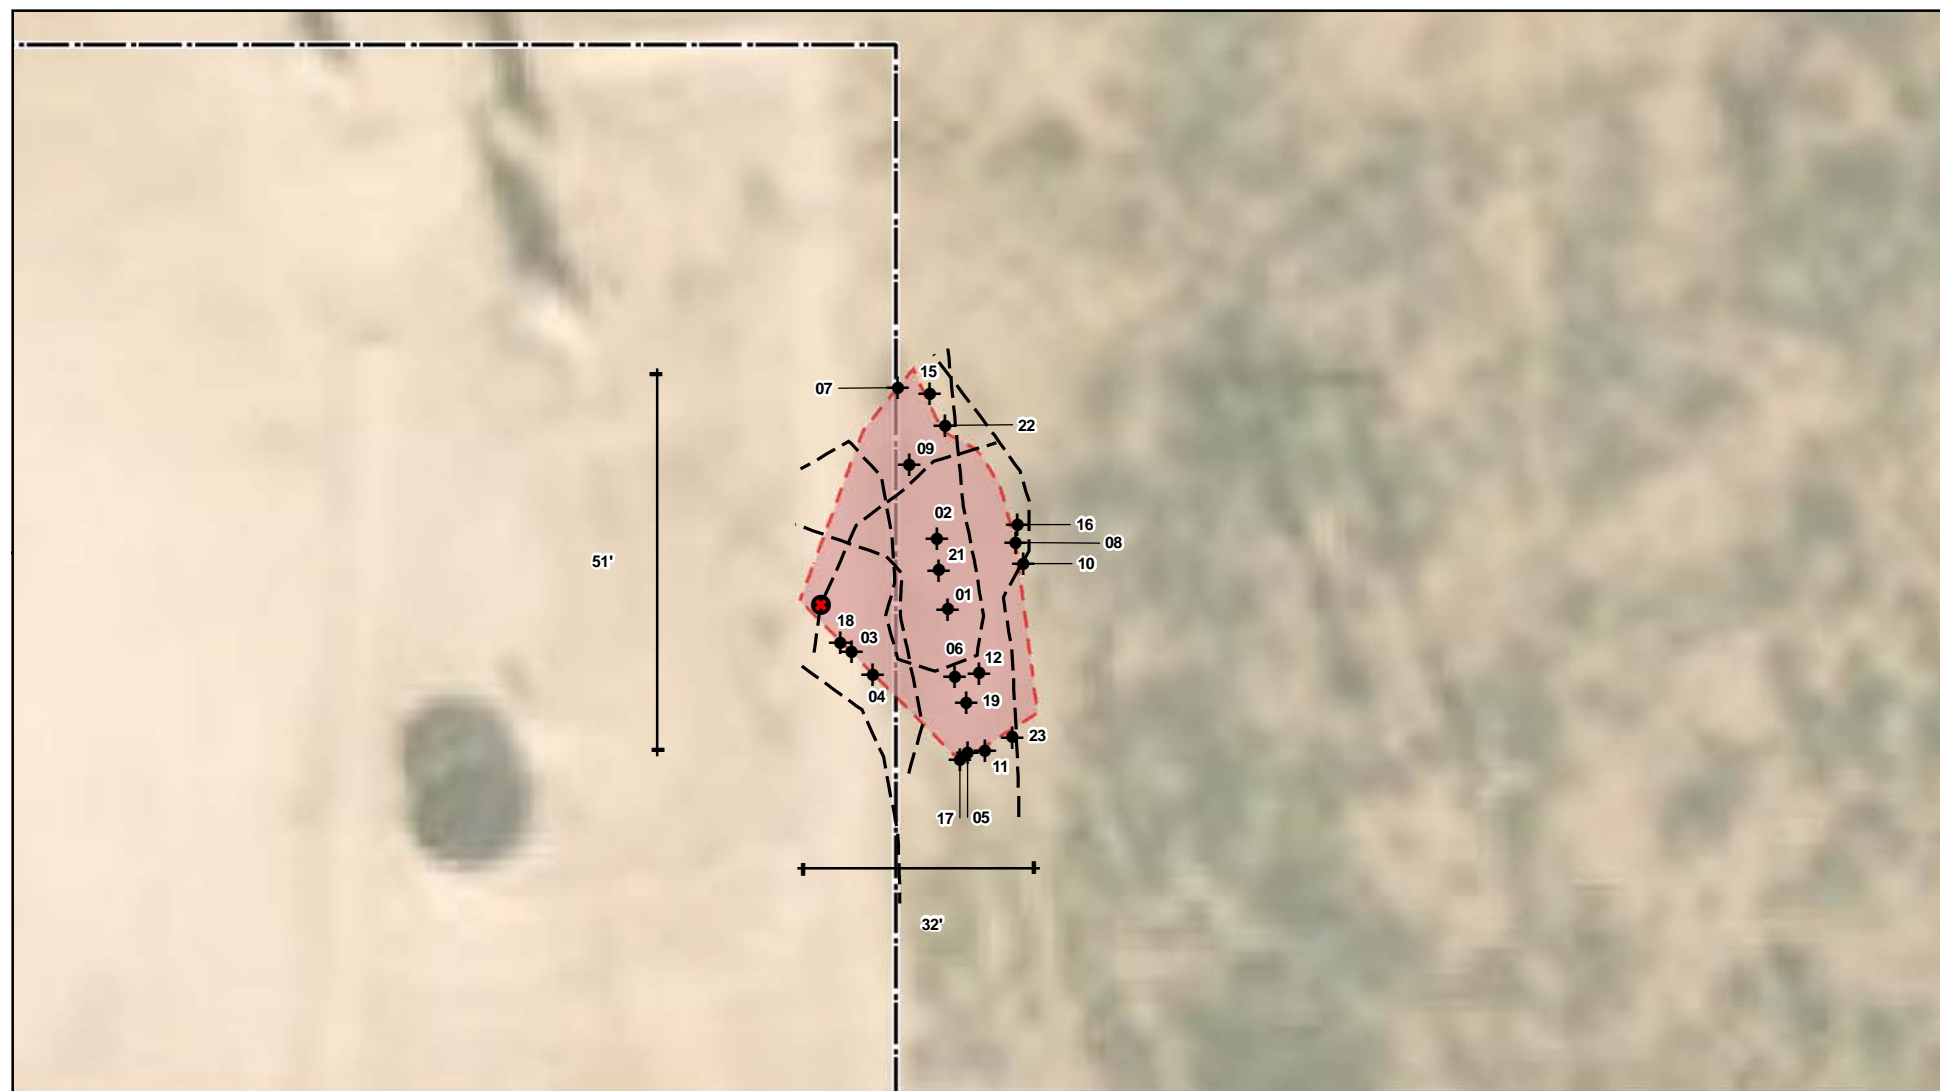
1

- ◆ Borehole (Prefixed by "BH21-")
- Point of Release
- Aboveground Pipeline
- Approximate Spill Extent (914 sq. ft.)
- Approximate Lease Boundary

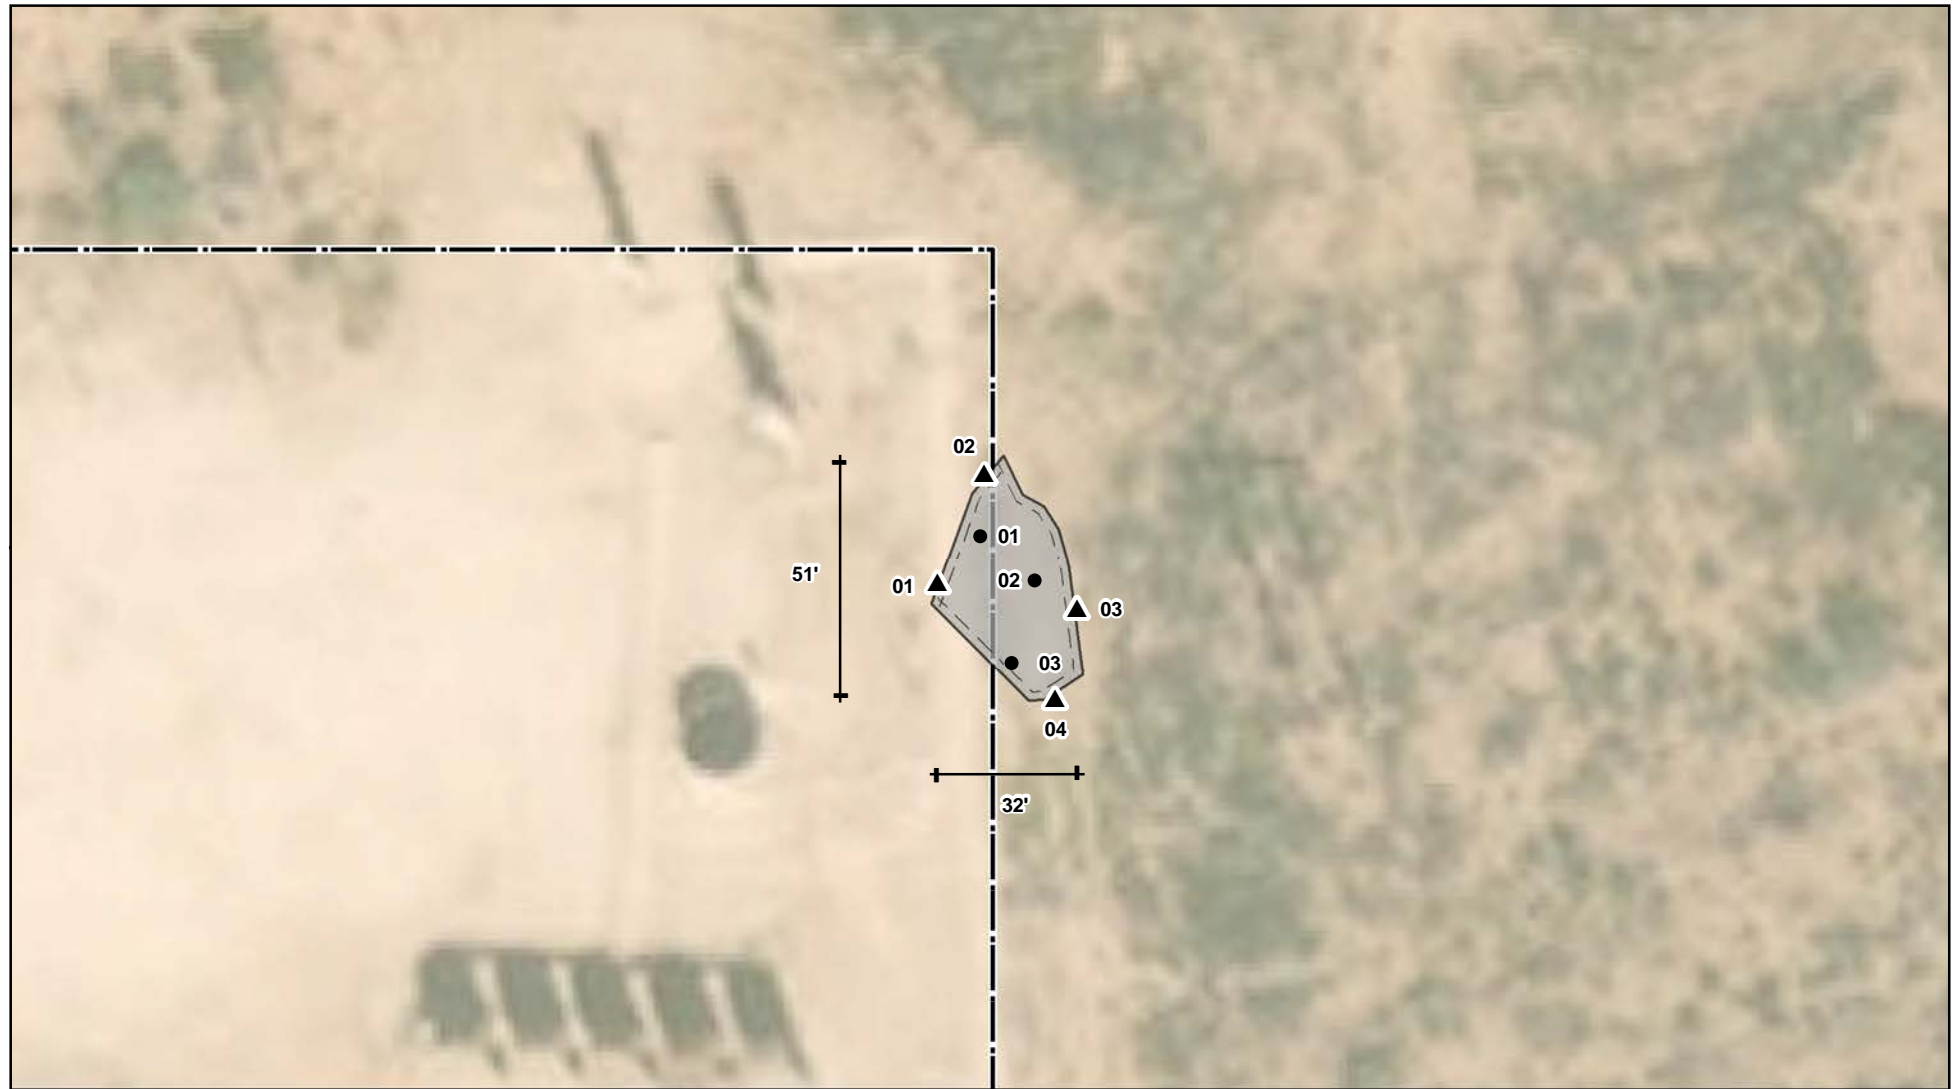
- Base Sample
- ▲ Wall Sample
-

A GeoExplorer 7000 Series Trimble global positioning system (GPS) unit, or equivalent, was used to map the approximate center of each of the five-point composite samples. The confirmatory sample locations are presented on Figure 1 (Attachment 2). Relevant equipment and prominent features/reference points at the site are mapped as well.

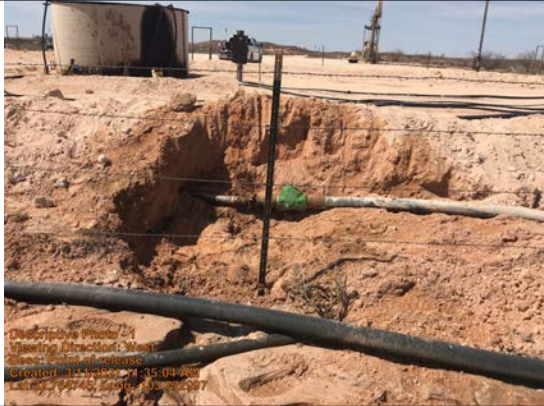
Viewing Direction: West

Point of release

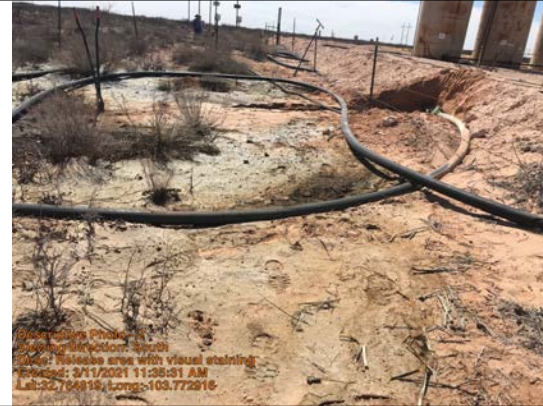
Viewing Direction: South

Release area with visual staining

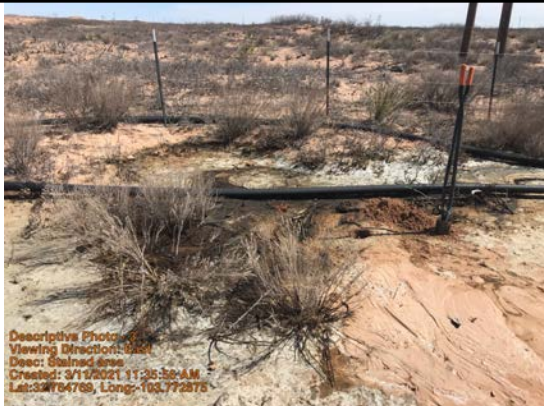
Viewing Direction: East

Stained area

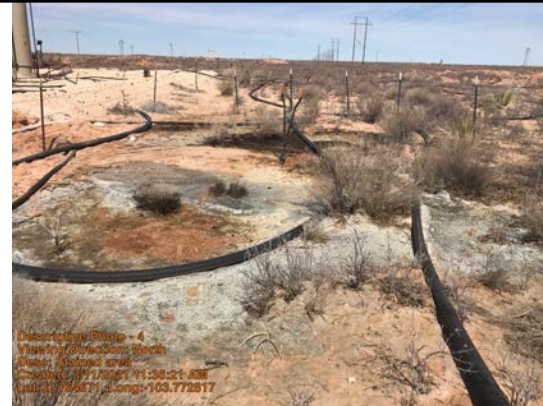
Viewing Direction: North

Stained area

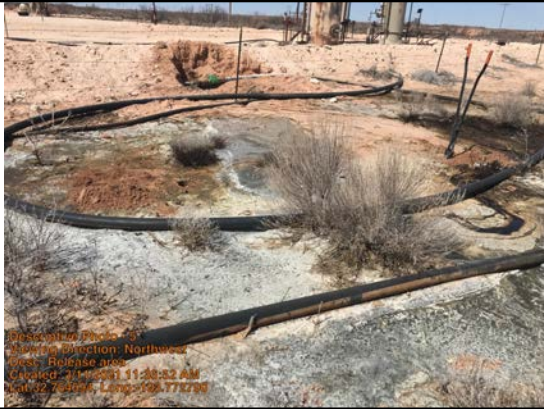
Viewing Direction: Northwest

Release area

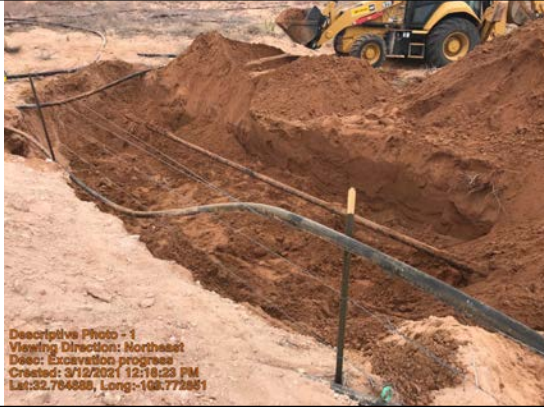
Viewing Direction: Northeast

Excavation progress

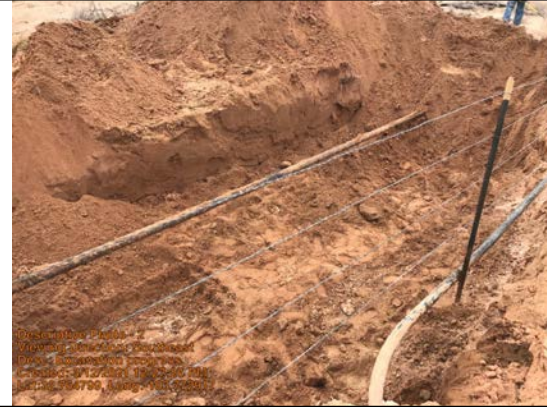
Viewing Direction: Southeast

Excavation progress

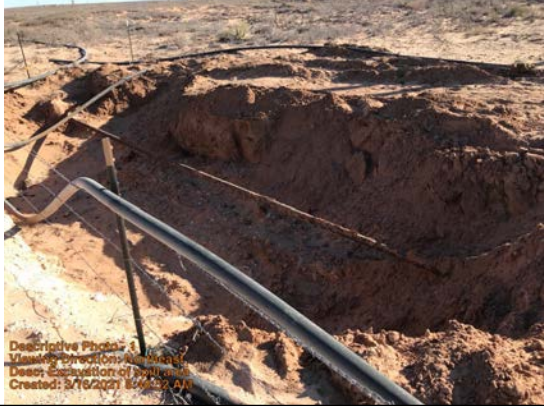
Viewing Direction: Northeast

Excavation of spill area

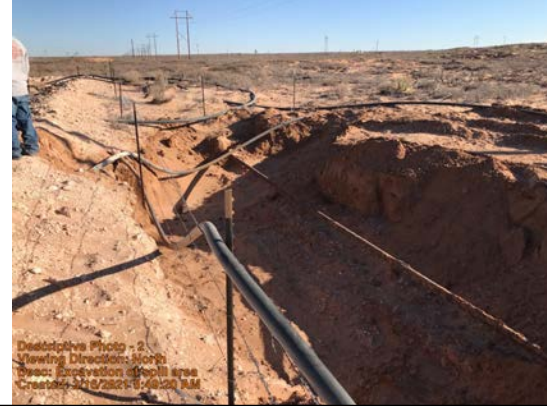
Viewing Direction: North

Excavation of spill area

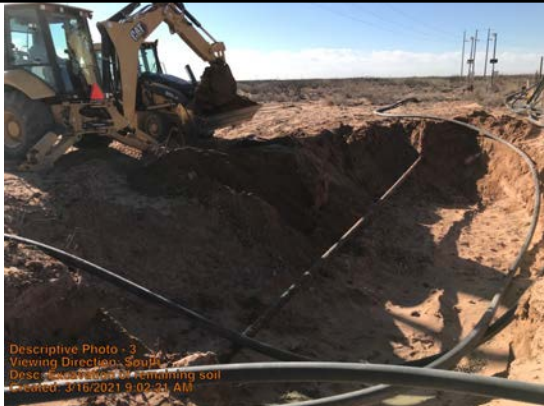
Viewing Direction: South

Excavation of remaining soil

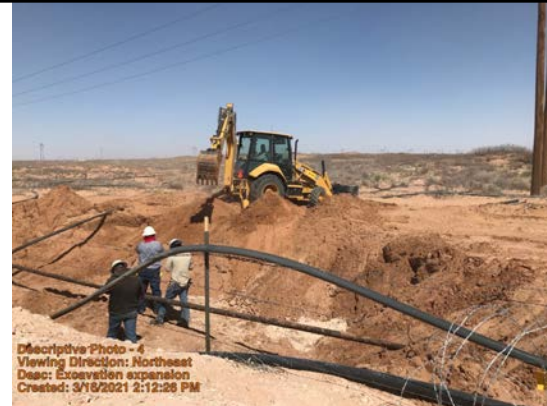
Viewing Direction: Northeast

Excavation expansion

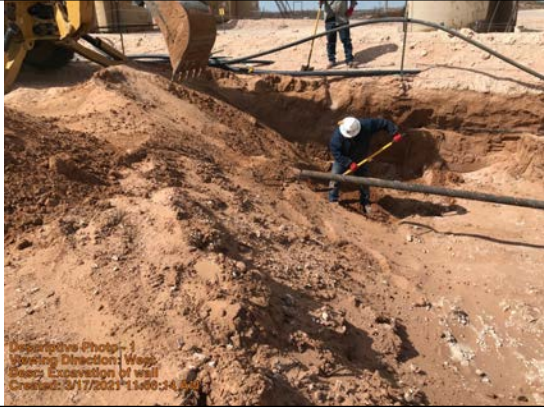
Viewing Direction: West

Excavation of wall

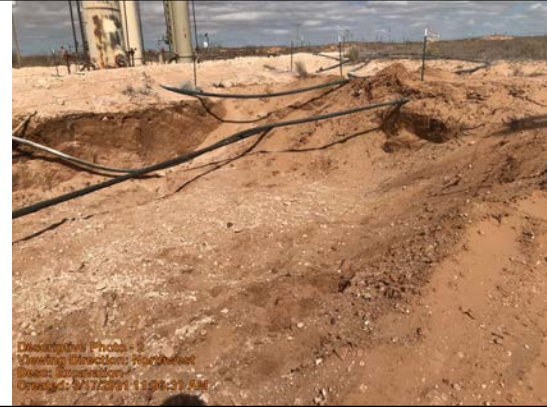
Viewing Direction: Northwest

Excavation

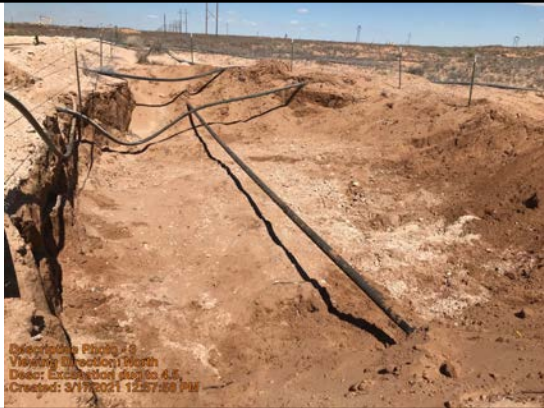
Viewing Direction: North

Excavation dug to 4.5' deep

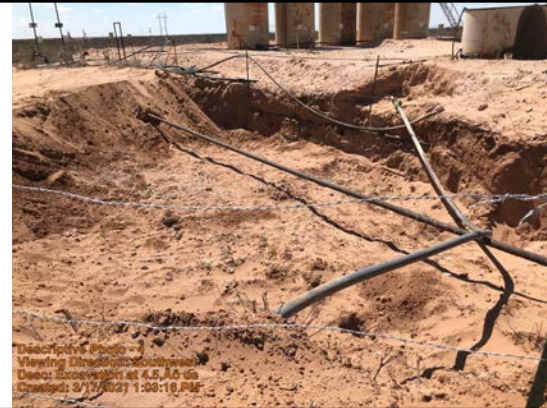
Viewing Direction: Southwest

Excavation at 4.5' deep

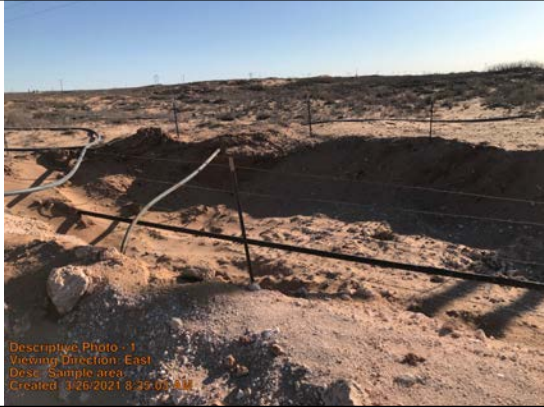
Viewing Direction: East

Sample area.

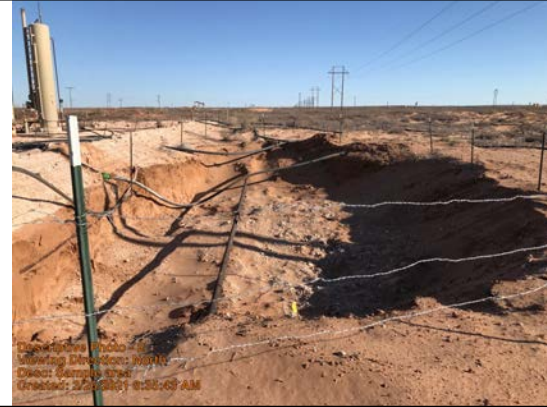
Viewing Direction: North

Sample area

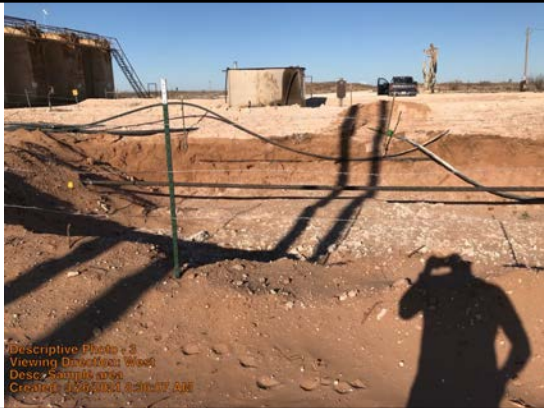
Viewing Direction: West

Sample area
