State of New Mexico
Energy Minerals and Natural
Resources Department
Oil Conservation Division
1220 South St. Francis Dr.
Santa Fe, NM 87505

RE: Closure Request
PLU 25 Brushy Draw West Tank Battery
Incident Number NRM2026546692
Eddy County, New Mexico

WSP USA Inc. (WSP) on behalf of XTO Energy, Inc. (XTO), presents the following Closure Request detailing site assessment, excavation, and soil sampling activities at the PLU 25 Brushy Draw West Tank Battery (TB) (Site) in Unit F, Section 25, Township 25 South, Range 30 East, in Eddy County, New Mexico (Figure 1). The purpose of the site assessment, excavation, and soil sampling activities was to address impacts to soil following a release of crude oil at the Site. Based on the excavation activities and soil sample laboratory analytical results, XTO is submitting this Closure Request, describing remediation that has occurred and requesting no further action (NFA) for Incident Number NRM2026546692.

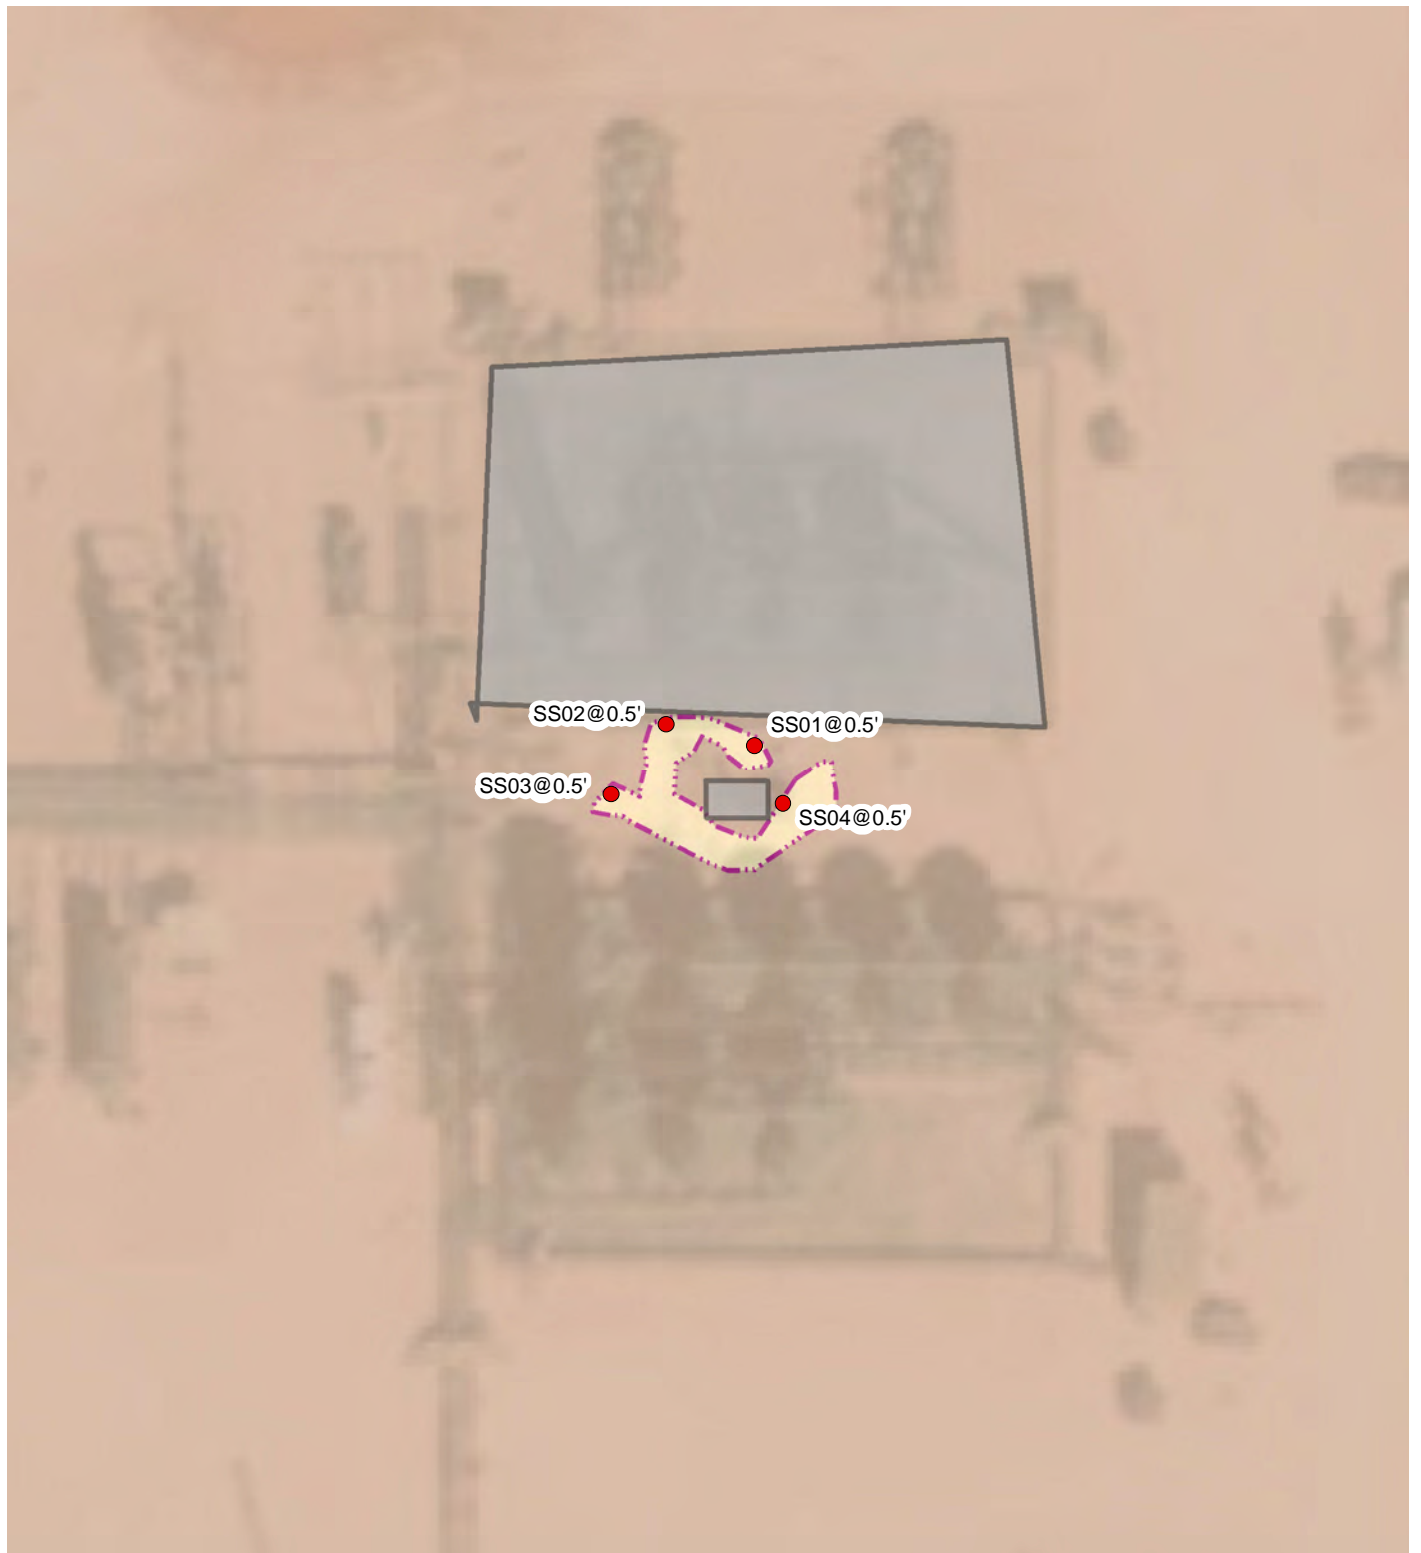
P:\XTO Energy\GIS\IMXD\012920141_PLU 25_BRUSHY DRAW WEST_TB\012920141_FIG02_PRELIMINARY_2020.mxd

calibrated photoionization detector (PID) and Hach® chloride QuanTab® test strips, respectively. The release extent and preliminary soil sample locations were mapped utilizing a handheld Global Positioning System (GPS) unit and are depicted on Figure 2.

Laboratory analytical results for preliminary soil samples SS01 through SS04, indicated that BTEX and/or TPH-GRO/TPH-DRO and TPH concentrations exceeded the Site Closure Criteria. Based on visible staining in the release area, elevated field screening results, and laboratory analytical results for the preliminary soil samples, excavation activities were warranted.

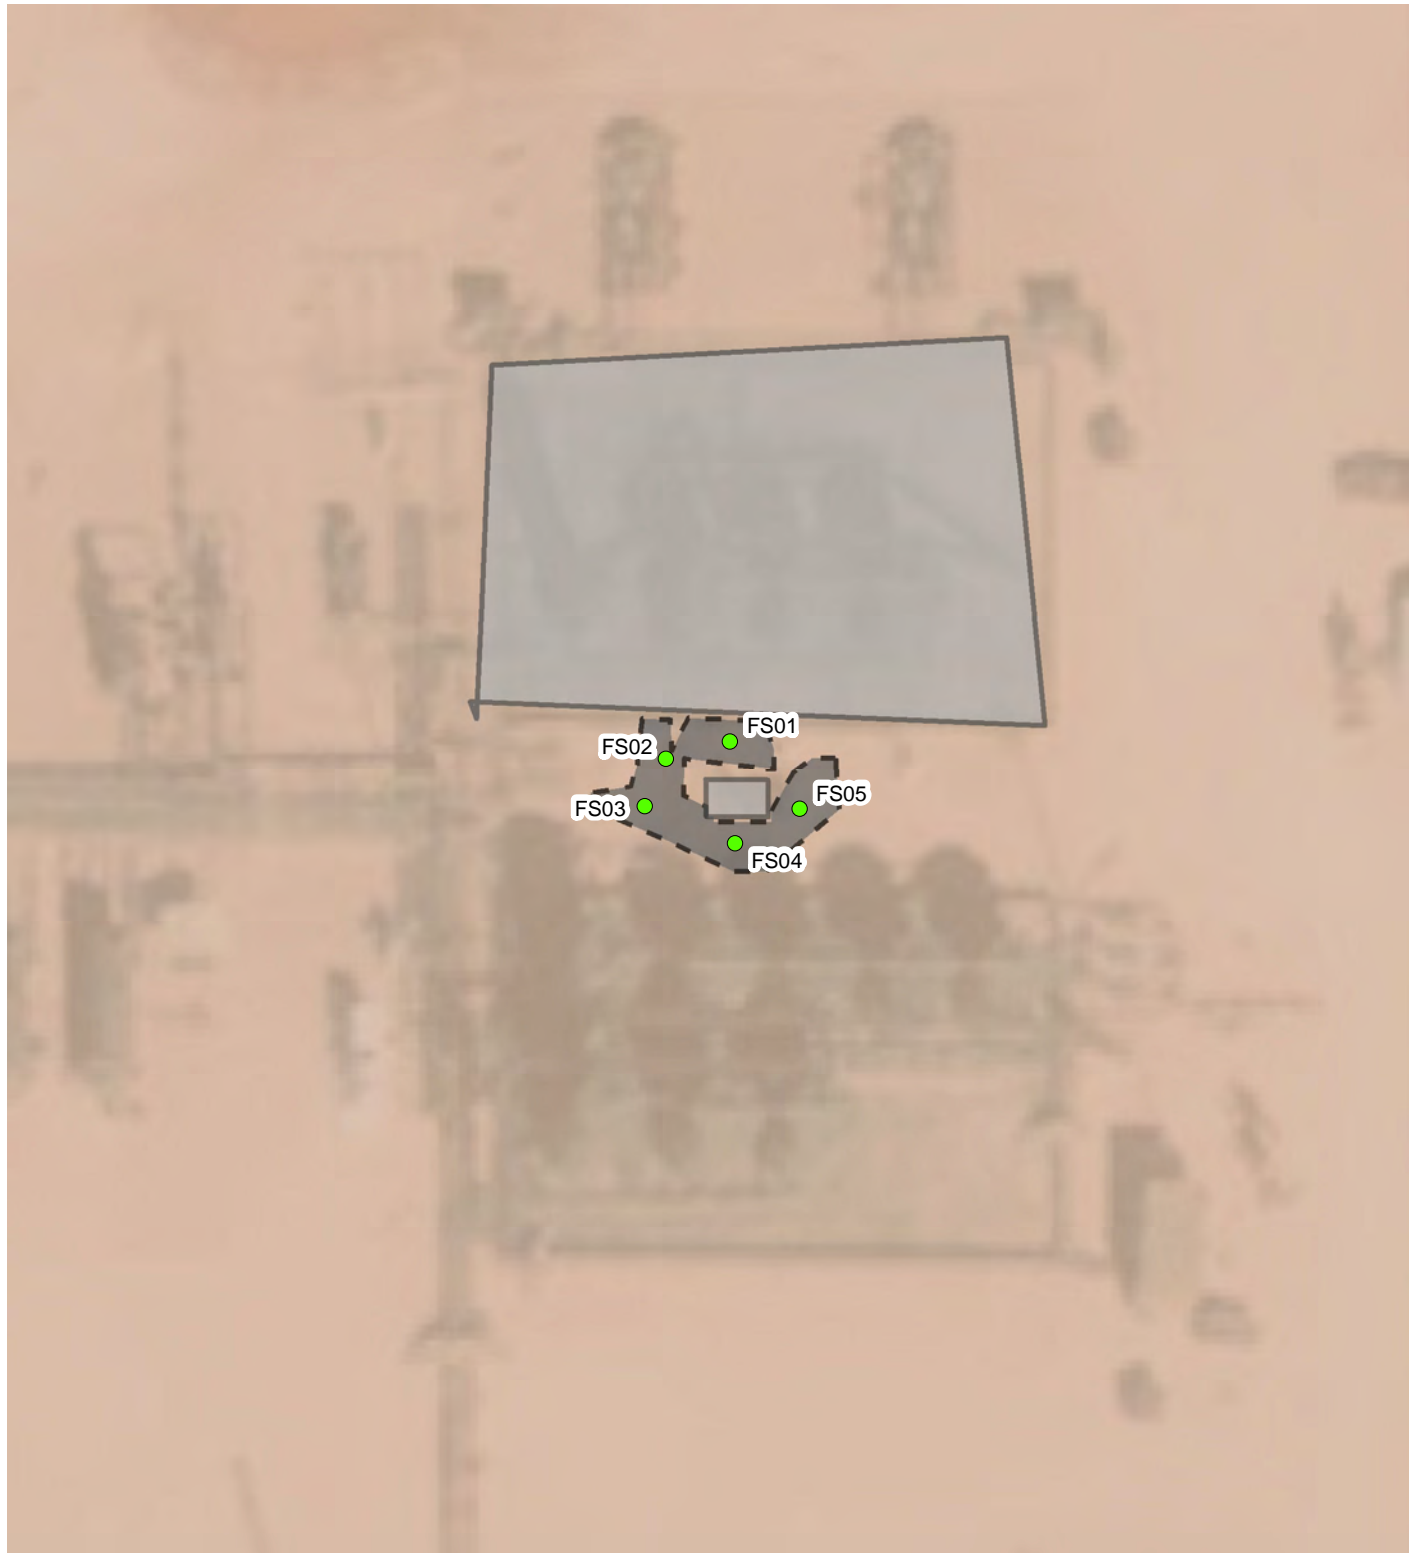
Following removal of impacted soil, WSP collected 5-point composite soil samples every 200 square feet from the floor of the excavation. The 5-point composite samples were collected by placing five equivalent aliquots of soil into a 1-gallon, resealable plastic bag and homogenizing the samples by thoroughly mixing. Composite soil samples FS01 through FS05 were collected from the floor of the excavation from a depth of 1 foot bgs. Due to the shallow depth of the excavation, the soil samples were representative of the floor and sidewalls of the excavation. The excavation soil samples were collected, handled, and analyzed following the same procedures as described above. The excavation extent and excavation soil sample locations are presented on Figure 3.

Laboratory analytical results for excavation floor samples FS01 through FS05 indicated that benzene, BTEX, TPH-GRO/TPH-DRO, TPH, and chloride concentrations were compliant with the Closure Criteria. Laboratory analytical results are summarized in Table 1 and laboratory analytical reports are included as Attachment 4.

- FLOOR SAMPLE IN COMPLIANCE WITH APPLICABLE CLOSURE CRITERIA
- EXCAVATION EXTENT
- WELLPAD EXTENT
- INFRASTRUCTURE

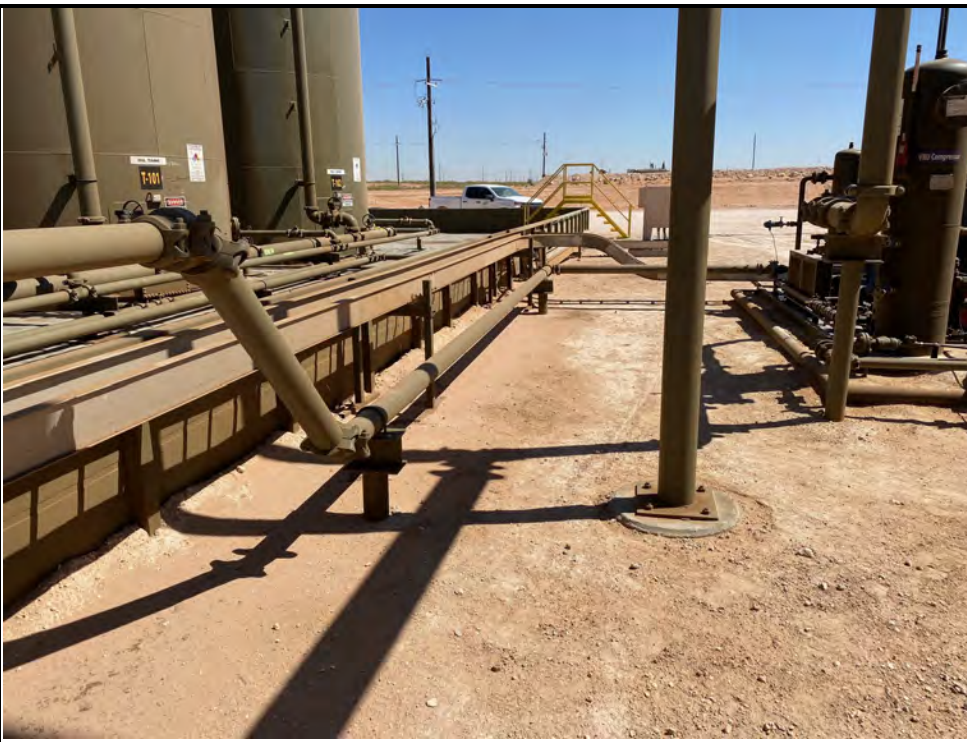
Photo No.	Date	
1	September 30, 2020	
View of release area facing east.

On September 8, 2020, an oil tank overfilled causing fluid to release out of the thief hatch. Approximately 7.5 barrels (bbls) of crude oil were released. A vacuum truck was immediately dispatched to the Site to recover free-standing fluids; approximately 7 bbls of crude oil were recovered. XTO reported the release to the New Mexico Oil Conservation Division (NMOCD) on a Release Notification and Corrective Action Form C-141 (Form C-141) on September 15, 2020. The release was assigned Incident Number NRM2026546692.

A photograph showing an industrial site with large storage tanks, pipes, and a yellow staircase. The ground is dry and dusty. The view is facing east.

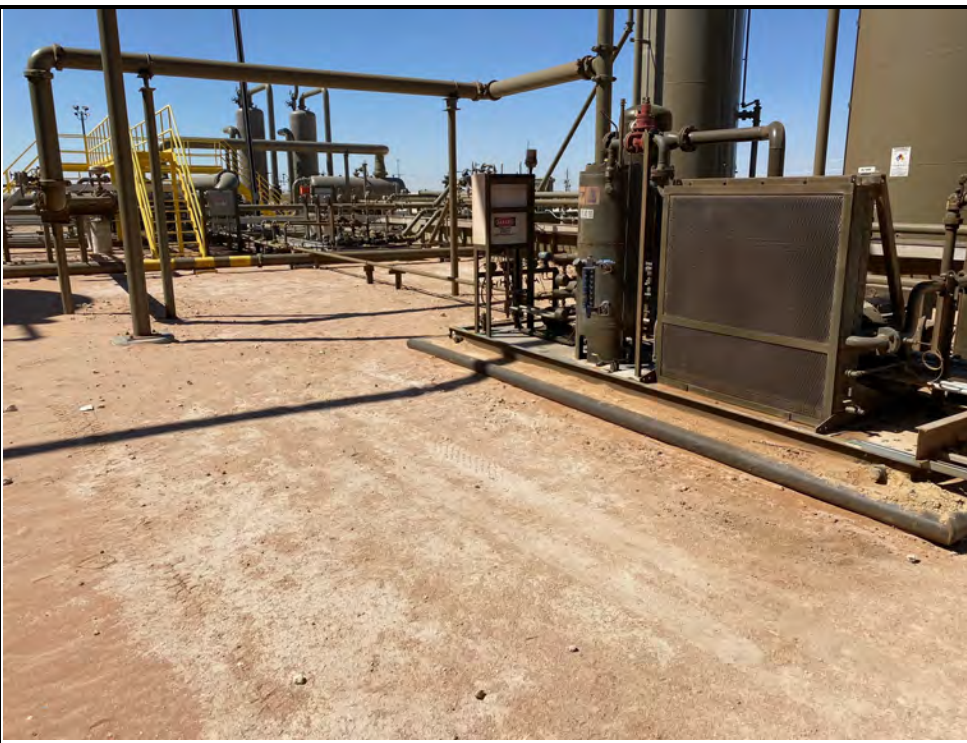
Photo No.	Date	
2	September 30, 2020	
View of impacted area facing northwest

A photograph showing an industrial site with large storage tanks, pipes, and a yellow staircase. The ground is dry and dusty. The view is facing northwest.

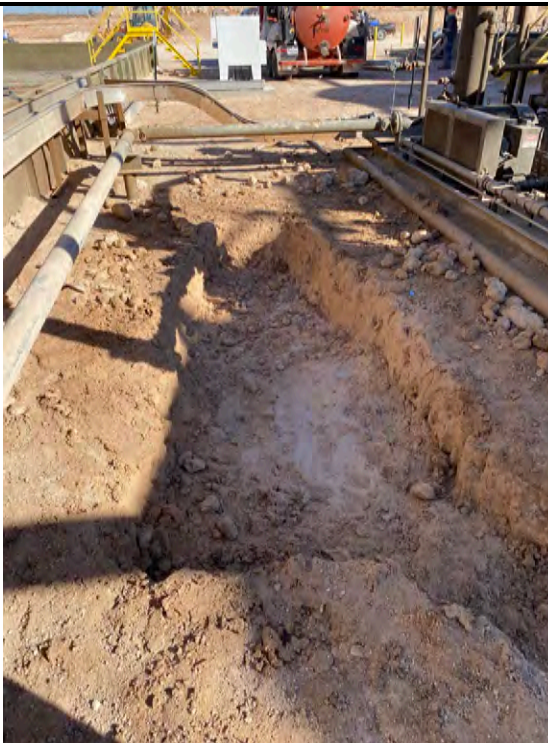
Photo No.	Date	
3	November 25, 2020	
View of final excavation facing east.

A photograph showing a deep, rectangular excavation pit. The pit is filled with loose, brown soil and some rocks. A large, dark, cylindrical object, possibly a pipe or a piece of machinery, is visible on the right side of the pit. In the background, there are some industrial structures and a yellow crane.

The excavation measured approximately 830 square feet. A total of approximately 30 cubic yards of impacted soil was removed during the excavation activities. The impacted soil was transported and properly disposed of at the R360 Facility in Hobbs, New Mexico. After completion of confirmation sampling, the excavation areas were backfilled.

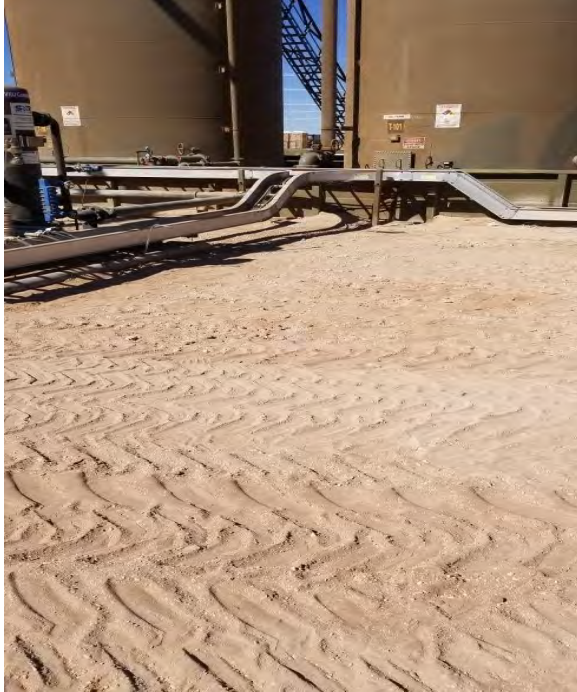
Photo No.	Date	
5	November 25, 2020	
View of final backfill.

A photograph showing a large area of sandy, light-brown soil with distinct, wavy, parallel tracks from heavy machinery, likely a bulldozer, indicating recent backfilling. In the background, there are industrial structures, including a tall metal tower and various pipes and equipment, under a clear blue sky.
