**Cameron  
State Q #003**

**Work Plan**

**U/L E, Section 30, T16S, R37E  
Lea County, New Mexico**

**NRM2034455815**

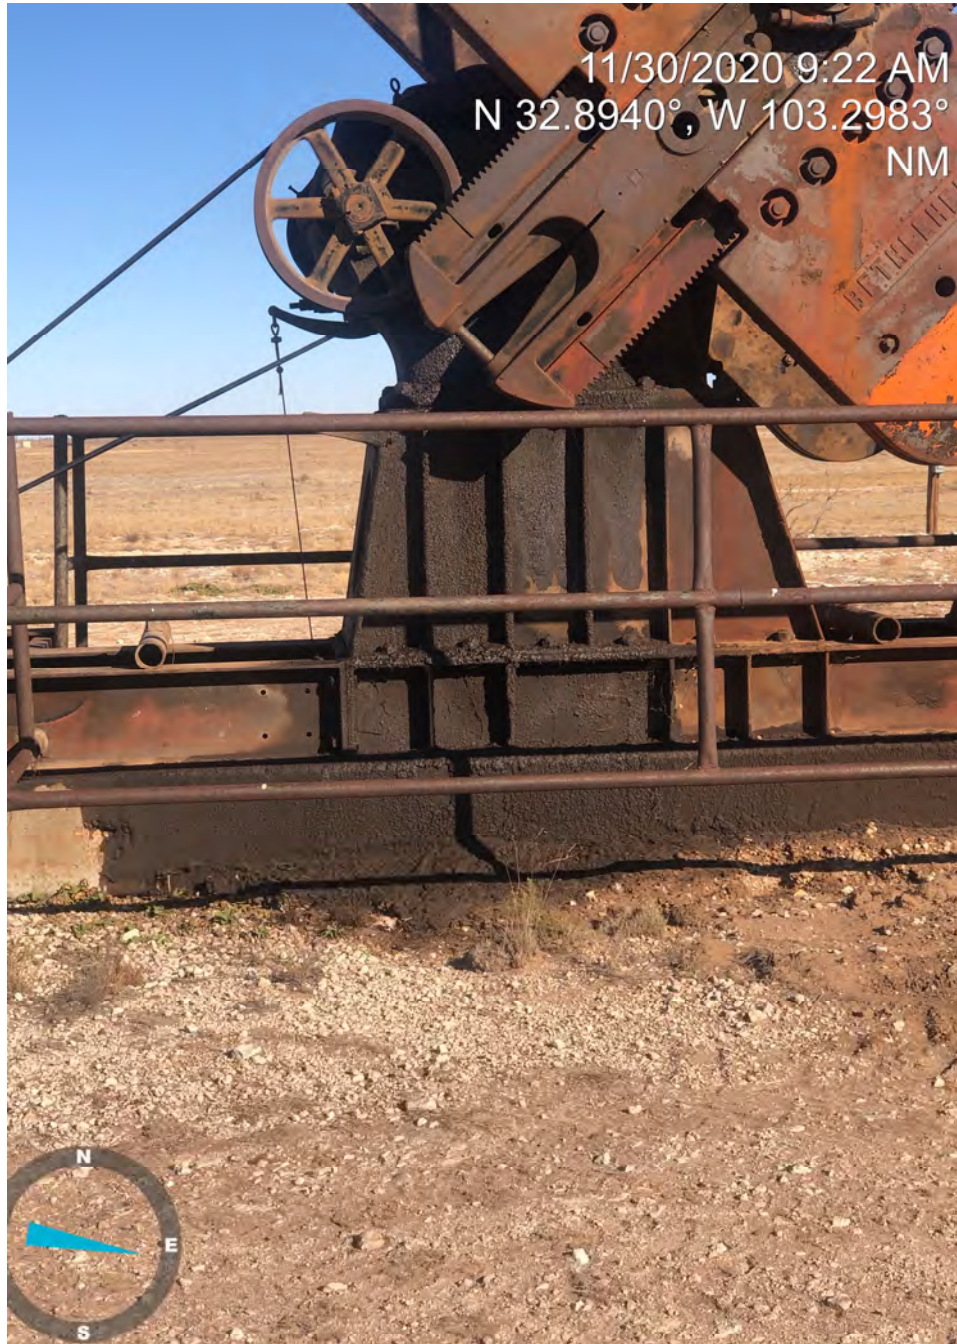
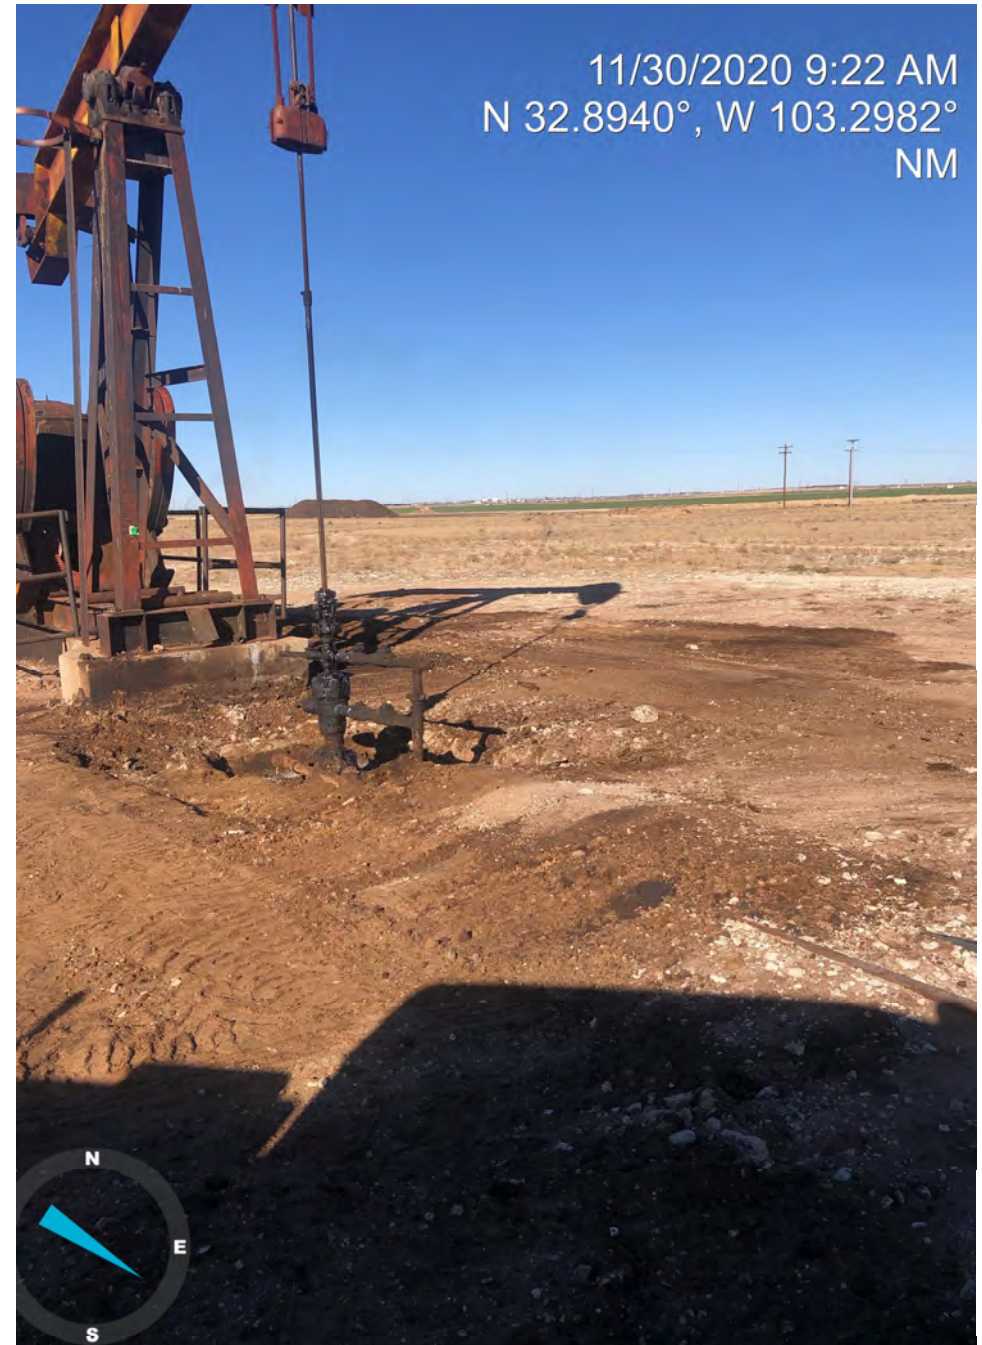
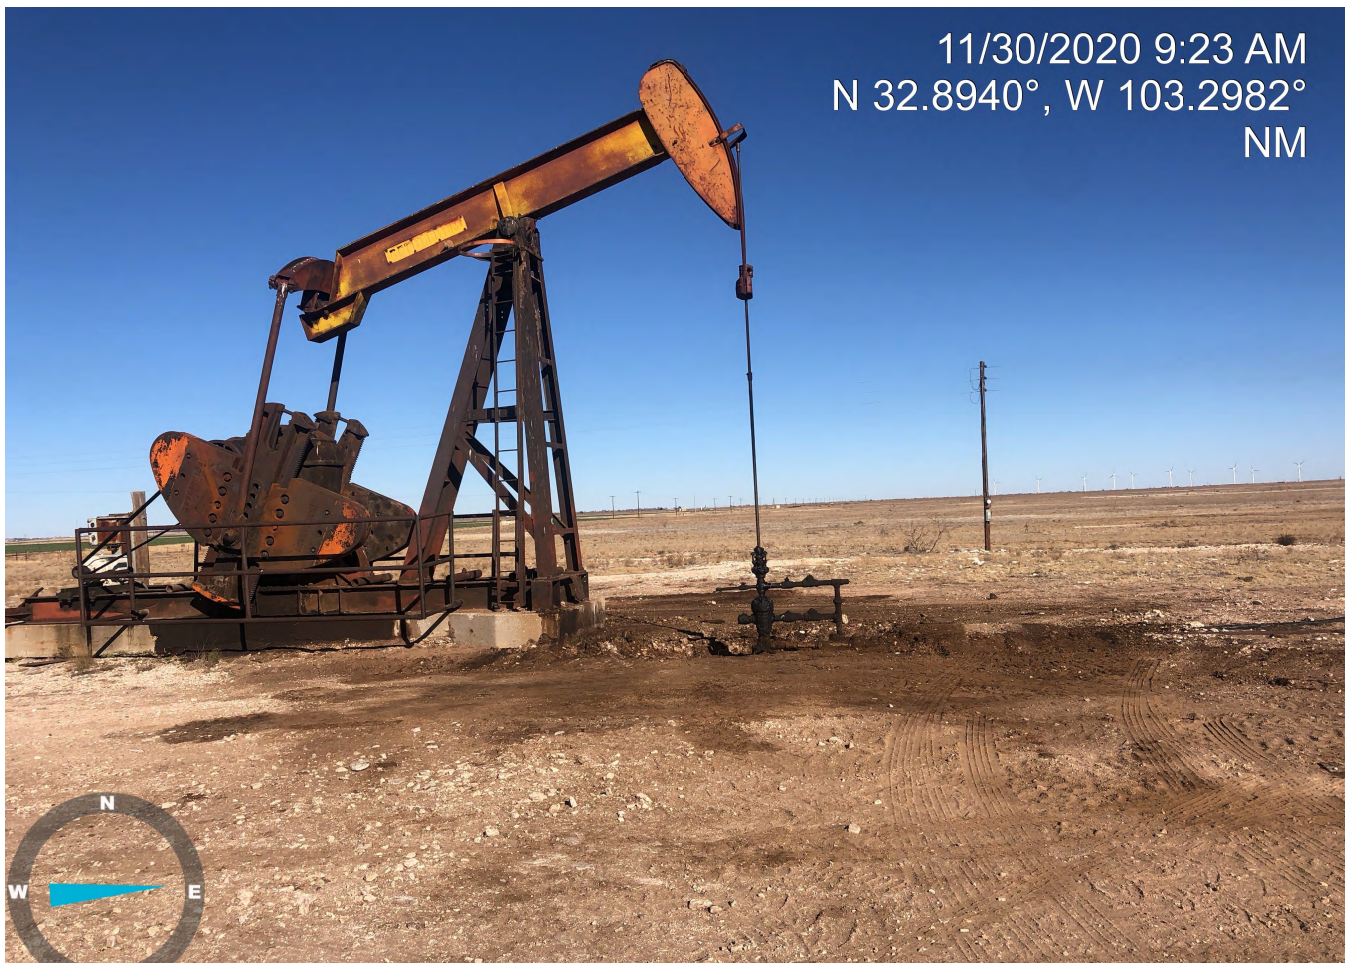
11/30/2020 9:23 AM  
N 32.8940°, W 103.2982°  
NM

According to the C-141 for incident NRM2034455815, a routine inspection revealed extensive staining from an apparent release of hydrocarbons and produced water near the well head. No fluids were recovered as this appears to be a historical leak. The inspection ID# for this incident is IEZB2029045721.

In April of 2021, SESI personnel, along with a subcontractor, collected samples at the well spill area. This spill area is very small but the ground at this location is extremely difficult to penetrate as it is all very hard rock and boulders. Furthermore, the well is very old (1960s) and potentially frail. Six sample points were advanced, including two vertical samples and four horizontal samples, were properly packaged and preserved, and sent to Hall Environmental laboratories to be analyzed. The results of the analyzation are captured in the table below:

For the area around the well, SESI proposes to only perform a cosmetic clean up of this area. Vertical extent of this area is simply not achievable. After a detailed discussion during a teleconference with Mike Bratcher of NMOCD, it was determined that extensive cleanup of this area is not realistic nor feasible. Due to the potentially fragile condition of the well (which was drilled in the 1960s), combined with the extreme hardness of the ground, excavation poses a dangerous safety threat. The only way to properly excavate the surface level rock would be to use a jack hammer or hammer hoe. The vibrations from these machines would potentially cause extensive damage to the well bore/casing. Therefore, it is strongly recommended by Mr. Bratcher and Bob Allen of SESI to only perform a cosmetic cleanup until this well is plugged.
