Site Assessment Report and Proposed Remediation Workplan

COG Operating, LLC

Eider Federal 2H

NMOCD Reference No. nAPP2110931060

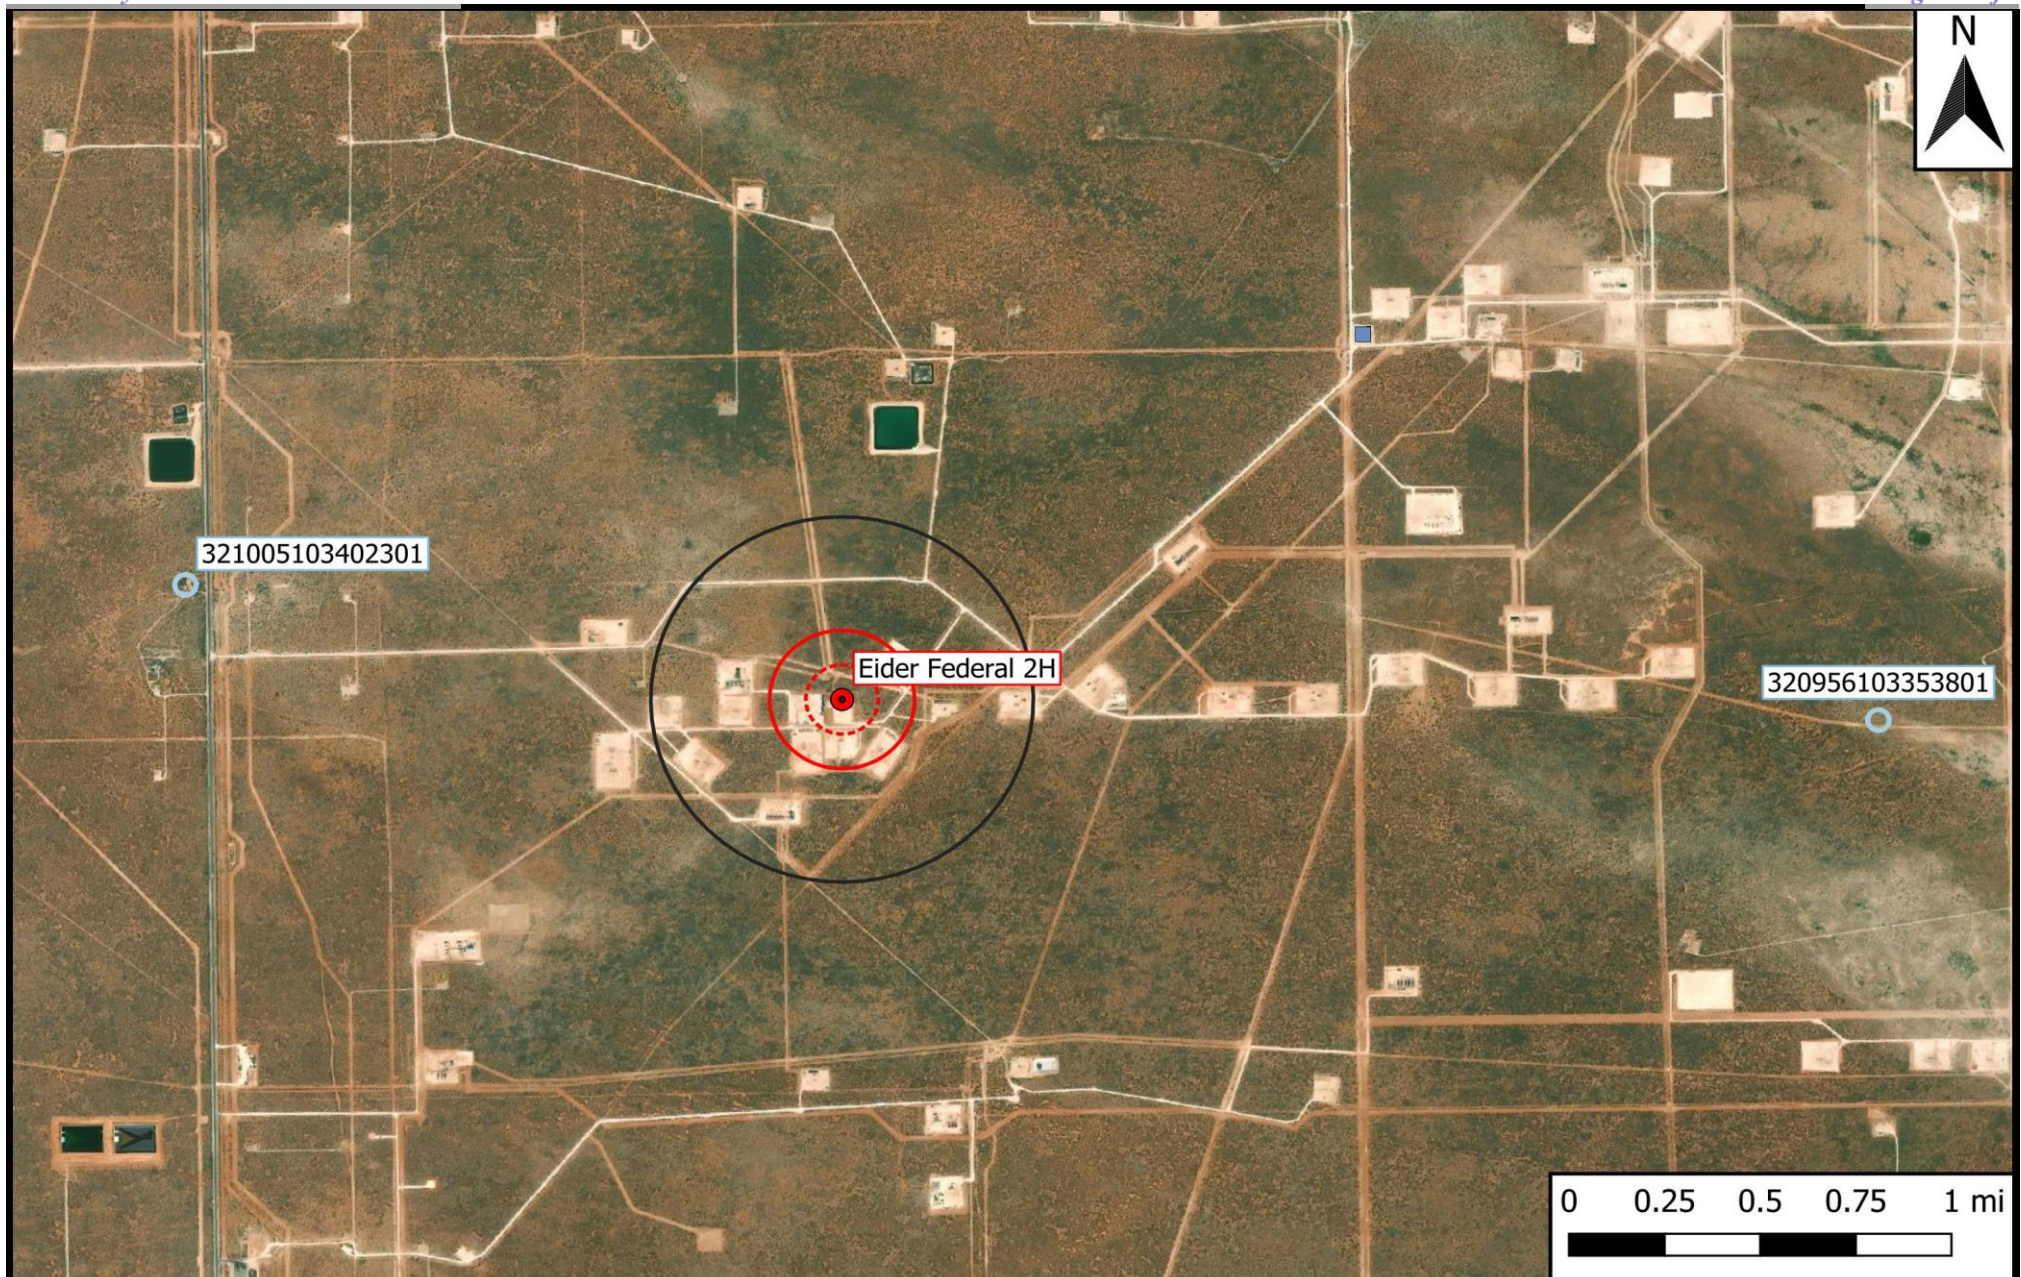
Figure 2

Aerial Proximity Map

Legend	500 Ft Radius
Site Location	1000 Ft Radius
Well - NMOSE	0.5 Mi Radius
Well - USGS	1% Annual Flood Chance
Potash Mine Workings	Lake/Freshwater Pond
Medium/High Karst	Emergent/Forested Wetlands
	Riverine

NMOCD Siting Criteria data was gathered from available resources including Bureau of Land Management (BLM) and Fish and Wildlife Services (FWS) shapefiles; topographic maps; NMOSE and USGS databases; and aerial imagery. The results are depicted on Figures 1, 2, 4, and 5.

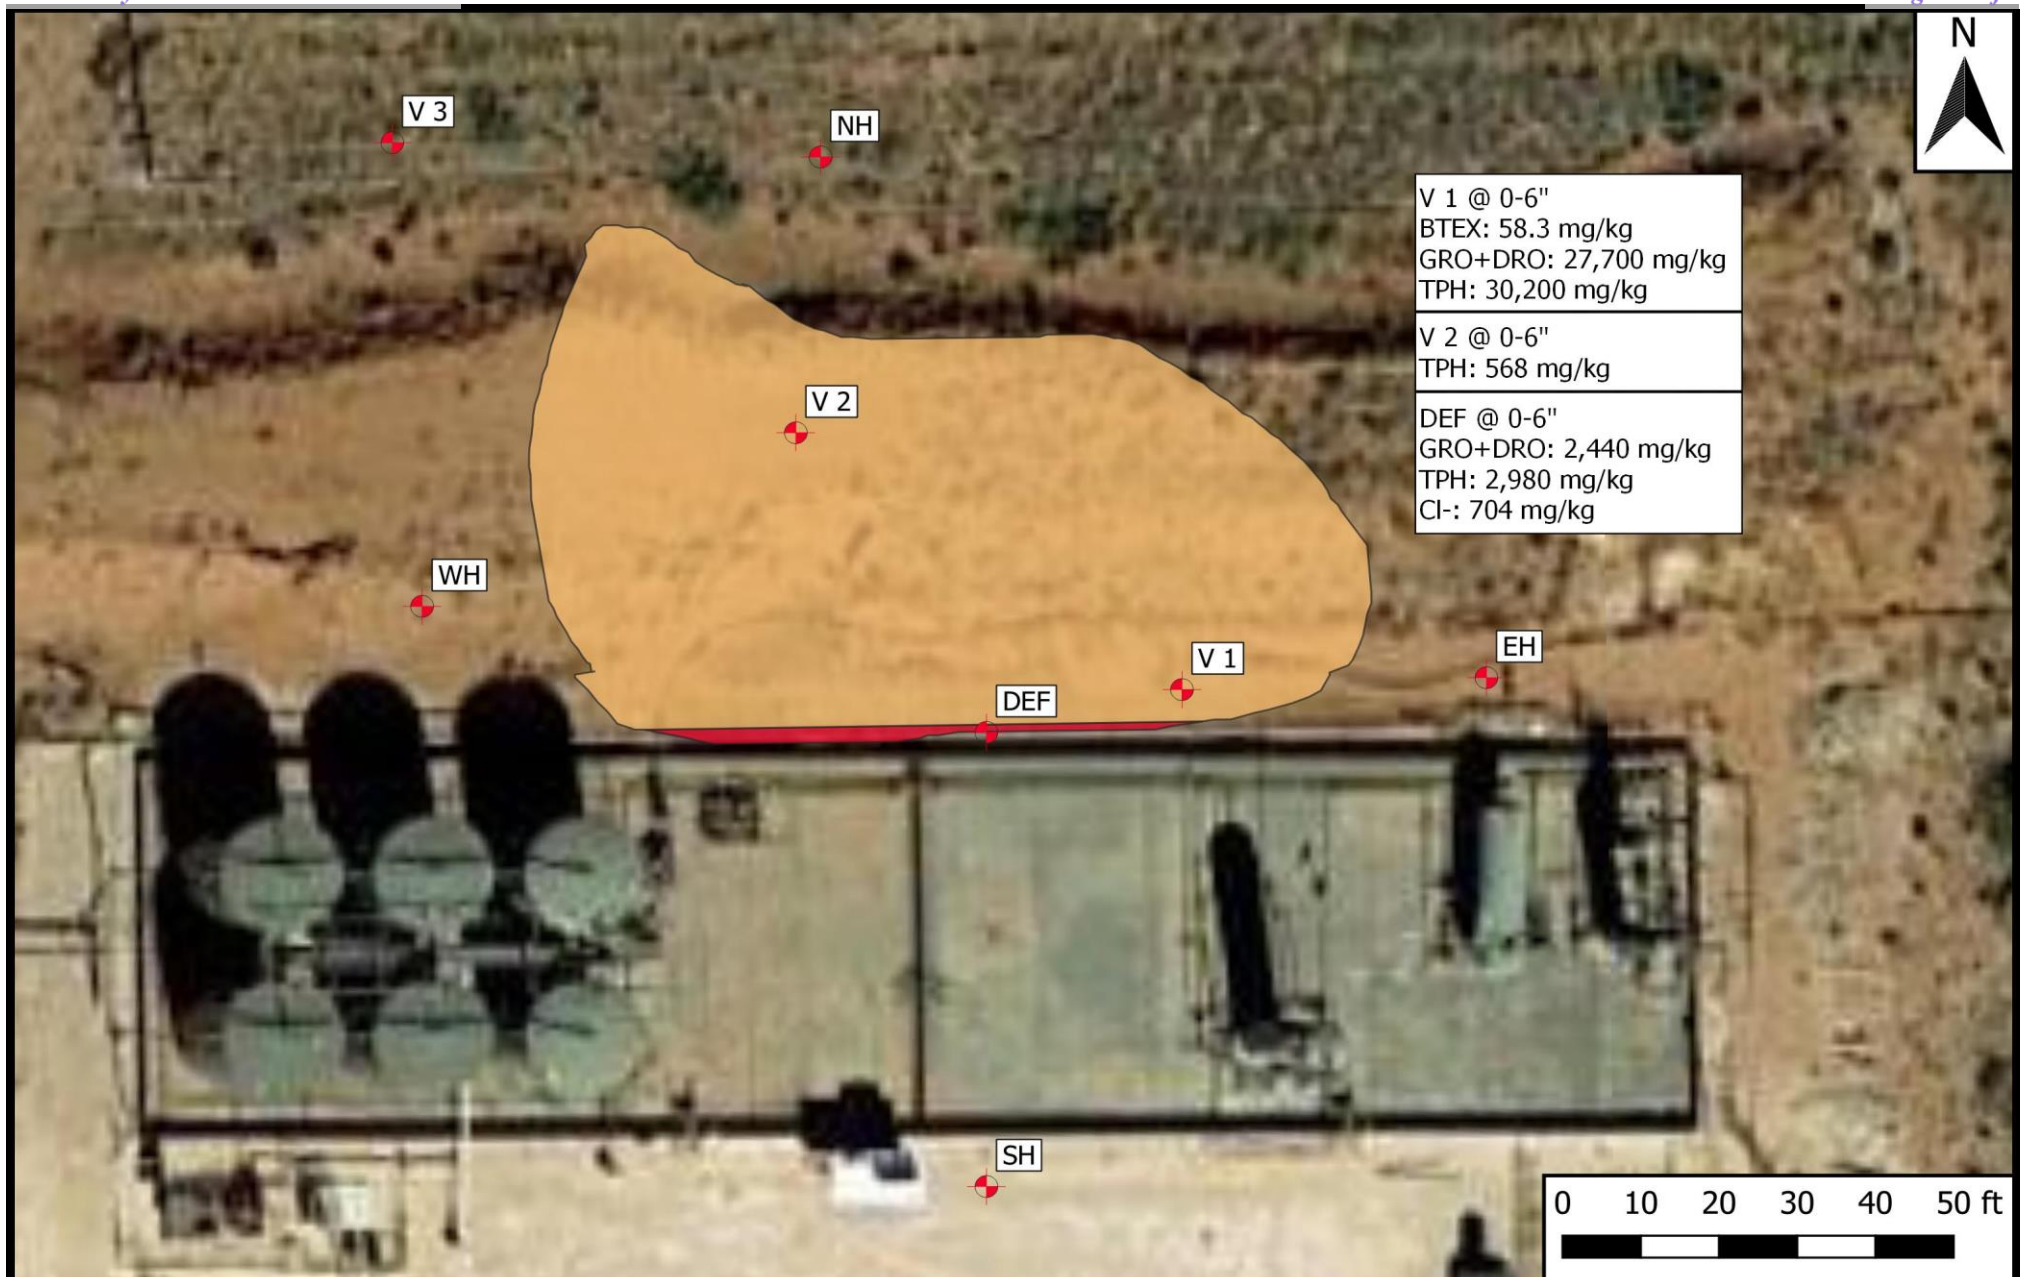
Figure 3

Site and Sample Location Map

- Sample Point
- Proposed Excavation - 5264 Sq Ft
- Estimated Deferral Area - 96 Sq Ft

A site and sample location map is provided as Figure 3. Field data and soil profile logs are provided as Appendix B. A soil chemistry table is provided as Table 1. Laboratory analytical reports are provided in Appendix C.

- Utilizing mechanical equipment and/or hand tools, excavate impacted soil affected above the NMOCD Reclamation Standard in the areas characterized by sample points V 1 and V 2 to an estimated depth of one (1) foot bgs, or until laboratory analytical results indicate BTEX, TPH, and chloride concentrations are below the NMOCD Reclamation Standard.

- Remediation of impacted soil adjacent to and underneath the fencing, containment, pipelines, and associated appurtenances along the northern edge of the production pad will be deferred until the decommission and reclamation of the facility.

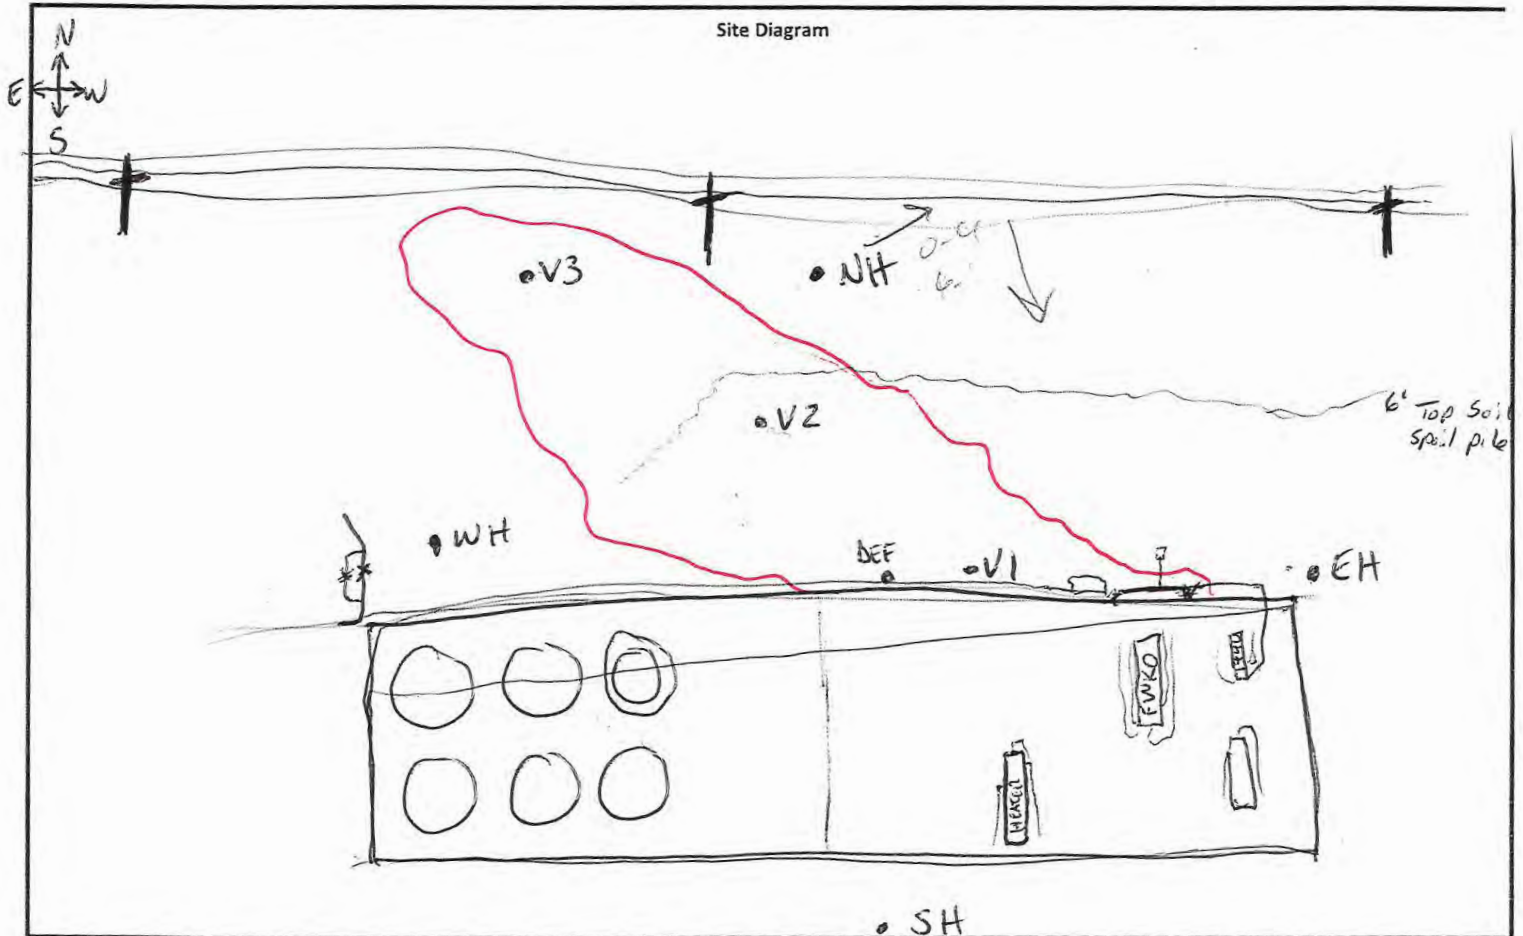
Site Diagram

Impacted Soil piles around Separator containment

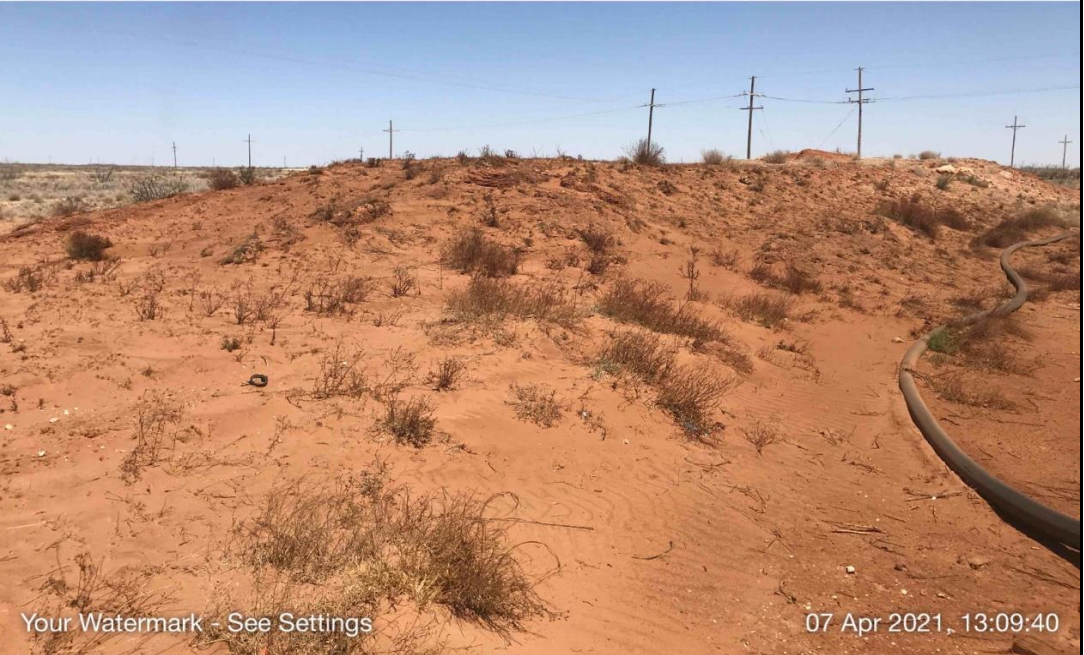
Photo Number: 1	<div>NW N NE E 0 330 0 30 60 90 120</div> <div>☀ 36°NE (T) ● 32°10'3"N, 103°38'33"W ±16ft ▲ 3536ft</div>

<div>Your Watermark - See Settings 07 Apr 2021, 13:09:40</div>
Photo Direction: Northeast	
Photo Description: Release area in pasture.

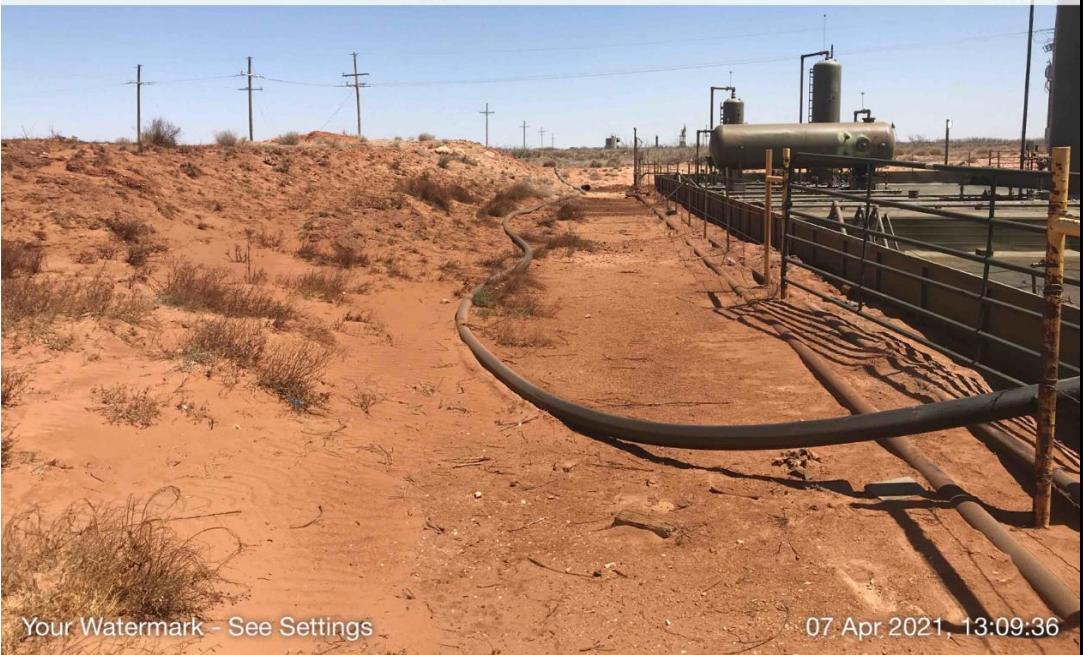
Photo Number: 2	<div>N NE E SE 330 0 30 60 90 120 150</div> <div>☀ 57°NE (T) ● 32°10'3"N, 103°38'33"W ±16ft ▲ 3536ft</div>

<div>Your Watermark - See Settings 07 Apr 2021, 13:09:36</div>
Photo Direction: Northeast	
Photo Description: Release area adjacent to containment.
