Site Assessment Report and Proposed Remediation Workplan

ETC Texas Pipeline, Ltd.

Cal C Release

NMOCD Reference No. nAPP2116745753

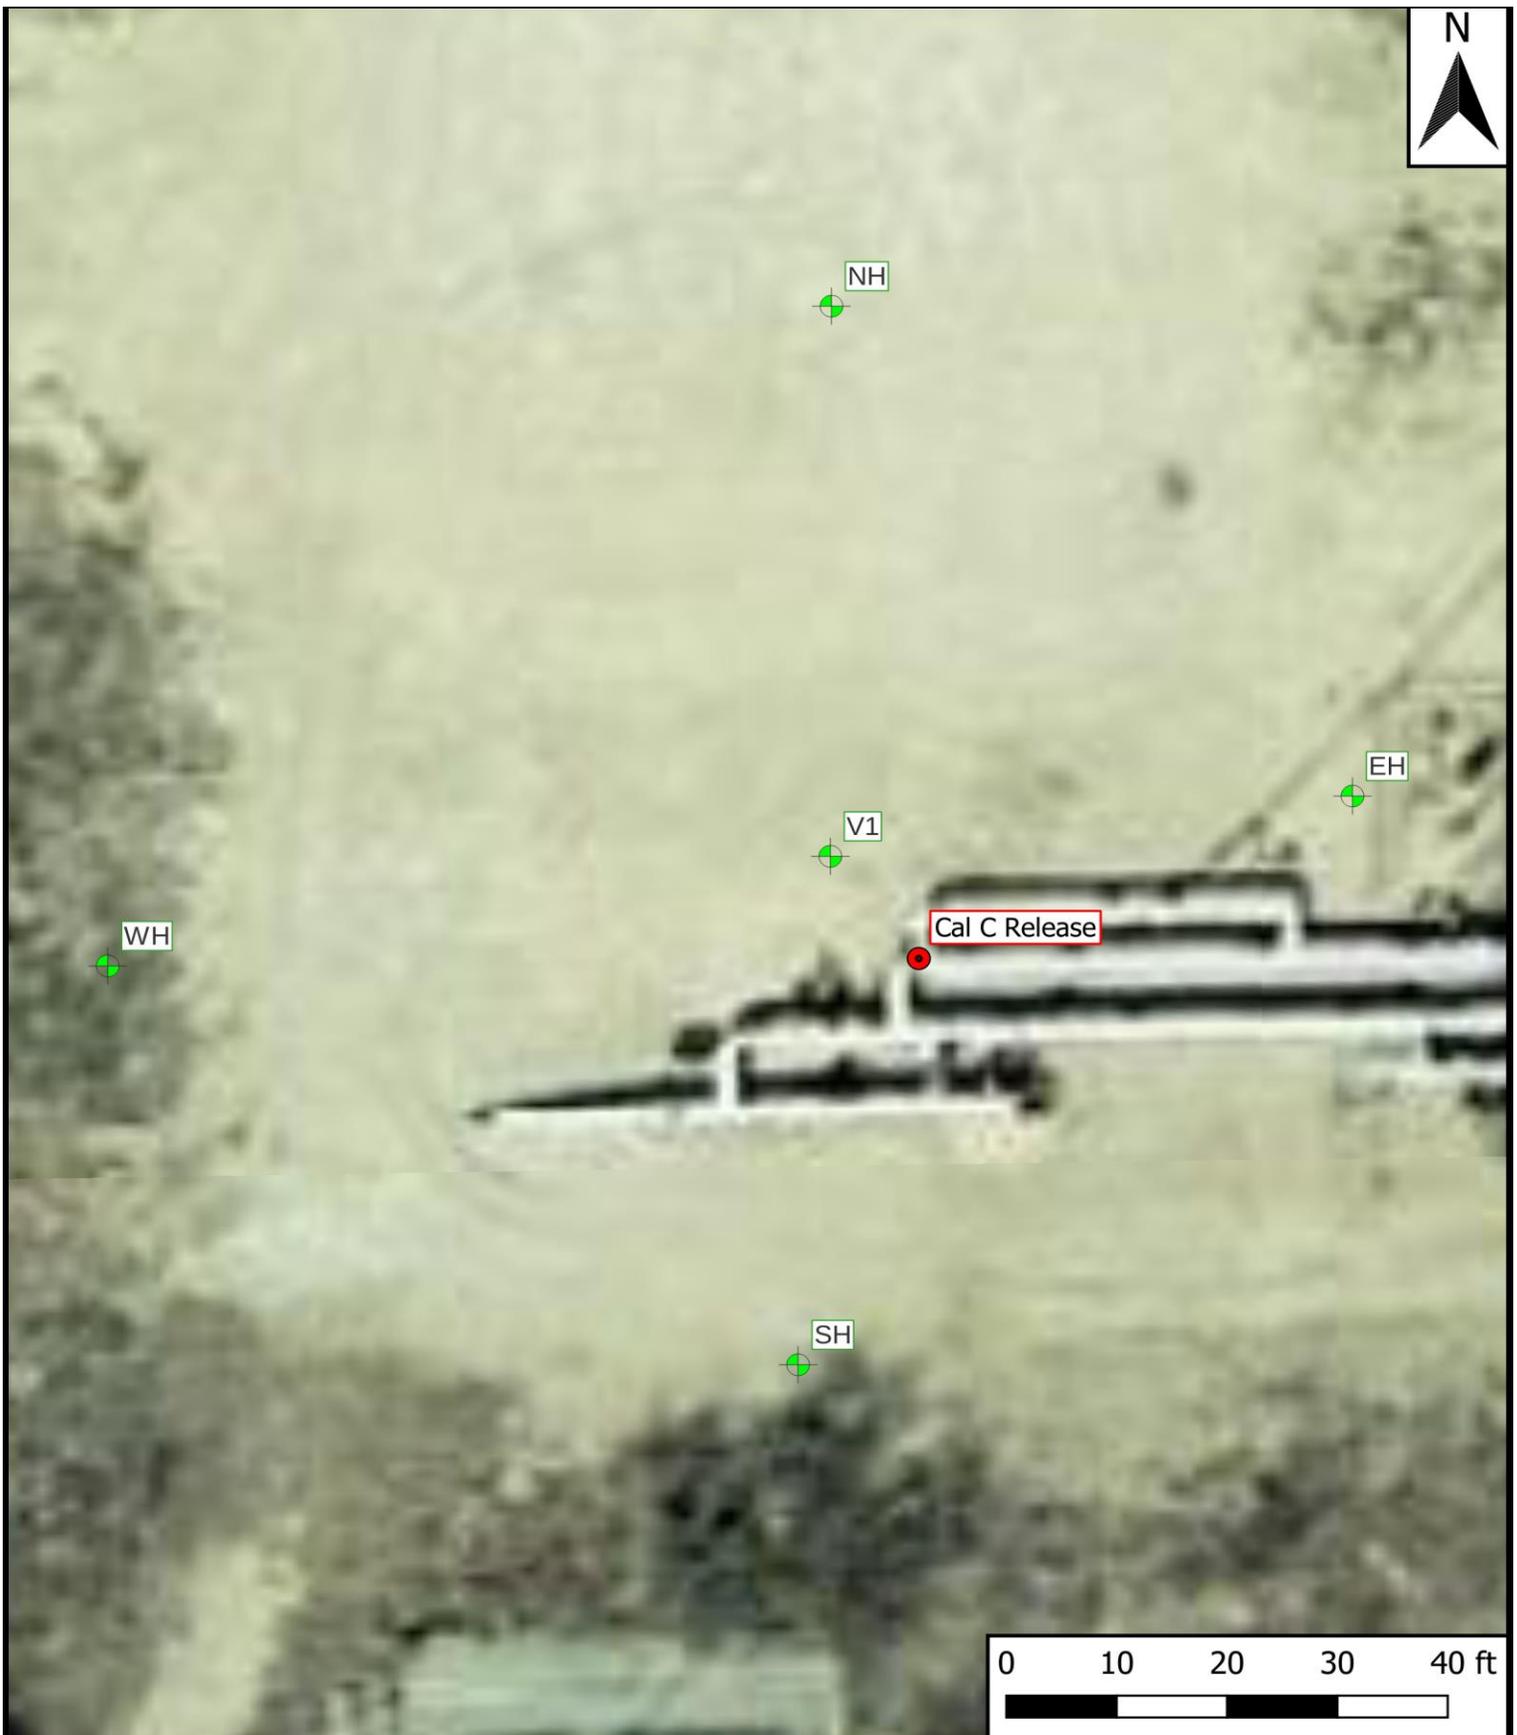
Figure 3

Based on field observations and field test data, eleven (11) delineation soil samples (EH @ 1', EH @ SURFACE, NH @ 1', NH @ SURFACE, SH @ 1', SH @ SURFACE, V1 @ SURFACE, V1 @ 2', V1 @ 4', WH @ 1', and WH @ SURFACE) were submitted to a certified commercial laboratory for analysis of BTEX, TPH, and Chloride. Based on laboratory analytical results, soil was not affected above the NMOCD Closure Criteria, and the horizontal extent of affected soil impacted above the NMOCD Closure Criteria was adequately defined. A soil chemistry table is provided as Table 1. Laboratory analytical reports are provided in Appendix C.

Site and Sample Location Map

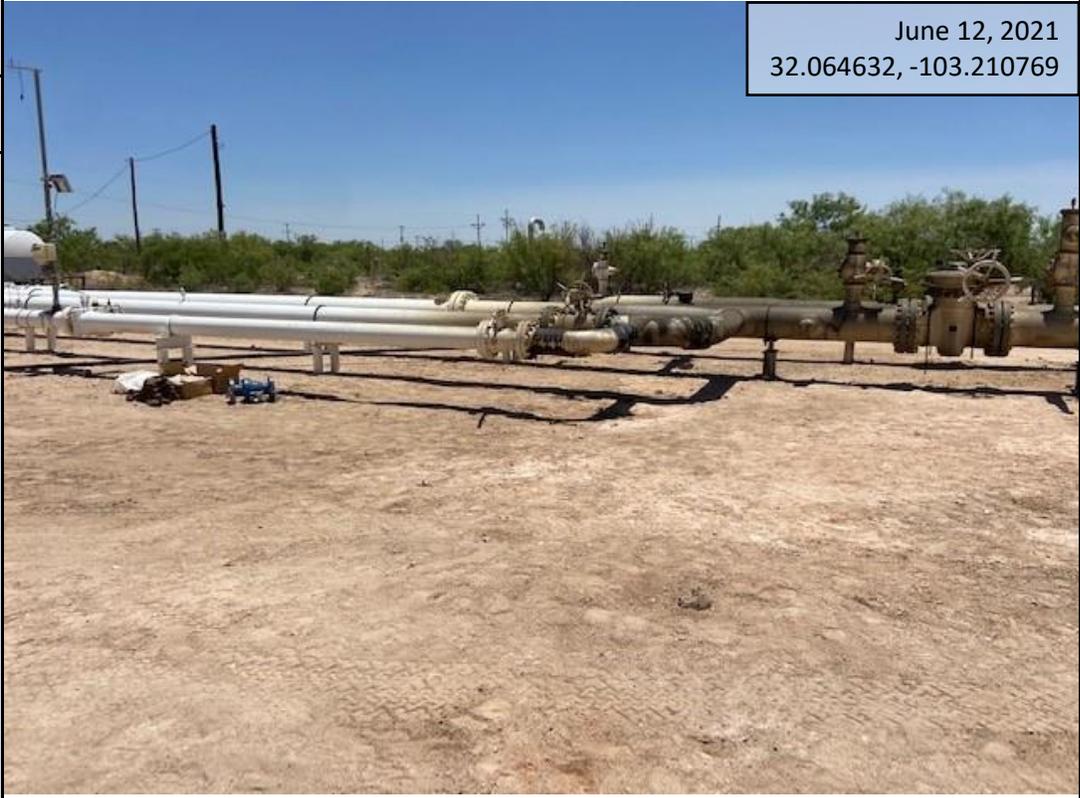
Photo Number: 1

Cause of Release:
 The release was attributed to the rubber blowing out of an existing clamp. The rubber on the clamp was replaced, then the section of line was put back into service.

<p>June 12, 2021 32.064632, -103.210769</p>
Photo Direction: South	
Photo Description: Initial release area.

- Excavate impacted soil within the release margins. The floor and sidewalls of the excavated area will be advanced until laboratory analytical results indicate concentrations of BTEX, TPH, and chloride are below the NMOCD Closure Criteria.
- The excavated soil will be temporarily stockpiled on-site and then transported to an NMOCD-approved facility for disposal.
- Upon receiving laboratory analytical results from confirmation soil samples, backfill the excavated area with locally sourced, non-impacted "like" material.
- Upon completion of remediation activities, a *Remediation Summary and Soil Closure Request* will be prepared detailing field activities and laboratory analytical results from confirmation soil samples.

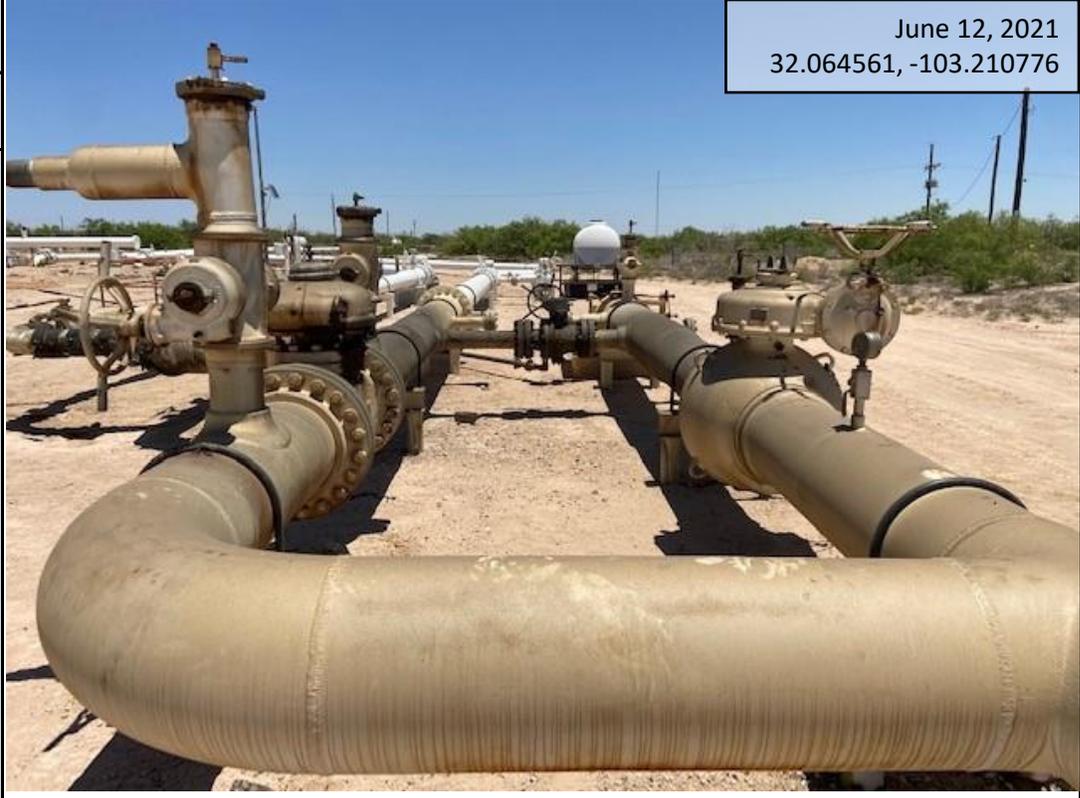
Photo Number: 2

<p>June 12, 2021 32.064561, -103.210776</p>
Photo Direction: East	
Photo Description: Initial release area.

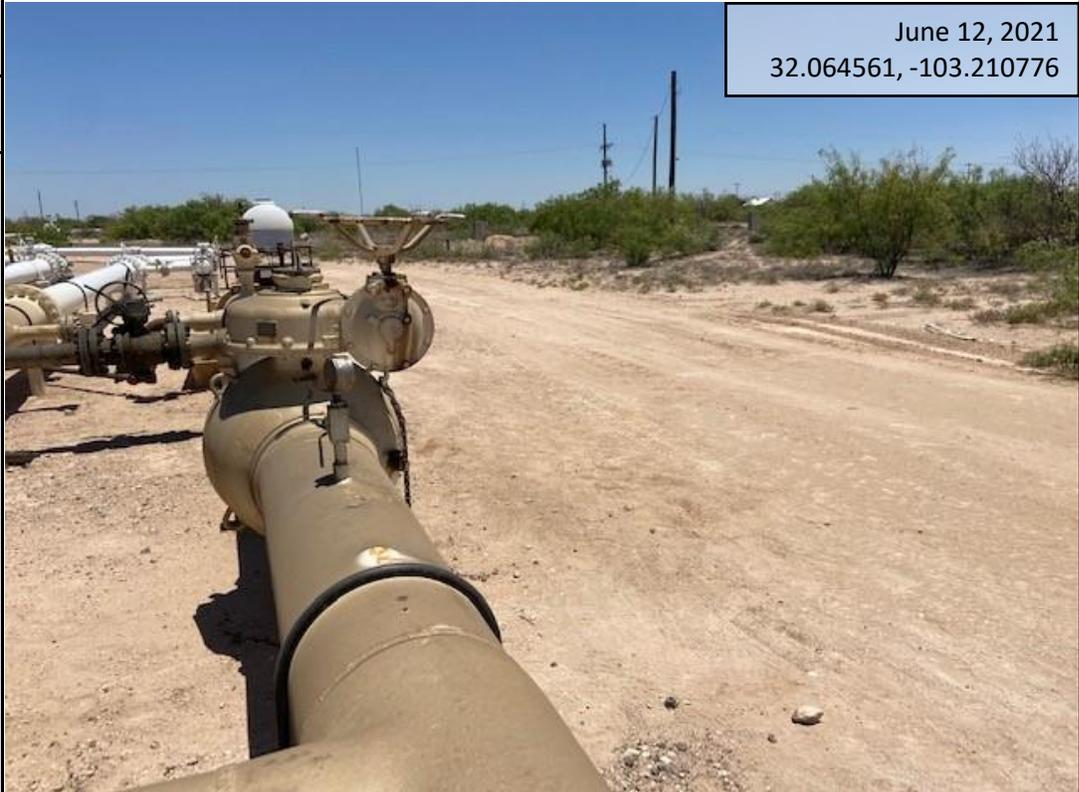
Photo Number: 3

<p>June 12, 2021 32.064561, -103.210776</p>
Photo Direction: East	
Photo Description: Initial release area.

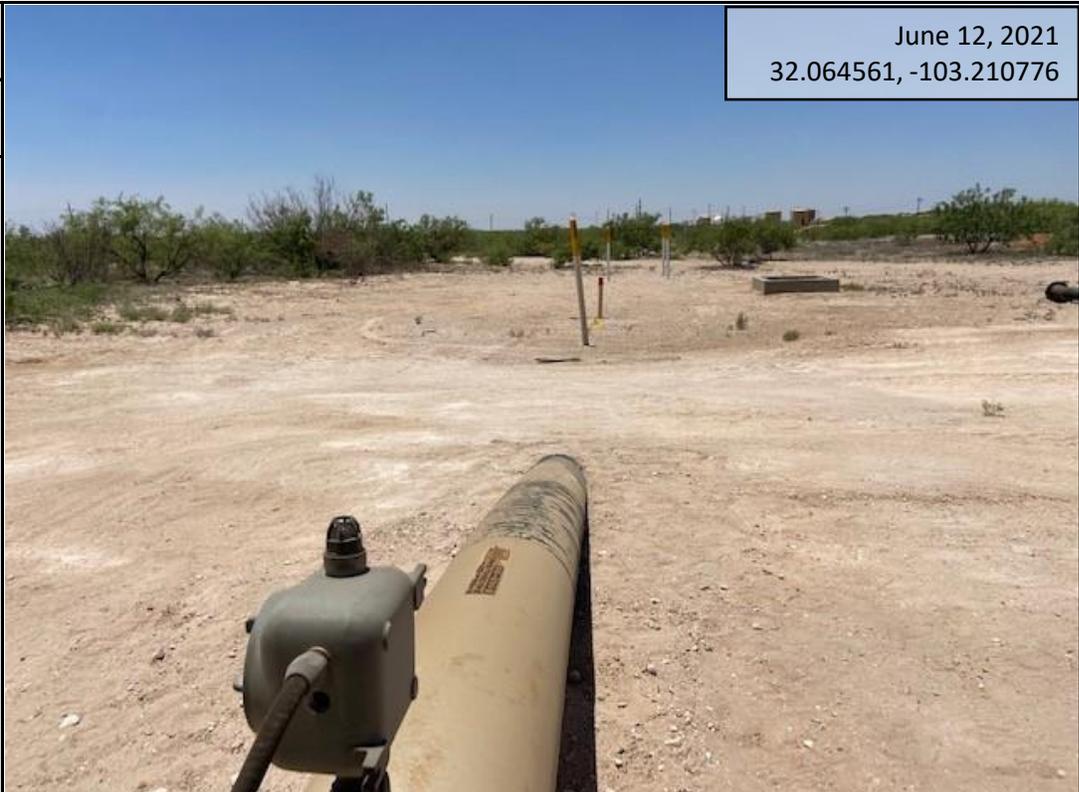
Photo Number: 4

<p>June 12, 2021 32.064561, -103.210776</p>
Photo Direction: West	
Photo Description: Initial release area.

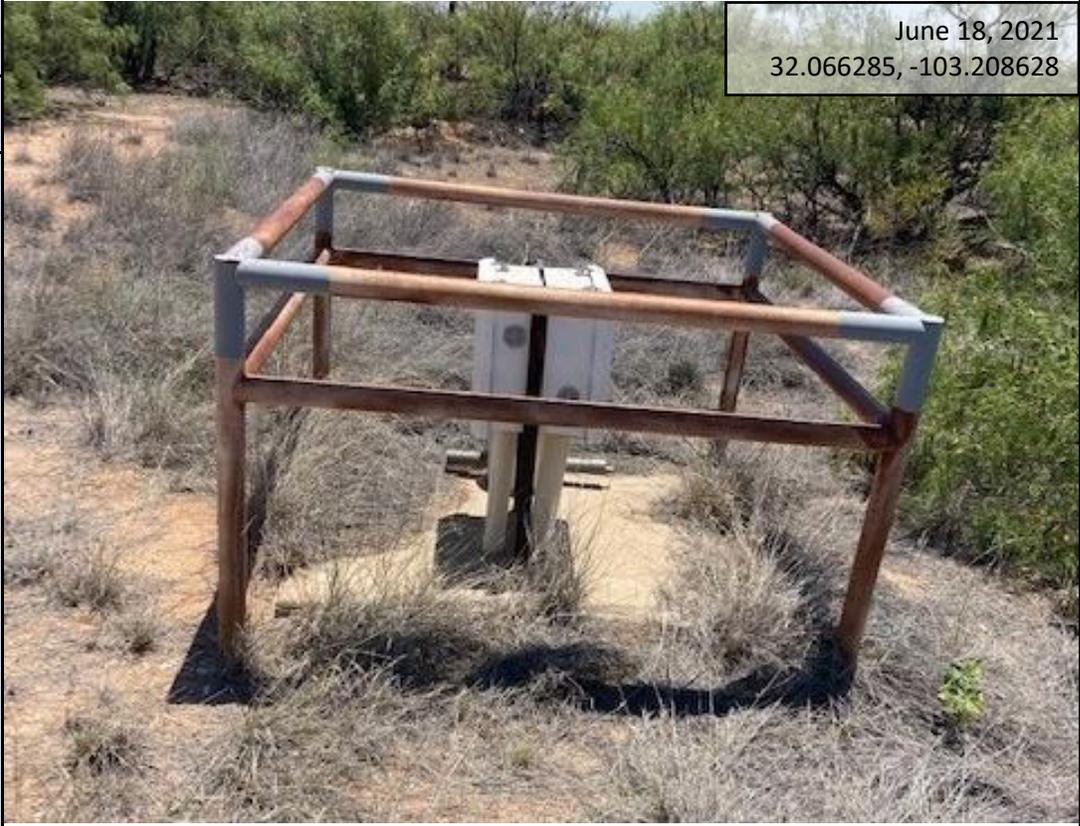
Photo Number: 5

Photo Direction: N/A	
Photo Description: Cathodic protection well.

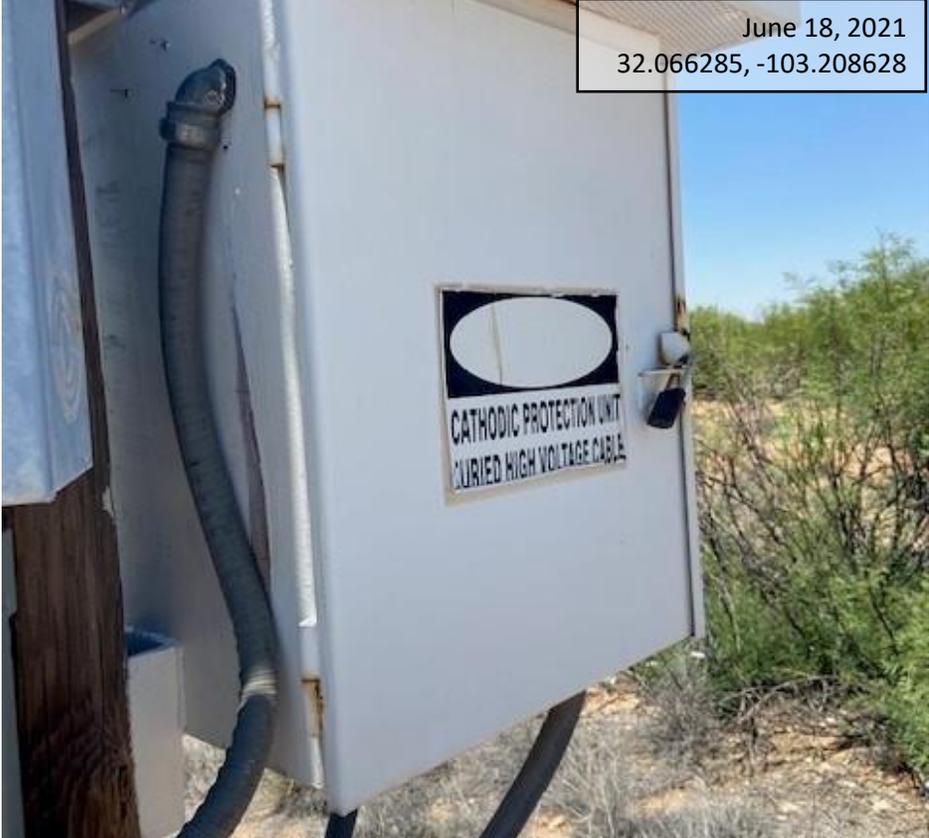
Photo Number: 6

Photo Direction: N/A	
Photo Description: Cathodic protection well electrical panel.
