## **REMEDIATION SUMMARY & SITE CLOSURE REQUEST**

**Chisholm Energy Operating, LLC  
PENNZOIL 3 MESCALERO FED BATTERY  
Lea County, New Mexico  
Unit Letter "I", Section 1, Township 19 South, Range 33 East  
Latitude 32.687958° North, Longitude 103.610569° West  
NMOCD Reference #1RP-4673**

**September 2019**

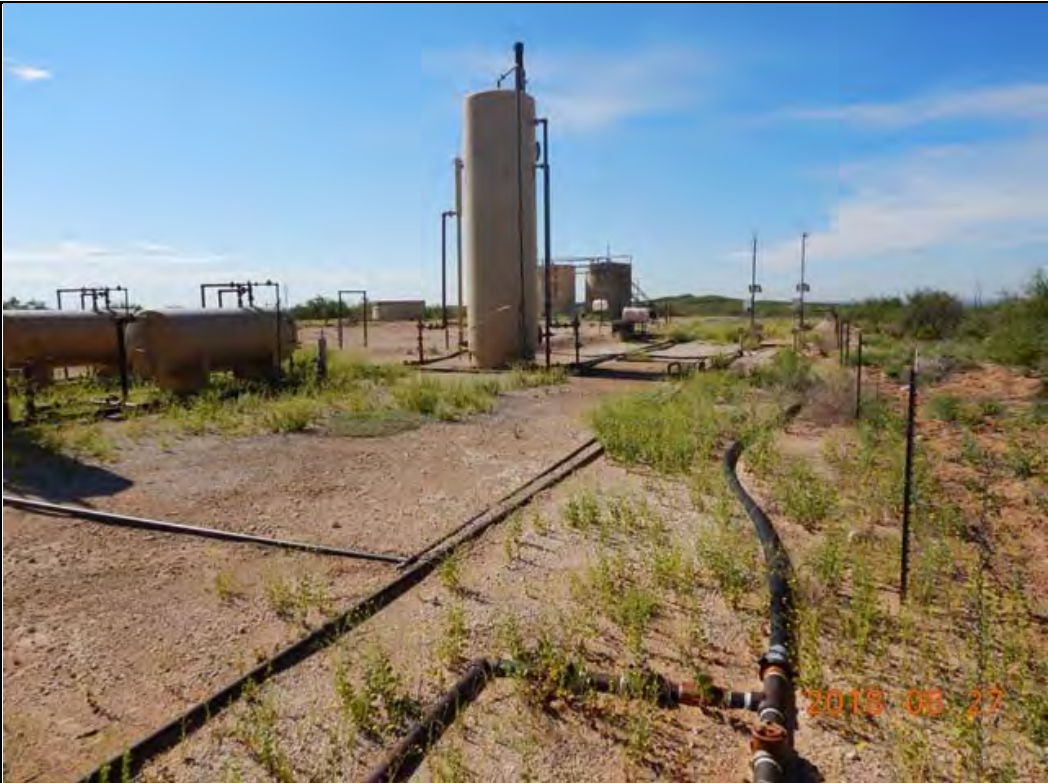
<b>Photo Number:</b> 4

<b>Photo Direction:</b> Southeast	
<b>Photo Description:</b> View of Surface Staining from the Initial Release

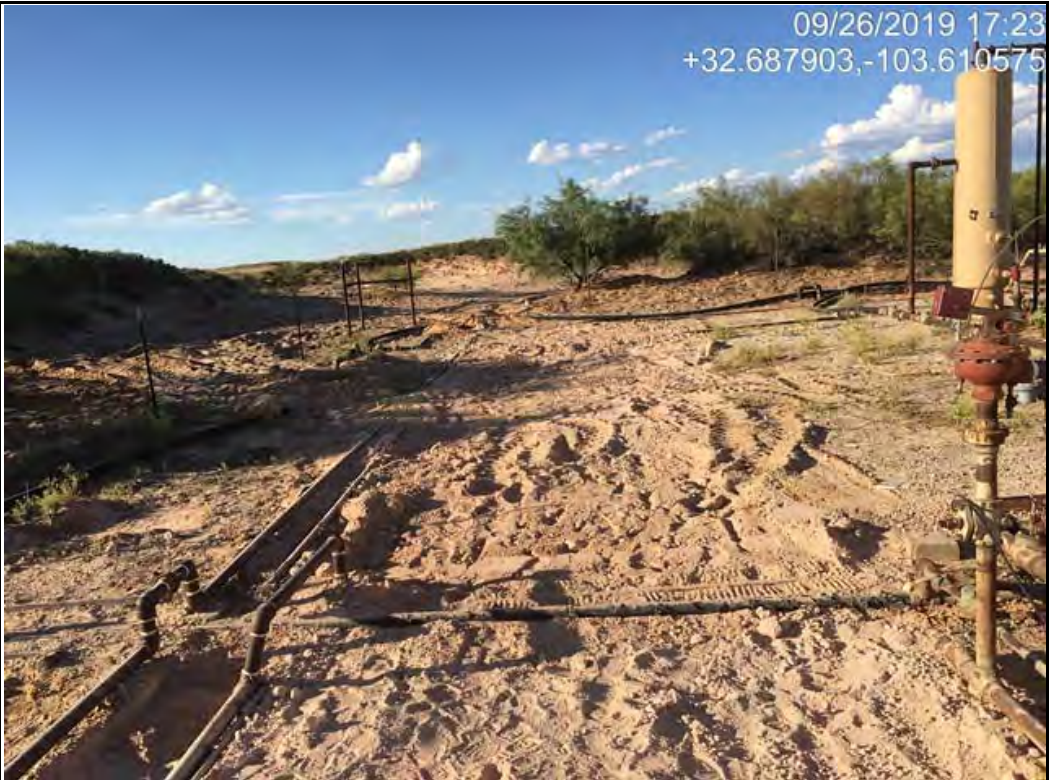
<b>Photo Number:</b> 13

<b>Photo Direction:</b> North	
<b>Photo Description:</b> Backfilled
