<b>Location:</b>	<b>Ross Draw 25-31 Battery</b>	
<b>Spill Date:</b>	<b>3/15/2021</b>	
<b>Area 1</b>		
Approximate Area =	123.52	cu.ft.
VOLUME OF LEAK		
Total Crude Oil =	22.00	bbls
<b>TOTAL VOLUME OF LEAK</b>		
Total Crude Oil =	22.00	bbls
<b>TOTAL VOLUME RECOVERED</b>		
Total Crude Oil =	22.00	bbls

**Re: Closure Request  
Ross Draw 25-31  
Incident Number nAPP2108858520  
Eddy County, New Mexico**

WSP USA Inc. (WSP) on behalf of XTO Energy, Inc. (XTO), presents the following Closure Request detailing site assessment and soil sampling activities at the Ross Draw 25-31 (Site) located in Unit D, Section 25, Township 26 South, Range 29 East, in Eddy County, New Mexico (Figure 1). The purpose of the site assessment and soil sampling activities was to assess for the presence or absence of impacts to soil following the release of crude oil within lined containment at the Site. Based on field observations, field screening activities, and soil sample laboratory analytical results, XTO is submitting this Closure Request and requesting no further action (NFA) for Incident Number nAPP2108858520.

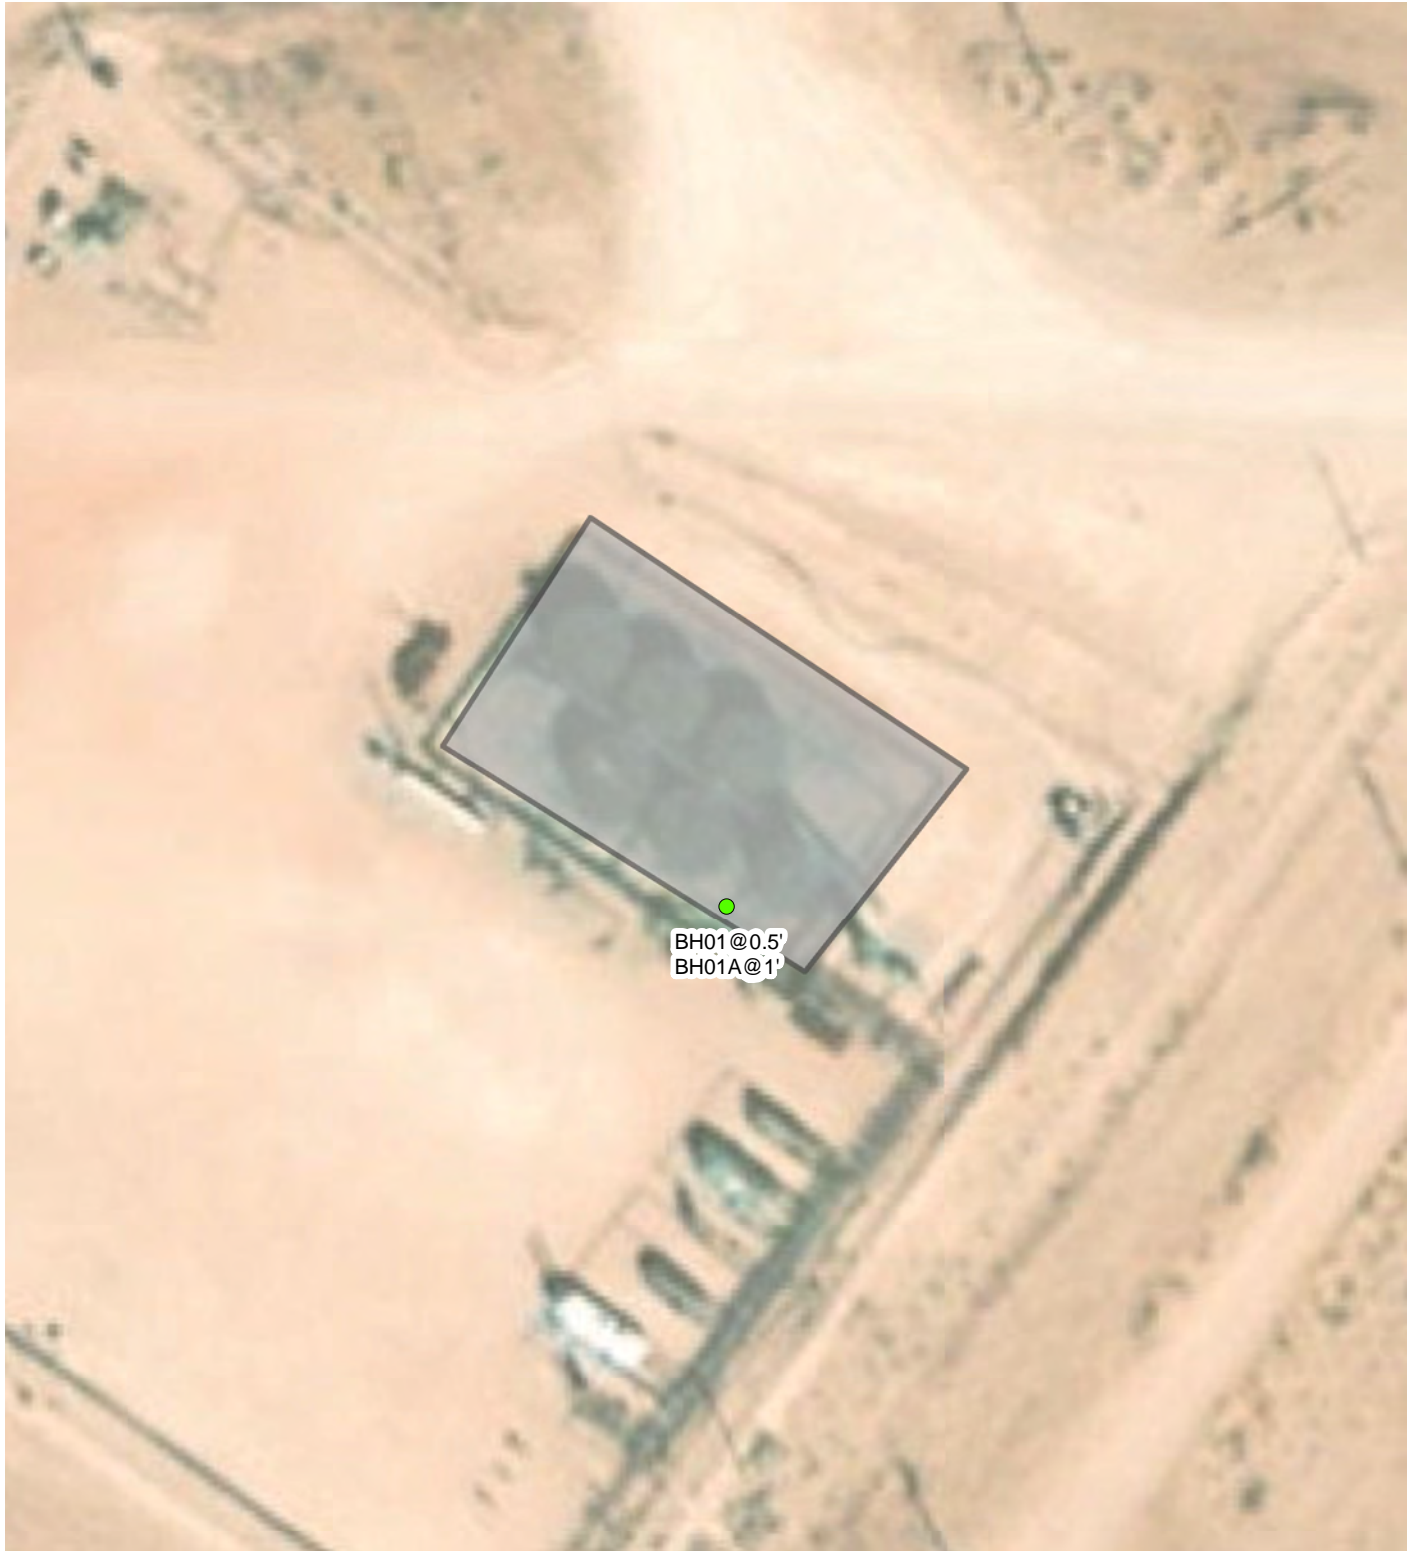
**FIGURE 2**  
**DELINEATION SOIL SAMPLE LOCATIONS**  
ROSS DRAW 25-31  
UNIT D SEC 25 T26S R29E  
EDDY COUNTY, NEW MEXICO  
**XTO ENERGY, INC.**

- DELINEATION SOIL SAMPLE IN COMPLIANCE WITH APPLICABLE CLOSURE CRITERIA
- INFRASTRUCTURE

NOTE: INCIDENT NUMBER nAPP2108858520  
SAMPLE ID@DEPTH BELOW GROUND SURFACE (FEET)

Laboratory analytical results for delineation soil samples BH01 and BH01A, collected at depths of approximately 0.5 feet and 1-foot bgs, indicated that benzene, BTEX, TPH-GRO/TPH-DRO, TPH, and chloride concentrations were compliant with the Closure Criteria. Laboratory analytical results are summarized in Table 1 and the complete laboratory analytical report is included as Attachment 4.

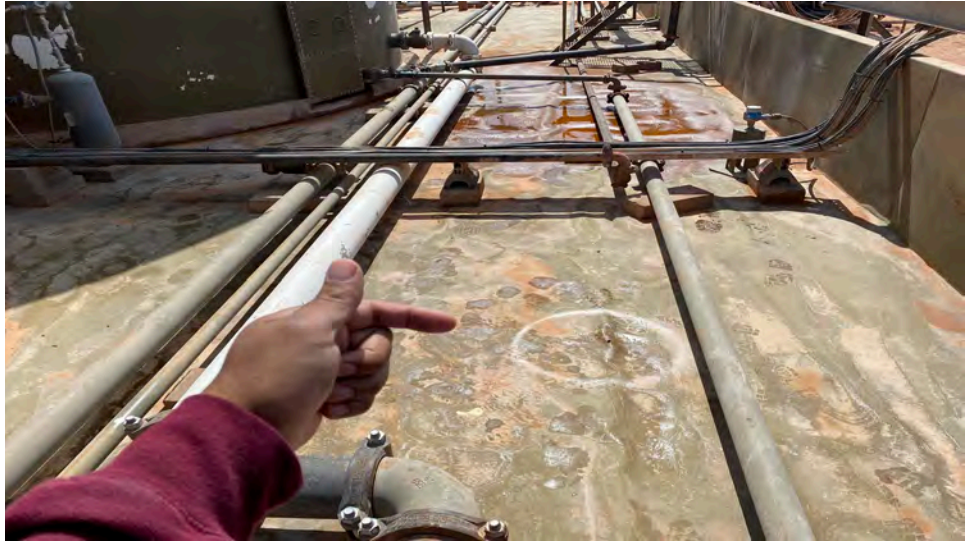
1

View of the liner breach near the  
western edge of the liner.

Following the failed liner integrity inspection at the Site, WSP personnel advanced one borehole (BH01) at the location of the tear in the liner to assess for the presence or absence of soil impacts resulting from the March 15, 2021 crude oil release within lined containment. Two delineation soil samples were collected from borehole BH01 at depths of approximately 0.5 feet and 1-foot bgs. Laboratory analytical results indicated that benzene, BTEX, TPH-GRO/TPH-DRO, TPH, and chloride concentrations were compliant with the Closure Criteria. Additionally, field screening of soil from the borehole indicated no elevated volatile aromatic hydrocarbons or chloride concentrations beneath the tear in the liner. The release was contained laterally by the lined containment and all released fluids were recovered during initial response activities. The tear in the liner was subsequently repaired.

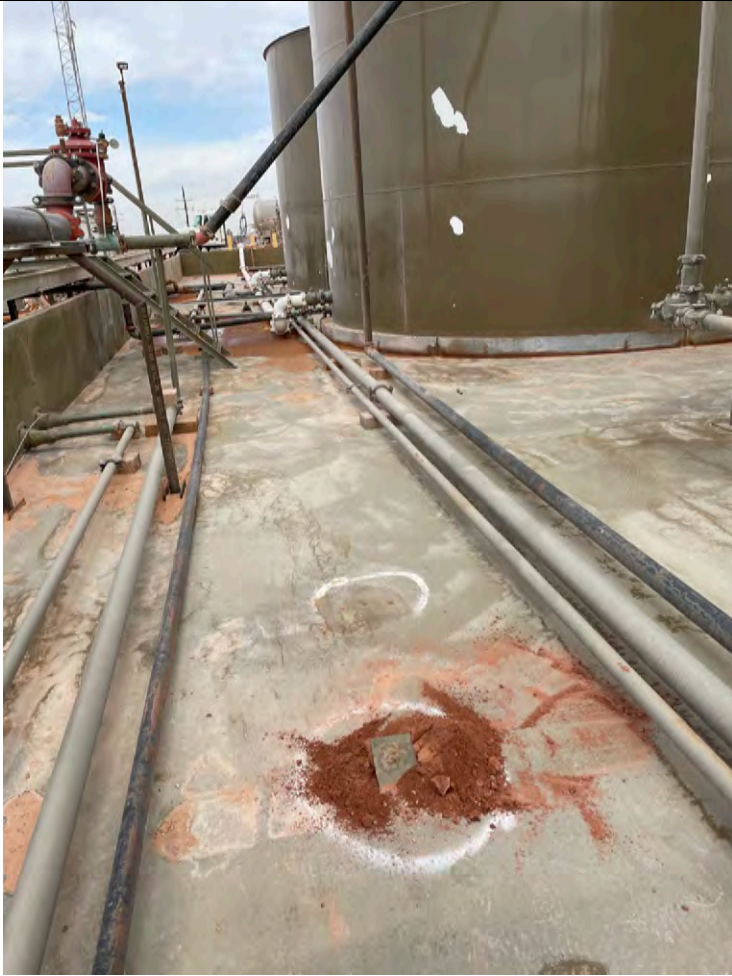
<b>Photo No.</b>	<b>Date</b>	
3	April 27, 2021	
View of liner breach and soil near western edge of the liner after delineation.

A photograph showing an industrial site. In the foreground, there is a concrete or metal surface with a circular area of reddish-brown soil or sediment. A small, dark, rectangular object is placed in the center of this area. To the right, a large, dark, cylindrical storage tank is visible. In the background, there are various pipes, valves, and a crane under a cloudy sky.
