Release Notification

Site Name 20210109-0245-112934	Site Type Lease Road (NMNM 112934)
Date Release Discovered 01/09/2021	API# (if applicable)

RE: Closure Report
Incident ID: nAPP2109056450
AEP #: 20210109-0245-112934
Location: BLM Lease Road # 112934

Executive Summary

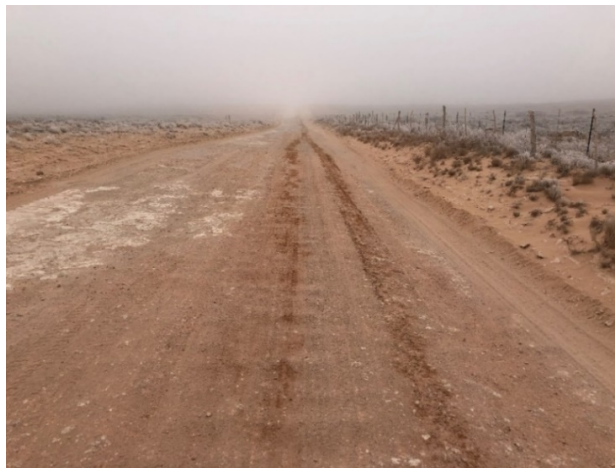
Figure 1: Suspect unauthorized discharge along the north/south lease road; viewing north. Time/Date: 2021-01-09 08:41:09. GPS: 32.4751778 N, 103.6201083 W.

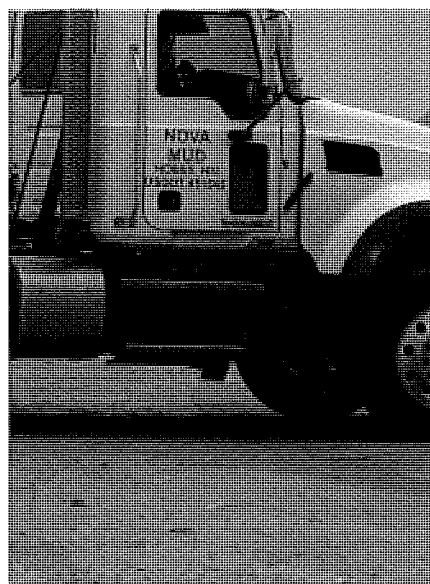
*Exhibit 1: Produced water transport activities on the Marathon Battle 34 Federal #4 lease.
Date/Time: 2021-01-09 15:28:39.
GPS: 32.4434250 N, 103.5660167 W*

AEP personnel observed produced water transporting activities later in the afternoon of January 9th (Exhibit 1) from the Marathon Battle 34 Federal #4 lease.

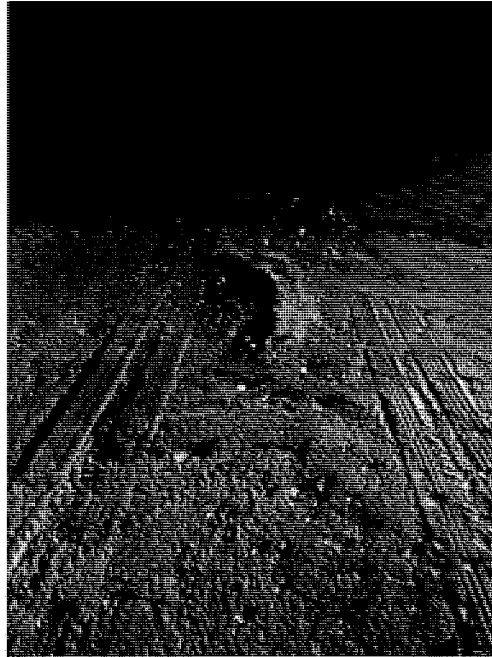
Figure 2: Suspect unauthorized discharge on the AEP lease Abe #1. Photo is viewing north at the discharge point. Date/Time: 2021-01-09 02:50:32. GPS: 32.4446722 N, 103.5756833 W.

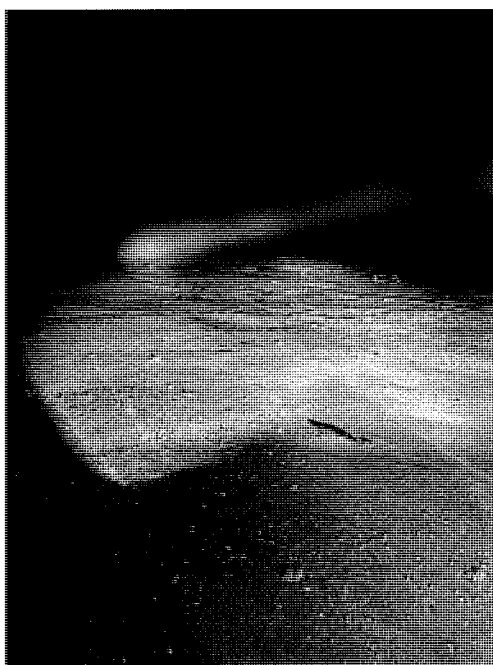
Figure 3: Suspect unauthorized discharge at the AEP lease Abe #1. Photo is viewing northwest. The spotlight is focused on the northwestern extent of the release extent. Date/Time: 2021-01-09 03:01:53. GPS: 32.4446972 N, 103.5755000 W.

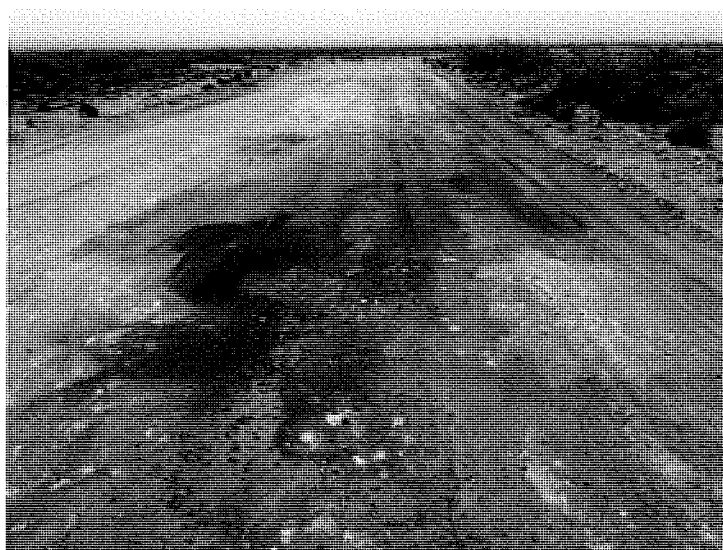
Figure 8: Suspect unauthorized discharge at the southern node of the 0.5-mile tracked route within the “Abe lease area”. Photo is viewing south at the node terminus. Date/Time: 2021-01-09 09:43:18. GPS: 32.4502861 N, 103.5768667 W.

2. A 0.5-mile section within the “Abe lease area” tracking northwest to southeast. Figures 8 and 9 shows discharges along the route. The northwest node of the segment is located at the entrance to the shared location of the BC Operating Abe State #2 tank battery (API: 30-025-42066; Figure 10) and the Marathon Abe Unit #2 wellhead (API: 30-025-34146).

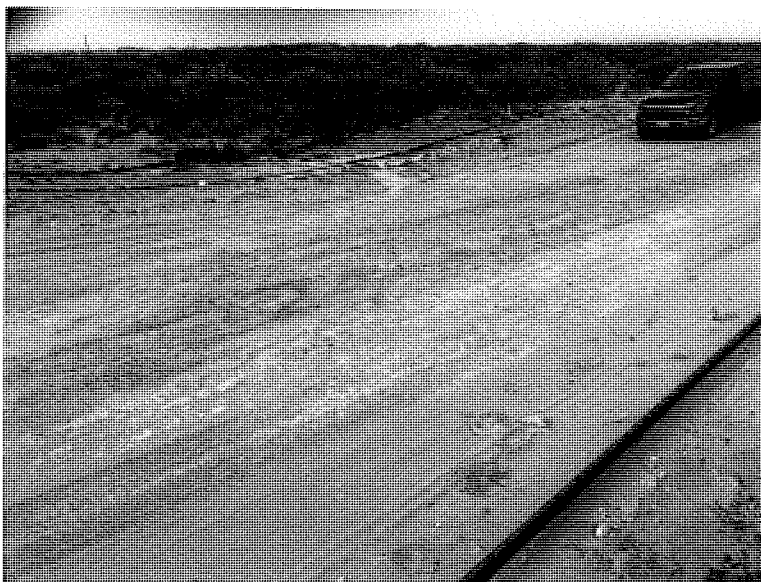
Figure 9: Suspect unauthorized discharge along the 0.5-mile tracked route within the "Abe lease area". Discharge flowed off the lease road. Date/Time: 2021-01-09 09:54:37. GPS: 32.4514611 N, 103.5797722 W.

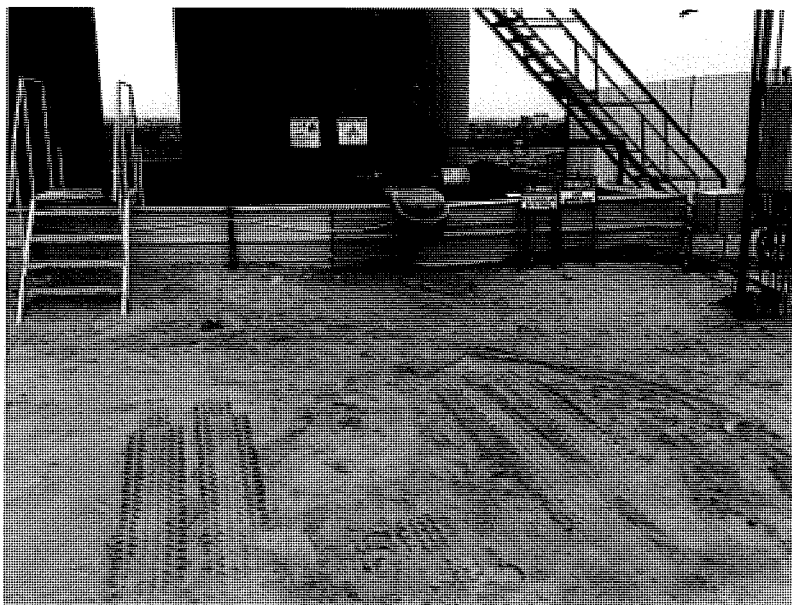
Figure 10: Loading area at BC Operating Abe State #2 tank battery (API: 30-025-42066). Date/Time: 2021-01-09 12:40:27. GPS: 32.4522361 N, 103.5884861 W.

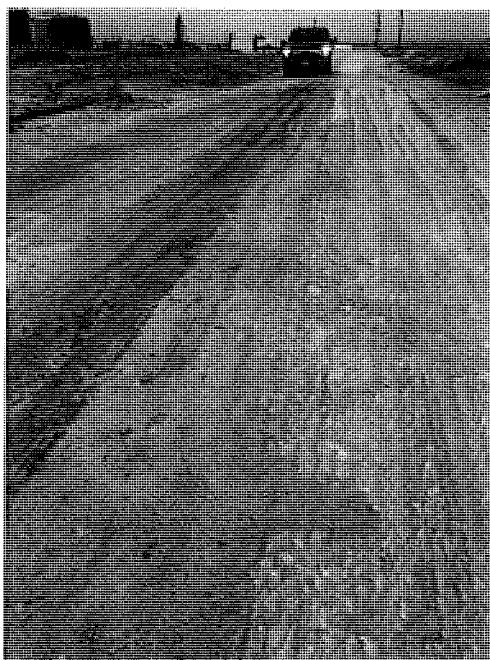
Figure 12: Suspect unauthorized discharge along the north/south lease road to the Marathon Battle 34 Federal 4H lease (API: 30-025-42636); viewing south. The Battle 34 Federal 4H is visible in the photo background. Date/Time: 2021-01-09 10:27:12. GPS: 32.4448611 N, 103.5664000 W.

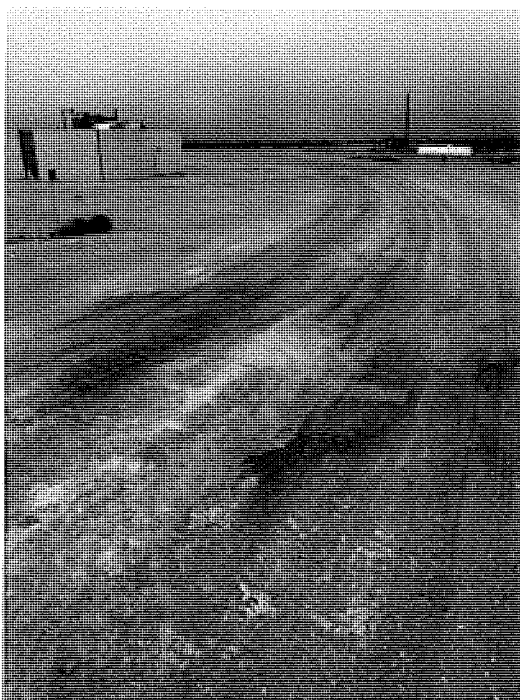
Figure 13: Suspect unauthorized discharge along a 0.2-mile segment of a north/south lease road. Photo is viewing south at the entrance to the Marathon Battle 34 Federal 4H lease. Date/Time: 2021-01-09 10:25:47. GPS: 32.4438833 N, 103.5663833 W.
