**Breitburn Operating, LP  
AKA Maverick Natural Resources LLC  
State 647 AC 721 Tank Battery**

**Closure Report**

**Section 33, Township 18S, Range 28E  
Eddy County, New Mexico**

**2RP-4238**

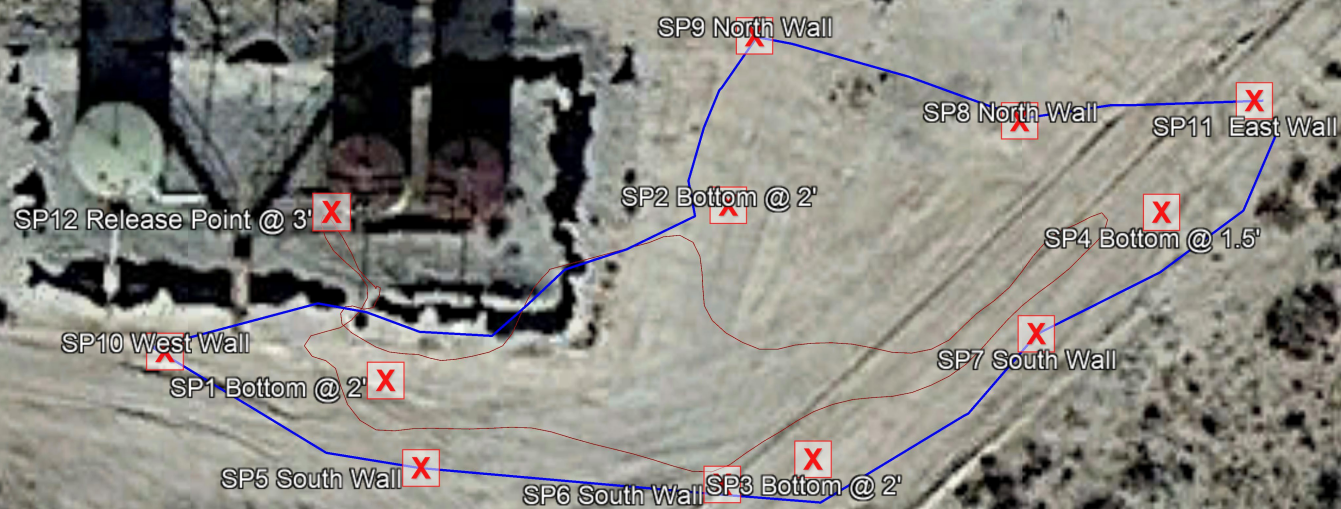
## **Figure 1**

### **Site Map**

- Confirmation Sample points Red X
- Remediation Area
- Spill Area

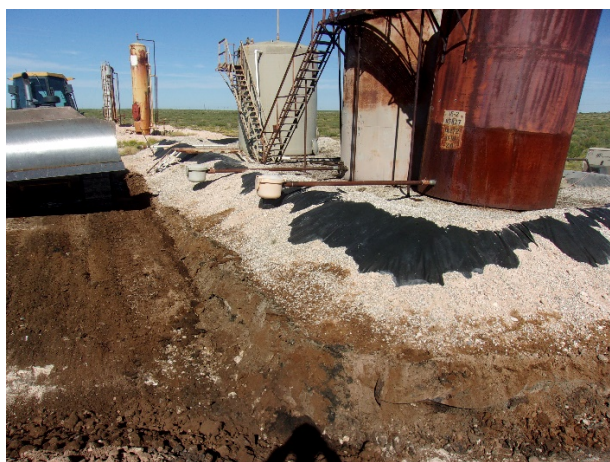
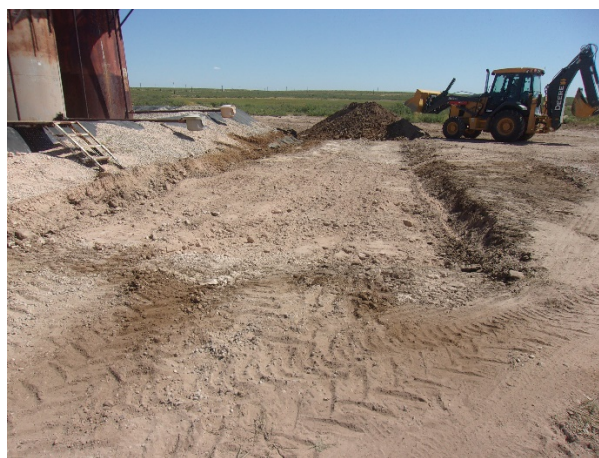
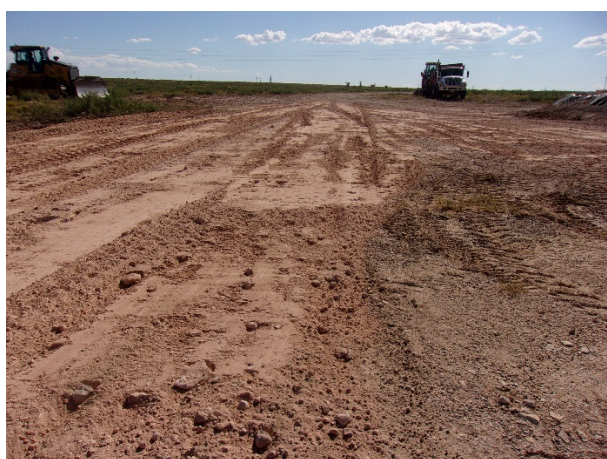
Excavation

On September 25, 2019 SESI personnel are onsite together with personnel and equipment from Custom Welding of Hobbs, NM. The SESI Field technician traversed the site assessing the release area with the equipment operator. The release area on the east side of the containment is excavated, a soil sample grabbed, and field tested for TPH. At 1ft. bgs. heavy hydrocarbon staining is encountered. The equipment operator is instructed to advance to 2 ft. bgs until the stained soil is removed. There were two (2) DCP pipelines that ran through the location along the edge of the release area. A Hydro-vac is utilized to daylight the pipeline area. The equipment continues to excavate the impacted area, while the field technician is simultaneously field testing the bottom and sidewalls of the excavation.

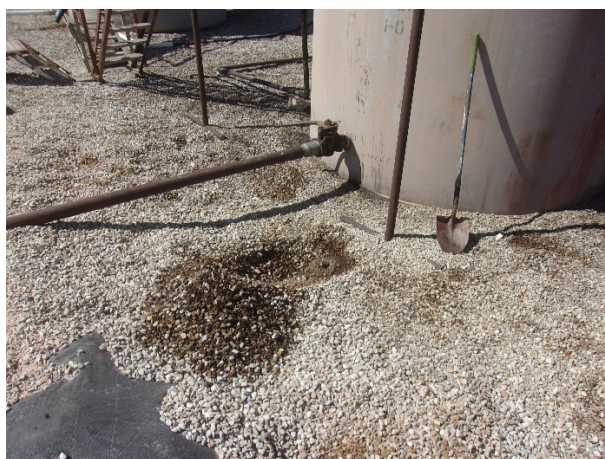
Lease Road Area

According the C-141 as it was filed with NMOCD: approximately One Hundred Fifty (150) barrels of oil and produced water were released due to internal corrosion in the bottom of tank #731. Most of the fluid was contained inside the lined containment. A vac truck was dispatched by Maverick personnel. Approximately Ninety (90) barrels of fluid were recovered from within the containment. Approximately 2 bbls of fluid leached over the berm, traversing the pad and lease road area. SESI was contacted to assess and remediate the site. A Trimble Juno 3B was used to map the spill and excavation area. The mapped spill area encompassed approximately 134 square yards of pad and lease road area.
