CLOSURE REPORT

Oxy Sand Dunes North

Eddy County, New Mexico 32.266889 N, 103.792056 W NMOCD Incident # NAPP2035042855 Enterprise ECIRT # 90098

March 4, 2021 Ensolum Project No. 03B1226035

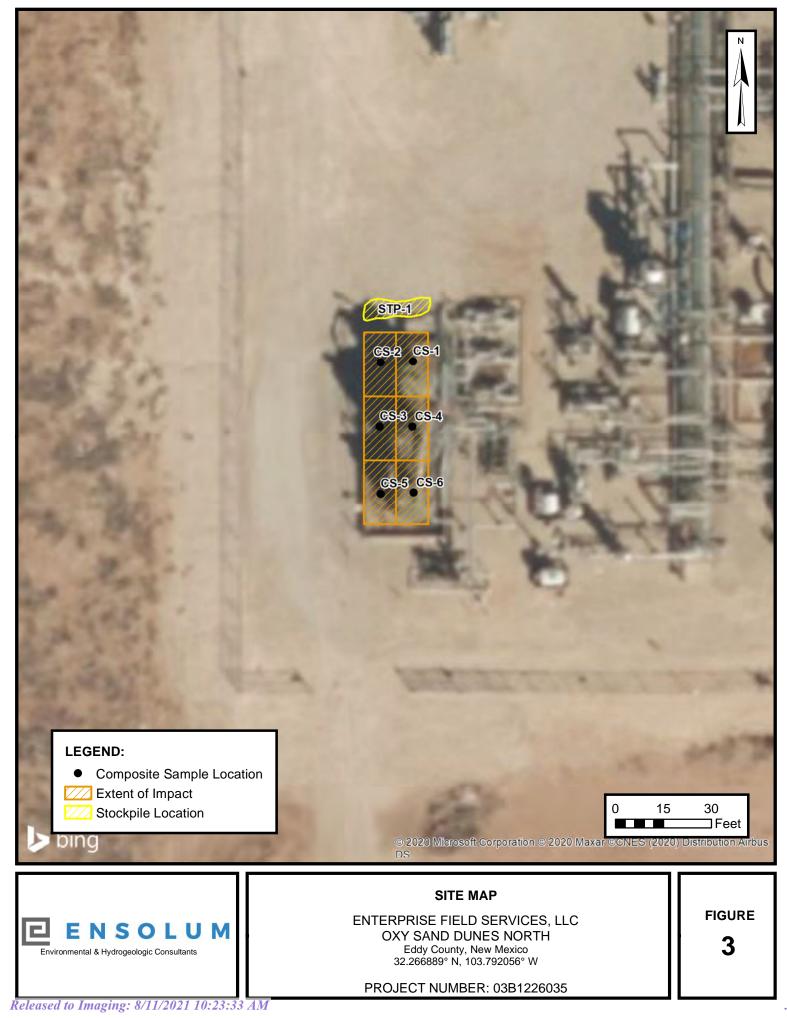
The Topographic Map depicting the location of the Site is included as **Figure 1**, the Site Vicinity Map is included as **Figure 2**, the Site Map indicating the locations of composite soil samples and soil stockpile is included as **Figure 3**, and the Closure Criteria Map is included as **Figure 4** in **Appendix A**.

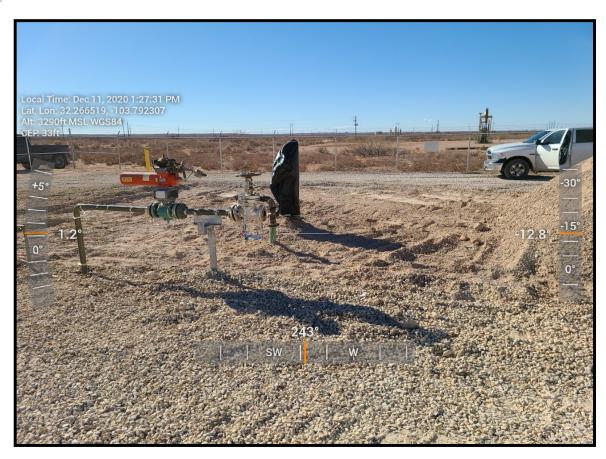
View of excavated area during remediation activities, facing west.

On August 2, 2020, a fire was reported at the Site due to condensate vapors emitted from a gun barrel tank igniting from a secondary source. A slop tank, gun barrel tank, and a condensate tank were fully involved in the fire, including the secondary containment. The fire was fully extinguished with the extent of the damage including the lining of the secondary containment, and electrical wiring, motor windings, and plastic components that were up to 40 feet away from the tanks. An approximate amount of 250 bbls of condensate liquid was lost, presumably consumed by the fire. The site was then excavated by Strike, LLC (Strike) and all impacted soil was placed into a stockpile that was staged on-Site.

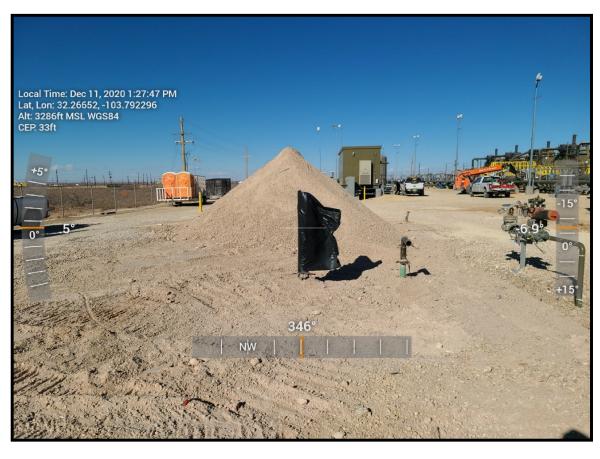
View of excavated area and stockpile during remediation activities, facing north.

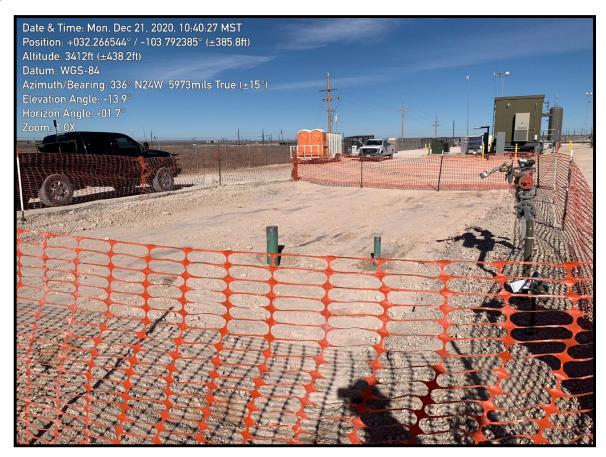
View of excavated area during remediation activities, facing northwest.
