**Re: Site Assessment and Closure Report  
Cooter 16 St. Com 5H Battery  
API No. 30-015-37875  
GPS: Latitude 32.1236382 Longitude -103.9883423  
UL "O", Sec. 16, T25S, R29E  
Eddy County, NM  
NMOCD Ref. Incident ID NRM2028059512 & NRM2029653030**

Cooter 16 St Com 5H Battery  
API 30-015-37875  
Eddy County, NM  
Site Map

**SITE PHOTOGRAPHS**  
**DEVON ENERGY PARTNERS**  
**COOTER 16 ST. COM 5 H BATTERY**

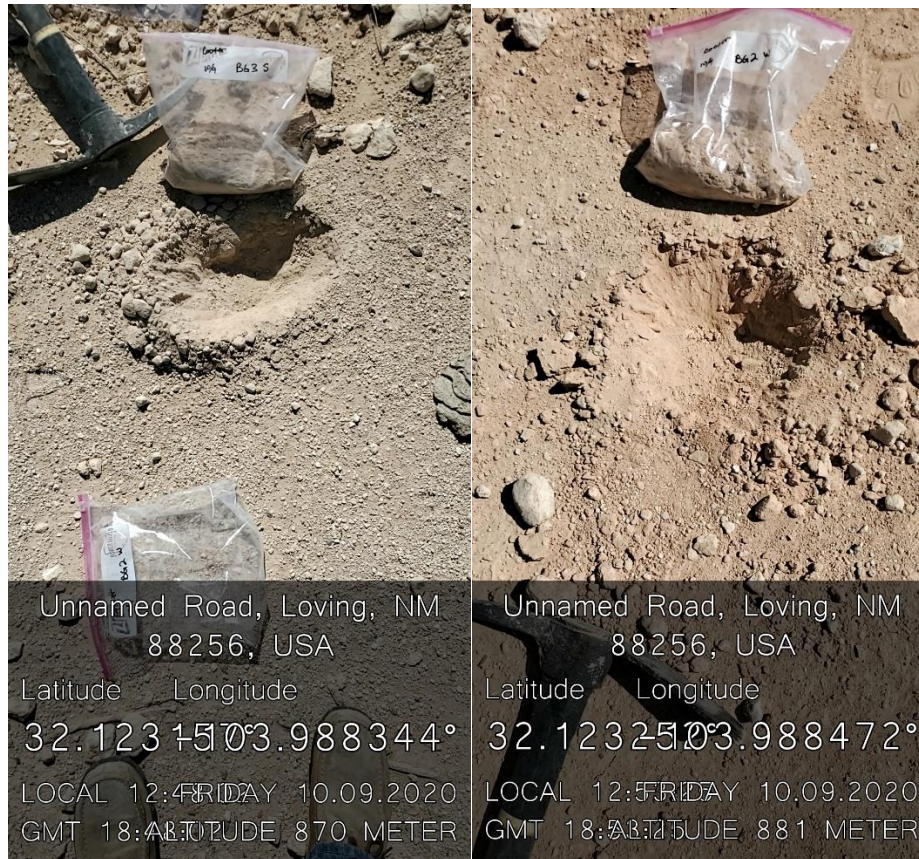
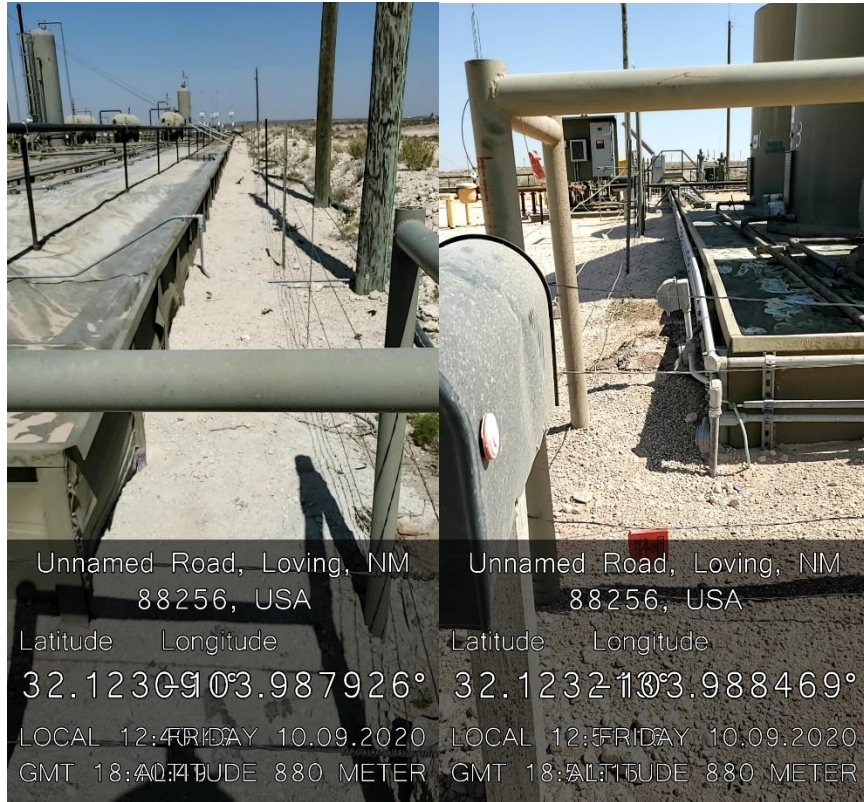
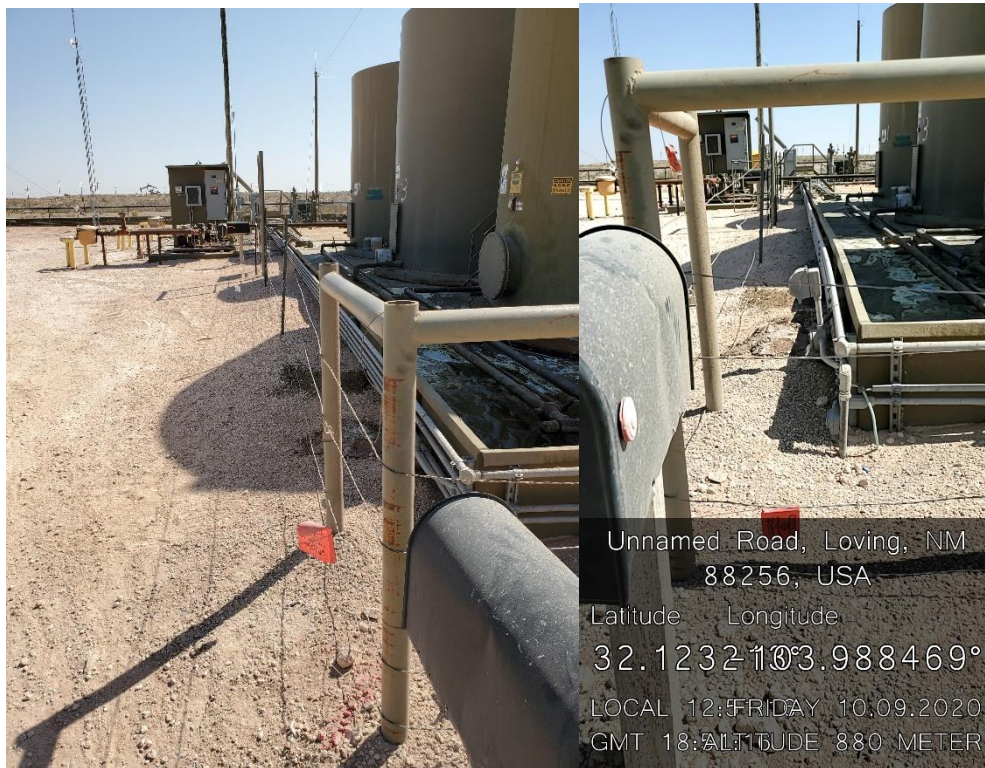
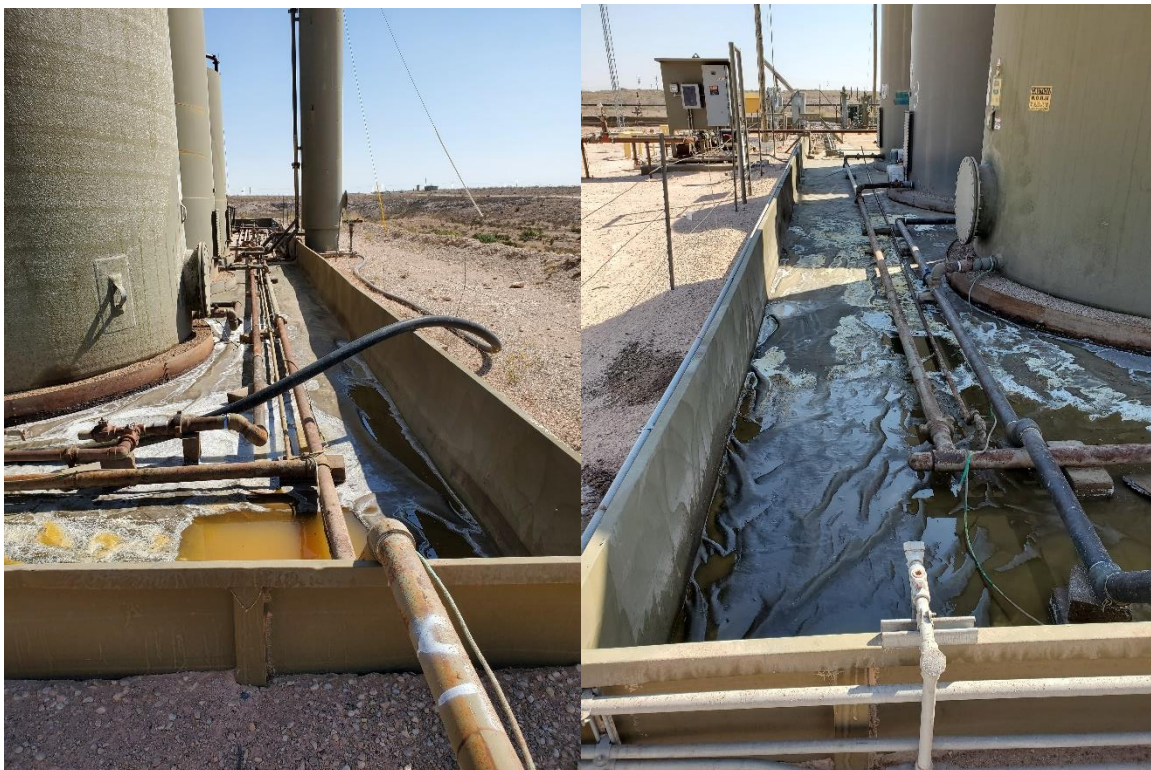
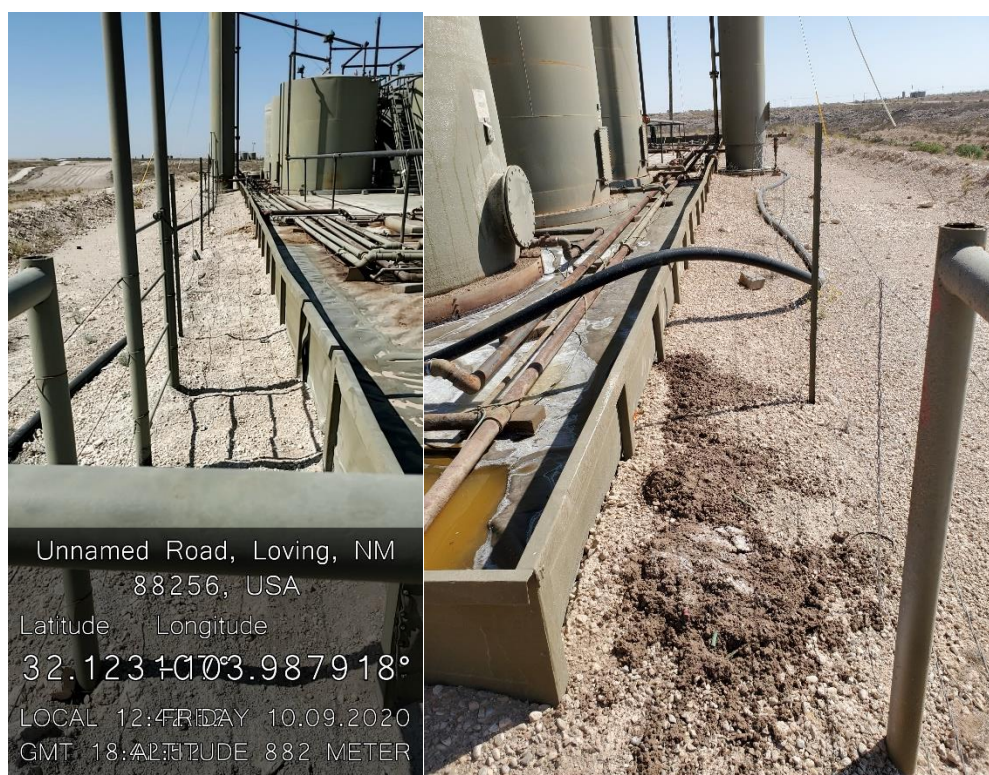
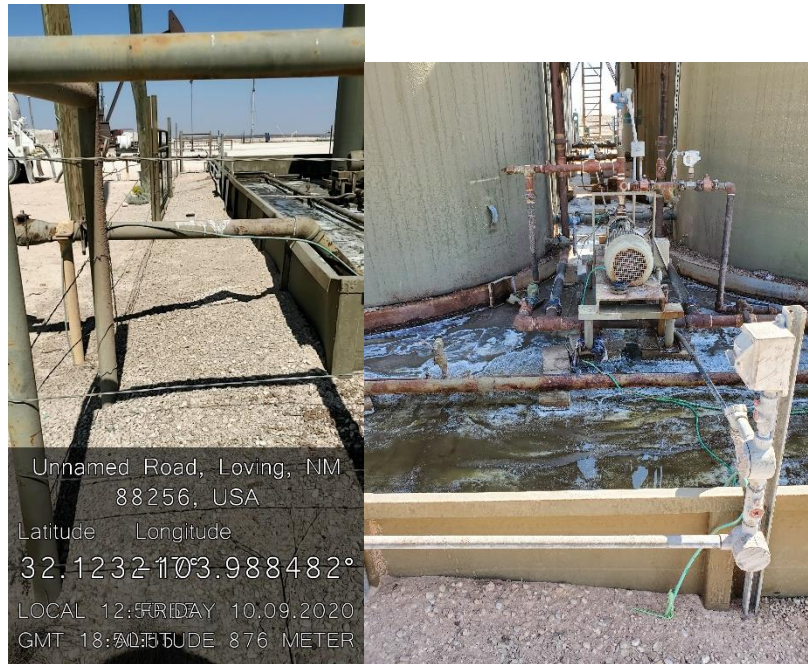
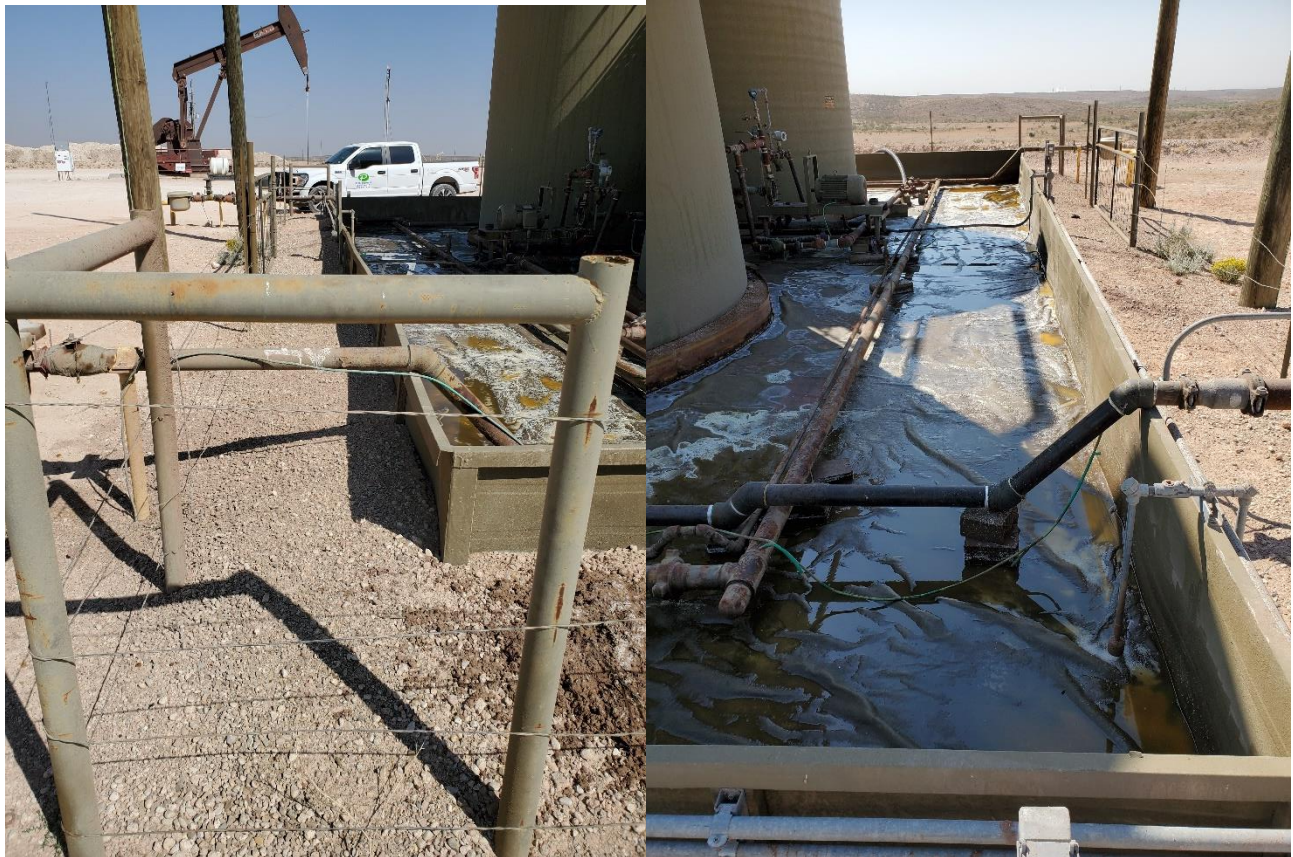
NRM2028059512: On September 24, 2020, a sight glass broke on one of the separators, releasing 8.91 barrels (bbls) of produced water released into the engineered steel and poly lined containment. 8.91 bbls were recovered, and the sight glass was replaced.

NRM2029653030: On October 8, 2020, a transfer pump packing failed causing a leak to begin while the pump was running. The result of the leak was a release of 30 bbls of produced water, all fluids stayed inside the engineered steel and poly lined containment and the 30 bbls of produced water were recovered.

The sample results were below NMOCD Closure Criteria 19.15.29 NMAC. Based on these findings, no remediation activities were needed at this location.
