Re: Closure Request Report

King Tut Federal CTB (4.3.21) Tracking # NAPP2110642327 GPS: 32.19545, -103.71811 Unit Letter D Section 30, Township 24 South, Range 32 East

COG Operating, LLC respectfully requests that the New Mexico Oil Conservation Division and the Bureau of Land Management grant closure approval for the King Tut Federal CTB fire that occurred on April 3, 2021. (Tracking # NAPP2110642327).

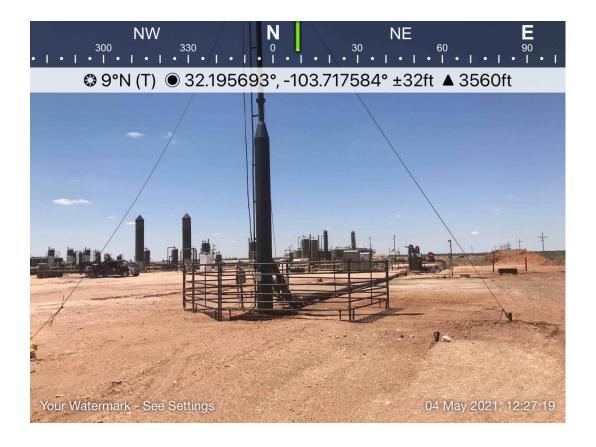
Photo

- The pad was scraped around the flare were the fire occurred. A five-point composite sample was collected.
- Table 1 shows the analytical results.
- All the excavated material was hauled to an NMOCD approved solid waste disposal facility.
- The analytical data shown in Table 1 show that the release area meets NMOCD closure criteria (NMAC 19.15.29.12(E) Table I).
