Release Notification

Site Name Ross Draw 25 North	Site Type Tank Battery
Date Release Discovered 7-10-2020	API# (if applicable)

On July 10, 2020, a 10-inch Victaulic tee failed and released approximately 40 barrels (bbls) of produced water into the lined containment of the tank battery. The fluids were recovered, and a subsequent visual inspection of liner integrity determined the liner was not in working condition. XTO reported the release to the New Mexico Oil Conservation Division (NMOCD) via email on July 11, 2020 and submitted a Form C-141 on July 23, 2020. The release assigned Incident Number NRM2020924128.

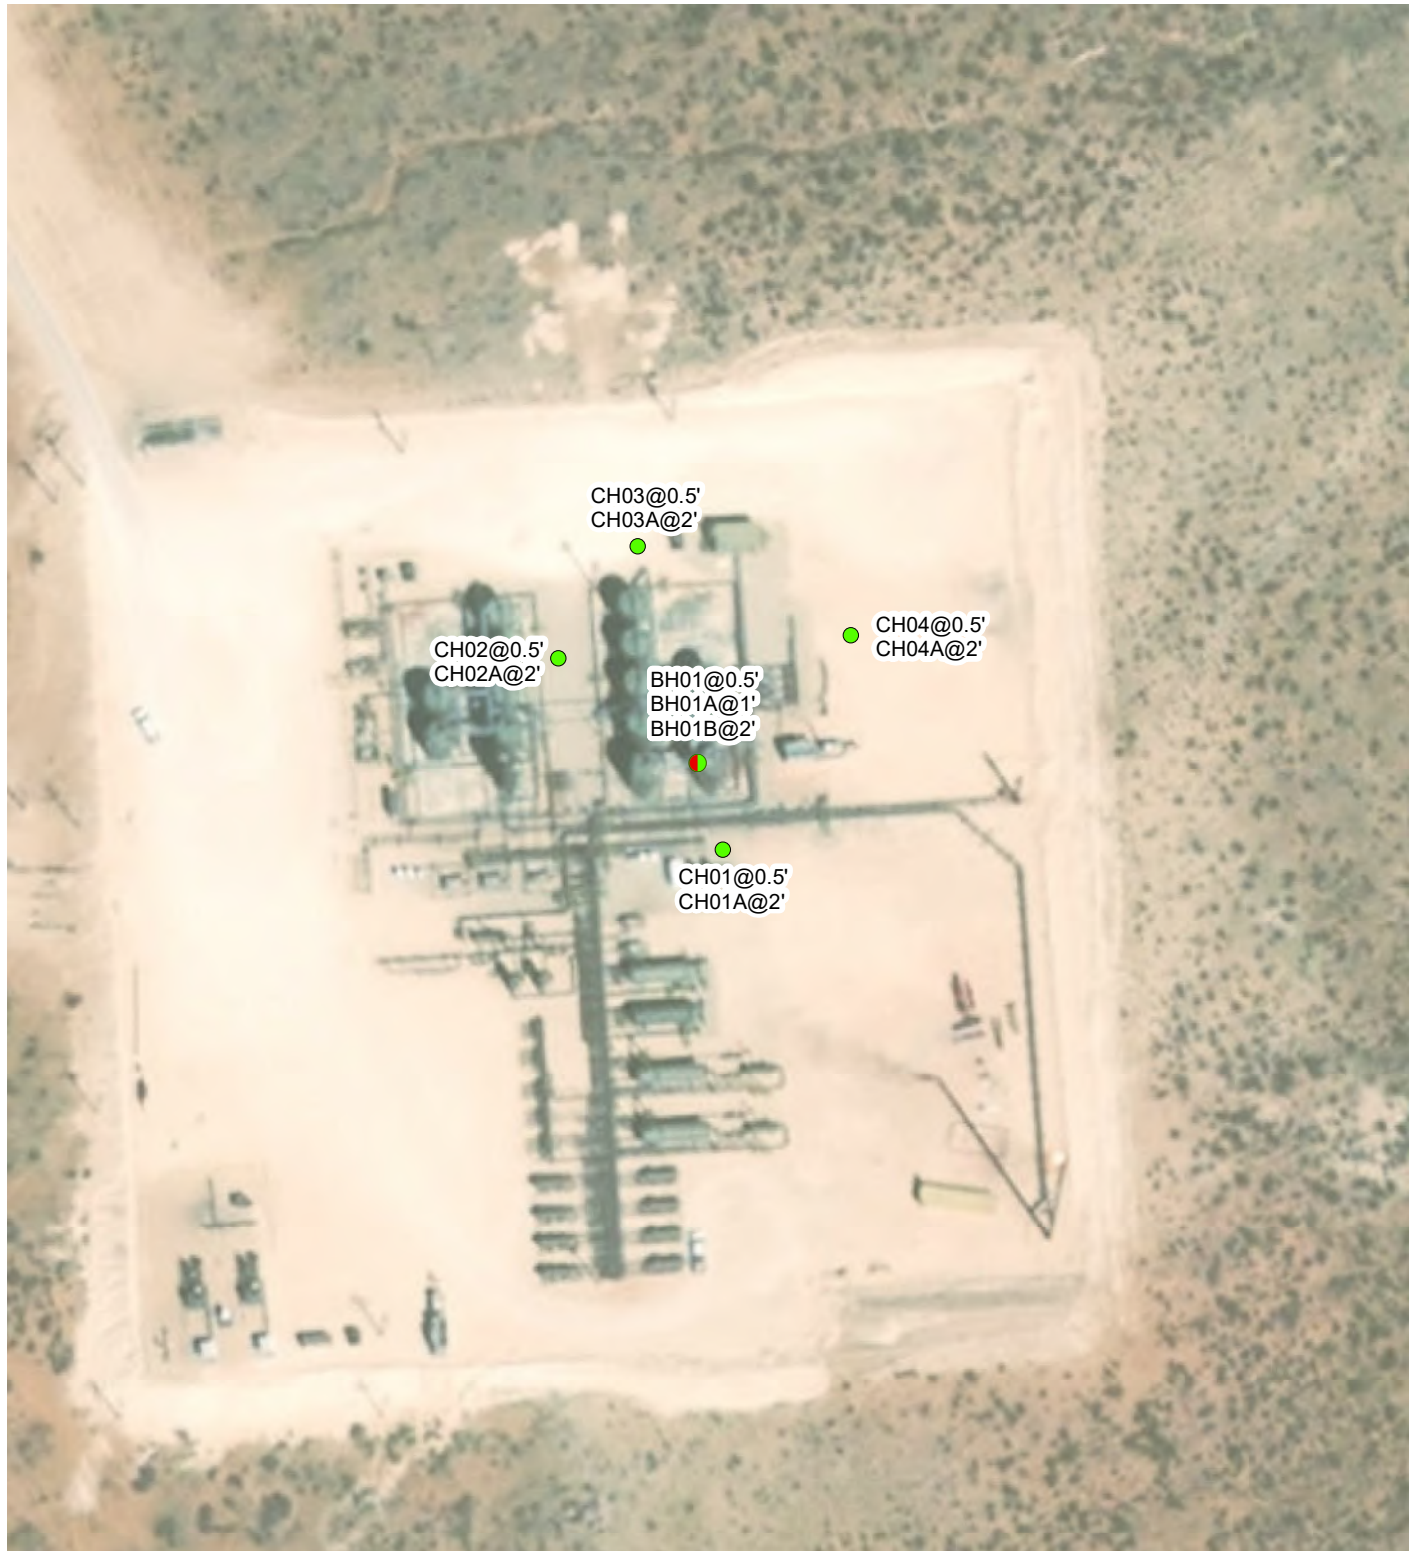
FIGURE 2
 DELINEATION SOIL SAMPLE LOCATIONS
 ROSS DRAW 25 NORTH
 UNIT B SEC 25 T26S R29E
 EDDY COUNTY, NEW MEXICO
 XTO ENERGY, INC.

- DELINEATION SOIL SAMPLE WITH CONCENTRATIONS PREVIOUSLY EXCEEDING APPLICABLE CLOSURE CRITERIA
- DELINEATION SOIL SAMPLE IN COMPLIANCE WITH APPLICABLE CLOSURE CRITERIA

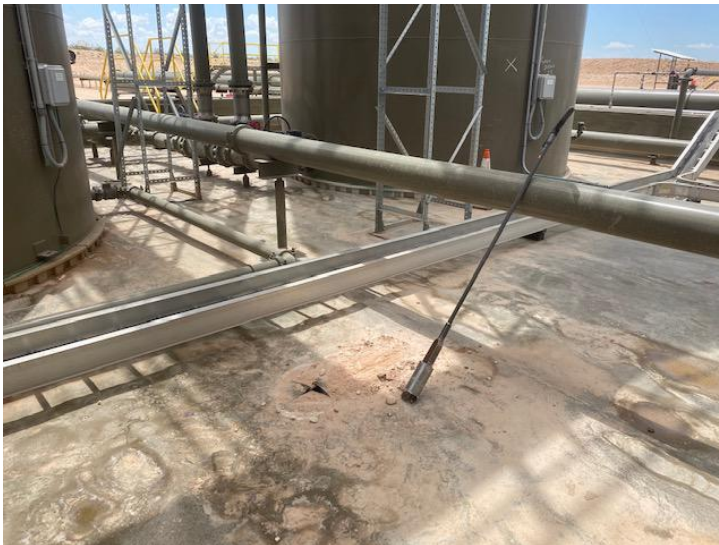
Photo No.	Date	
1	July 22- September 16, 2020

View of BH01 location within the lined containment during initial delineation efforts

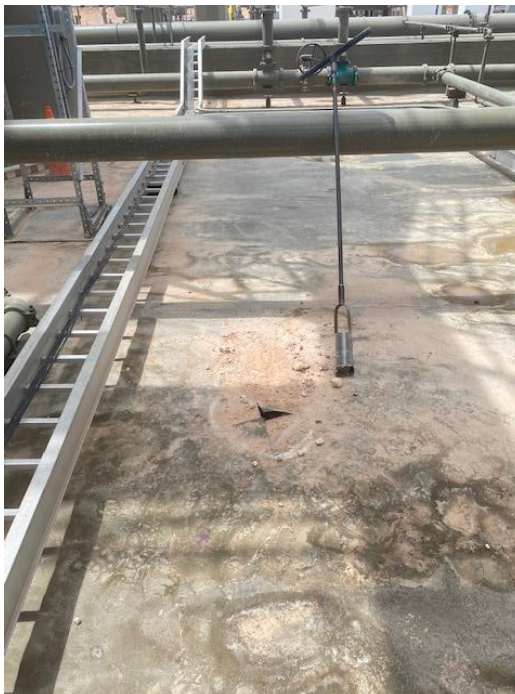
Photo No.	Date	
2	July 22- September 16, 2020

View of BH01 location within the lined containment during initial delineation efforts.

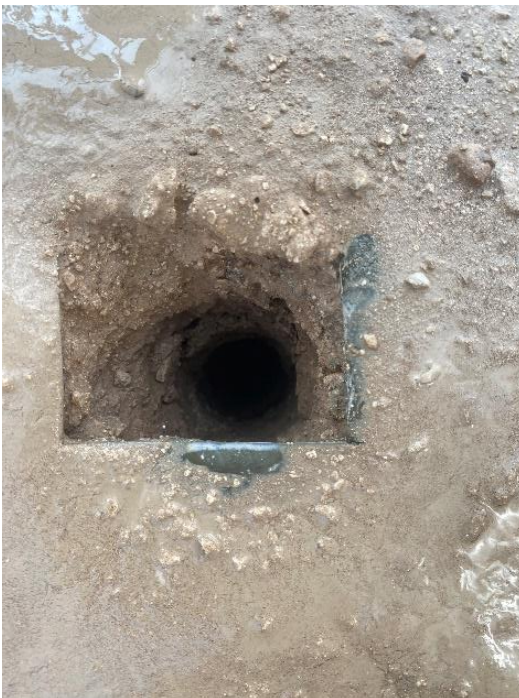
Photo No.	Date	
3	July 22- September 16, 2020

North view of the soil sample CH01 location following advancement with the core drill.

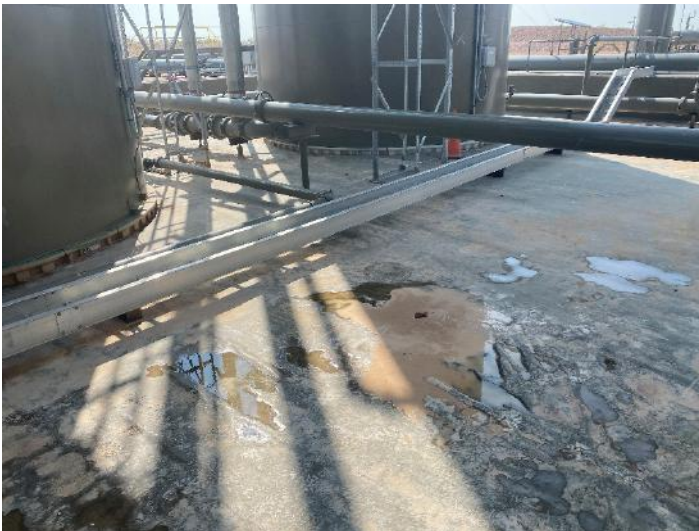
Photo No.	Date	
4	July 22- September 16, 2020

View of the area associated with BH01 following advancement with the core drill.

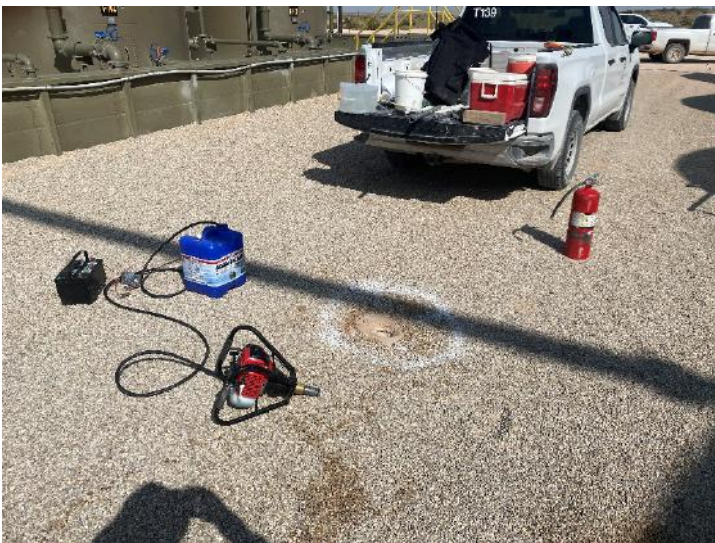
Photo No.	Date	
5	July 22- September 16, 2020

View of the soil sample CH02 location following advancement with the core drill.

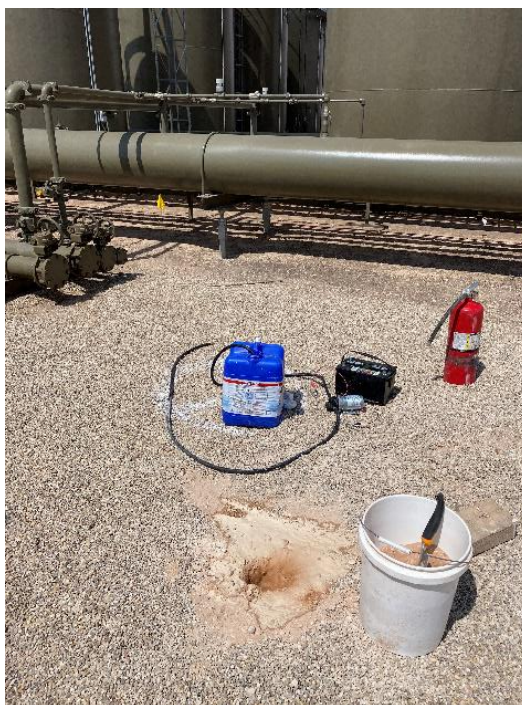
Photo No.	Date	
6	July 22- September 16, 2020

View of the soil sample CH01 location prior to backfilling.
