**JG STATE #001 BATTERY  
CLOSURE REQUEST**

**API NO. 30-025-39816  
U/L N, SECTION 16, TOWNSHIP 17S, RANGE 32E  
LEA COUNTY, NEW MEXICO  
RELEASE DATE: 6/13/2020  
INCIDENT NO. NRM2017041629**

**Subject: Closure Request for Spur Energy Partners – JG State #001 Battery**

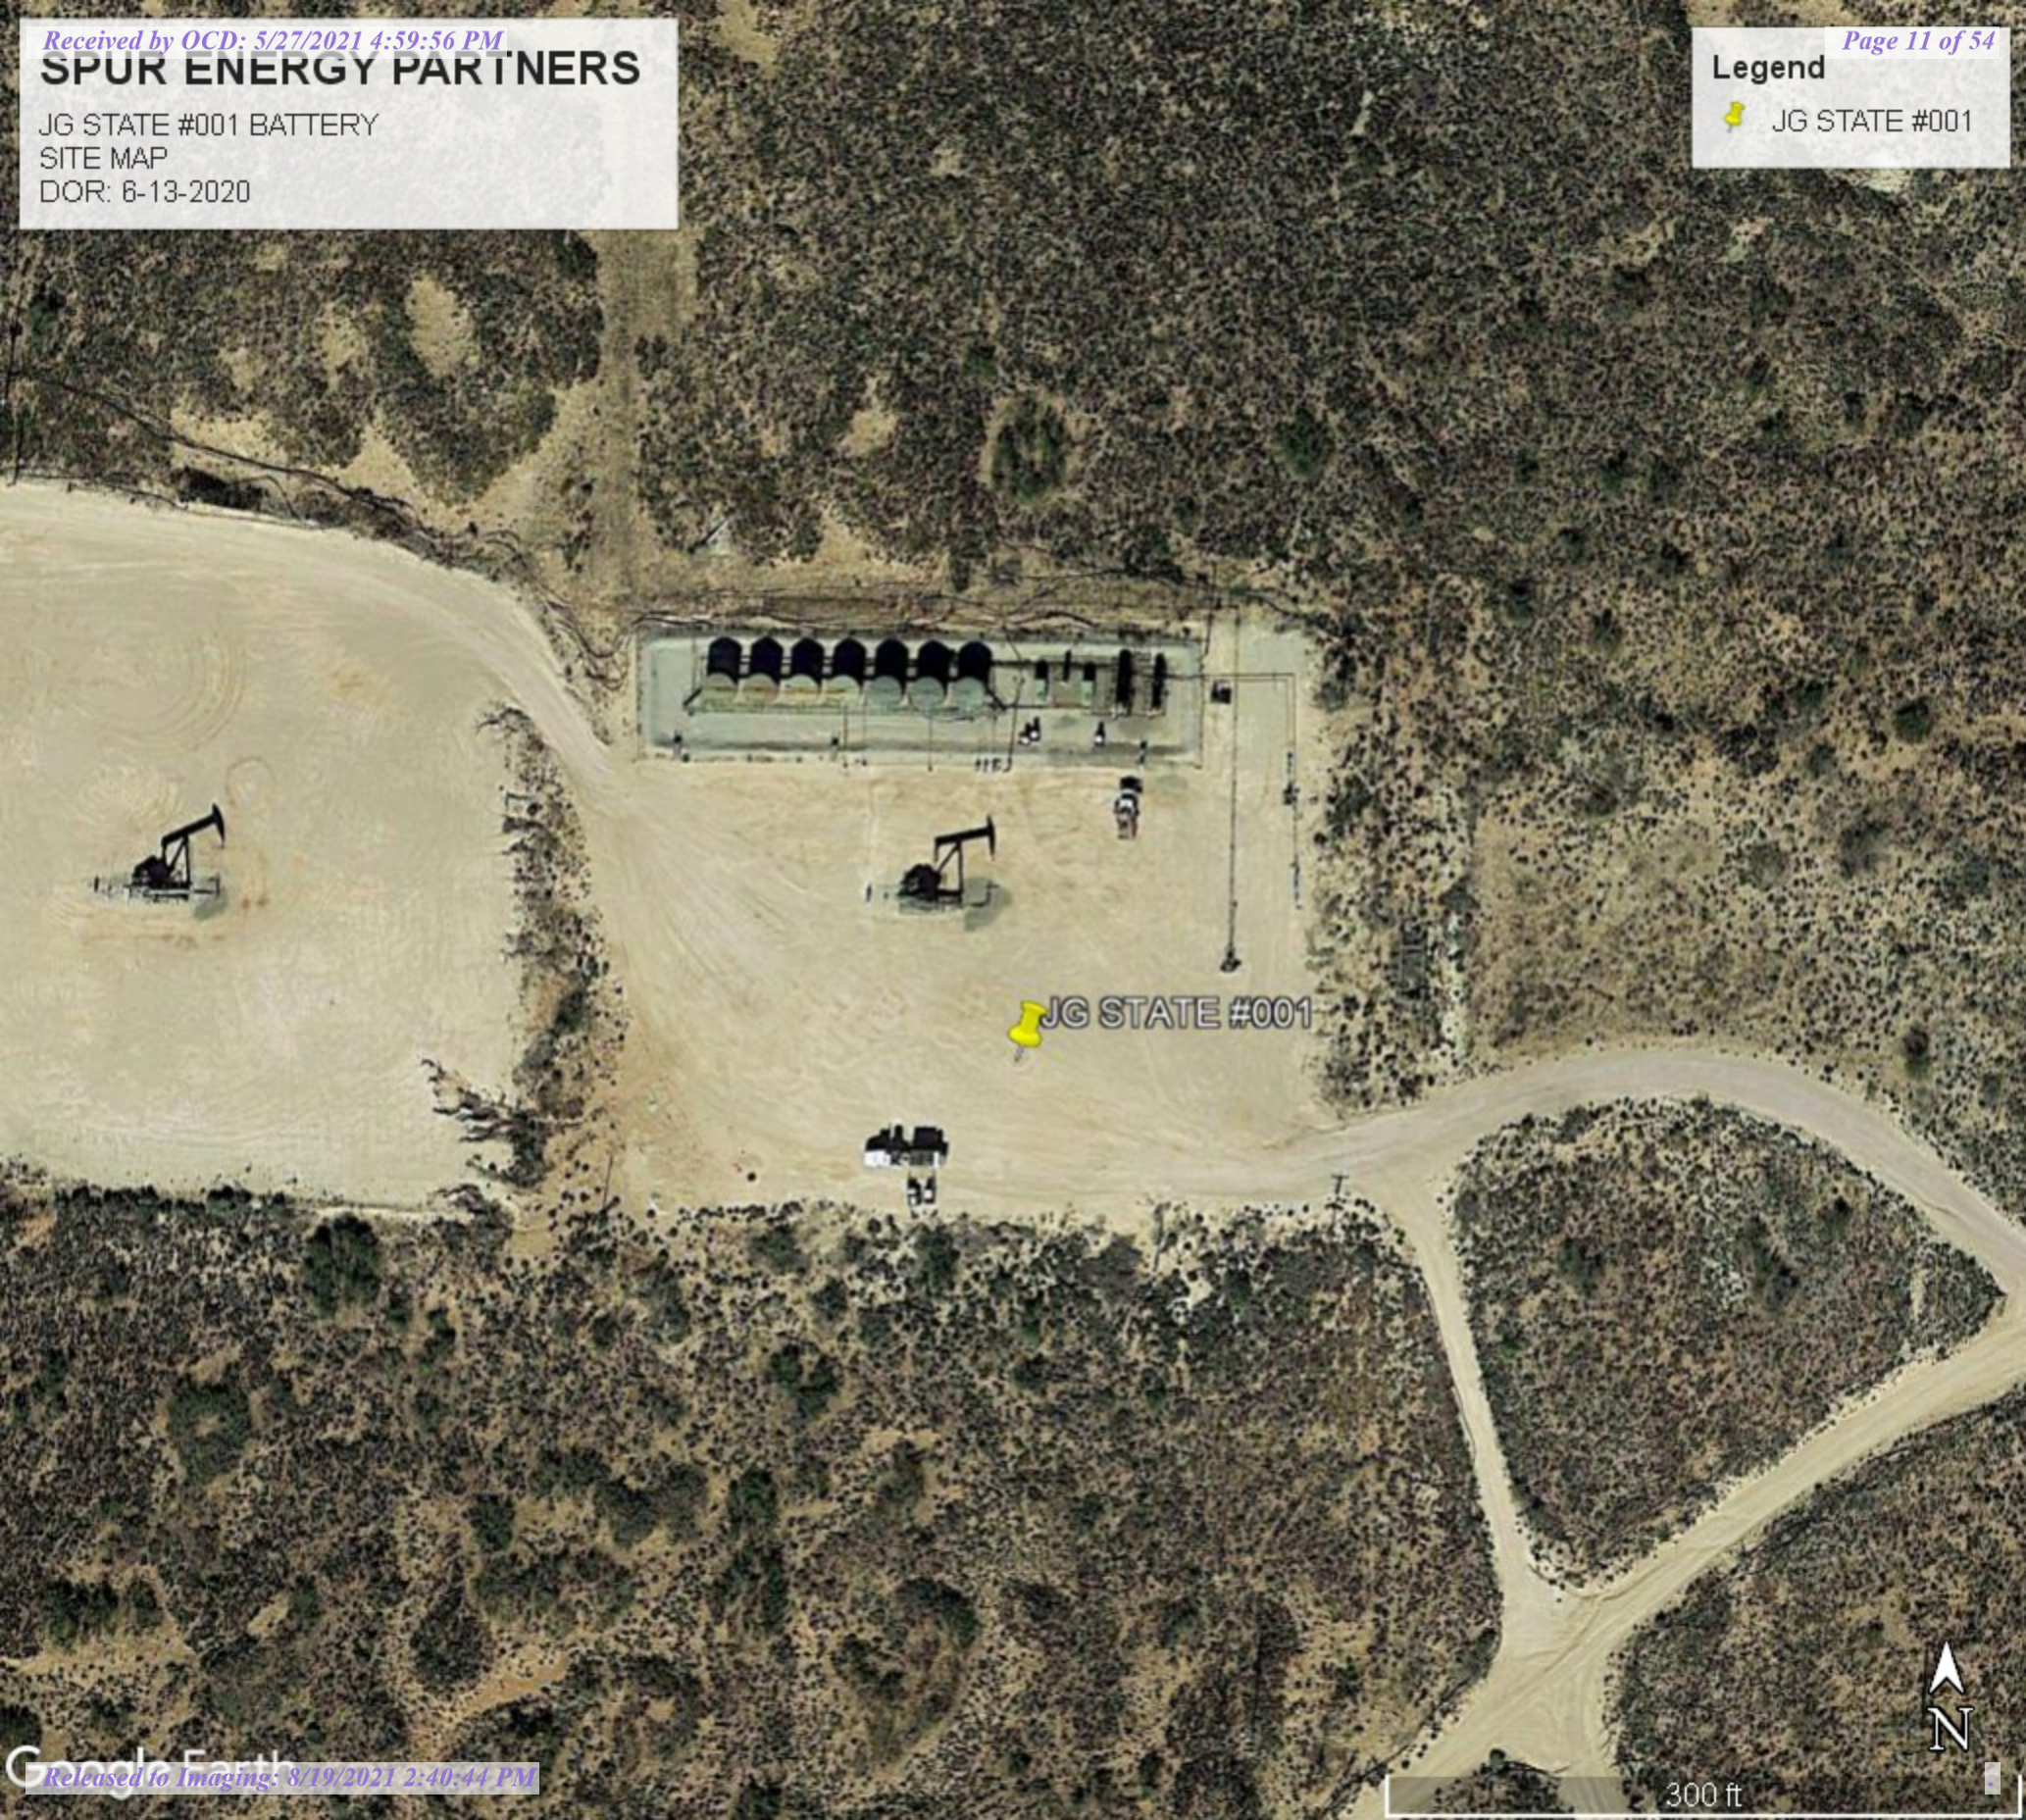
JG STATE #001 BATTERY  
SITE MAP  
DOR: 6-13-2020

The release at the JG State #001 occurred on state owned land and is located at 32.8283081 - 103.7735443, 2.02 miles southwest of Maljamar, New Mexico in Lea County. The legal description of the site is Unit Letter N, Section 16, Township 17S, Range 32E. A site schematic is included in this report.

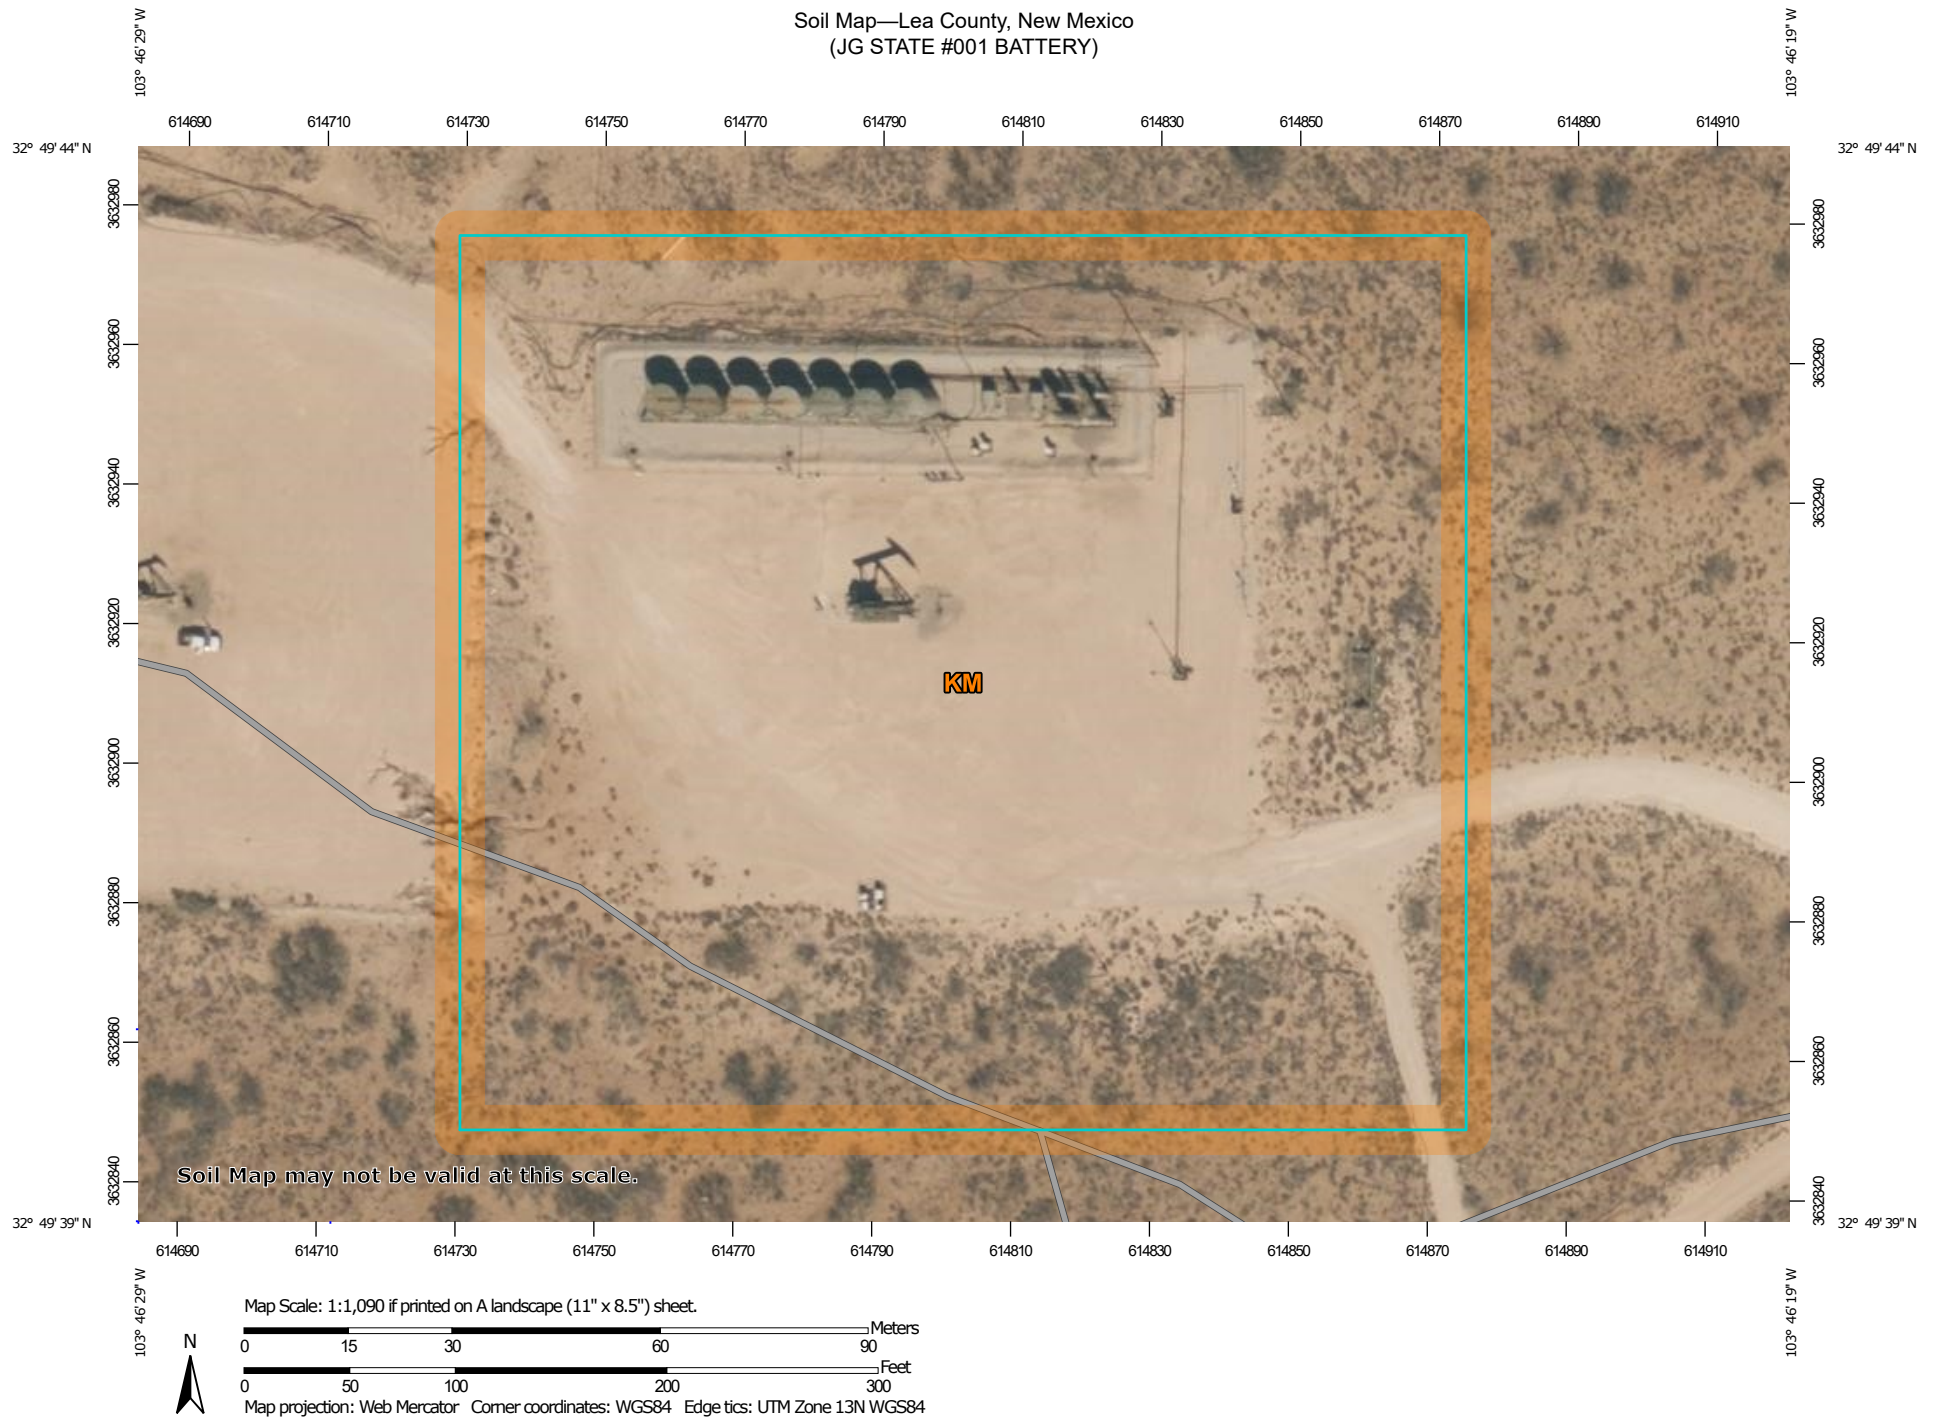
Soil Map—Lea County, New Mexico  
(JG STATE #001 BATTERY)

*The United States Department of Agriculture Natural Resources Conservation Services* indicates that the soil type found in the area consists of Kermit Soils and Dune Land, with 0 to 12 percent slopes. Please also find the Soil Map attached.

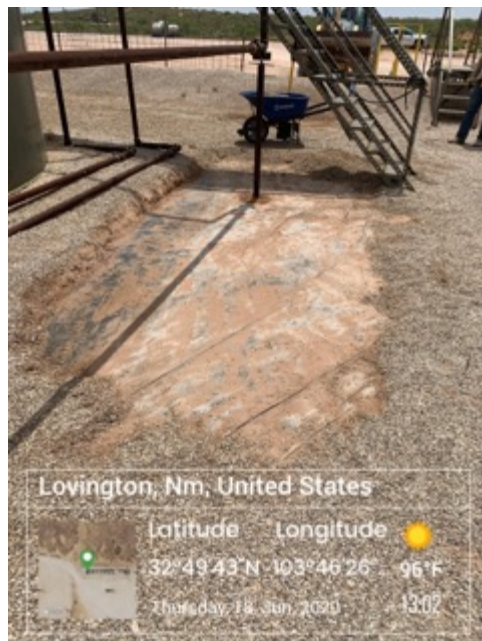
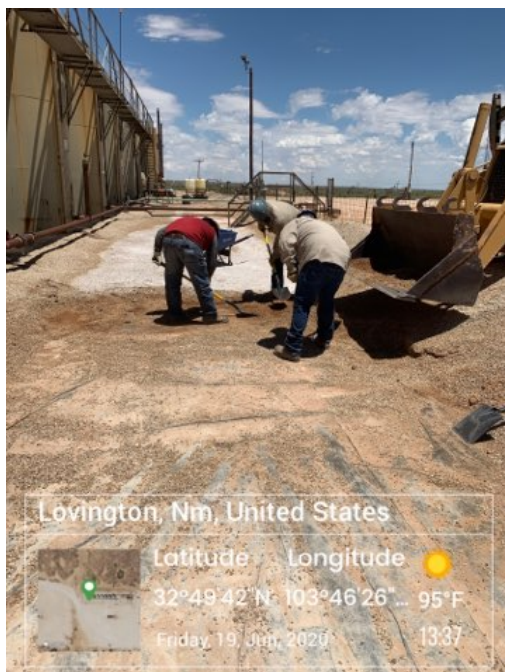
**J G STATE #001  
DURING PHOTOS**

On June 15<sup>th</sup>, 2020 ESS was dispatched out to the JG State to complete a site assessment. Initial Photos were taken of the release which was contained inside the lined facility. It was observed at that time that there was pea gravel and caliche on top of the liner and it would require removal before a liner inspection could be conducted. Due to the size of release, not all of the material was cleared from the liner due to the large size of the secondary containment. On June 19<sup>th</sup>, crews began to remove the material from the liner area, stockpiling on plastic to later be hauled to Lea Land Disposal. A total of 56 cubic yards of material was hauled to disposal. Please note that only the impacted area was cleared.

On September 4<sup>th</sup>, 2020 ESS notified the NMOCD by email, that sampling would be conducted under the exposed area of the liner. Please find the email attached herein. On September 9<sup>th</sup>, 2020 ESS arrived at the site to sample under the liner. Three areas of the liner were cut in 1'x 1' squares. Sampling was conducted by use of hand auger in 1' intervals. Sample crews field tested for chlorides using the titration method and checked for volatiles in the soil by use of a PID Meter. Each of the three sample points were delineated to 5'bgs and the only depths found to have any contaminants were directly under the liner, labeled as surface. These samples were well under the concentration thresholds and it was determined to patch the sample areas and repair the liner. A background sample was also gathered from the pasture area. Spur Energy opted to not cover the area with any further material at this time. Each bottom hole sample was jarred and delivered to Envirotech Laboratories for confirmation. The samples confirmed with laboratory analysis on the liner sampling procedure were well below the closure criteria for this site. Please find the sample data below and also is attached herein:
