Incident ID	NAPP2106151803
District RP	
Facility ID	
Application ID

Site Name: OPLTS CALMON 35 Federal #2 CTB	Site Type: Tank Battery
Date Release Discovered: 11/25/20	API# (if applicable)

Re: Request for Closure
OPLTS Calmon 35 Federal #2 CTB
Incident ID: NAPP2106151803

Liner Inspection Form

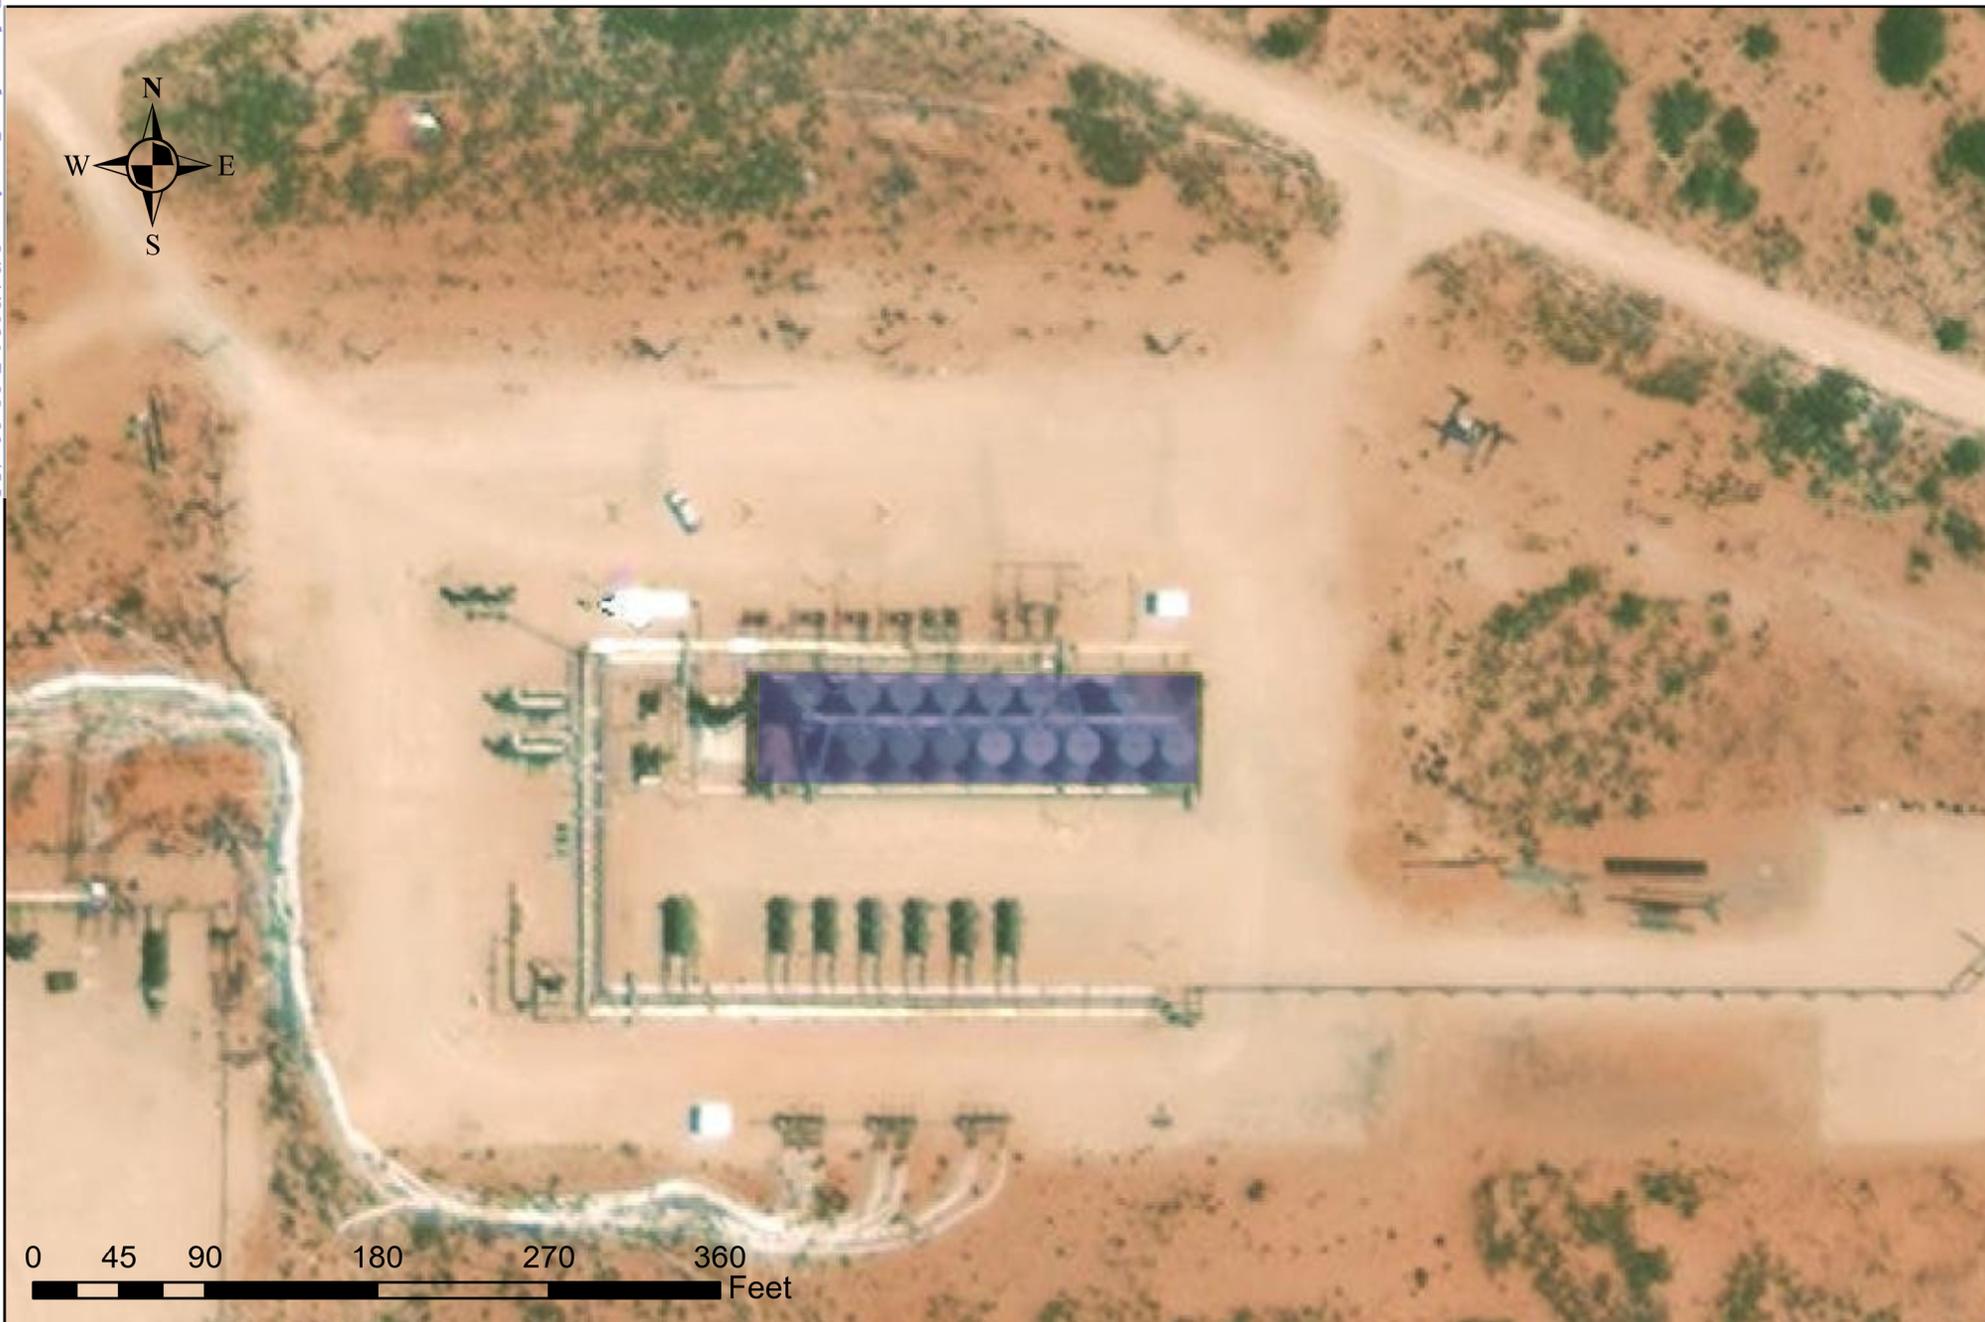
Figure 2
Release Area Map
 Calmon 35 Fed #002 CTB
 OXY USA, Inc.
 Eddy County, New Mexico
 EMNRD Incident ID NAPP2106151803

On November 25, 2020, OXY USA, Inc. (OXY), discovered a release at the Calmon 35 Federal #2 CTB. A water inlet line valve was closed due to human error during normal operations, causing produced water to leak from the top of the skim tank, resulting in the release of approximately 15 bbls of crude oil. The entire release was in a lined containment, and no liquids escaped the container. During initial response activities, the inlet line valve was opened, and a vacuum truck was utilized to recover approximately 12 bbls of free-standing liquid. The release affected an area in a lined container, measuring approximately 100 sq. ft.

This release was contained within a lined and contained facility, the liner was cleaned with a pressure washer. Upon inspection the liner is found to be in satisfactory condition.

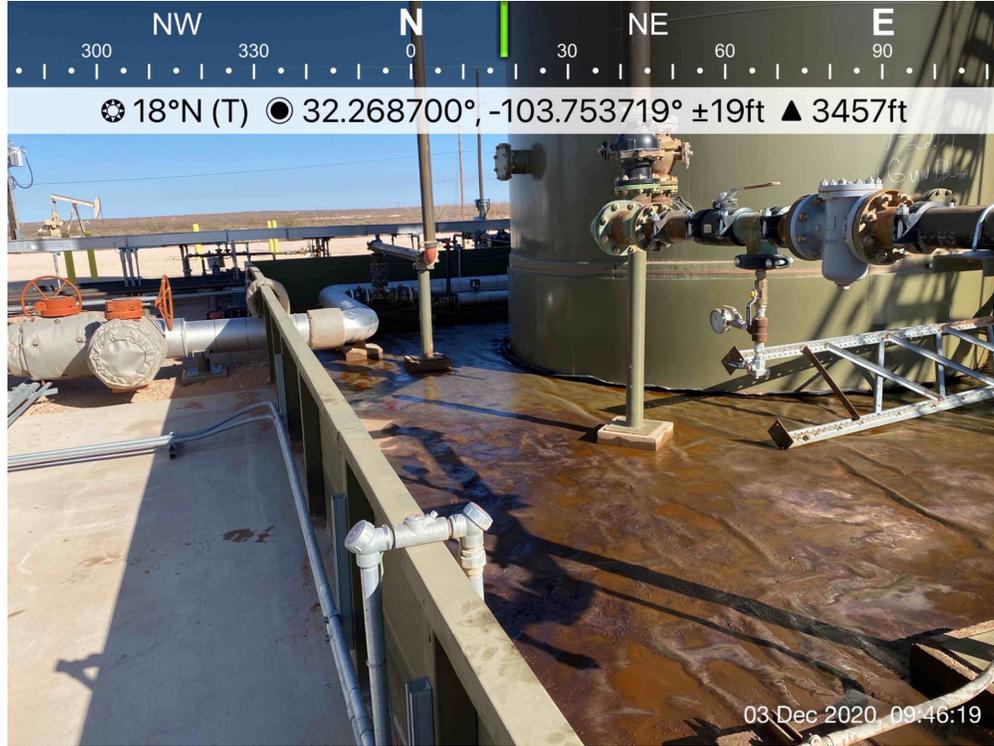
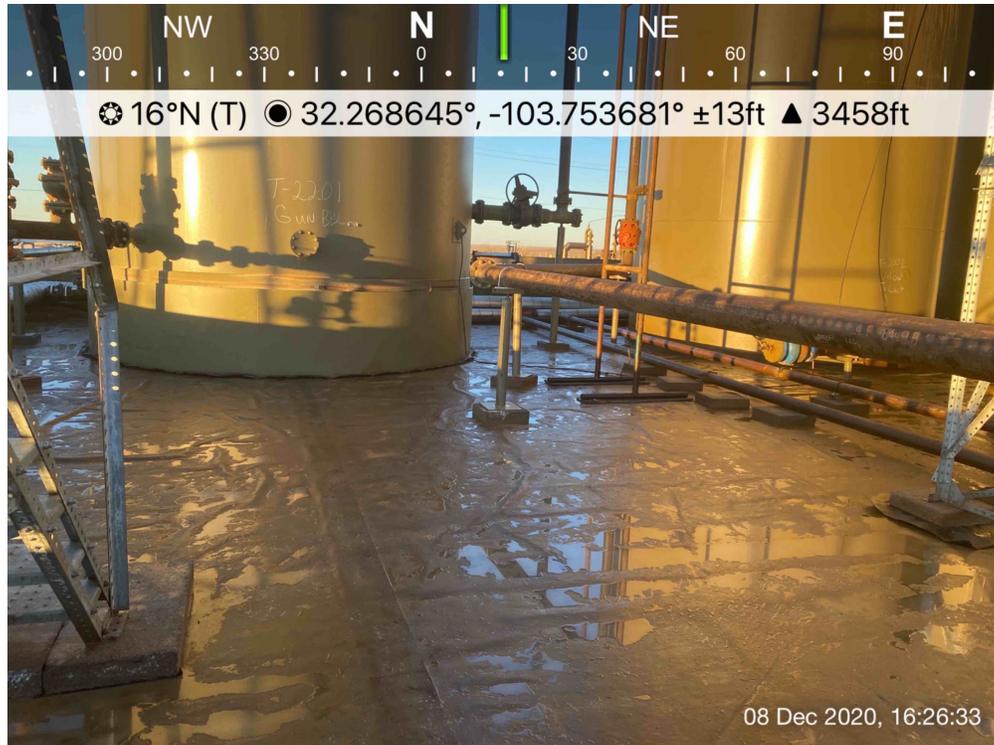
Facing North

At the time of inspection, it was noted that the liner material used at the OPLTS Calmon 35 Federal #2 CTB containment is typical 20-mil reinforced liner typical of the material used in oilfield containment structures. The overall condition of the liner was good, and no defects or holes were observed. No significant debris was observed in the containment area.
