Release Notification

**RE: Closure Request
PLU 13 DTD 108H
Incident Number NAPP2110460622
Eddy County, New Mexico**

PHOTOGRAPHIC LOG		
XTO	PLU 13 DTD 108H Carlsbad, New Mexico	NAPP2110460622

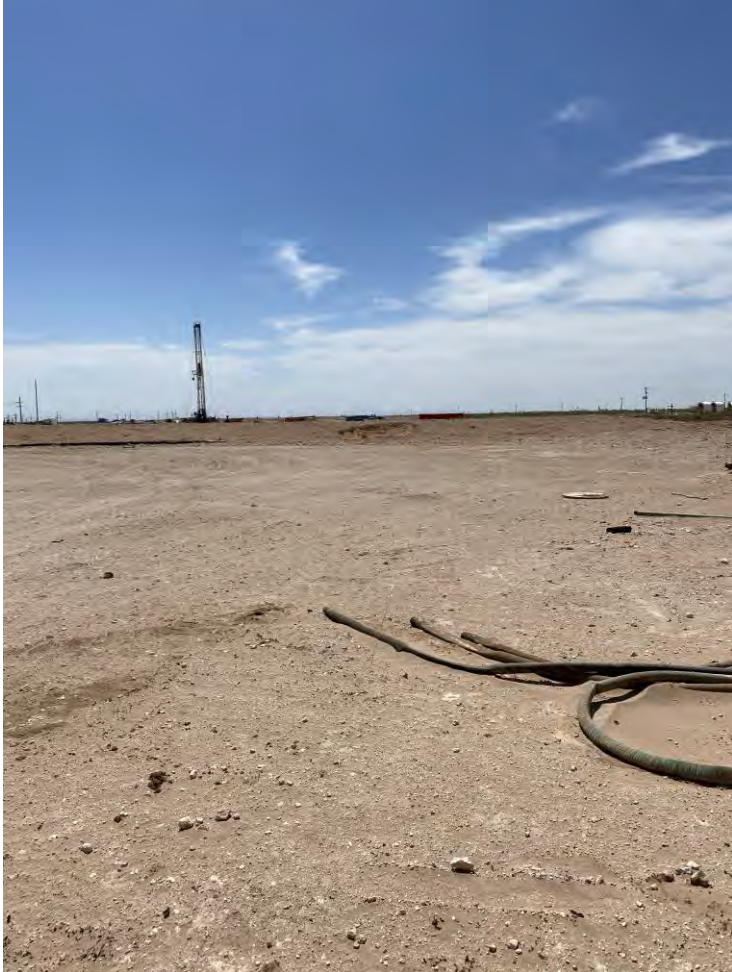
Photo No.	Date	
1	May 10, 2021	
View of release from the northeast corner of the one-call area.

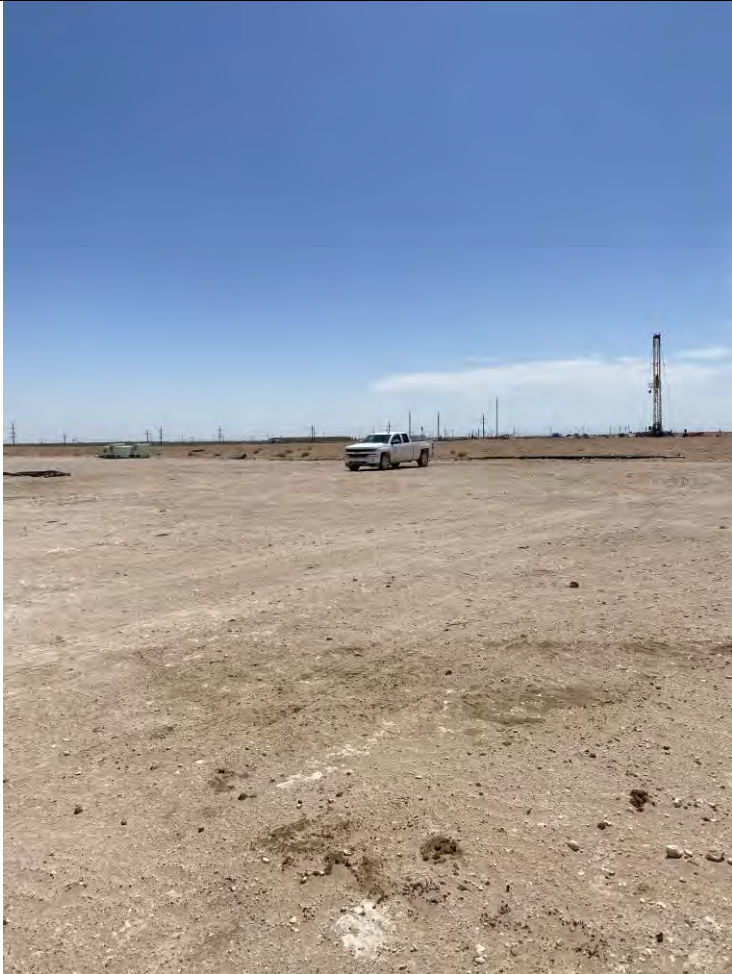
Photo No.	Date	
2	May 10, 2021	
Secondary view of release extent from the northeast corner of the one call area.
