Report Type: Closure Report 1RP-4455

Site:	Laguna Deep #7					
Company:	Cimarex Energy					
Section, Township and Range	Unit E	Sec. 36	T 19S	R 33E		
Lease Number:	API No. 30-025-36255					
County:	Lea County					
GPS:	32.618109°			-103.621671°		
Surface Owner:	State					
Directions:	From the intersection of W. Carlsbad Hwy. and Smith Ranch Rd., head northwest on Smith Ranch Rd. for 1.7 miles, turn right (northeast), go 325 feet and arrive on location.

Re: Closure Report for the Cimarex Energy, Laguna Deep #7, Unit E, Section 36, Township 19 South, Range 33 East, Lea County, New Mexico.

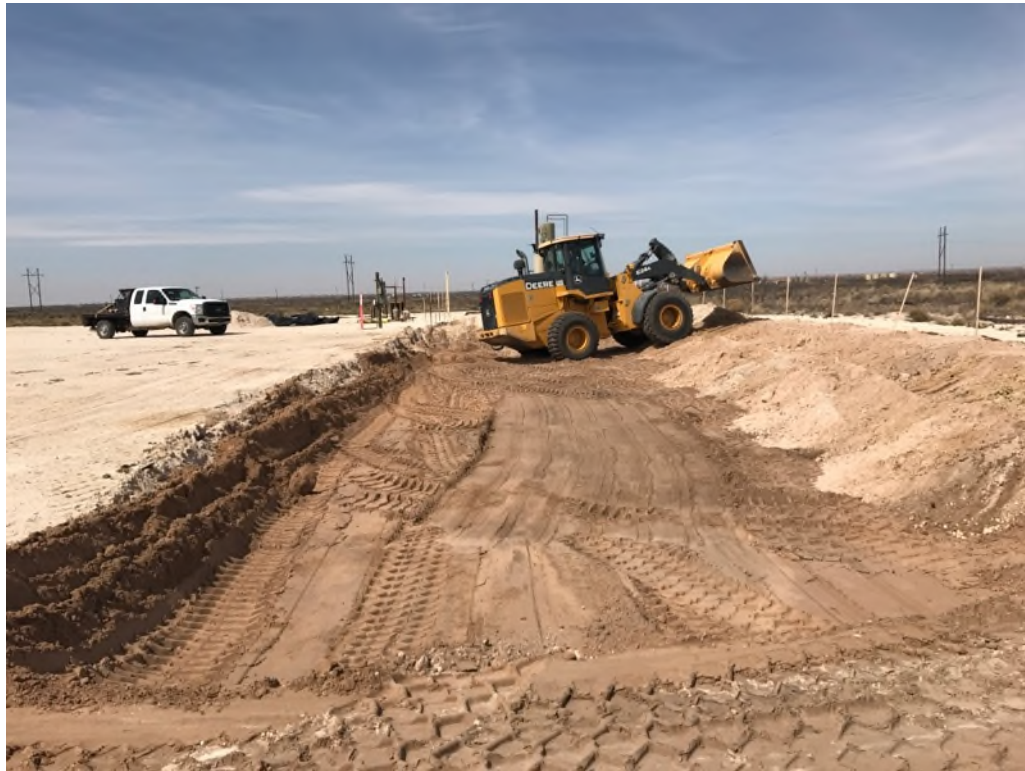
Area of SP-5 and SP-4 Excavation – View to Northwest

Approximately 170 cubic yards of material was removed and hauled to proper disposal. The excavations were then lined with a 20 mil liner, backfilled with clean material and returned to surface grade. The excavation areas and depths are shown on Plat 4.

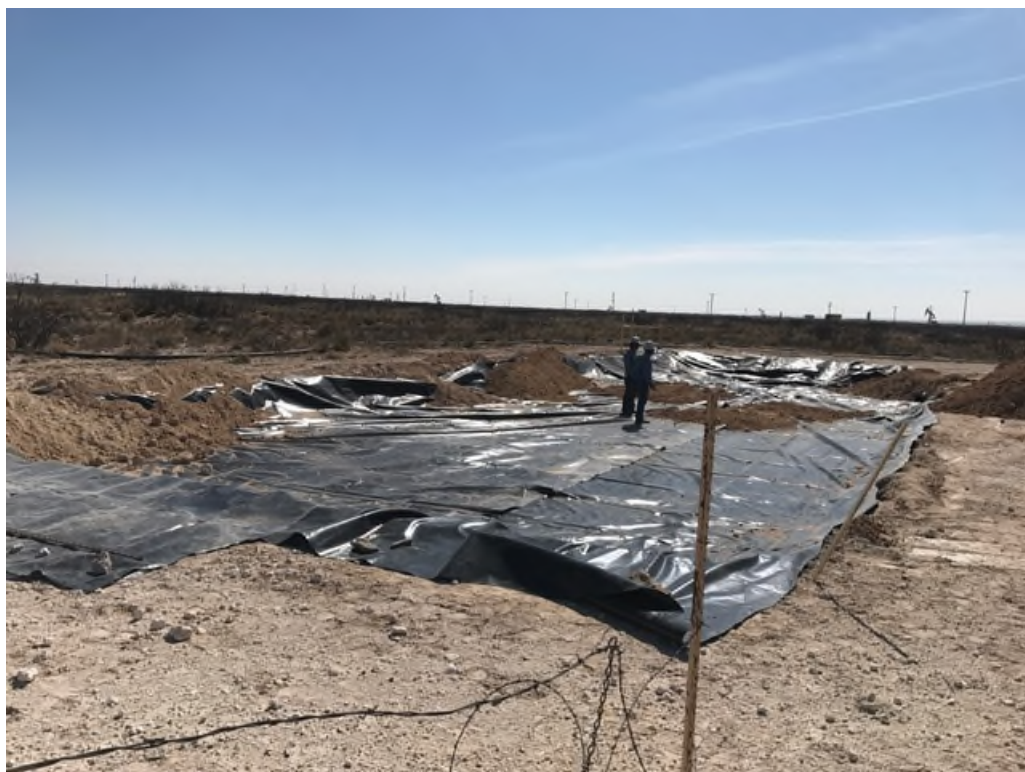
Area SP-5 and SP-4 Liner Installation – View to Southeast

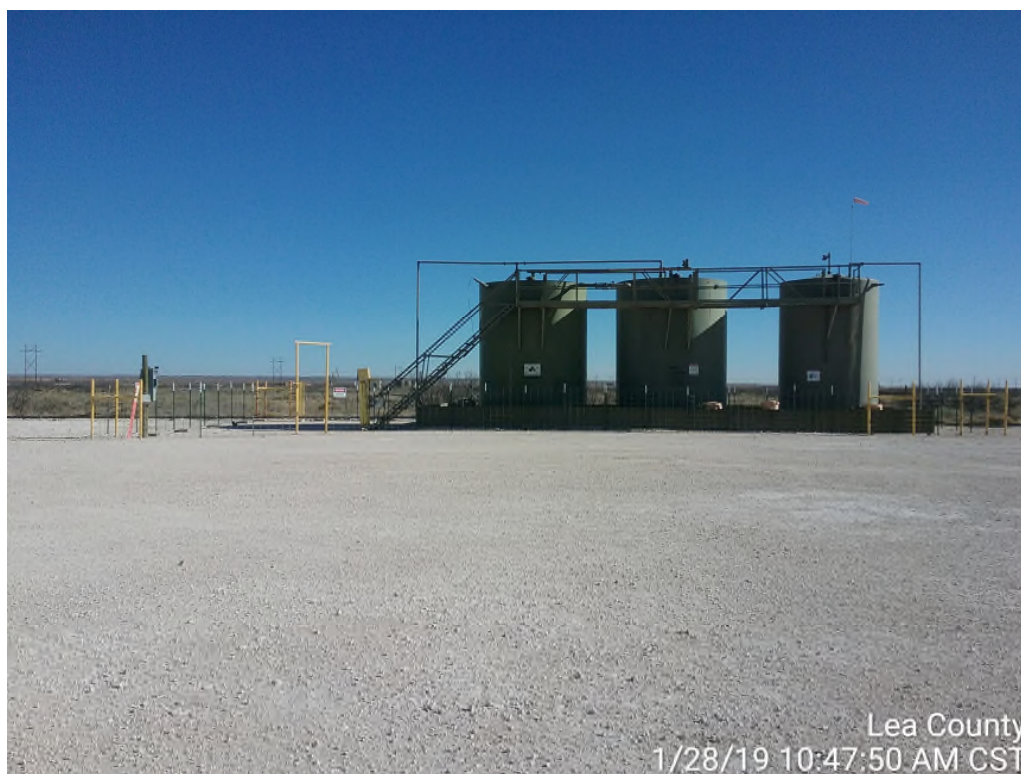
Reconstructed Tank Battery Area of SP-5 – View to Northeast

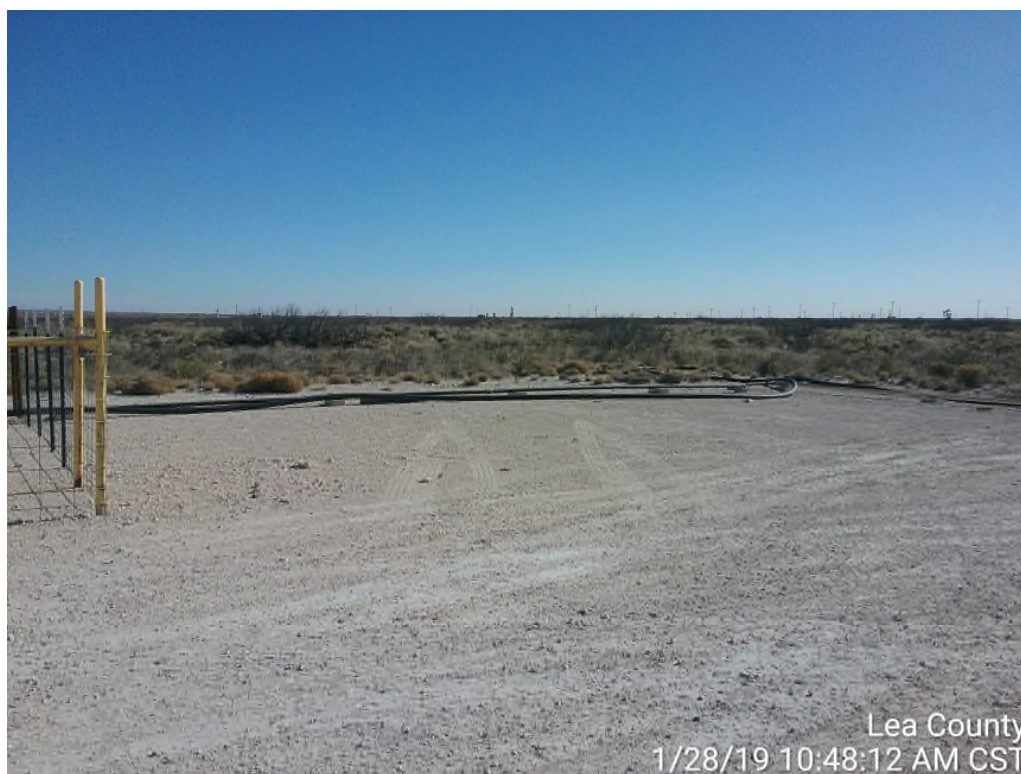
Area of SP-4 after reconstruction – View East

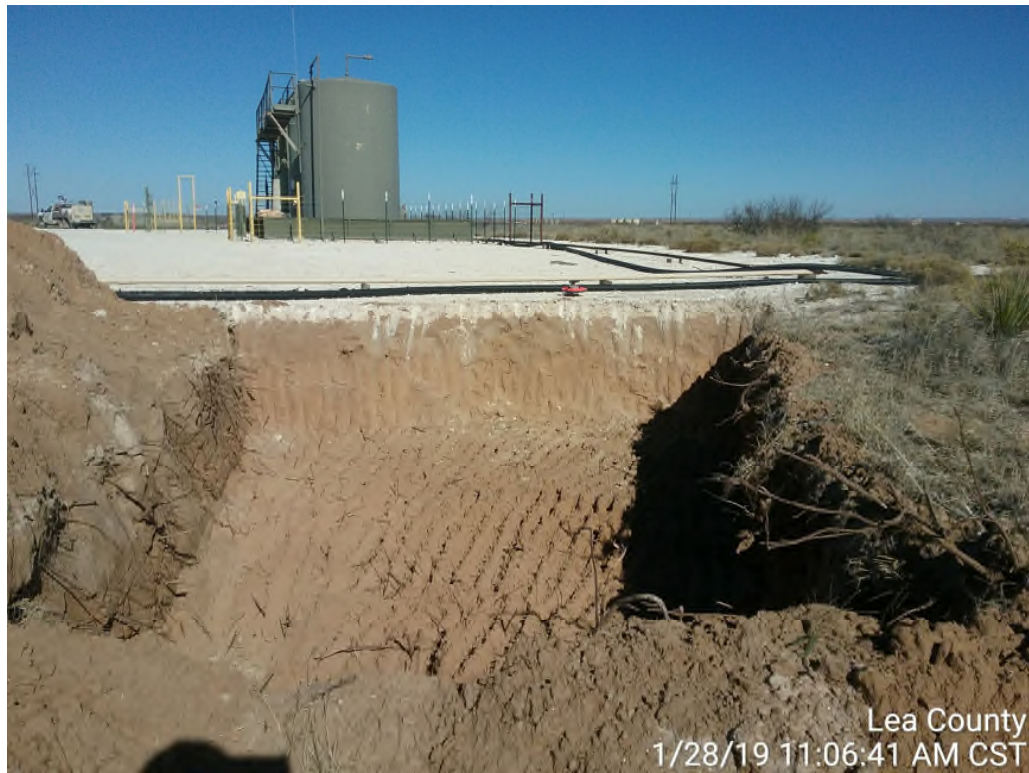
SP-3 Excavation – View to Northwest

Tetra Tech personnel were onsite January 28-29, 2019, to supervise the remediation activities in the southeast pasture area. The areas of auger holes (SP2 and SP3) were excavated to 4' below surface. Sidewall and bottom hole confirmation samples were then collected from those excavations. Additionally, the area of auger hole (SP-1) was trenched with a backhoe, per NMOCD's request for delineation in the area.

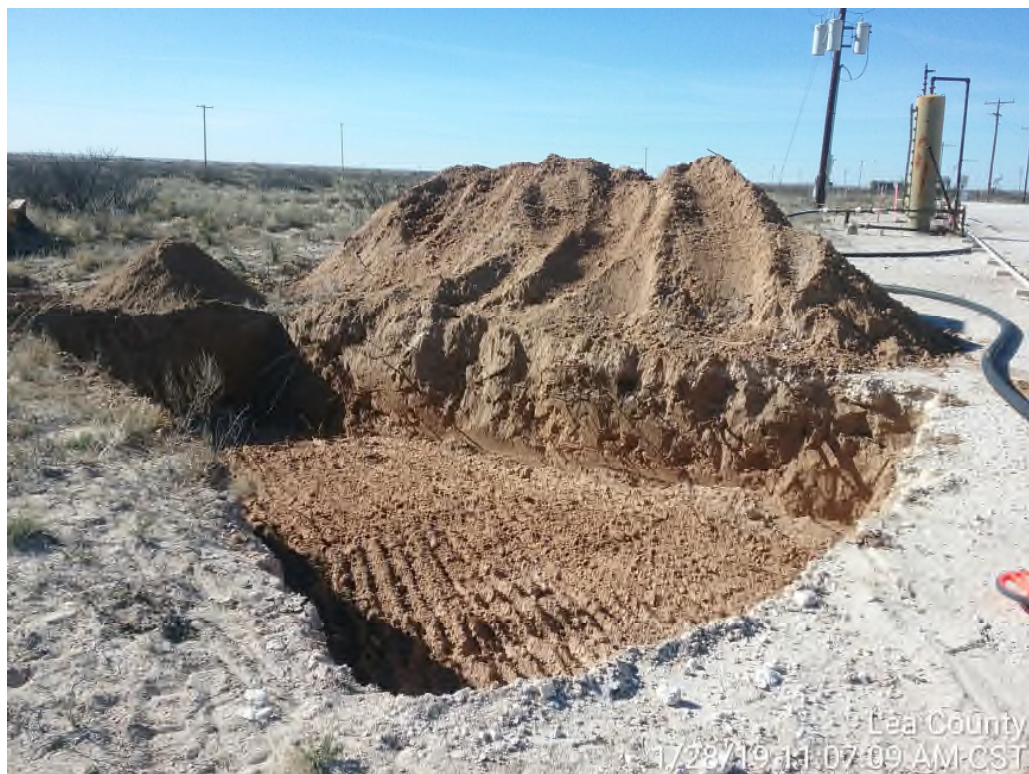
SP-3 Excavation – View Southwest

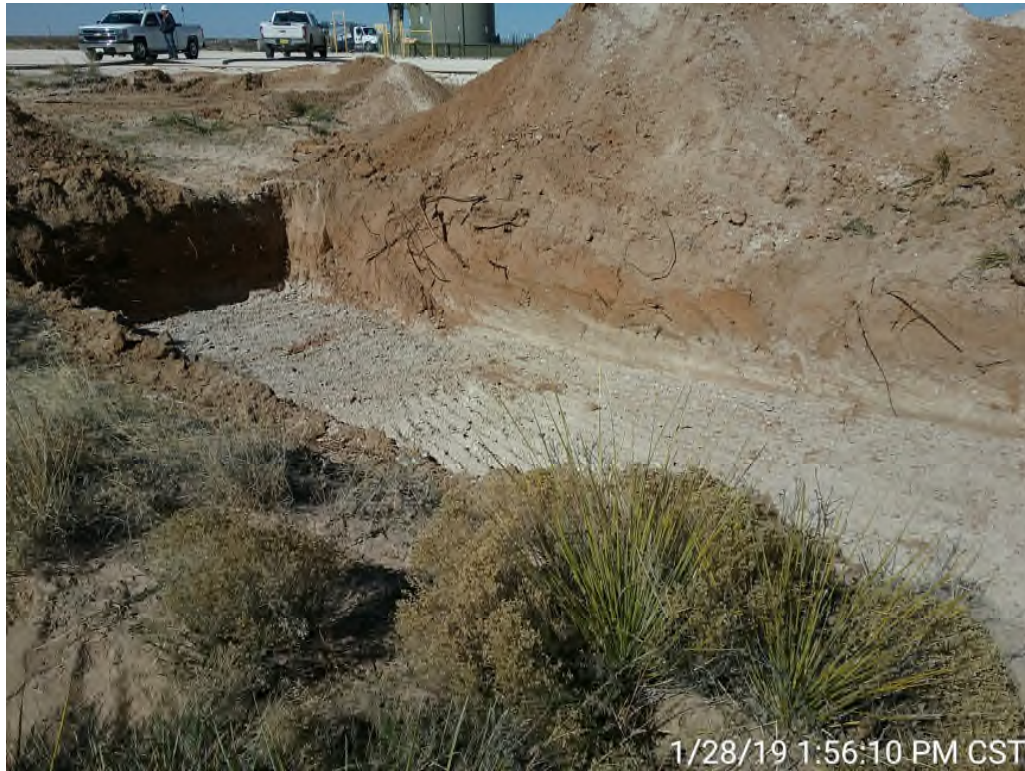
SP-2 Excavation – View to Northwest

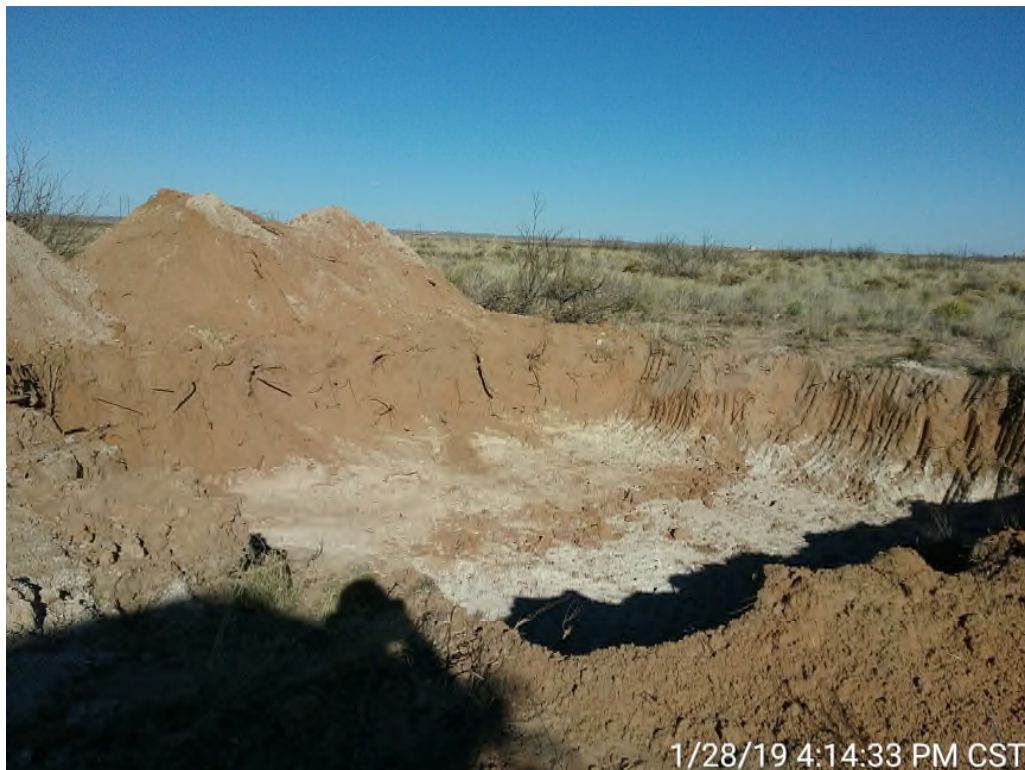
SP-2 Excavation – View East

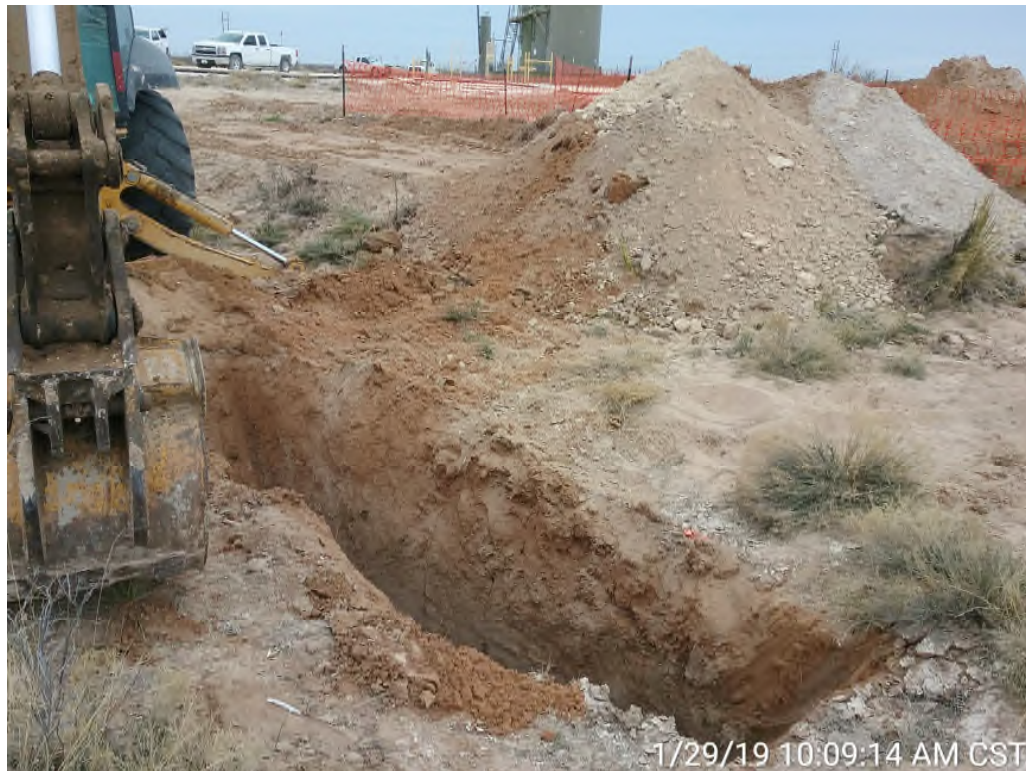
Area of T-1 – View to Northwest

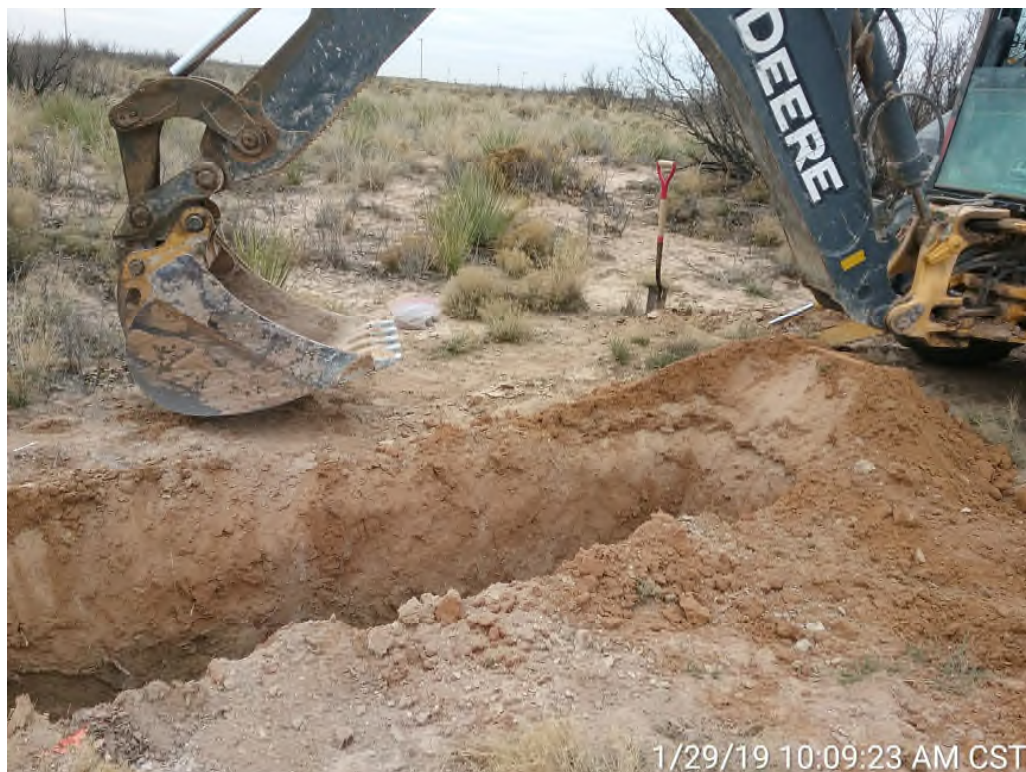
Area of T-1 – View South

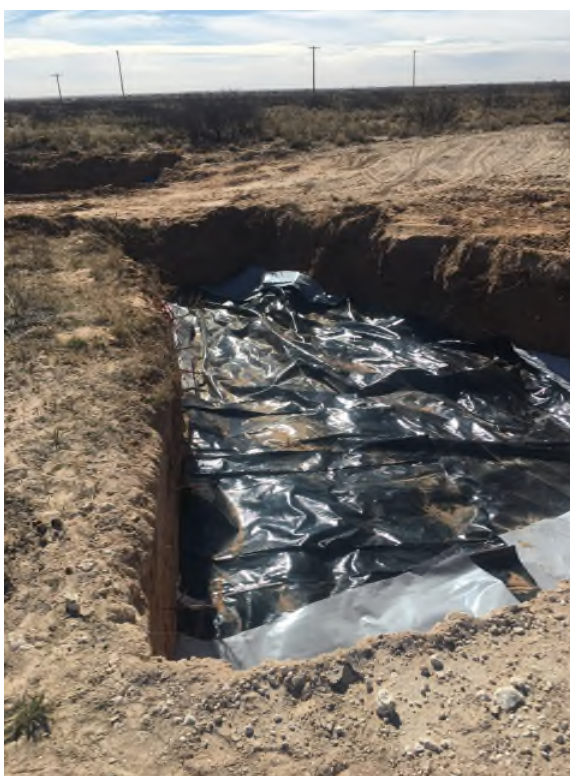
Area of SP-2 Liner Installation – View to South

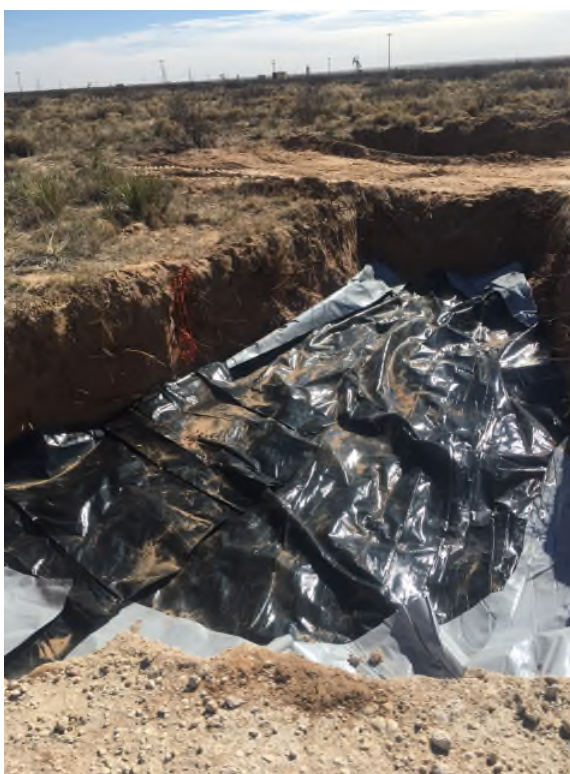
Area of SP-2 Liner Installation – View Southeast

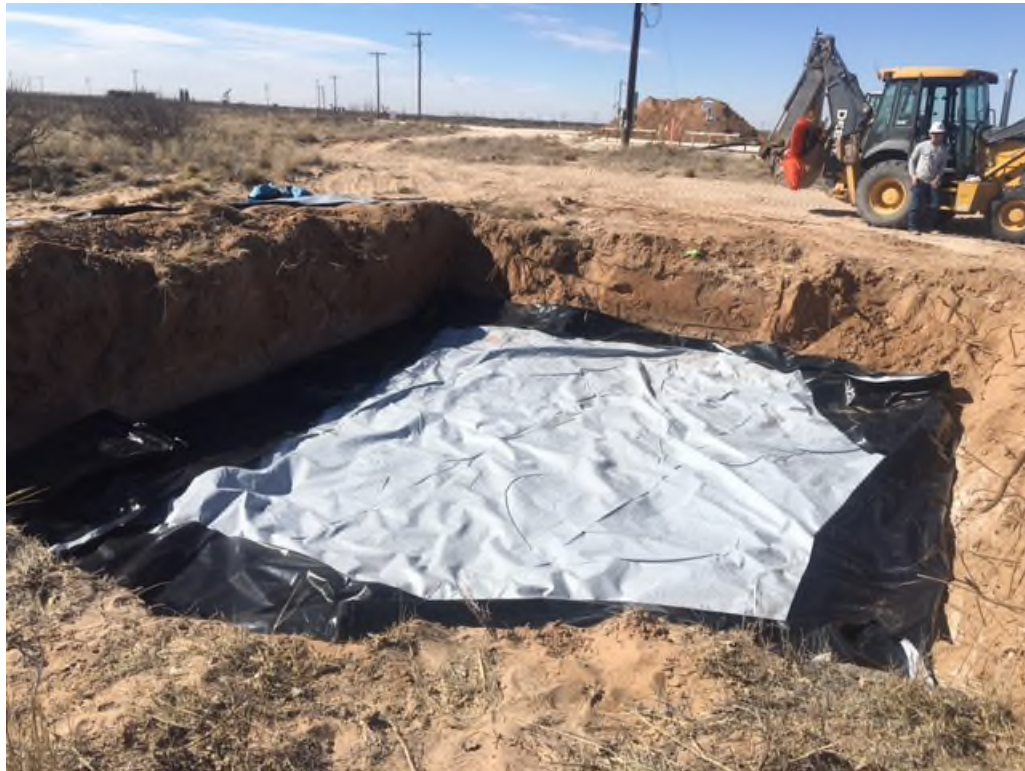
Area of SP-3 Liner Installation – View to North

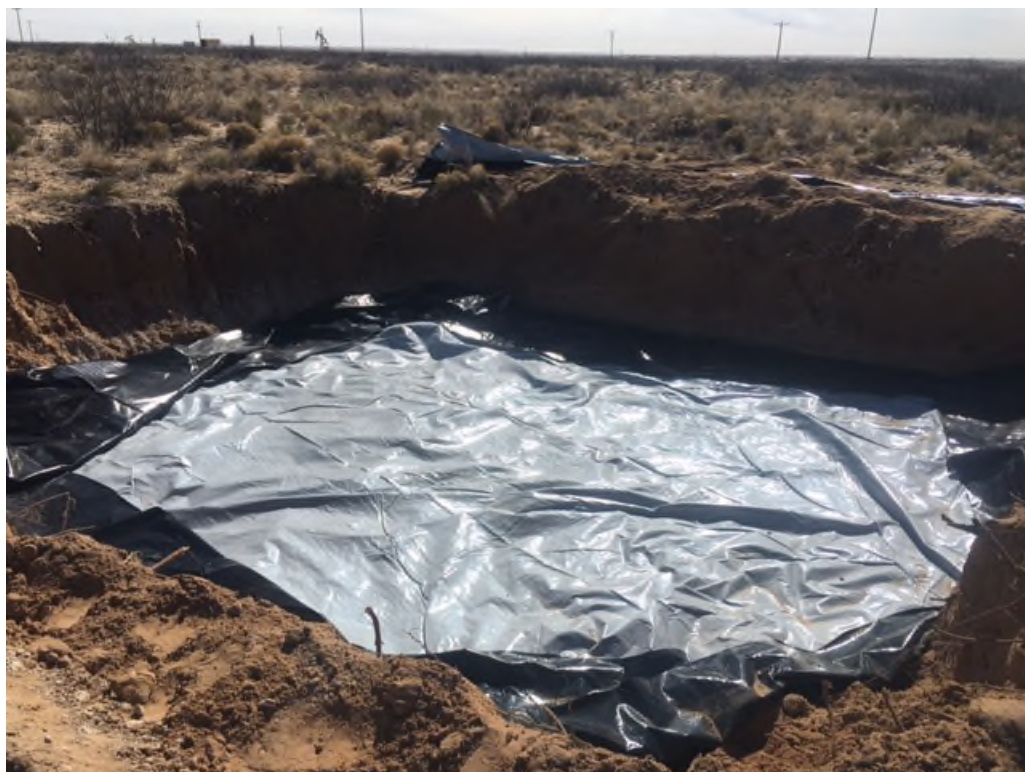
Area of SP-3 Liner Installation – View East
