Release Notification

Site Name	Ross Ranch 6	Site Type	Battery
Date Release Discovered	11-28-2020	API#	(if applicable)

On November 28, 2020, the supply gas regulator for the heater treater pneumatic dumps malfunctioned and resulted in the release of approximately 221.05 barrels (bbls) of produced water and 17.41 bbls of crude oil onto the caliche well pad and adjacent pasture. The release traveled approximately 4,395 feet west into the pasture through a drainage and caused an overspray immediately west of the well pad. A vacuum truck was immediately dispatched to the Site to recover freestanding fluids, of which approximately 139.05 bbls of produced water and 10.95 bbls of crude oil were recovered. XTO reported the release to the New Mexico Oil Conservation Division (NMOCD) via email on November 28, 2020 and with a subsequent Release Notification and Corrective Action Form C-141 (Form C-141) on December 10, 2020. The release was assigned Incident Number NAPP2034638293.

WATERCOURSE SURVEY

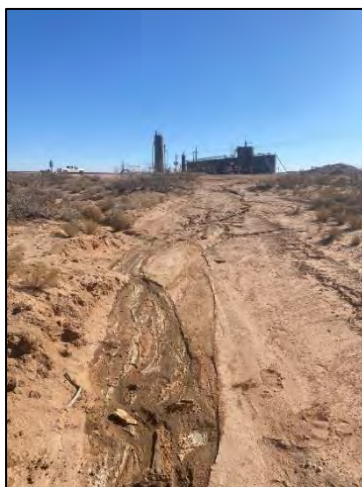
SURVEY PHOTO 1: VIEW SOUTHEAST SHOWING STAINED SOIL IN AN EROSIONAL DRAINAGE.

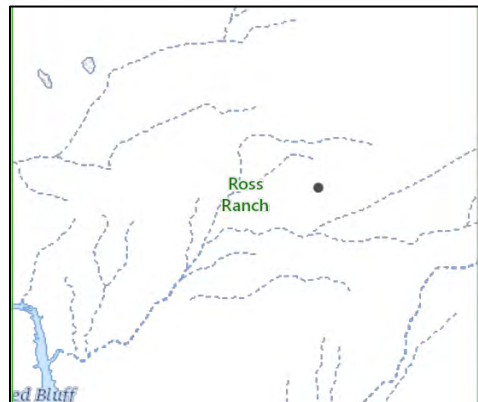
DIAGRAM 2: VIEW OF THE SITE LOCATION (GRAY CIRCLE) UTILIZING THE CURRENT USGS 7.5 MINUTE QUADRANGLE HYDROLOGY BASE LAYER MAP. REFERENCE:

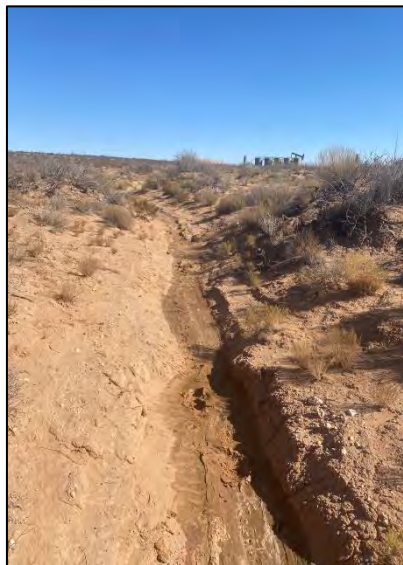
SURVEY PHOTO 2: VIEW NORTHEAST OF AN EROSIONAL RUT WITH SOIL STAINING FROM THE RELEASE.

No bed or bank was identified during the visual field survey of the watercourse. Only erosional paths or swales and ruts aligned with the topographic gradient were visible (Survey Photo 1 and survey Photo 2). The drainage did not appear to connect to a larger watercourse.

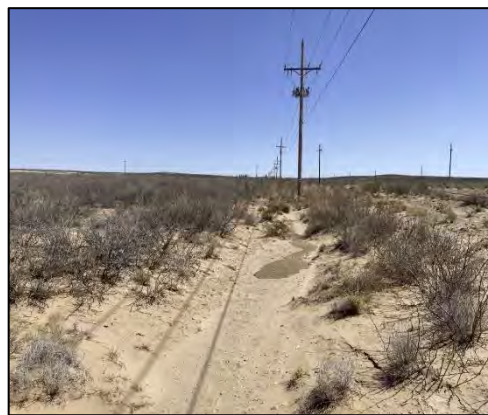
SURVEY PHOTO 3: VIEW EAST SHOWING THE FARTHEST EXTENT OF SOIL STAINING FROM THE RELEASE (OVER ROW). NO BED OR BANK IS EVIDENT.

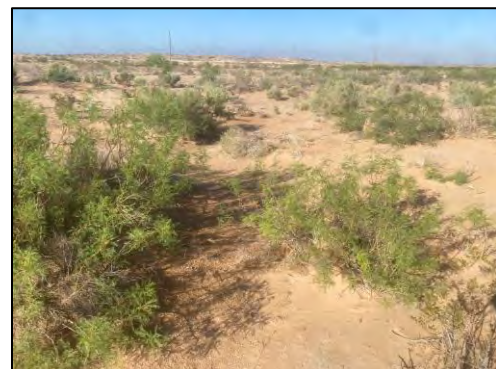
SURVEY PHOTO 4: VIEW SOUTHWEST SHOWING THE END OF THE DRAINAGE FEATURE SPLAYING OUT ALONG THE DESERT FLOOR. NO BED OR BANK IS EVIDENT.

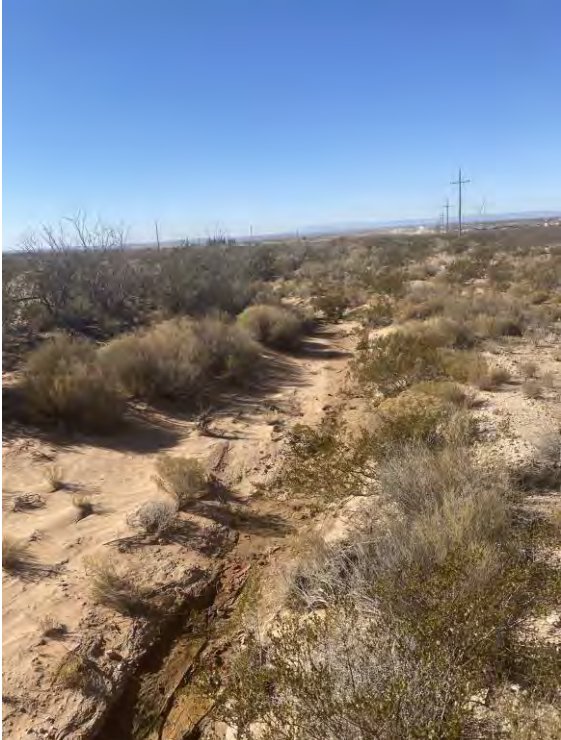
Photo No.	Date	
1	December 4, 2020	
Release within pasture facing east.

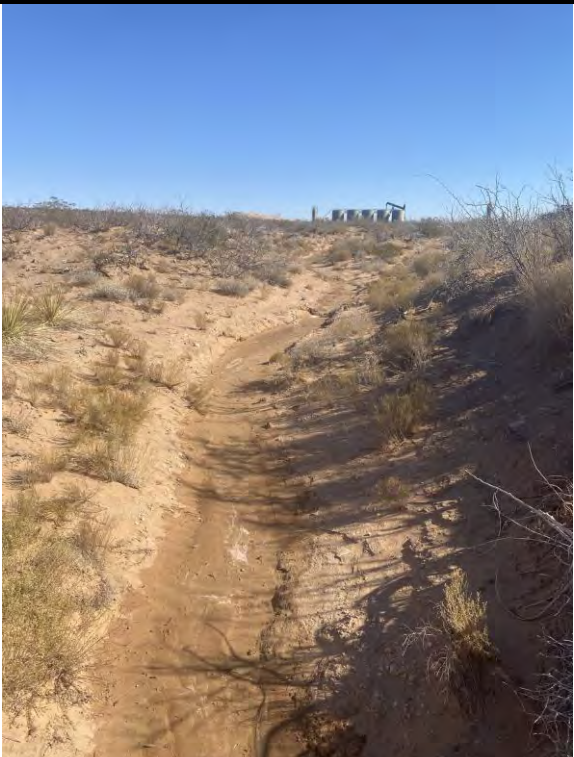
Photo No.	Date	
2	December 4, 2020	
Release within pasture facing east.

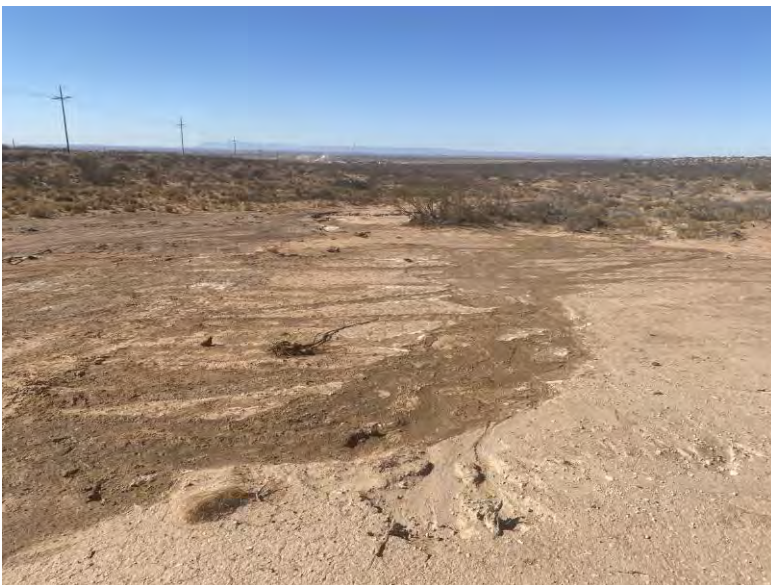
Photo No.	Date	
3	December 4, 2020	
Release at edge of well pad facing west.

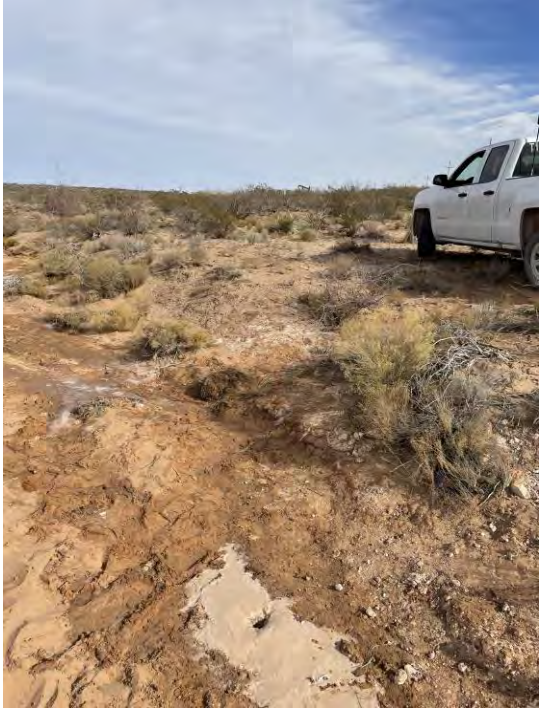
Photo No.	Date	
5	December 23, 2020	
View of corehole (CH02) facing east during delineation activities.

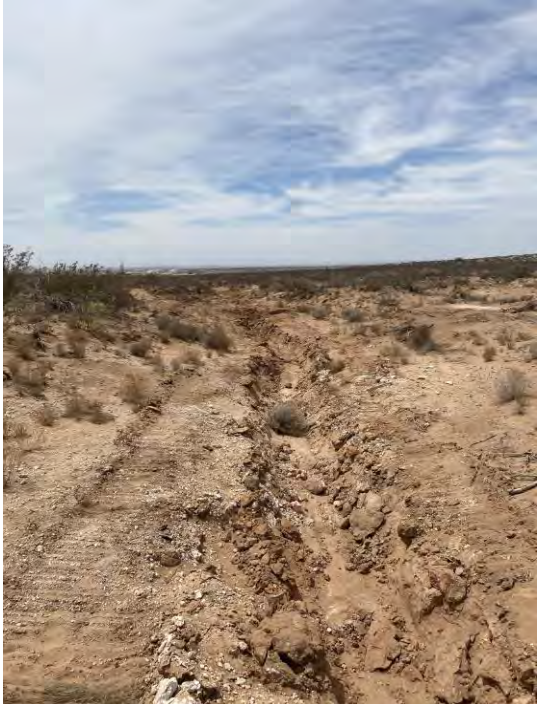
Photo No.	Date	
6	April 22, 2021	
View of the excavation facing west.

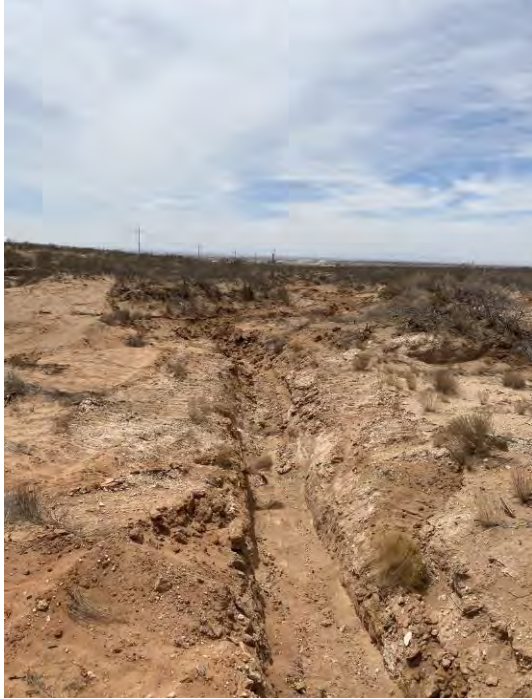
Photo No.	Date	
7	April 22, 2021	
View of the excavation facing west.

A photograph showing a deep, narrow excavation in a dry, desert-like environment. The soil is reddish-brown and appears to be composed of sand and small rocks. The excavation runs diagonally across the frame. In the background, there are some sparse, dry bushes and a clear sky with a few wispy clouds.

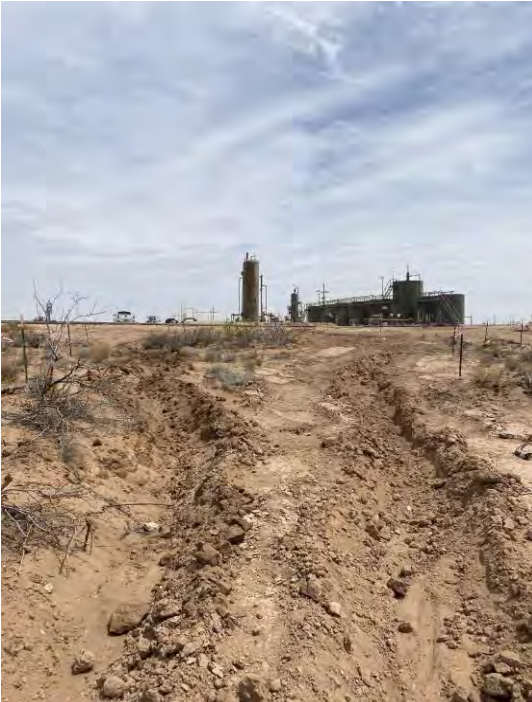
Photo No.	Date	
8	April 22, 2021	
View of the excavation facing east-southeast.

A photograph showing a deep, narrow excavation in a dry, desert-like environment. The soil is reddish-brown and appears to be composed of sand and small rocks. The excavation runs diagonally across the frame. In the background, there are some sparse, dry bushes and a clear sky with a few wispy clouds. A large industrial structure, possibly a wellhead or pumpjack, is visible in the distance on the right side of the frame.
