Re: Closure Report

Chevron USA, Inc

F.B. Davis Battery

Site Characterization and Closure Request

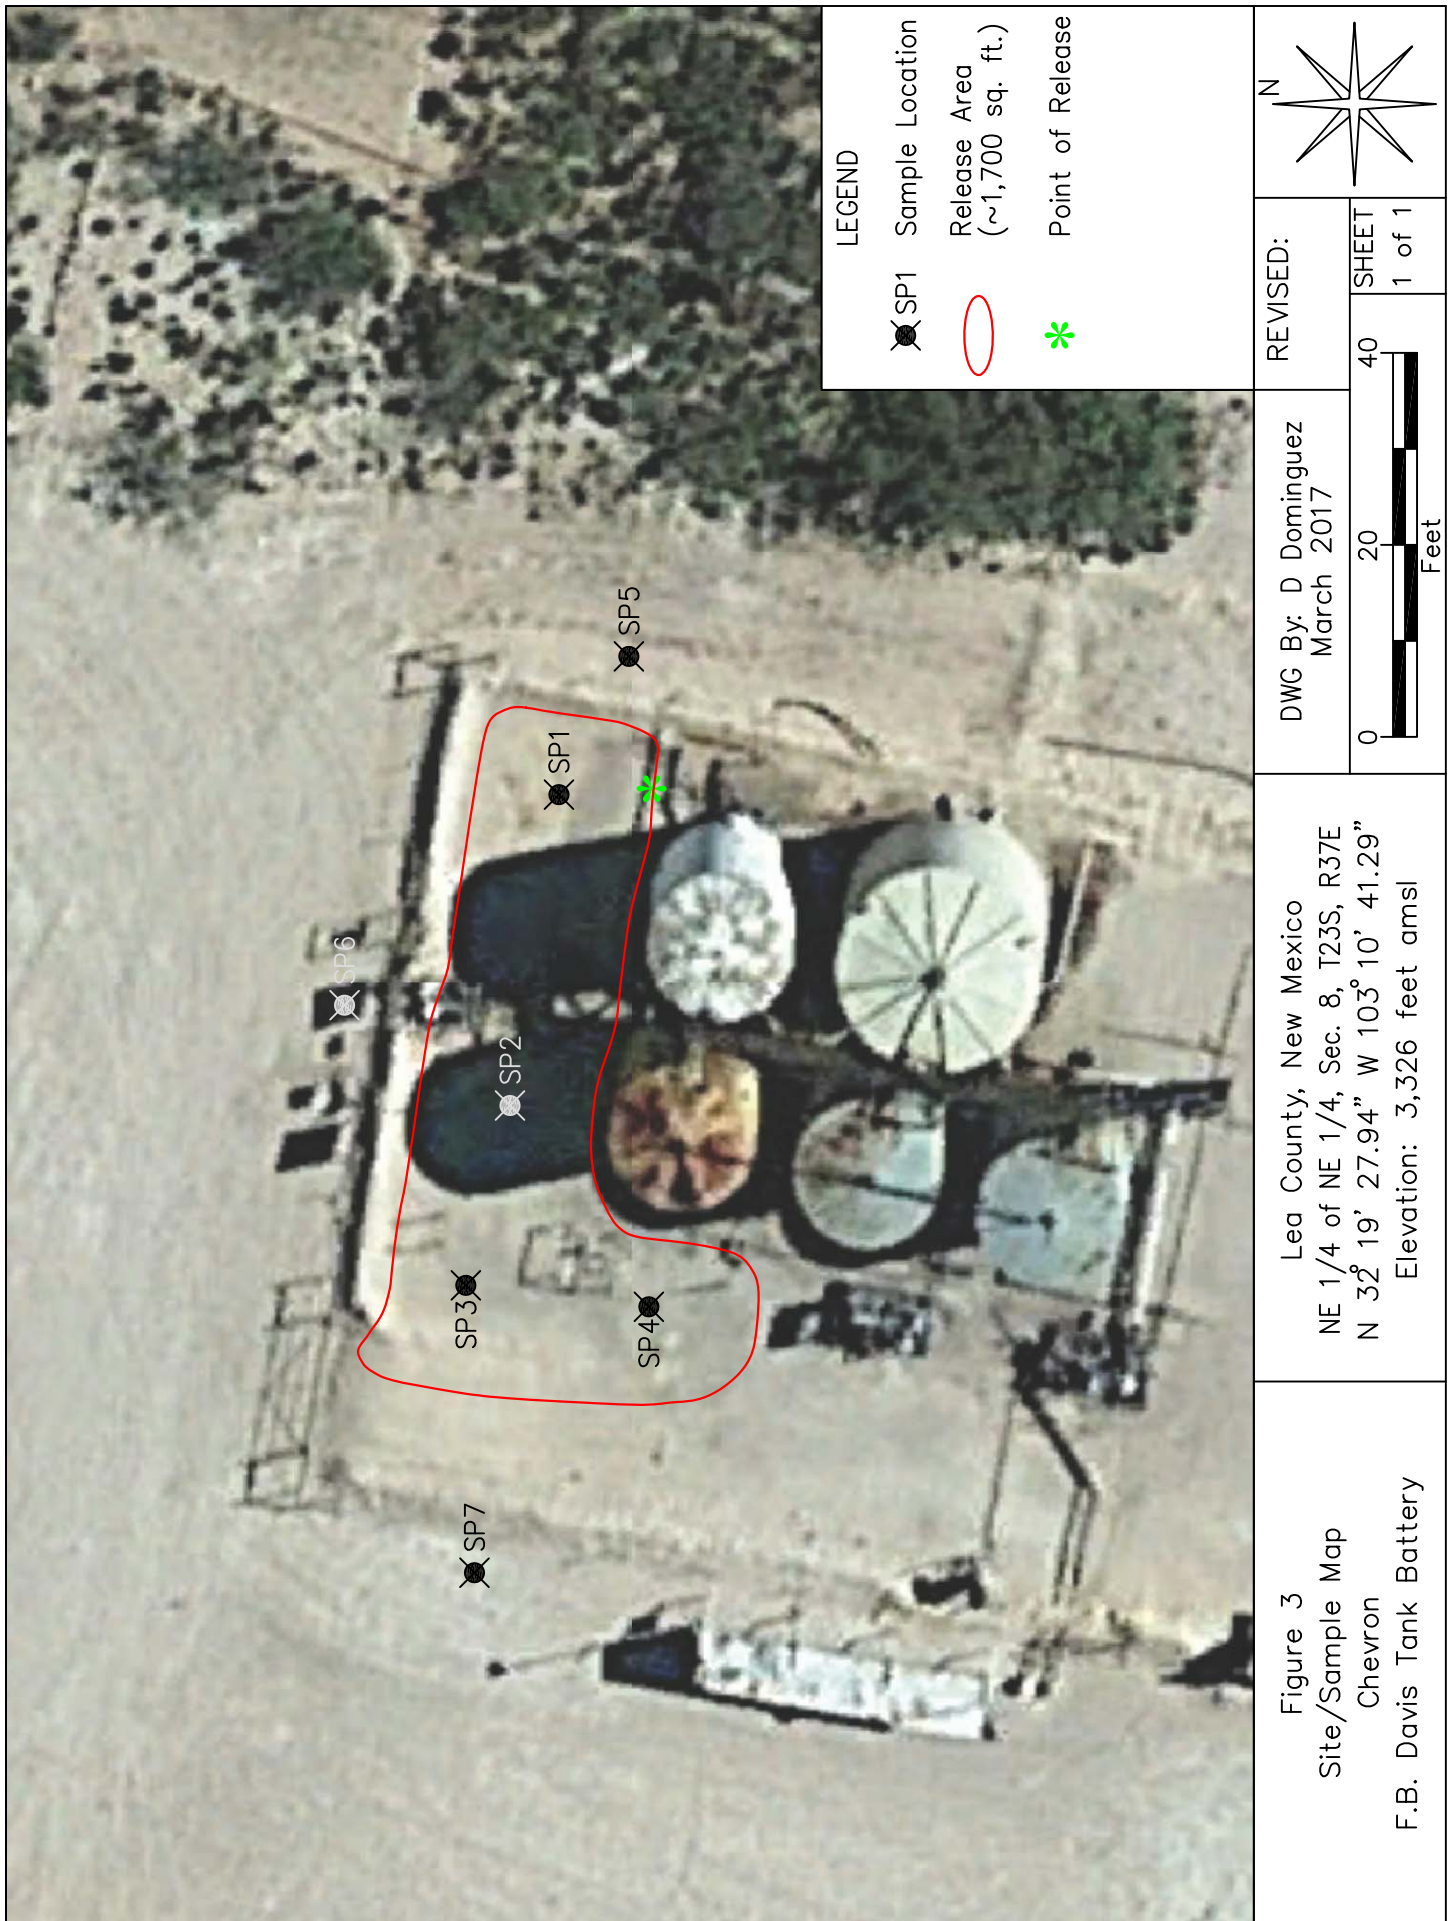
On January 31, 2017 EPI personnel mobilized on site to collect soil samples to determine the vertical extent of contamination. A total of thirteen soil samples were collected from four sample locations; SP1 – SP4. Two soil samples from each sample location were sent to Cardinal Labs in Hobbs, New Mexico, for testing. Laboratory analytical results indicate that other than elevated TPH levels at SP1 and SP2, the release area is void of Benzene, BTEX, TPH and Chloride concentrations in excess of NMOCD RRALs (reference *Figure 3* and *Table 2*).

On April 6, 2017 EPI personnel mobilized on site to collect soil samples to determine the horizontal extent of contamination. A total of six horizontal soil samples were collected from three sample locations surrounding the release area; SP5 – SP7. All six soil samples were sent to Cardinal Labs in Hobbs, New Mexico, for testing. Laboratory analytical results indicate that the area adjacent to the release area, horizontally, to be below NMOCD RRALs (reference *Figure 3* and *Table 2*).

Taking into consideration the release occurred on an active tank battery, and laboratory analytical data indicating elevated TPH levels at surface level at SP1 and SP2 (reference *Table 2*), The surface was scraped around the release area around SP1 and SP2, then backfilled with clean caliche. The area around SP3 and SP4, as well as the area adjacent to the release area on the tank battery pad, horizontally, was not be disturbed.
